#### Tree 0868 haybarn TPO 0579

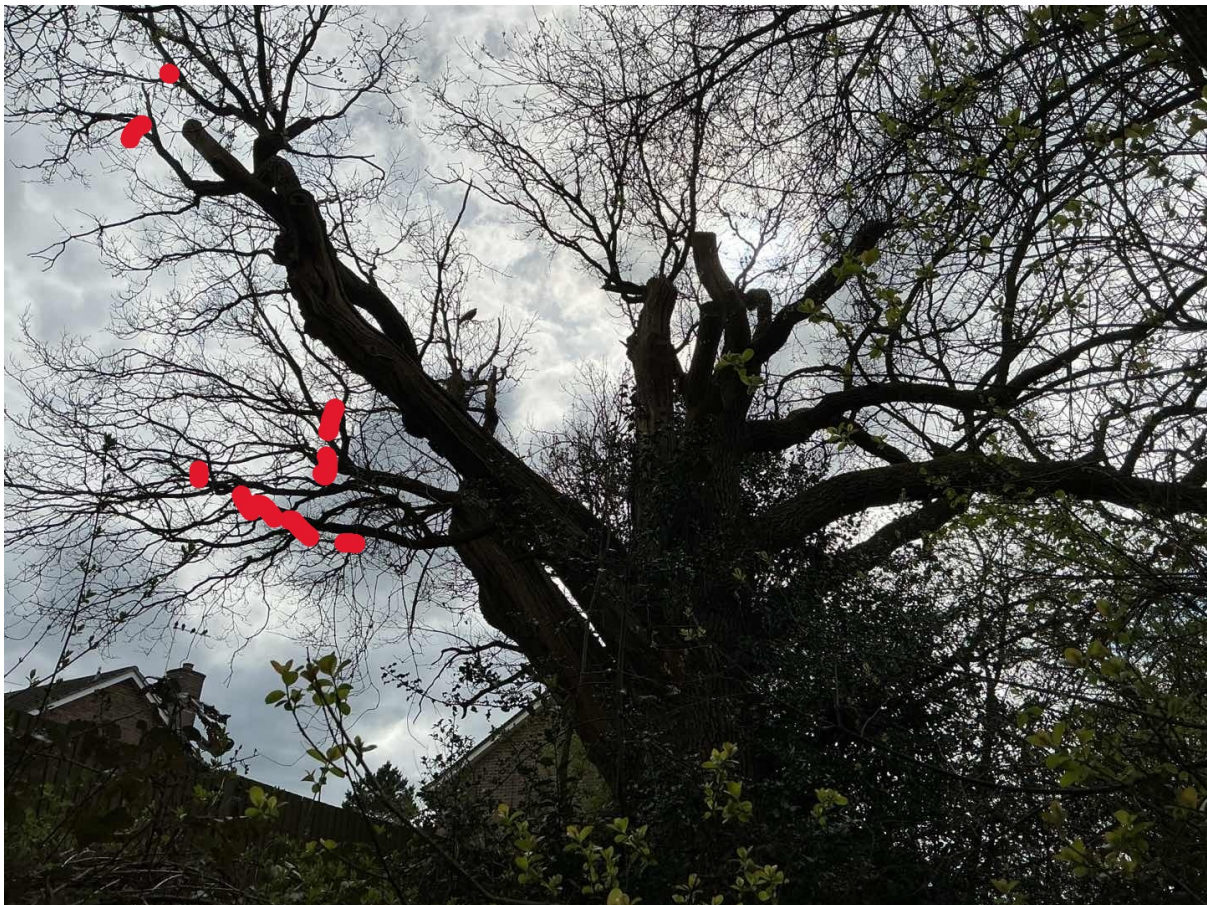
Proposed pruning cuts to east,

All cuts to be made with pruning (silky) saws.

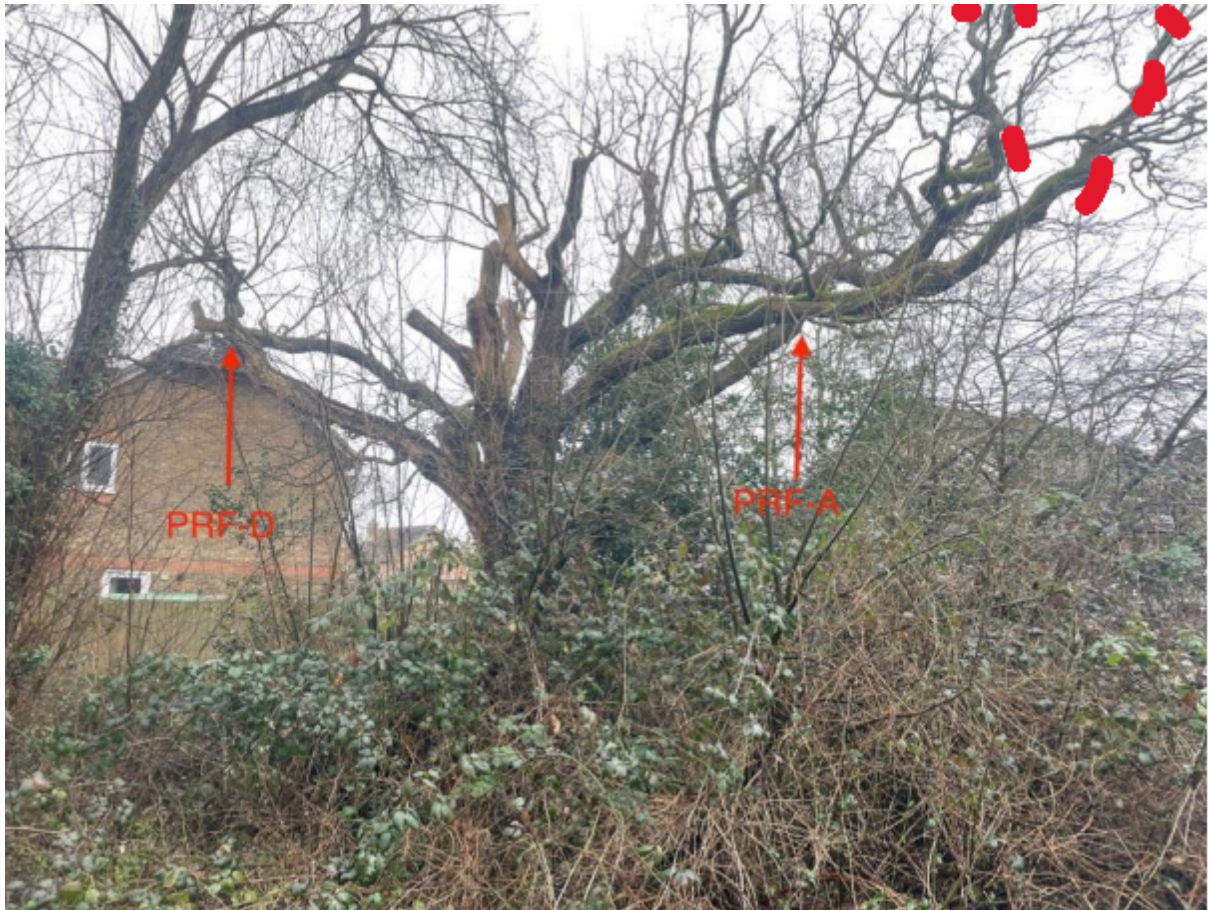
Proposed pruning cuts to west.

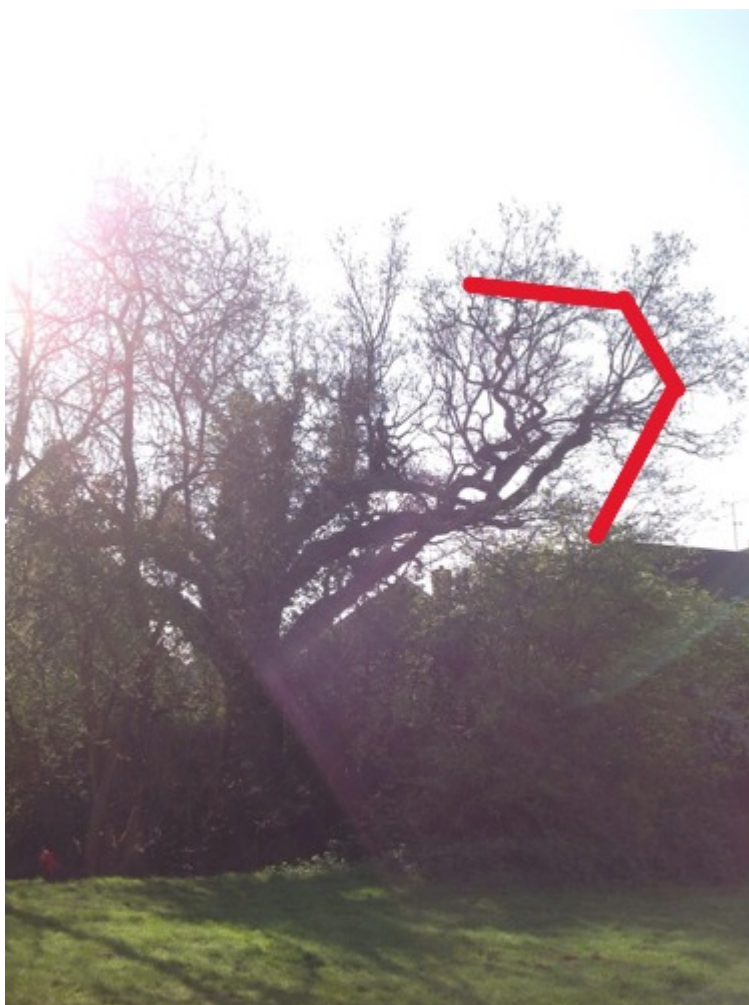
Final crown shape looking east.
