# Asbestos Demolition Survey

The Church Hall, Church Place, Pulborough, West Sussex RH20 1AF

Project: DLMA 2026-016

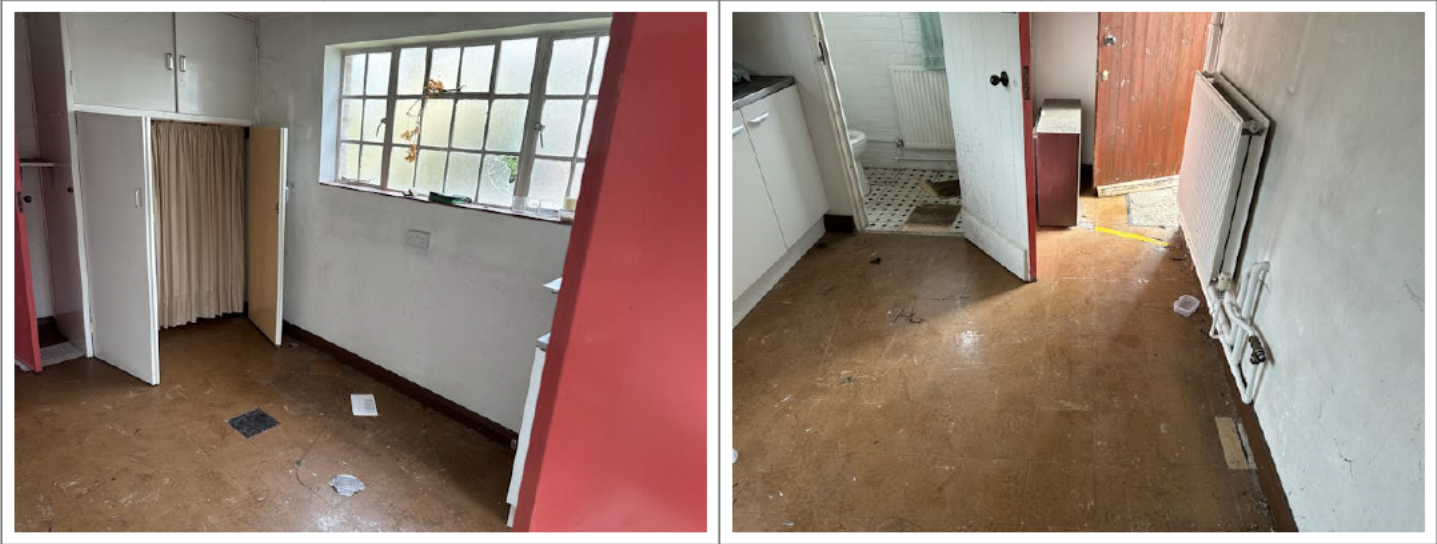
| Location | Brick built concrete slab ceiling. Critall windows with putty. Vinyl floor tiles on concrete slab. Steel and timber roof structure over clad with natural slate. Cast iron downpipes and gutters. | Item | |

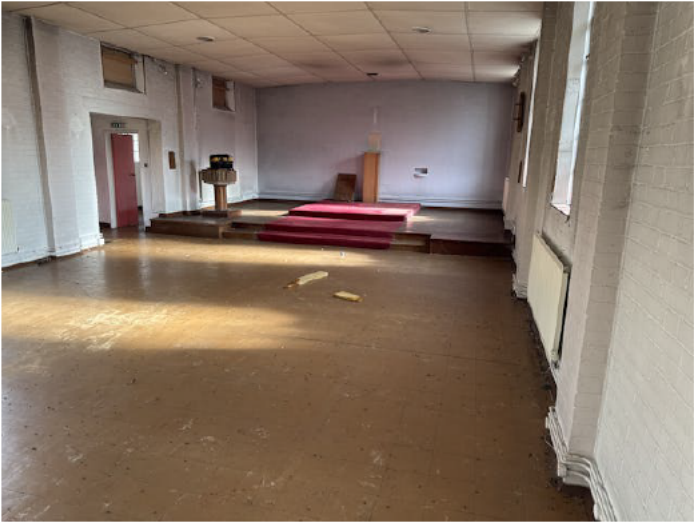
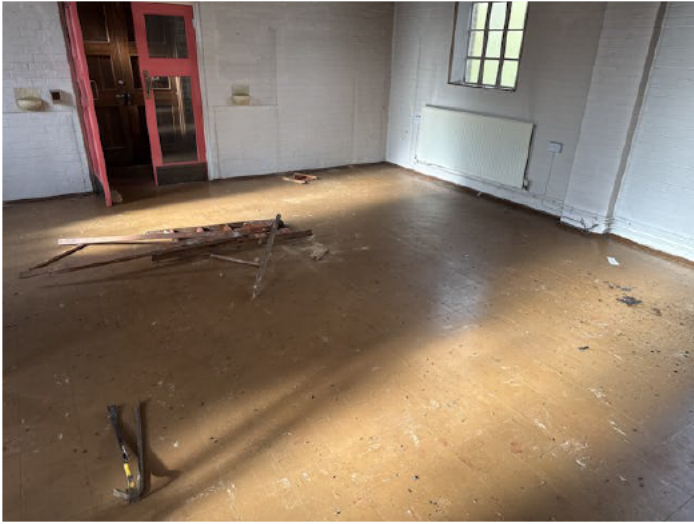
## Main Building &gt; 0 &gt; Hall &gt; Vinyl floor tiles

| Material | Bituminous Product | Extent | 150 sqm |
| Strategy / Sample Id | Strongly Presume / S03 | Presumed Fibre Type | Chrysotile |

| Material Score | 3 / Very Low | | |

| Recommendation | Removal by licensed contractor | | |

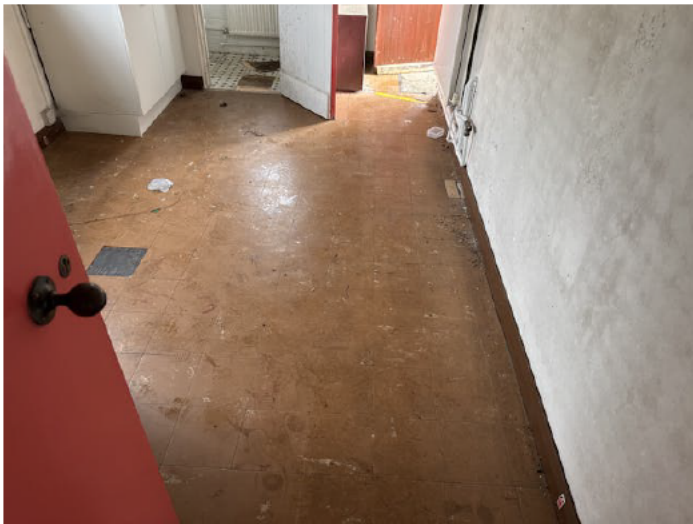
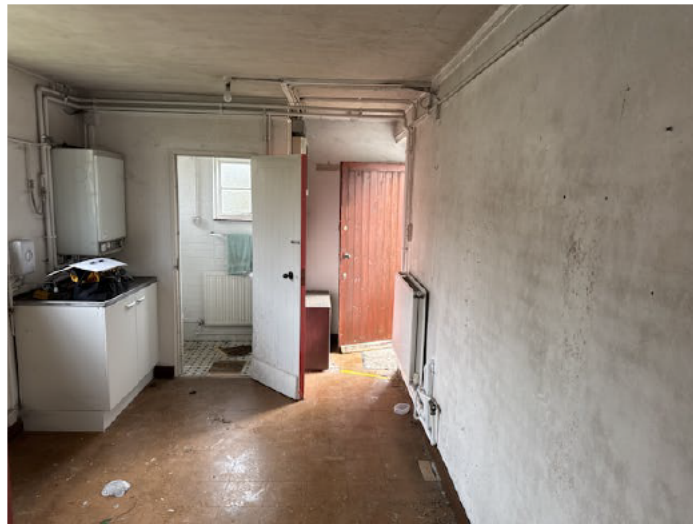
## Main Building &gt; 0 &gt; Rest Room &gt; Vinyl floor tiles

| Material | Bituminous Product | Extent | 15 sqm |
| Access / Notes | No Access / No Access Within Storage Heater - Live Plant - Sealed | | |
| Strategy / Sample Id | Sample / S03 | Fibre Type | Chrysotile |
| General Comments | No Access within storage heater | | |

| Material Score | 3 / Very Low | | |

| Recommendation | Removal by licensed contractor | | |

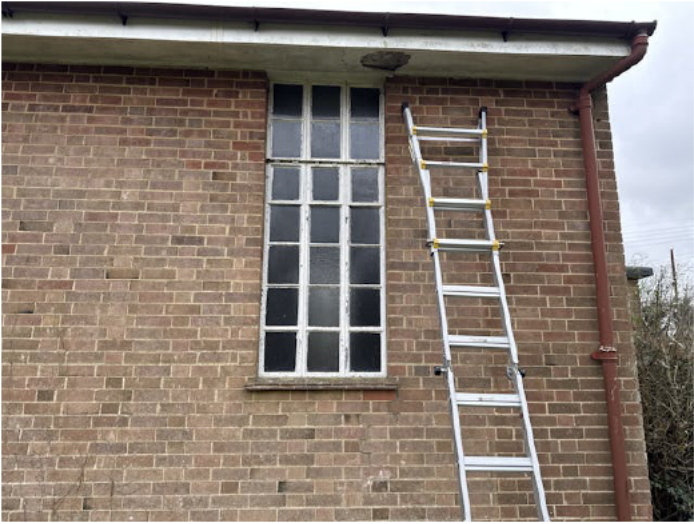
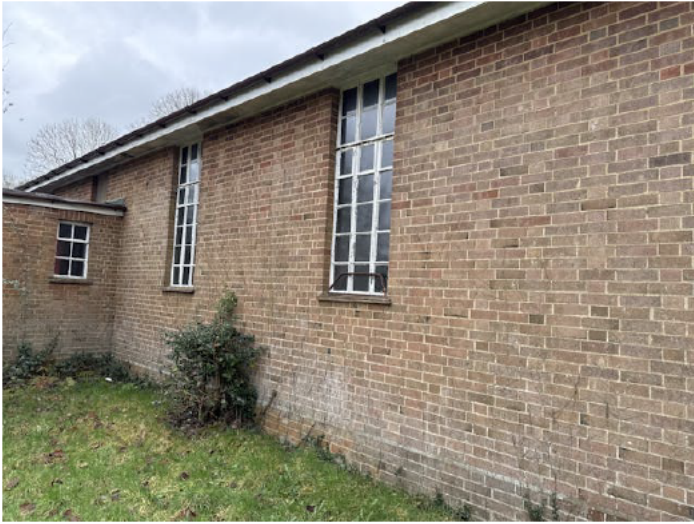
Main Building > 0 > Windows > Putty

| Strategy / Sample Id | Sample / S01 | Fibre Type | NADIS |

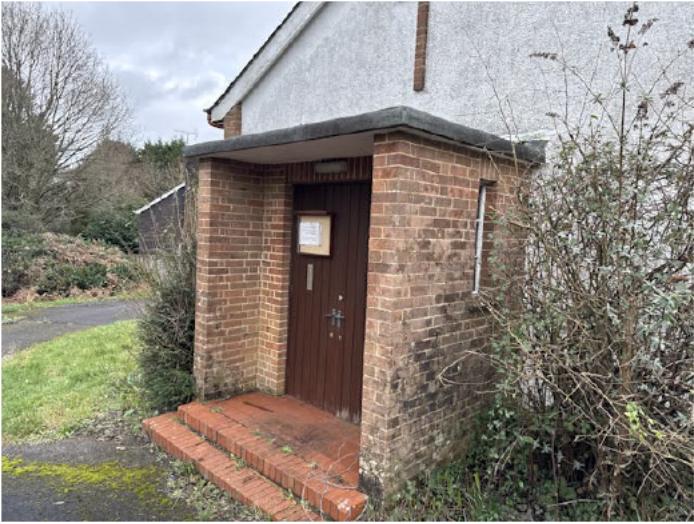
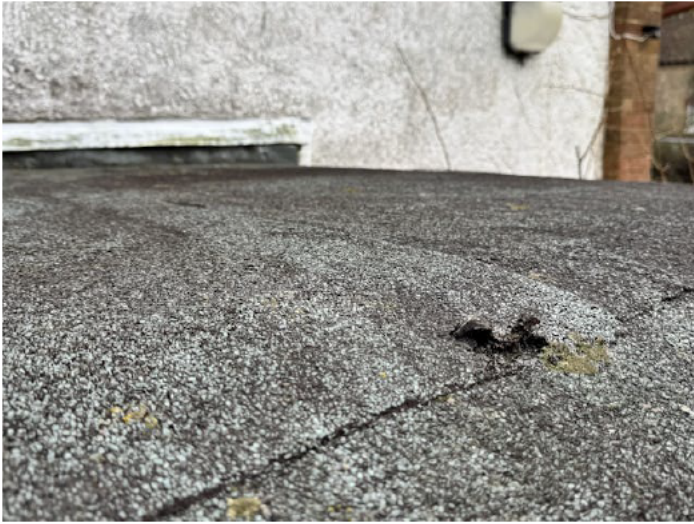
Main Building > 1 > Roof > Roof felt

| Strategy / Sample Id | Sample / S02 | Fibre Type | NADIS |

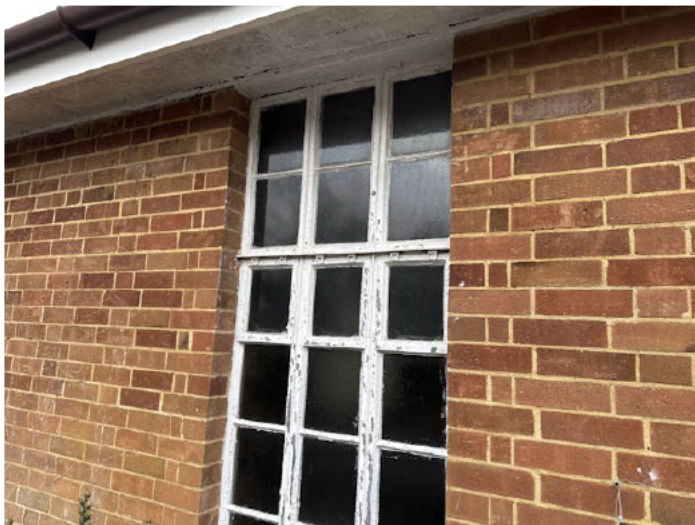
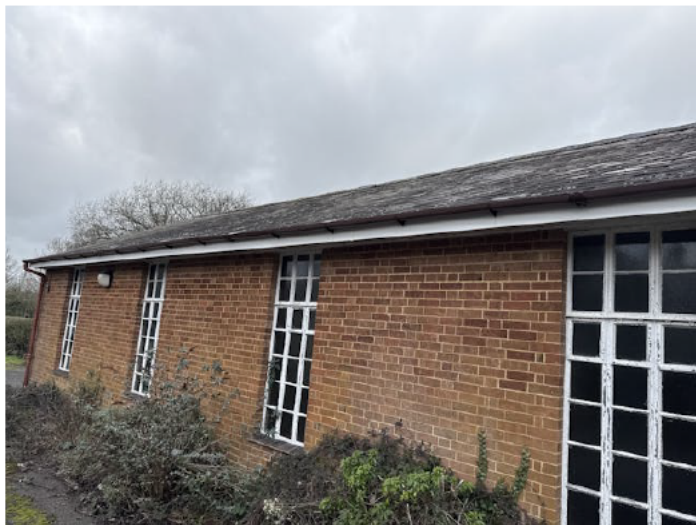
Main Building > 1 > Roof > Location Notes

| Location Notes | Putty to windows. Timber and upvc soffits. Plastic and cast iron rain water goods. Natural slate roof. Brick walls and crital windows. Timber doors. | | |

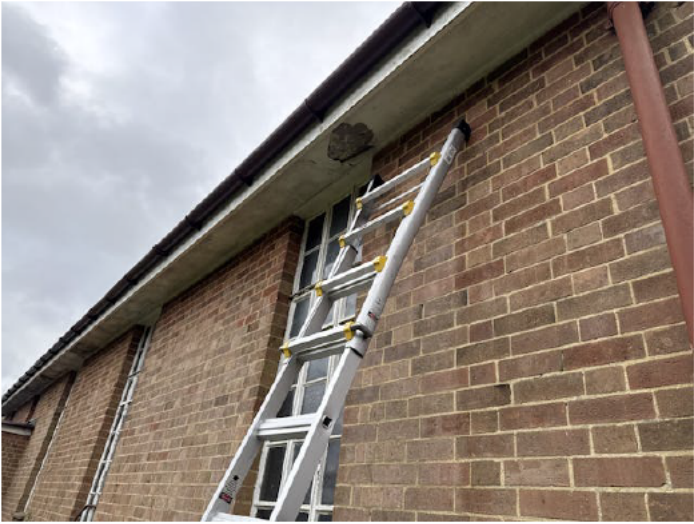
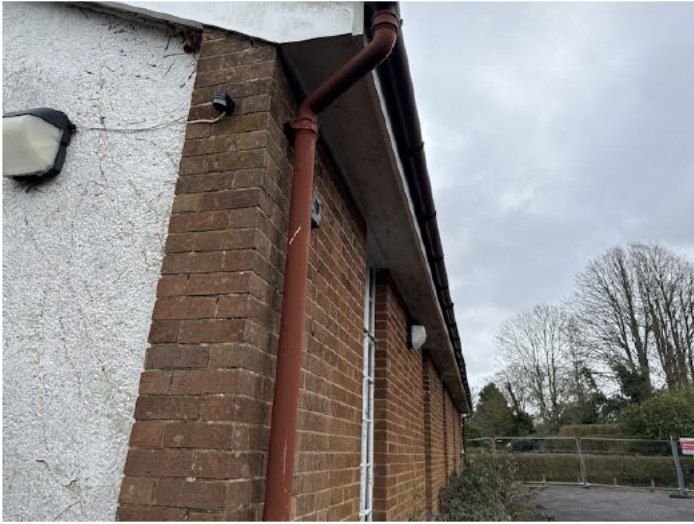
Main Building > 1 > Roof (x 2 Flat Roofs) > Soffit Panels

| Strategy / Sample Id | Sample / S04 | Fibre Type | NADIS |
