Batts Barn  
School Lane  
Ashurst  
Steyping  
BN44 3AY

Job No: 24316

Date: September 2024

## Report on inspection of Batts Barn, School Lane, Ashurst, Steyning BN44 3AY.

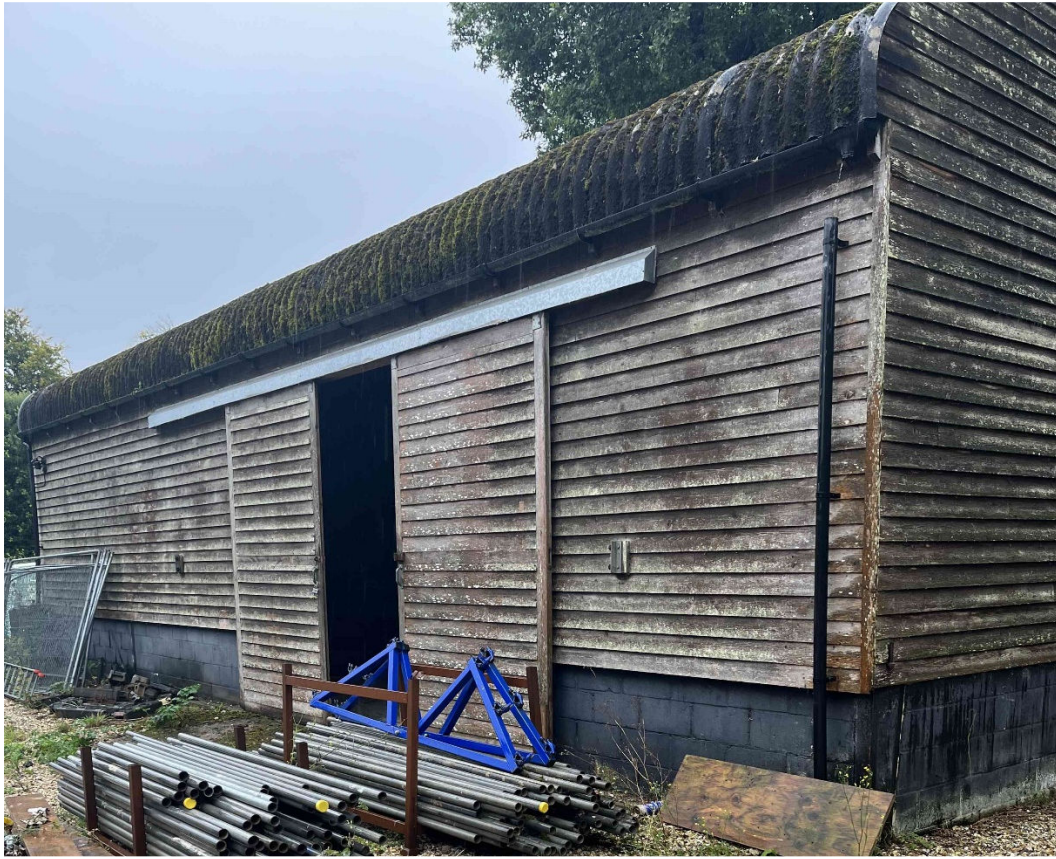
The barn walls were timber clad from roof to 900mm above floor level with the bottom 900mm being blockwork. The roof was covered with a/c sheeting with curved eaves and apex. There were large, double sliding doors on the north 'front' elevation. The external condition of the barn was good with no noticeable significant defects.

Front/north elevation.

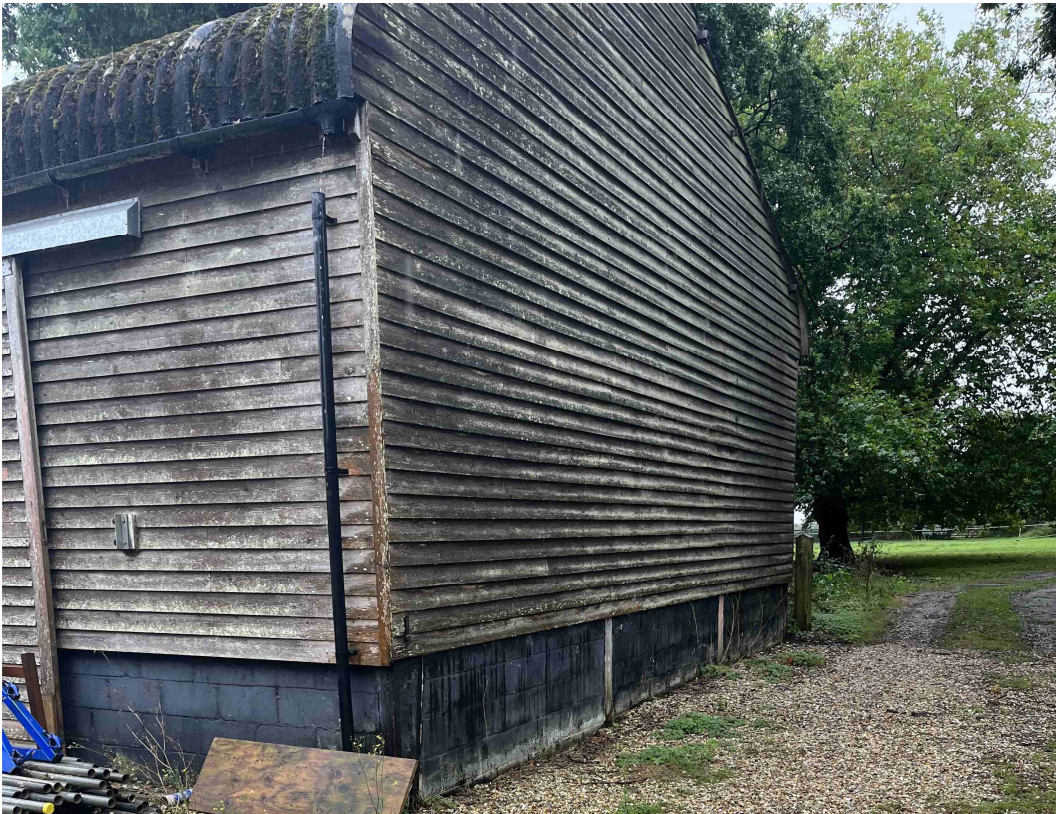
West side elevation.

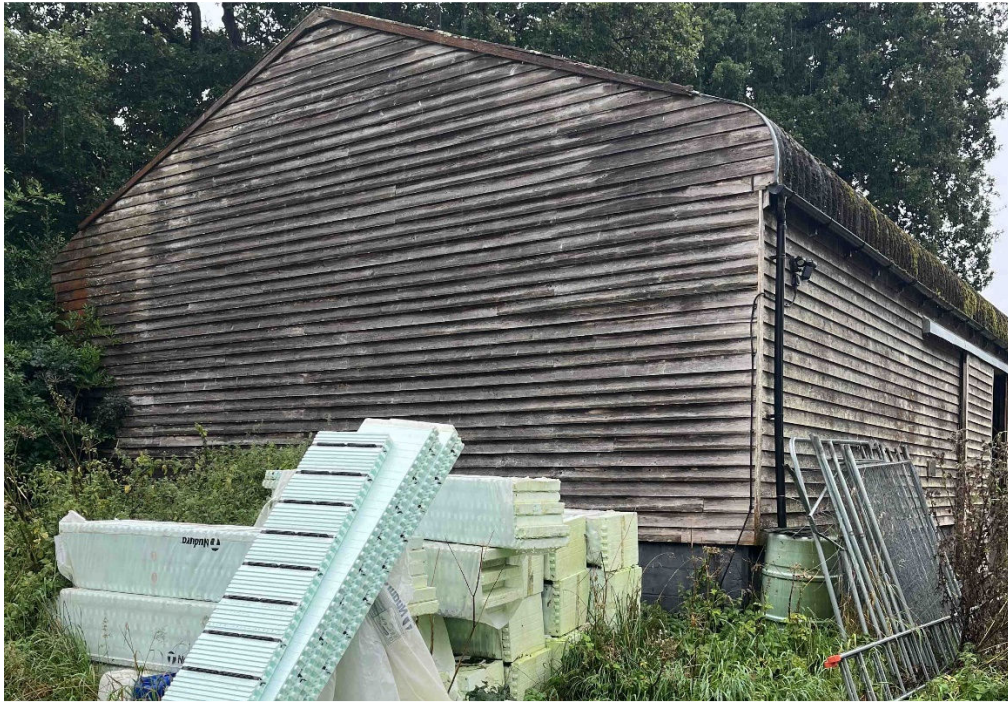
East elevation

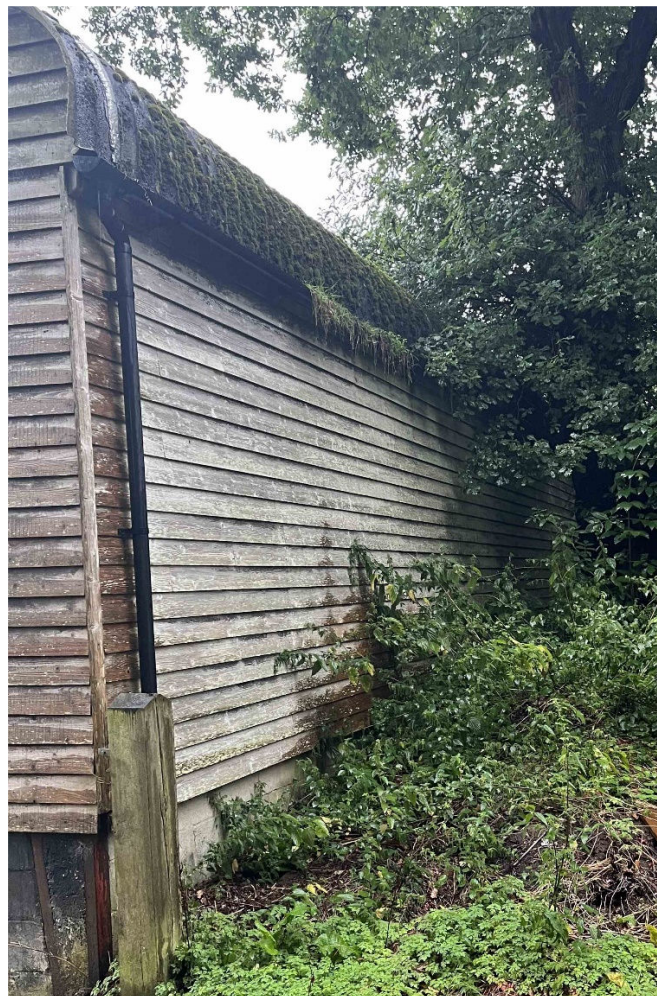
The south facing side wall was hidden from view by shrubs and a close-by tree. Whilst the external view was hidden, the cladding to the inside appeared unaffected by shrubbery outside.

South side covered with shrubbery and close to tree.

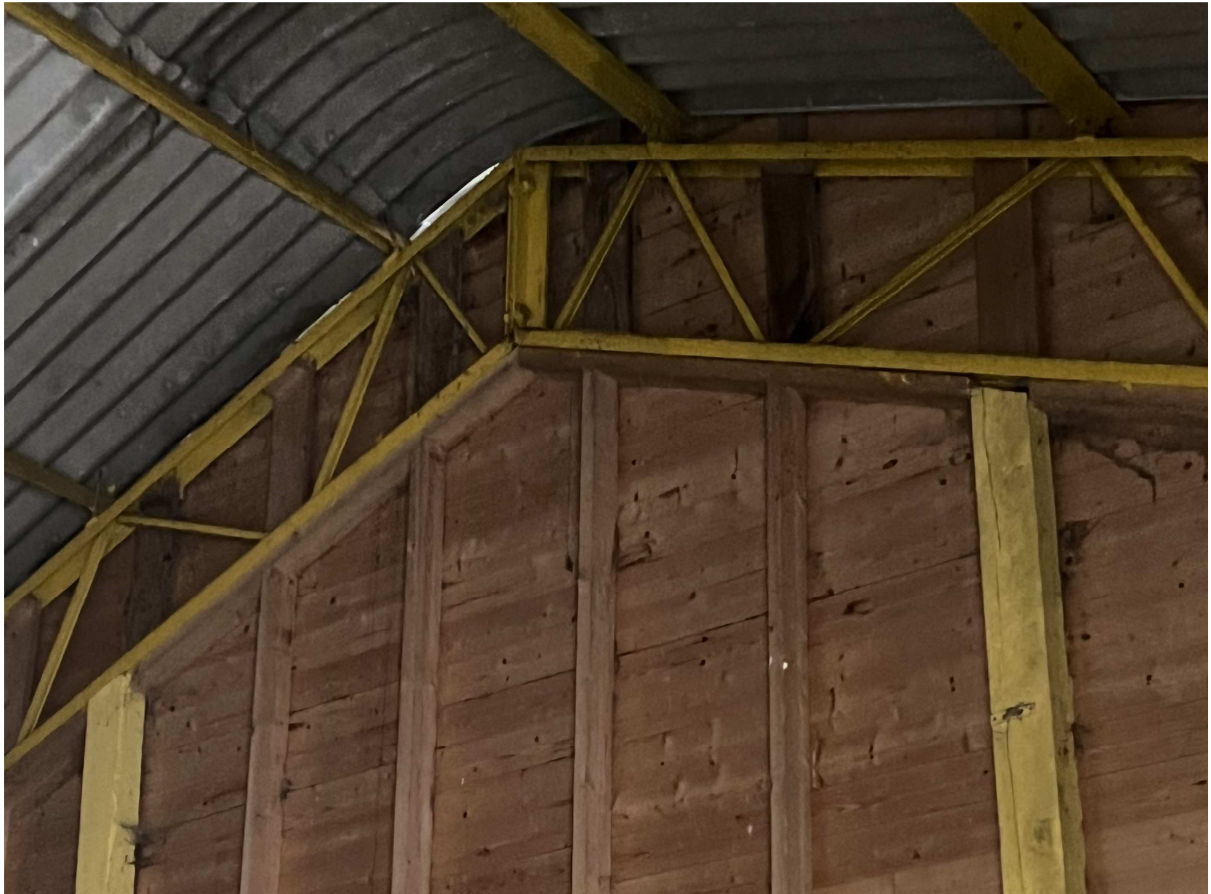
The main structure of the barn was portalised steel lattice trusses with tapering columns. The gable ends had steel channel posts at 1/3 width points. The roof sheeting was supported on steel channel purlins spanning between the main frame rafters. All of the observed steel sections were in good condition.

The wall timber cladding was fixed to vertical timber sections that spanned from the top of the block wall to eaves. The timber sections were all in good condition with no excess deflections or distortions.

Gable end – truss rafters and posts. Vertically spanning timbers.

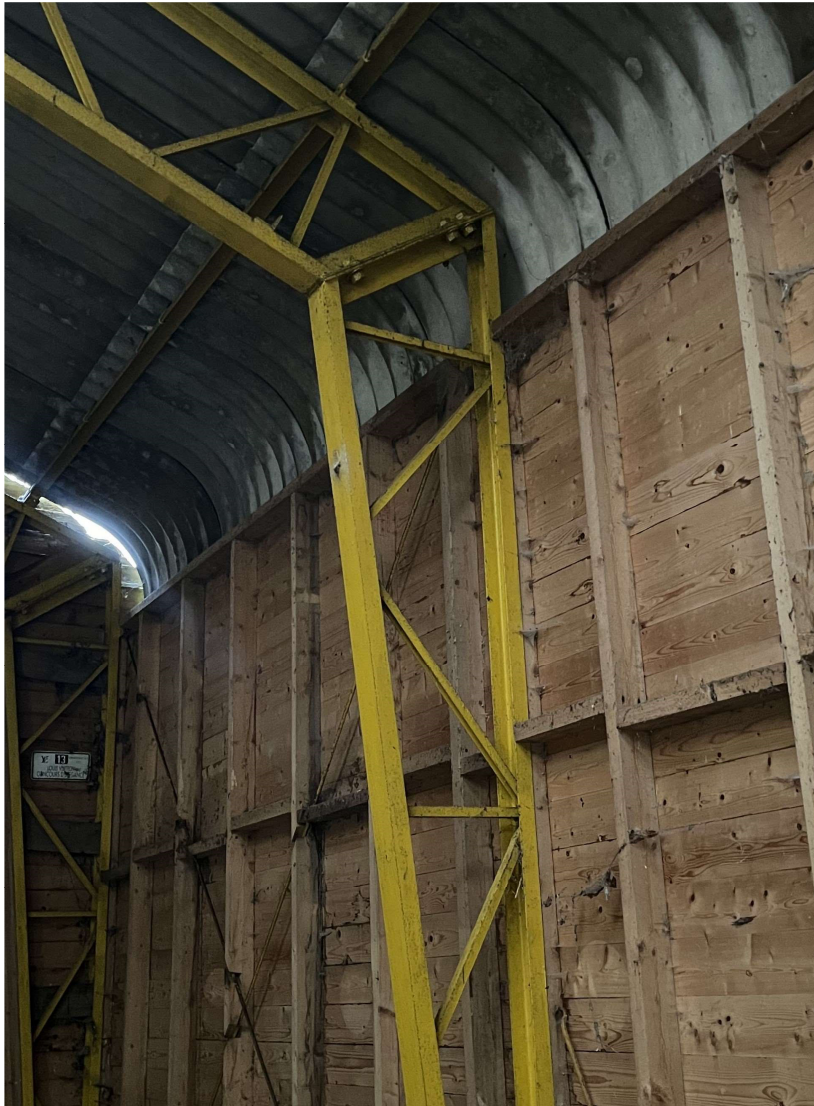
Typical eaves/column/rafter detail.

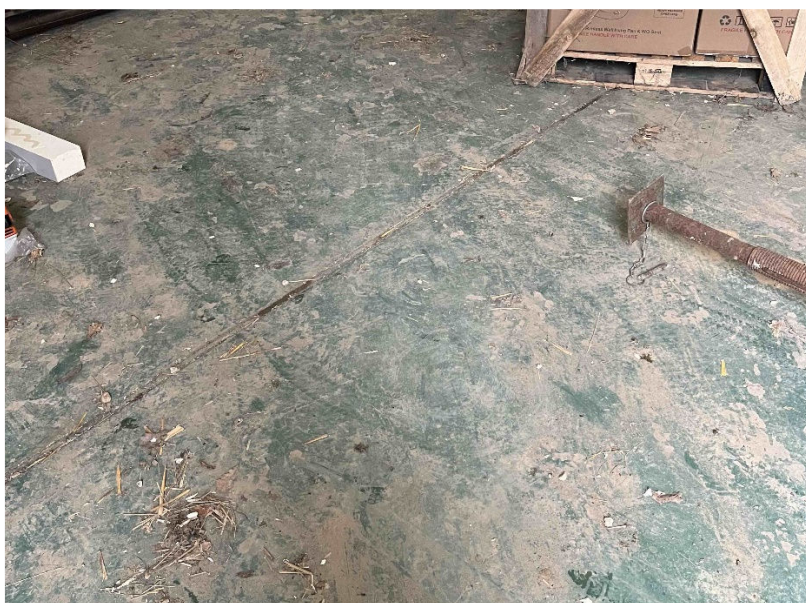
The floor was a concrete slab that appeared to be in very good condition.

Floor was in good condition.
