**RJS6372**

68-70 The High Street  
Billingshurst  
RH14 9QS

Survey Date: 03/04/2025

The survey was conducted to establish the presence of asbestos containing materials in the areas noted below:  
**Management asbestos survey (building 68 was vacant at time of survey).**

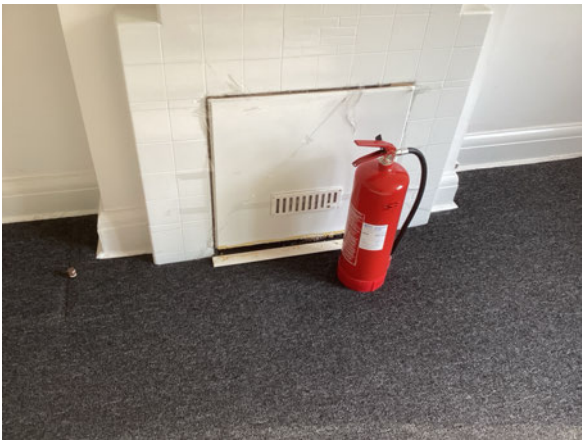
| PHOTO | Sample No. | Location | Product Details | Analysis Result |
|---|---|---|---|---|
| 01 | 01 | No.68: F.01 - Office 1 | Board to fireplace | No asbestos detected |

| | Sample Reference (Bulk ID): | BS1049402 |
| | Condition: | 0 (None) |
| | Recommendation | No Action Required |

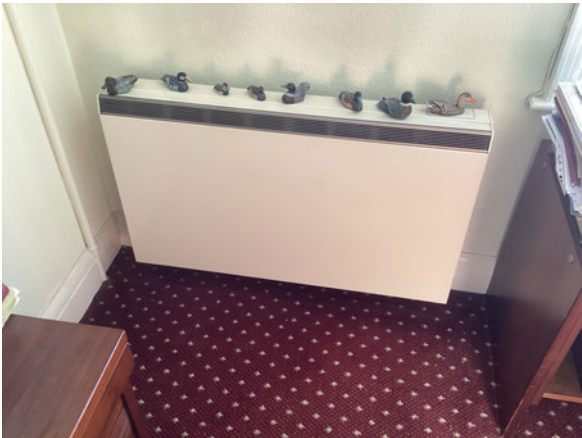
| Building: <b>Main</b> | | | | |
|---|---|---|---|---|
| F.01 - Office 1 Storage heater | 02 | 02 | Is presumed to contain Amosite (Brown Asbestos) | Mark & Manage<br>Removal to be carried out by trained personnel |

| Building Room Number/ Name<br>Product Details | Sample No. | Bulk ID | Photo No. | Product Type | Surface Treatment | Surface Condition | Type | Score | Possible Disturbance | Quantity M, M2,x? | ID A, SP, P | Rmd MM, E, R, Other. |
|---|---|---|---|---|---|---|---|---|---|---|---|---|
| No. 70: F.01 - Office 1<br>Storage heater | 02 | Visual | 02 | 3 | 2 | 3 | 2 | 10 | 1 | 1No. | P | MM |

| PHOTO | Sample No. | Location | Product Details | Analysis Result |
|---|---|---|---|---|
| 02 | 02 | No. 70: F.01 - Office 1 | Storage heater | Presumed Amosite |

| | Condition: | 3 (High) |

| | Recommendation | Mark & Manage |

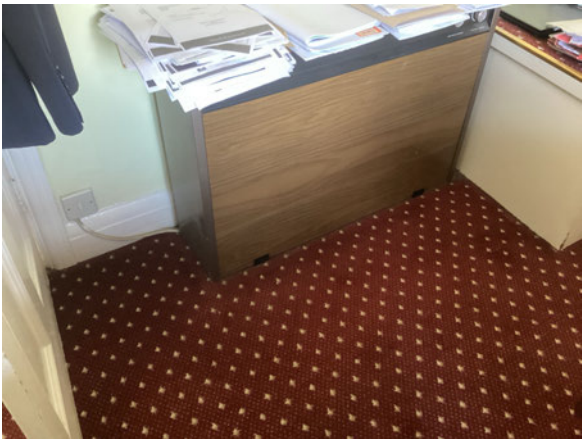
| Building: <b>Main</b> | | | | |
|---|---|---|---|---|
| F.03 - Office2 Storage heater | 03 | 03 | Is presumed to contain Amosite (Brown Asbestos) | Mark & Manage<br>Removal by trained personnel only |

| Building Room Number/ Name<br>Product Details | Sample No. | Bulk ID | Photo No. | Product Type | Surface Treatment | Surface Condition | Type | Score | Possible Disturbance | Quantity M, M2,x? | ID A, SP, P | Rmd MM, E, R, Other. |
|---|---|---|---|---|---|---|---|---|---|---|---|---|
| No. 70: F.03 - Office2<br>Storage heater | 03 | Visual | 03 | 3 | 2 | 3 | 2 | 10 | 1 | 1No. | P | MM |

| PHOTO | Sample No. | Location | Product Details | Analysis Result |
|---|---|---|---|---|
| 03 | 03 | No. 70: F.03 - Office2 | Storage heater | Presumed Amosite |

| | Condition: | 3 (High) |

| | Recommendation | Mark & Manage |

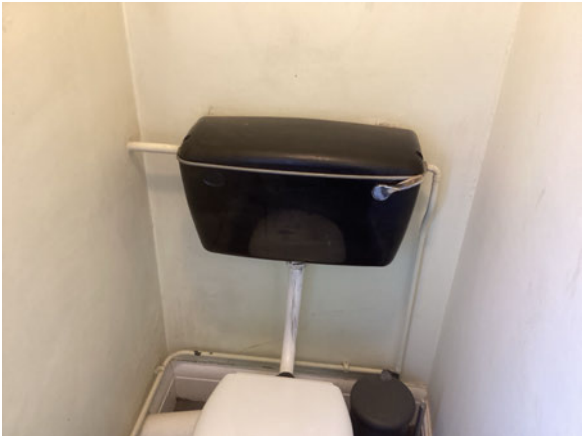
| Building: <b>Main</b> | | | | |
|---|---|---|---|---|
| G.01 - W/C Toilet cistern | 04 | 04 | Was found to contain Amosite (Brown Asbestos) | Mark & Manage<br>If removed --dispose as hazardous waste and ensure no breakage occurs |

| Building Room Number/ Name<br>Product Details | Sample No. | Bulk ID | Photo No. | Product Type | Surface Treatment | Surface Condition | Type | Score | Possible Disturbance | Quantity M, M2,x? | ID A, SP, P | Rmd MM, E, R, Other. |
|---|---|---|---|---|---|---|---|---|---|---|---|---|
| No. 70: G.01 - W/C<br>Toilet cistern | 04 | BS104 9403 | 04 | 1 | 0 | 1 | 2 | 4 | 2 | 1No. | A | MM |

| PHOTO | Sample No. | Location | Product Details | Analysis Result |
|---|---|---|---|---|
| 04 | 04 | No. 70: G.01 - W/C | Toilet cistern | Amosite |
| | | | Sample Reference (Bulk ID): | BS1049403 |
| | | | Condition: | 1 (Low) |

| PHOTO | Sample No. | Location | Product Details | Analysis Result |
|---|---|---|---|---|
| | | | Recommendation | Mark & Manage |
| | | | Comment: | If removed --dispose as hazardous waste and ensure no breakage occurs during removal |

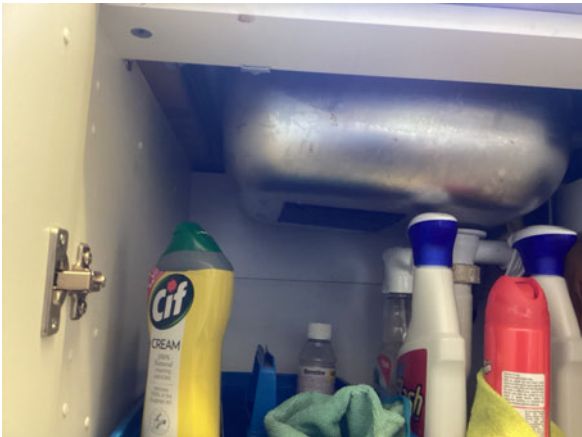
| PHOTO | Sample No. | Location | Product Details | Analysis Result |
|---|---|---|---|---|
| 05 | 05 | No. 70: G.02 - Kitchen | Sink pad | No asbestos detected |
| | | | Sample Reference (Bulk ID): | BS1049404 |
| | | | Recommendation | No Action Required |

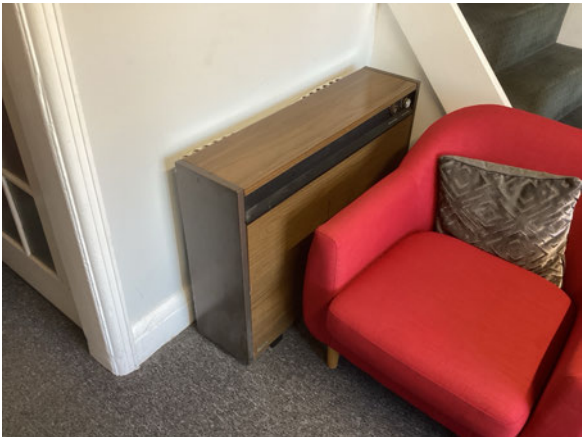
| Building: <b>Main</b> | | | | |
|---|---|---|---|---|
| G.03 - Rear office Storage heater | 06 | 06 | Is presumed to contain Amosite (Brown Asbestos) | Mark & Manage<br>Removal by trained personnel only |

| Building Room Number/ Name<br>Product Details | Sample No. | Bulk ID | Photo No. | Product Type | Surface Treatment | Surface Condition | Type | Score | Possible Disturbance | Quantity M, M2,x? | ID A, SP, P | Rmd MM, E, R, Other. |
|---|---|---|---|---|---|---|---|---|---|---|---|---|
| No. 70: G.03 - Rear office<br>Storage heater | 06 | Visual | 06 | 3 | 2 | 3 | 2 | 10 | 1 | 1No. | P | MM |

| PHOTO | Sample No. | Location | Product Details | Analysis Result |
|---|---|---|---|---|
| 06 | 06 | No. 70: G.03 - Rear office | Storage heater | Presumed Amosite |
| | | | Condition: | 3 (High) |

| PHOTO | Sample No. | Location | Product Details | Analysis Result |
|---|---|---|---|---|
| | | | Recommendation | Mark & Manage |

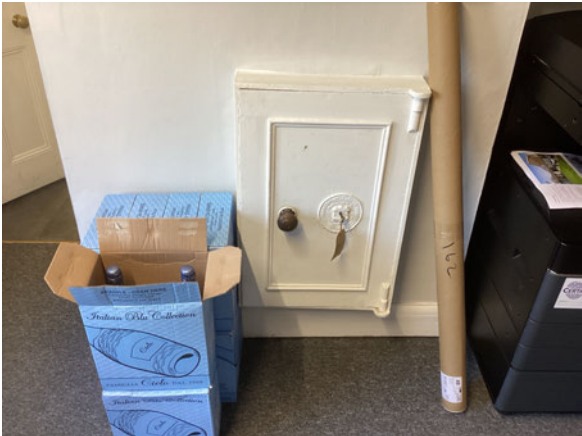
| Building: <b>Main</b> | | | | |
|---|---|---|---|---|
| G.03 - Rear office Old safe in wall | 07 | 07 | Is presumed to contain Amosite (Brown Asbestos) | Mark & Manage<br>Safe has been presumed to contain asbestos materials as 'fireproofing' |

| Building Room Number/ Name<br>Product Details | Sample No. | Bulk ID | Photo No. | Product Type | Surface Treatment | Surface Condition | Type | Score | Possible Disturbance | Quantity M, M2,x? | ID A, SP, P | Rmd MM, E, R, Other. |
|---|---|---|---|---|---|---|---|---|---|---|---|---|
| No. 70: G.03 - Rear office<br>Old safe in wall | 07 | Visual | 07 | 3 | 3 | 3 | 2 | 11 | 1 | 1No. | P | MM |

| PHOTO | Sample No. | Location | Product Details | Analysis Result |
|---|---|---|---|---|
| 07 | 07 | No. 70: G.03 - Rear office | Old safe in wall | Presumed Amosite |
| | | | Condition: | 3 (High) |

| PHOTO | Sample No. | Location | Product Details | Analysis Result |
|---|---|---|---|---|
| | | | Recommendation | Mark & Manage |

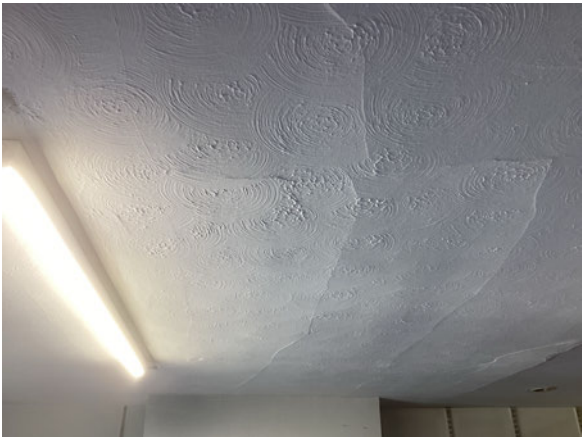
| PHOTO | Sample No. | Location | Product Details | Analysis Result |
|---|---|---|---|---|
| 08 | 08 | No. 70: G.03 - Rear office | Textured coating | No asbestos detected |
| | | | Sample Reference (Bulk ID): | BS1049405 |
| | | | Recommendation | No Action Required |

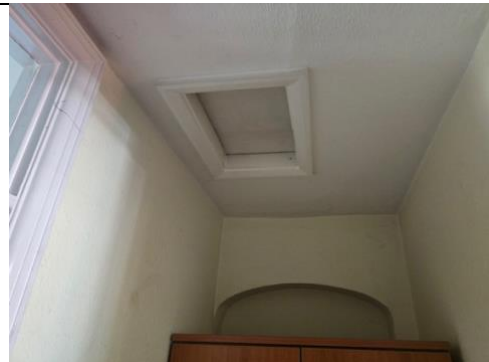
| Location | Comments |
|---|---|
| No. 70: L.01 - Loft space | Loft not accessed due to size of hatch |

No 70 room F.02 (no access to loft, hatch too small)
