# Tree Condition Report

## & Management Recommendations

**Acorn Avenue, Eastlands Lane, Fairfield and  
Cottages Recreational Ground  
Cowfold  
RH13 8BL**

**Dated**  
**10<sup>th</sup> February 2026**

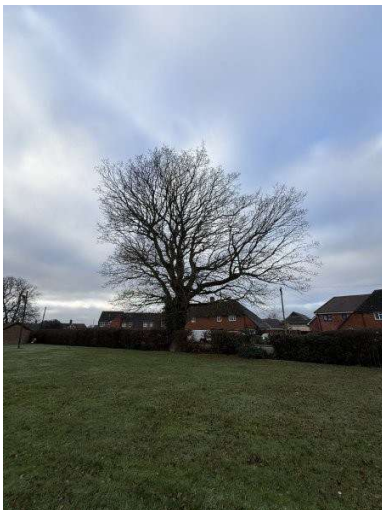
Photo 1. T1

| Ref. | Other Reference | Life Stage | Species | Height | DBH (cm) | North | East | South | West | Photo | Location & Targets | Survey Notes | Inspection Limitations | Physiological Condition | Structural Condition | Recommended Works | Priority | Inspect Frequency (yrs) | Safety Category |
|---|---|---|---|---|---|---|---|---|---|---|---|---|---|---|---|---|---|---|---|
| T001 | | Mature | Pedunculate oak ( <i>Quercus robur</i> ) | 21 | 110 | 14 | 11 | 12 | 12 | | Parkland tree. Target - dwelling. Target - road. | Defects: Ganoderma fruiting bodies at base to north and east. Sounding mallet suggests acceptable at present. Several significant cavities developing to stem and scaffold limbs where branches previously failed. Occasional significant deadwood over road. | Vegetation | Normal | Fair | Monitor progression of decay as part of future inspections. Remove deadwood >5cm diameter over road. | Moderate | 1.5 | 2 |

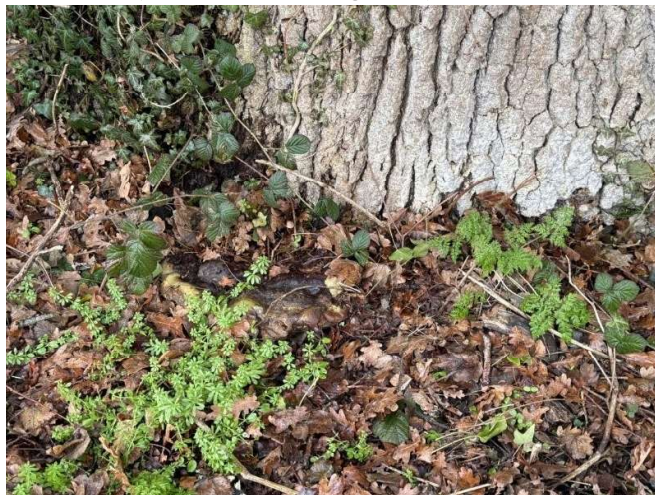
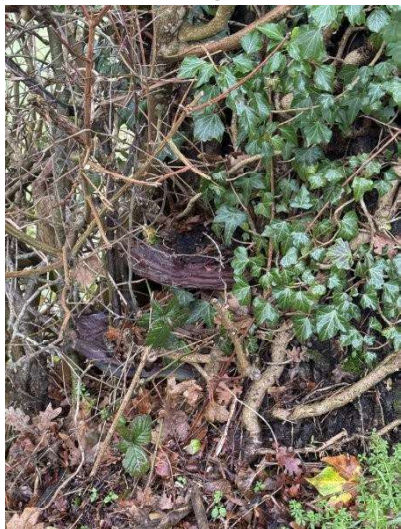
**Additional Notes:** some of the oak trees have fungal fruiting bodies present, indicating internal decay. This is a normal part of the natural life cycle of veteran and mature trees and is not necessarily a cause for concern. As trees age, heartwood is progressively broken down and recycled, and trees are able to accommodate internal hollows with minor impact on their overall structural integrity.

Photo 2. T1 (Ganoderma fruiting body)

Photo 3. T1 (Ganoderma fruiting body)

However, given the location of these trees and the presence of nearby targets, it is recommended that the extent and progression of internal decay is monitored as part of future inspections. This may be undertaken using non-invasive techniques such as a sounding mallet. Should more extensive decay be identified, further assessment using specialist diagnostic equipment may be required to better understand the internal condition of the trees.

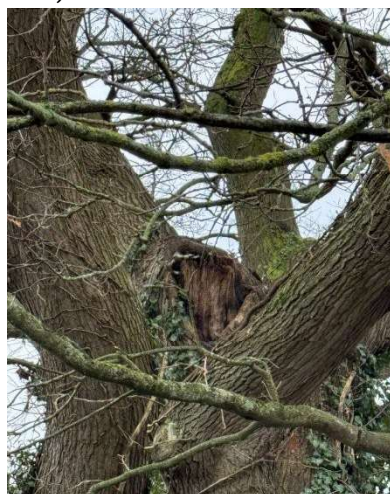
Photo 4. T1 (significant cavity developing to stem, good wound wood)

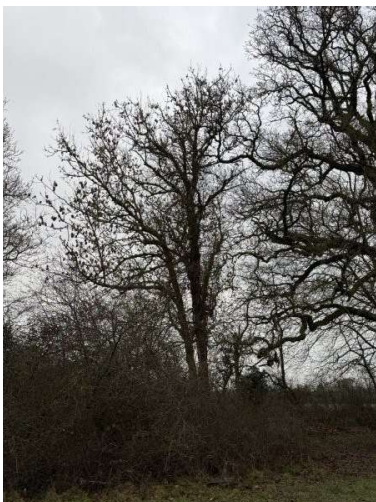
Photo 5. T2

| Ref. | Other Reference | Life Stage | Species | Height | DBH (cm) | North | East | South | West | Photo | Location & Targets | Survey Notes | Inspection Limitations | Physiological Condition | Structural Condition | Recommended Works | Priority | Inspect Frequency (yrs) | Safety Category |
|---|---|---|---|---|---|---|---|---|---|---|---|---|---|---|---|---|---|---|---|
| T002 | | Early Mature | Common ash ( <i>Fraxinus excelsior</i> ) | 11 | 35 | 4 | 4 | 2.5 | 2.5 | | Parkland tree. Target - playground. | Defects: Ash dieback 75%-50% remaining canopy | Vegetation | Fair | Fair | Monitor for ash dieback | Moderate | 1.5 | 2 |

G12 do not currently show signs of Chalara Ash Die back. However, it is likely they will be infected within the next 10 years. Therefore, it would be prudent to monitor their condition as part of future professional inspections, as well as informal inspections. More information on this disease can be found at the following websites:

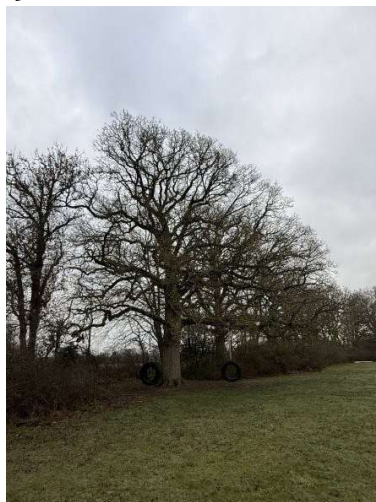
Photo 6. T3

| Ref. | Other Reference | Life Stage | Species | Height | DBH (cm) | North | East | South | West | Photo | Location & Targets | Survey Notes | Inspection Limitations | Physiological Condition | Structural Condition | Recommended Works | Priority | Inspect Frequency (yrs) | Safety Category |
|---|---|---|---|---|---|---|---|---|---|---|---|---|---|---|---|---|---|---|---|
| T003 | | Early Mature | Pedunculate oak ( <i>Quercus robur</i> ) | 16 | 92 | 10 | 10 | 10 | 10 | | Parkland tree. Target - playground. | Compacted soil around base associated with play area<br><br>Defects:<br>Significant deadwood over playground area | None | Normal | Normal | Remove deadwood over 5cm diameter (high priority) mulch ground around play area (low priority) | High | 3 | 2 |

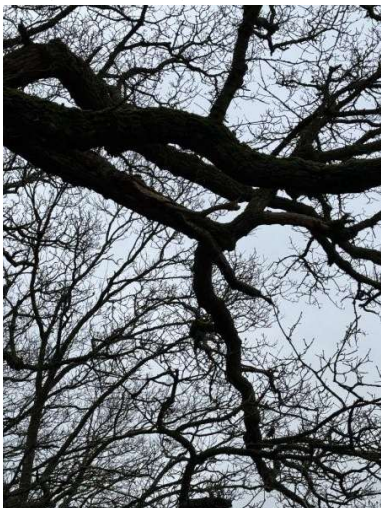
Photo 7. T3 (dead wood)

**Additional Notes:** Deadwood is present within these trees and forms an important natural habitat for a variety of species. However, a balance must be achieved between maintaining ecological value and safeguarding site users. In this instance, we recommend removing deadwood with a diameter greater than 5cm that extends over potential targets. Any deadwood that does not extend over potential targets can be retained. Moreover, rather than completely removing the large dead branch (and associated habitat) from T4, simply shortening it by 4m will greatly reduce the lever arm acting on it, and thus likelihood of it failing.

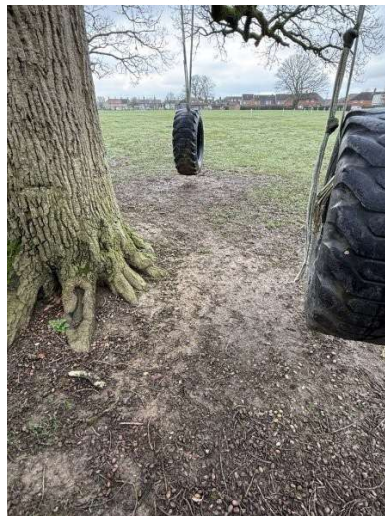
| Ref. | Other Reference | Life Stage | Species | Height | DBH (cm) | North | East | South | West | Photo | Location & Targets | Survey Notes | Inspection Limitations | Physiological Condition | Structural Condition | Recommended Works | Priority | Inspect Frequency (yrs) | Safety Category |
|---|---|---|---|---|---|---|---|---|---|---|---|---|---|---|---|---|---|---|---|
| T003 | | Early Mature | Pedunculate oak (Quercus robur) | 16 | 92 | 10 | 10 | 10 | 10 | | Parkland tree. Target - playground. | Compacted soil around base associated with play area<br>Defects:<br>Significant deadwood over playground area | None | Normal | Normal | Remove deadwood over 5cm diameter (high priority) mulch ground around play area (low priority) | High | 3 | 2 |

Photo 8. T3 (compact soil)

**Additional Notes:** Options are available for mechanical soil amelioration, including the use of specialist equipment such as Terravents and air-spade techniques, with soil conditioners (for example biochar) incorporated into the soil profile. Such approaches are typically focused within the upper soil horizons, noting that the majority of tree roots are generally located within the top c.300 mm of soil.

As an alternative to the use of costly and potentially disruptive equipment, a low-impact approach may be undertaken. This could involve manually loosening the soil to a depth of approximately 300 mm using a garden fork, with the aim of improving soil aeration and drainage across the rooting area. This process may be carried out at regular intervals, for example at approximately one-metre spacings, across the area beneath the tree canopy (dripline), and not within 0.5m of the base and buttress roots.

In addition to the initial soil loosening, the soil surface may then be covered with a layer of woodchip mulch to a depth of approximately 50 mm. Care should be taken to ensure that mulch is not placed directly against the base of the tree and does not come into contact with buttress roots or exposed surface roots. Mulch should not be applied when the ground is waterlogged or excessively dry; therefore, it may be preferable for such works to be undertaken later in the spring or during early summer.

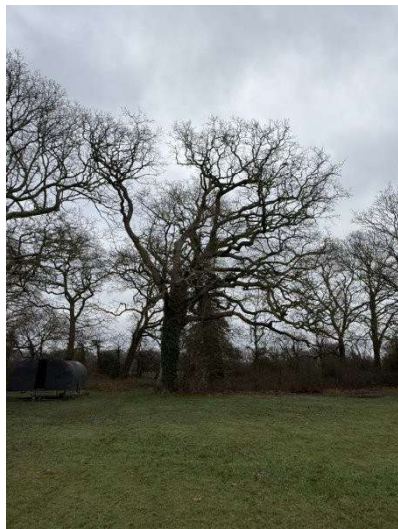
Photo 9. T4

| Ref. | Other Reference | Life Stage | Species | Height | DBH (cm) | North | East | South | West | Photo | Location & Targets | Survey Notes | Inspection Limitations | Physiological Condition | Structural Condition | Recommended Works | Priority | Inspect Frequency (yrs) | Safety Category |
|---|---|---|---|---|---|---|---|---|---|---|---|---|---|---|---|---|---|---|---|
| T004 | | Mature | Pedunculate oak ( <i>Quercus robur</i> ) | 17 | 100 | 5 | 5 | 9 | 7 | | Parkland tree. | Defects:<br>Significant dead branch to south c. 30cm diameter, 9m length. Significant bark wound at base to north with extensive decay developing. Stem sounded, acceptable condition at present. Occasional minor cavities developing to stem. | None | Fair | Fair | Reduce length of dead branch by 4m and monitor. | High | 1.5 | 3 |

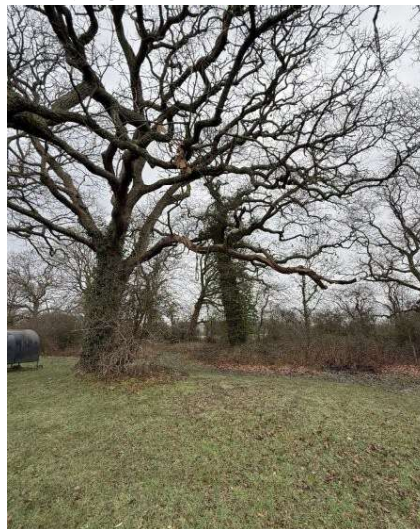
Photo 10. T4 (large dead branch)

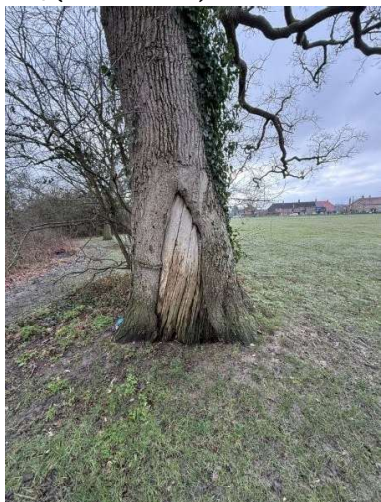
Photo 11. T4 (bark wound)

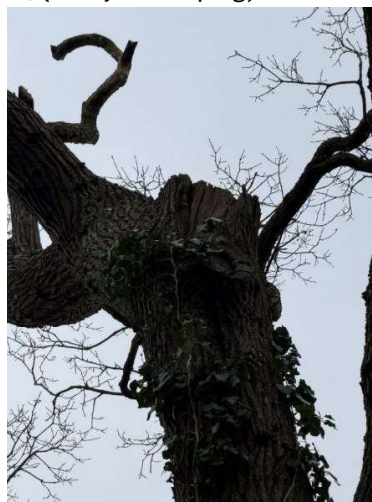
Photo 12. T4 (cavity developing)

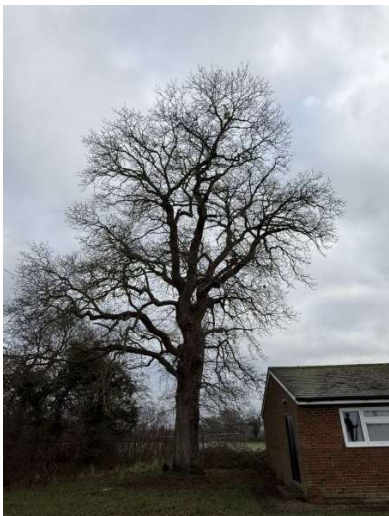
Photo 13. T5

| Ref. | Other Reference | Life Stage | Species | Height | DBH (cm) | North | East | South | West | Photo | Location & Targets | Survey Notes | Inspection Limitations | Physiological Condition | Structural Condition | Recommended Works | Priority | Inspect Frequency (yrs) | Safety Category |
|---|---|---|---|---|---|---|---|---|---|---|---|---|---|---|---|---|---|---|---|
| T005 | | Mature | Pedunculate oak ( <i>Quercus robur</i> ) | 20 | 100 | 8 | 8 | 8 | 8 | | Parkland tree. Target - building | Defects: Perished fungal bracket at base to north. Stem sounded, acceptable condition at present. Occasional significant deadwood (low target occupancy). Occasional minor cavities developing. | None | Normal | Fair | Monitor condition of stem | Moderate | 1.5 | 2 |

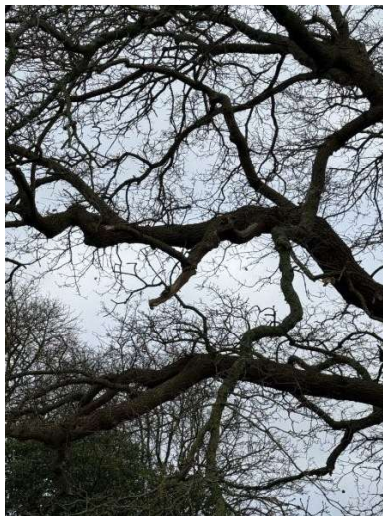
Photo 14. T5 (dead wood)

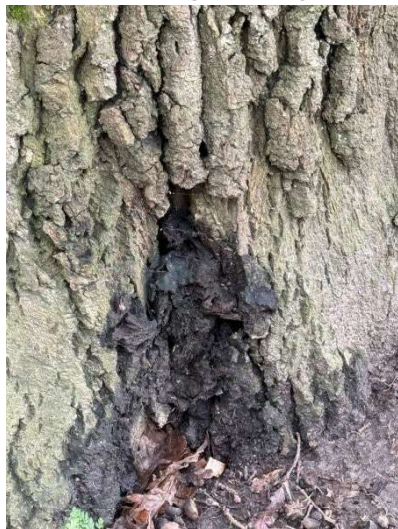
Photo 15. T5 (perished fungal fruiting body)

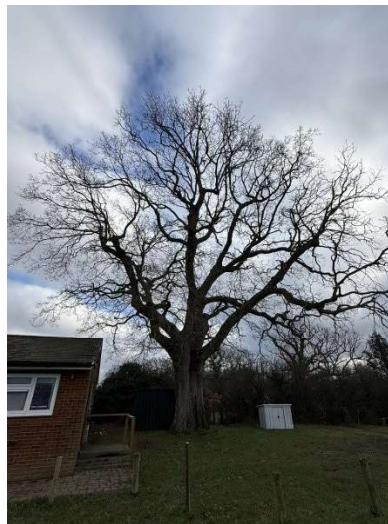
Photo 16. T6.

| Ref. | Other Reference | Life Stage | Species | Height | DBH (cm) | North | East | South | West | Photo | Location & Targets | Survey Notes | Inspection Limitations | Physiological Condition | Structural Condition | Recommended Works | Priority | Inspect Frequency (yrs) | Safety Category |
|---|---|---|---|---|---|---|---|---|---|---|---|---|---|---|---|---|---|---|---|
| T006 | | Mature | Pedunculate oak ( <i>Quercus robur</i> ) | 20 | 137 | 10 | 10 | 10 | 10 | | Parkland tree. Target - building | Defects: Perished fungal bracket at base to southeast. Sounding mallet indicates stem is in acceptable condition at present. Minor damage to buttress to southwest, mallet indicates significant patch of associated dead bark higher on stem, probe indicates solid timber beneath. Minor deadwood and cavities developing to canopy. | None | Normal | Fair | Monitor condition of stem. | Moderate | 1.5 | 2 |

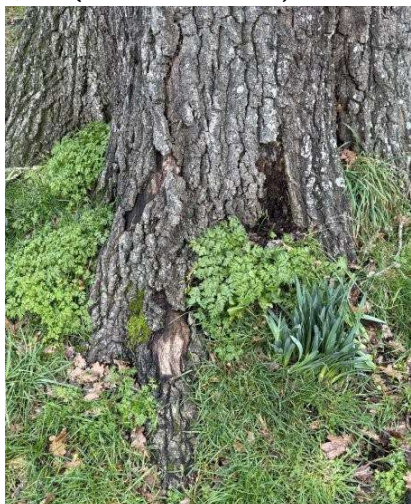
Photo 17. T6 (dead bark at base)

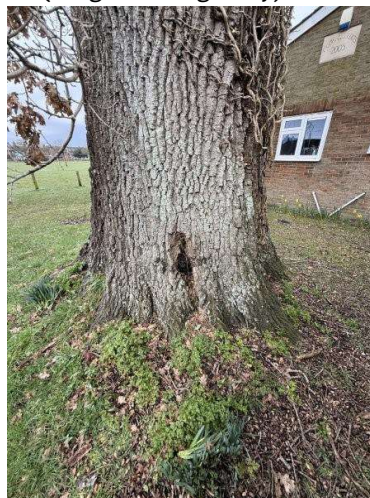
Photo 18. T6 (fungal fruiting body)

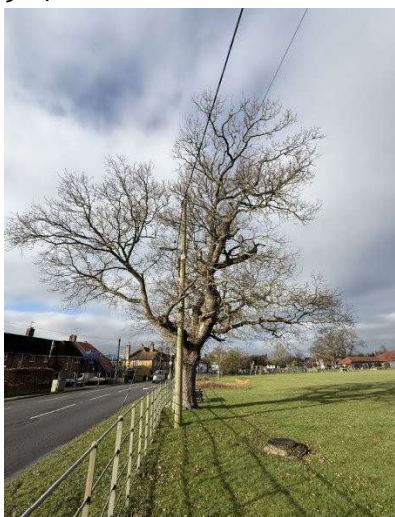
Photo 19. T7

| Ref. | Other Reference | Life Stage | Species | Height | DBH (cm) | North | East | South | West | Photo | Location & Targets | Survey Notes | Inspection Limitations | Physiological Condition | Structural Condition | Recommended Works | Priority | Inspect Frequency (yrs) | Safety Category |
|---|---|---|---|---|---|---|---|---|---|---|---|---|---|---|---|---|---|---|---|
| T007 | | Early Mature | Pedunculate oak ( <i>Quercus robur</i> ) | 15 | 95 | 8 | 8 | 8 | 8 | | Parkland tree.<br>Target - road. | Branches encroaching overhead services (previously pruned back)<br><br>Defects:<br>No significant defects observed, occasional minor cavities developing. | None | Normal | Normal | Reduce branches encroaching services back to previous pruning points. | Low | 3 | 1 |

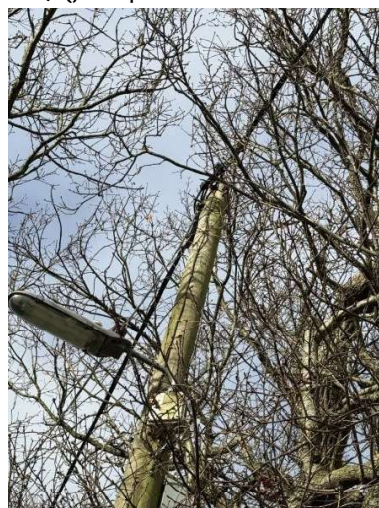
Photo 20. T7 (juxtaposition with overhead services)

**No Additional Notes:** T7 has previously been pruned back away from the cables. Branches have now grown back and are encroaching the cables. We recommend these be pruned back to the previous pruning points.

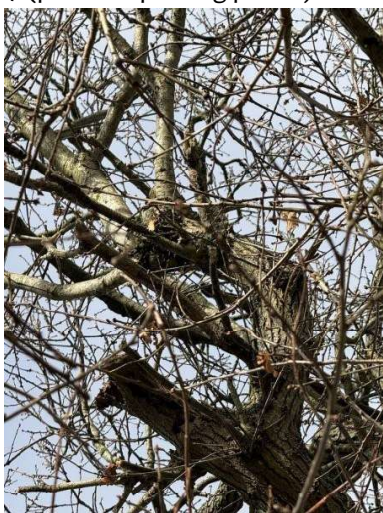
Photo 21. T7 (previous pruning points)

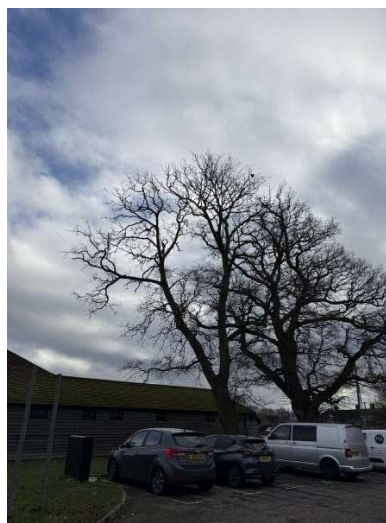
Photo 22. T8

| Ref. | Other Reference | Life Stage | Species | Height | DBH (cm) | North | East | South | West | Photo | Location & Targets | Survey Notes | Inspection Limitations | Physiological Condition | Structural Condition | Recommended Works | Priority | Inspect Frequency (yrs) | Safety Category |
|---|---|---|---|---|---|---|---|---|---|---|---|---|---|---|---|---|---|---|---|
| T008 | | Early Mature | Pedunculate oak ( <i>Quercus robur</i> ) | 18 | 91 | 7.5 | 9 | 4 | 8 | | Target - building Target - car park. | Defects: Low vitality, scattered dead twigs to upper canopy. | None | Fair | Normal | Monitor condition | Moderate | 1.5 | 2 |

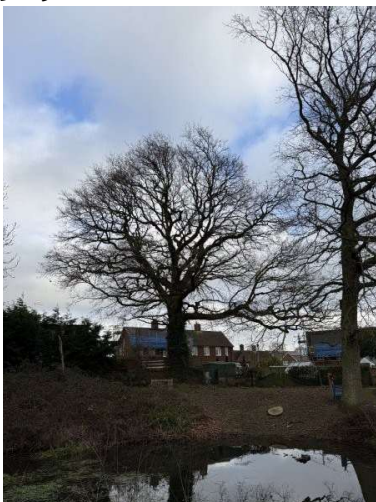
Photo 23. T9

| Ref. | Other Reference | Life Stage | Species | Height | DBH (cm) | North | East | South | West | Photo | Location & Targets | Survey Notes | Inspection Limitations | Physiological Condition | Structural Condition | Recommended Works | Priority | Inspect Frequency (yrs) | Safety Category |
|---|---|---|---|---|---|---|---|---|---|---|---|---|---|---|---|---|---|---|---|
| T009 | | Mature | Pedunculate oak ( <i>Quercus robur</i> ) | 20 | 140 | 8 | 9 | 9 | 8 | | Parkland tree.<br>Target - dwelling.<br>Target - footpath.<br>Target - garden | Defects:<br>Ganoderma fruiting body at base to north, mallet indicates extensive decay to northeast. Occasional minor cavities and tear wounds developing within canopy. | None | Normal | Fair | Decay detection required. | High | 1.5 | 3 |

**Additional Notes:** A sounding mallet indicated the internal decay to be more significant than the other oak trees with fungal fruiting bodies, due to a hollow sound to the northeast. The use of a Picus Tomograph, Residril and/or increment borer is required in order to map out the extent of decay. Please contact Crown Tree Consultancy to arrange for such an inspection.

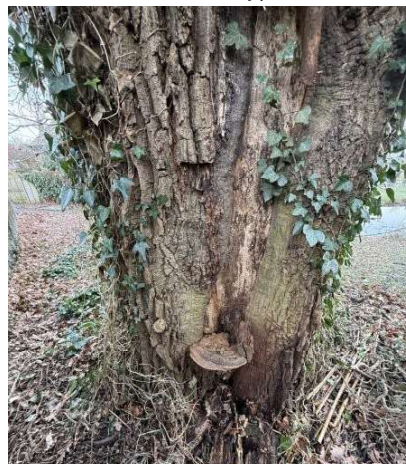
Photo 24. T9 (bark wound with *Ganoderma* sp. fruiting body)

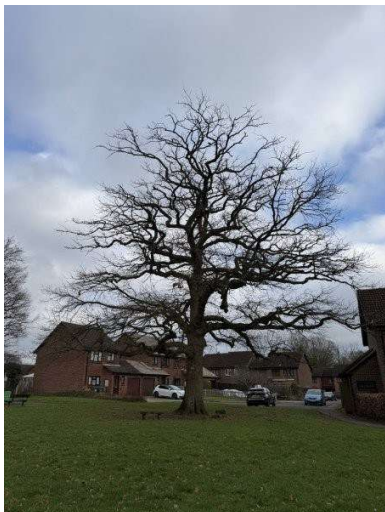
Photo 25. T10

| Ref. | Other Reference | Life Stage | Species | Height | DBH (cm) | North | East | South | West | Photo | Location & Targets | Survey Notes | Inspection Limitations | Physiological Condition | Structural Condition | Recommended Works | Priority | Inspect Frequency (yrs) | Safety Category |
|---|---|---|---|---|---|---|---|---|---|---|---|---|---|---|---|---|---|---|---|
| T010 | | Mature | Pedunculate oak ( <i>Quercus robur</i> ) | 17 | 100 | 8 | 8 | 8 | 8 | | Parkland tree. Target - building. Target - footpath. Target - road. | Boggy, waterlogged ground in root area.<br><br>Defects:<br>Sparse upper canopy, tree in decline. Significant deadwood present. Decaying branch with 'hazard beam' to east at 5m. | None | Poor | Fair | Remove deadwood over 5cm diameter and Decaying branch (high priority). Undertake soil amelioration (low priority) and monitor condition. | High | 1.5 | 3 |

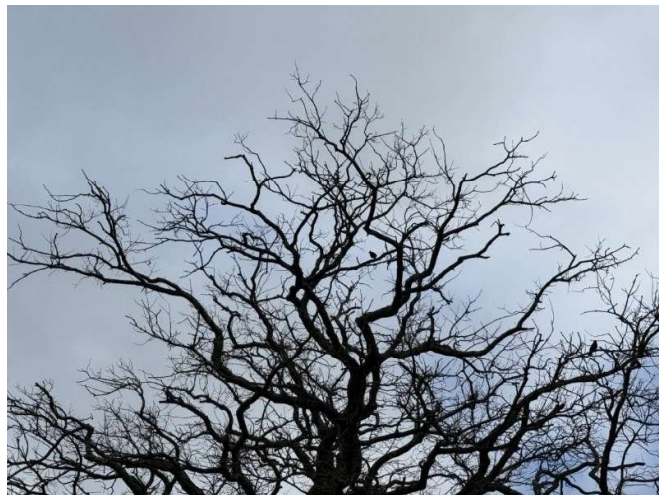
Photo 26. T10 (top of canopy sparse)

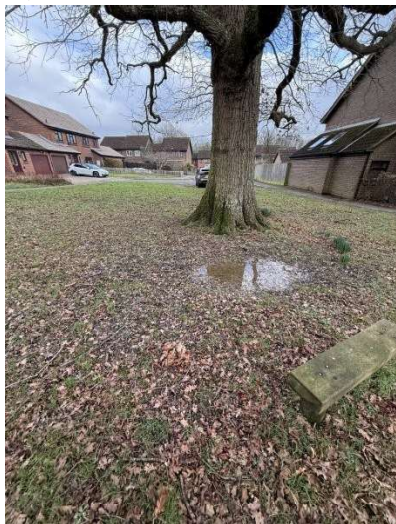
| Ref. | Other Reference | Life Stage | Species | Height | DBH (cm) | North | East | South | West | Photo | Location & Targets | Survey Notes | Inspection Limitations | Physiological Condition | Structural Condition | Recommended Works | Priority | Inspect Frequency (yrs) | Safety Category |
|---|---|---|---|---|---|---|---|---|---|---|---|---|---|---|---|---|---|---|---|
| T010 | | Mature | Pedunculate oak (Quercus robur) | 17 | 100 | 8 | 8 | 8 | 8 | | Parkland tree. Target - building. Target - footpath. Target - road. | Boggy, waterlogged ground in root area.<br>Defects:<br>Sparse upper canopy, tree in decline. Significant deadwood present. Decaying branch with 'hazard beam' to east at 5m. | None | Poor | Fair | Remove deadwood over 5cm diameter and Decaying branch (high priority). Undertake soil amelioration (low priority) and monitor condition. | High | 1-5 | 3 |

Photo 27. T10 (poor soil condition)

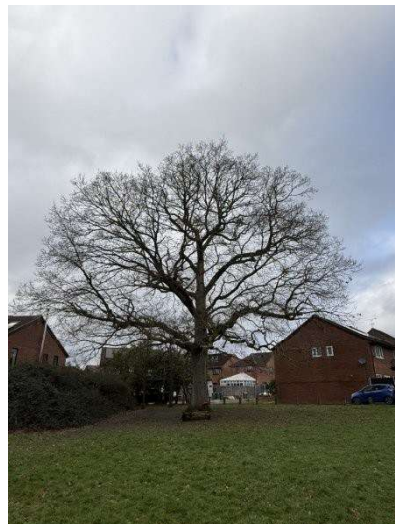
Photo 28. T11

| Ref. | Other Reference | Life Stage | Species | Height | DBH (cm) | North | East | South | West | Photo | Location & Targets | Survey Notes | Inspection Limitations | Physiological Condition | Structural Condition | Recommended Works | Priority | Inspect Frequency (yrs) | Safety Category |
|---|---|---|---|---|---|---|---|---|---|---|---|---|---|---|---|---|---|---|---|
| T011 | | Mature | Pedunculate oak ( <i>Quercus robur</i> ) | 20 | 103 | 10 | 10 | 10 | 10 | | Parkland tree. Target - dwelling. Target - road. | Defects:<br>C. 30cm diameter decaying branch to south at c. 11m over play area (rope swings). Occasional minor cavities developing to stem and canopy. Occasional significant deadwood over play area. | None | Fair | Normal | Remove decaying branch and deadwood over 5cm diameter. | High | 3 | 3 |

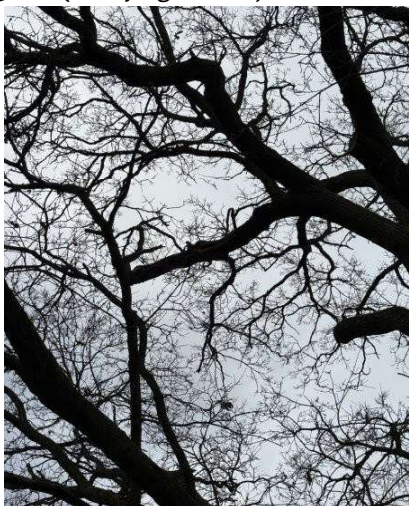
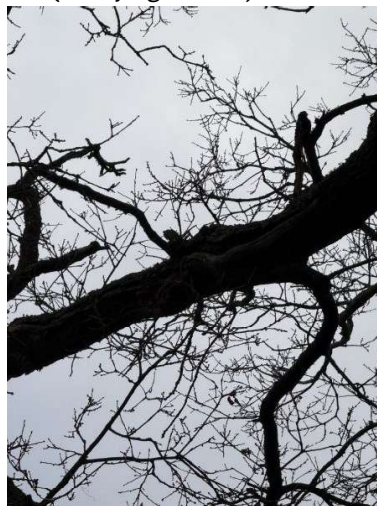
Photo 29. T11 (decaying branch)

Photo 30. T11 (decaying branch)

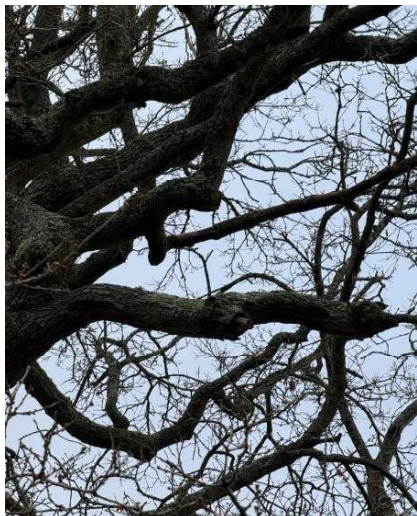
Photo 31. T11 (dead wood).

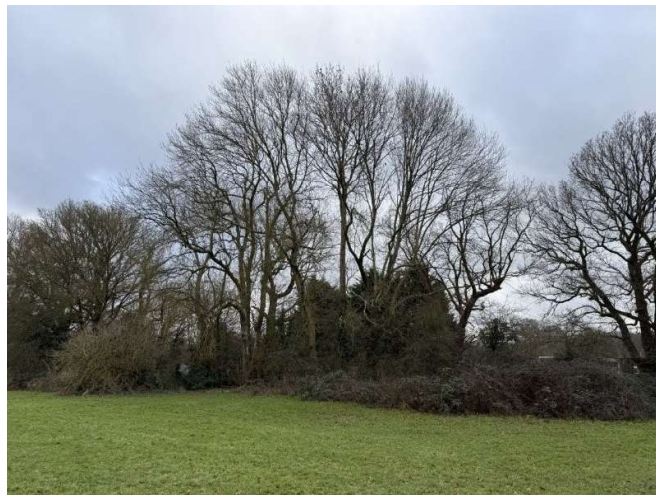
Photo 32. G12

| Ref. | Other Reference | Life Stage | Species | Height | DBH (cm) | North | East | South | West | Photo | Location & Targets | Survey Notes | Inspection Limitations | Physiological Condition | Structural Condition | Recommended Works | Priority | Inspect Frequency (yrs) | Safety Category |
|---|---|---|---|---|---|---|---|---|---|---|---|---|---|---|---|---|---|---|---|
| G012 | | Early Mature | Common ash ( <i>Fraxinus excelsior</i> ) | 22 | 45 | 5 | 5 | 5 | 5 | | Parkland tree. Target - road. | Trees in overall healthy physiological condition. No obvious symptoms of ash dieback. Defects: Easternmost ash has tight union at base where multiple stemmed (acceptable condition at present due to upright stems). | None | Normal | Normal | Monitor for ash dieback | Low | 3 | 1 |
