**MARK AND JO ROBINSON**

MILL FARM, MILL LANE, ITCHINGFIELD, HORSHAM,  
WEST SUSSEX RH13 0NP

**Preliminary Contamination Risk Assessment**

February 2026

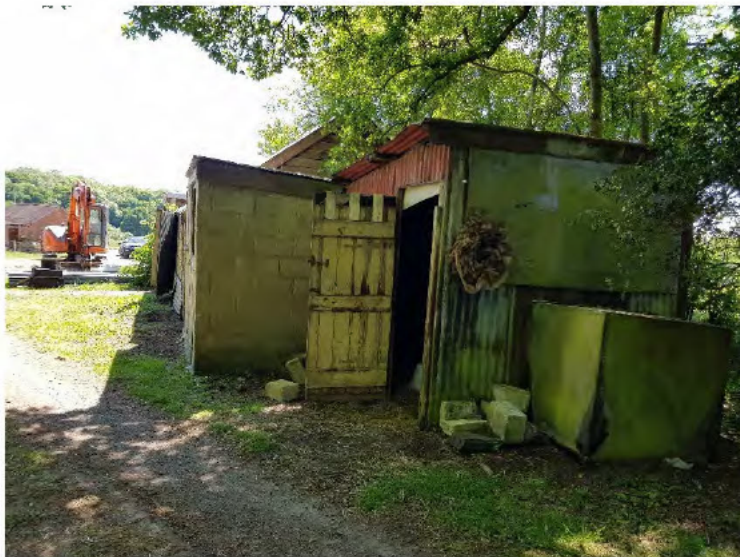
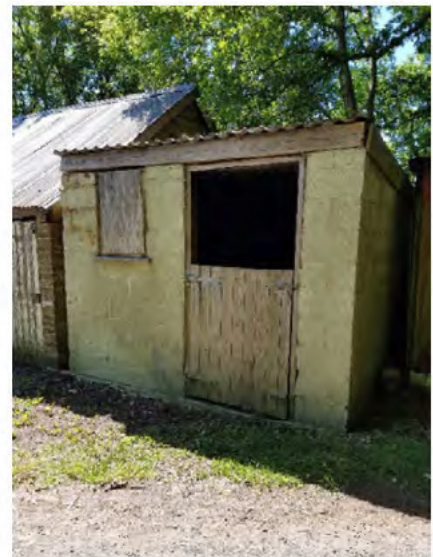
**Photographs 2 and 3:**

A small, single pitched 'shed' constructed from corrugated metal (left) and a concrete block stable with corrugated metal roof, located to the south of the access road. A metal fuel tank is located adjacent to the western façade of the shed. Inspection of the tank identified a small quantity of diesel at the bottom of the tank.

- iii. The diesel tank to the west of the yard has been removed. The soil within the vicinity of the tank should be removed and replaced with clean topsoil from an uncontaminated source.

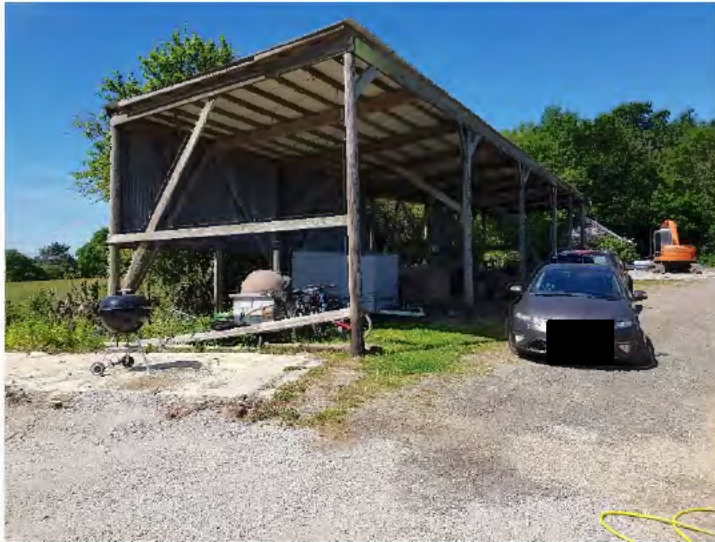
**Photograph 8:**

- 9.6 A pre-demolition asbestos survey was undertaken by Pass Consulting in July 2019. Asbestos containing materials were identified on and around a single garage located to the east of the haybarn (on site). This material has been removed from the site by the current site owner and occupier. No remaining asbestos containing materials were observed during the site walkover assessment undertaken on 19 May 2020.

To the east of the hay barn is the remaining concrete base of a single garage. The garage included asbestos containing materials and has been removed from the site.

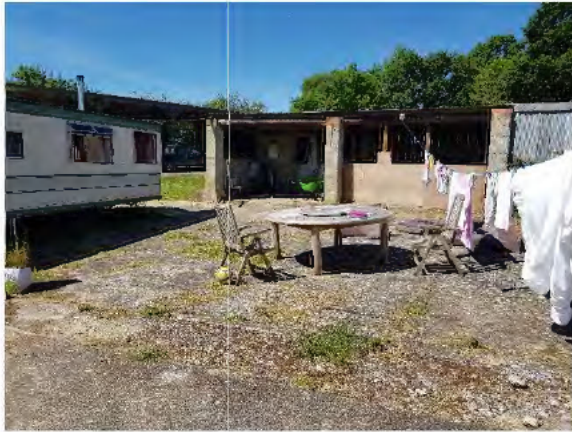
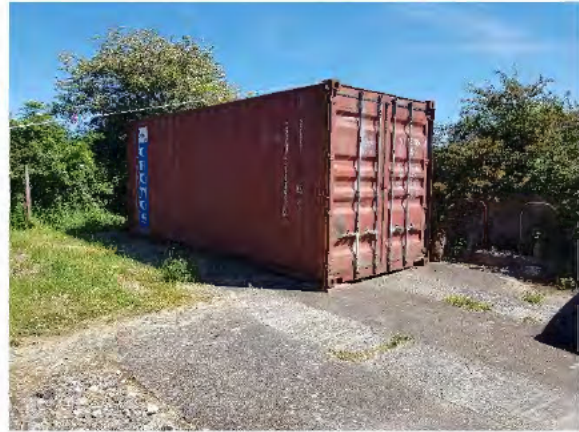
**Photographs 12 and 13:**

To the north of the caravan is an area of concrete hardstanding thought to be the remains of a dairy building. To the east is a wall with the remains of milking bays (from the dairy) and to the west is a concrete block building with corrugated metal roof and concrete floor. The building comprises two bays currently used for stabling a horse and associated equipment. A metal shipping container (used for household storage) has been placed within the northeast corner of the concrete 'yard'.

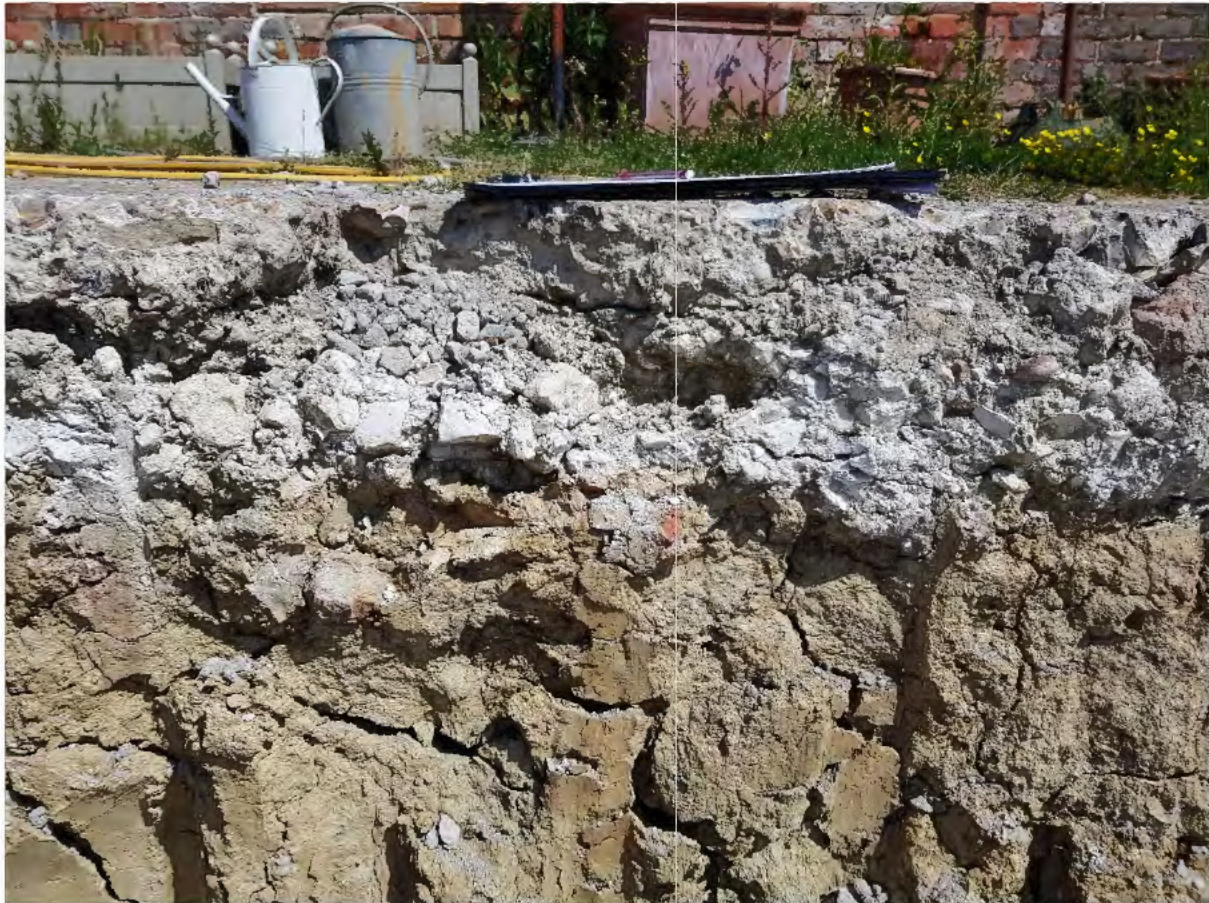
**Photograph 18:**

An excavation within the footprint of the proposed dwelling revealed a shallow layer of topsoil over clay with Horsham Stone. Immediately adjacent to the existing dwelling excavation revealed a layer of concrete with flints and brick up to 200 mm bgl, over a layer of chalk between 200 mm and 300 mm bgl over the natural ground (pictured above).

- i. As part of the site's redevelopment it is proposed to remove the existing buildings and hardstanding. It is recommended that any underlying fill is removed down to the natural ground (clay) and ground levels are restored

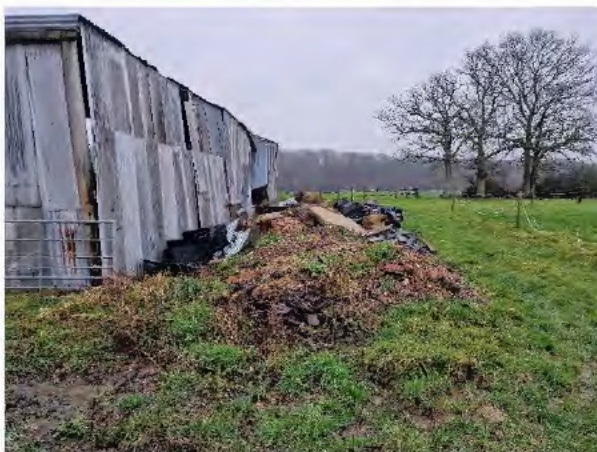
**Photograph 4: Mixed Earth and Rubble Pile**

- 5.11 To the south of the haybarn, east of the field gate, is a large pile of waste material comprising mixed building rubble and soil, believed to be generated from the more recent redevelopment of the site for residential use. Materials observed include concrete, brick, wood, corrugated metal sheets and soil.

- 8.3.3 Mixed soil and rubble such as that observed within the field to the south of the haybarn can be a source of contamination, however, it is believed that the source of this material was on site, associated with the residential development of the adjacent land. An asbestos survey was undertaken on the site prior to the redevelopment and the identified asbestos containing materials were removed from the site. It is therefore unlikely that the mixed soil and rubble on site contains asbestos containing materials.

- 9.7 As part of the wider site's redevelopment some buildings were removed and surfacing lifted. There is a large pile of mixed building rubble and earth located to the rear (south) of the haybarn (on site). It is believed that the source of this material is from these buildings and surfacing. Whilst the buildings were thought to be free of asbestos, due to the unknown nature of ground conditions beneath the former hard standing areas, it is recommended that the mixed rubble and earth should be disposed of offsite, or tested for suitability if it is intended to be retained on site for use elsewhere, and the underlying ground, which may have been impacted, be excavated back to the natural ground (clay) and the ground levels restored with 'clean' material from an uncontaminated source.

To the rear (south) of the hay barn is a pile of mixed earth and building rubble comprising concrete, brick, wood and sheet metal.

- ii. The mixed soil and rubble deposited within the field to the south of the haybarn (on site) is to be removed as part of the site's redevelopment. It is recommended that the soil, rubble, and any underlying soil which may have been impacted is removed down to the natural ground (clay) and ground levels are restored with clean material from an uncontaminated source. The waste material should either be removed from site or, if it is intended to use this material elsewhere, it should be tested for suitability.

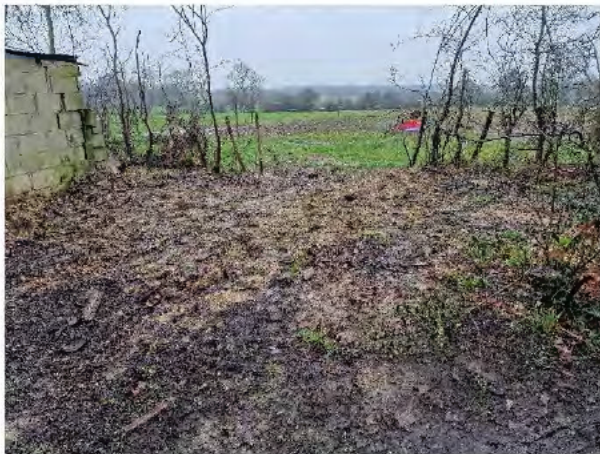
**Photograph 12:**

- 7.5 There was an old metal diesel tank located at the western end of the site. There is some potential for fuel contamination of the soil around the diesel tank caused during the dispensing process. The owner of the site has since removed the tank as part of the general tidying of the site. The ground in this area is now disturbed. No evidence of staining could be seen, however, underlying soil could be impacted by fuel contamination.

Former shed and tank location, now cleared.
