**INSURANCE CLAIM: ENGINEERING APPRAISAL REPORT**

30 Brushwood Road, HORSHAM, West Sussex, RH12 4PE

Date: 31/03/2026

Our Ref: 10060204

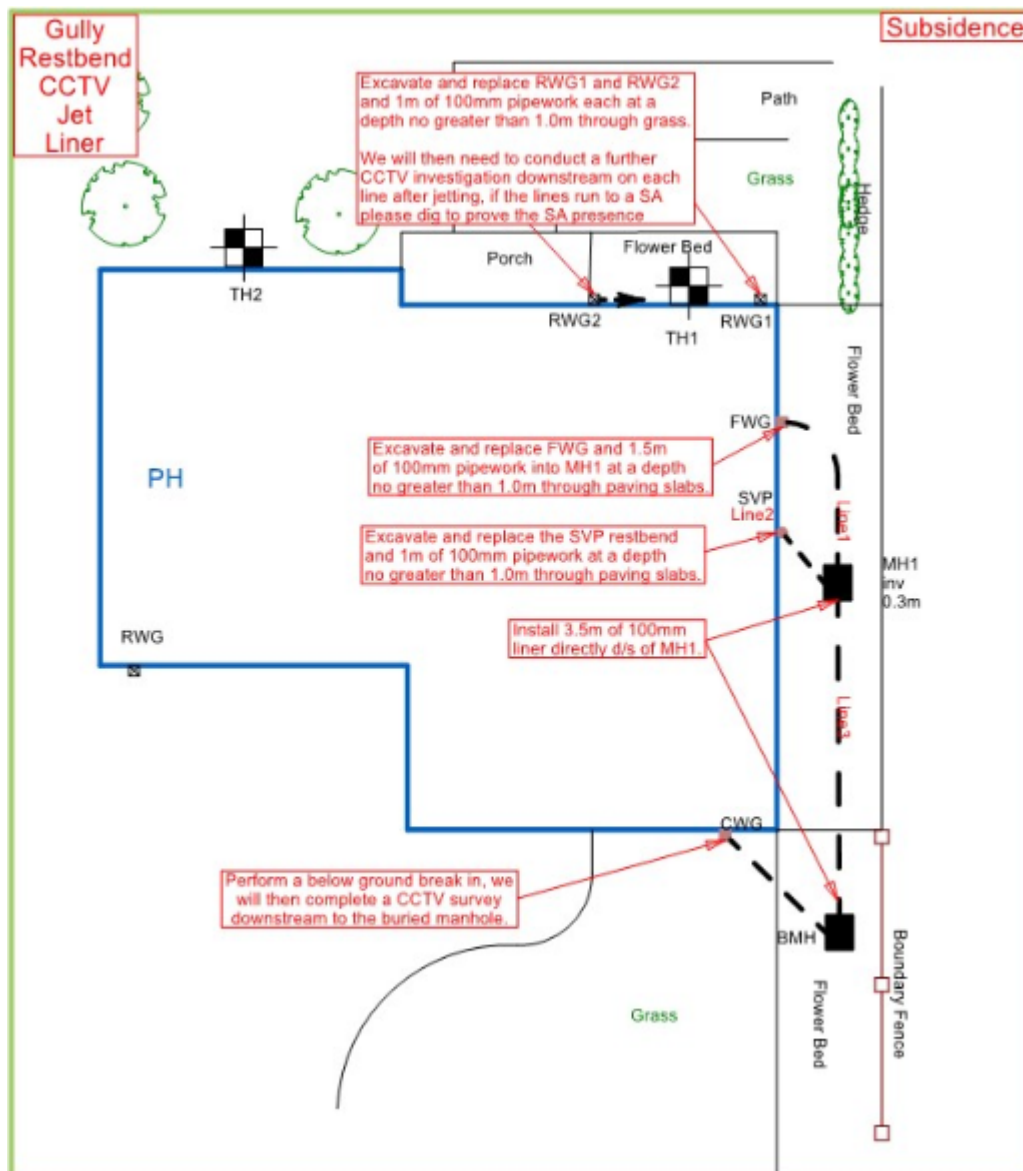
**Sketch showing location of trial pits/boreholes and location of drain runs**

Two trial pits/boreholes were excavated to the front elevation of the property, and a CCTV of the drainage was undertaken.

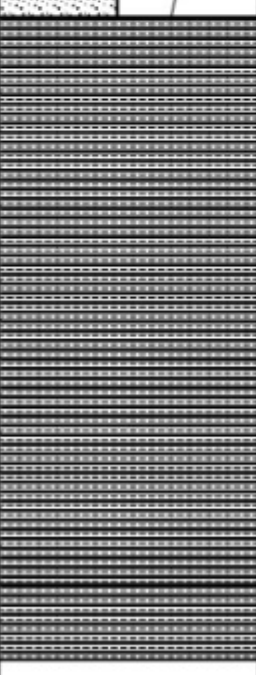
| | | Trial Hole Log No.1 | | Job Ref:<br>163384.1.USI | | |

Trial pit/borehole 1 was excavated to the front left corner of the property and this revealed a concrete strip footing at a depth of 700mm below external ground level bearing on to moist very stiff brown fine to medium gravelly silty clay. The borehole was terminated at a depth of 2.4metres. Roots were noted beneath the foundation, extending to a depth of 1.2metres.

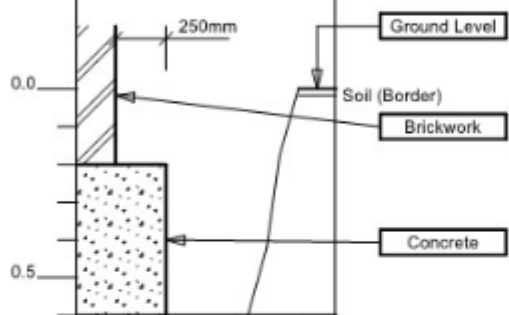
| | | Trial Hole Log No.2 | | Job Ref:<br>163384.1.USI | | |

Trial pit/borehole 2 was excavated to the front right of the property and this revealed a concrete strip footing at a depth of 600mm below external ground level bearing on to moist very stiff brown fine to medium gravelly silty clay. The borehole was terminated at a depth of 2.3metres. Roots were noted beneath the foundation, extending to a depth of 1.1metres.
