# ARBORICULTURAL ASSESSMENT REPORT

30 Brushwood Road, Horsham RH12 4PE

PRI Ref: 292495

Survey Date: 03/05/2024

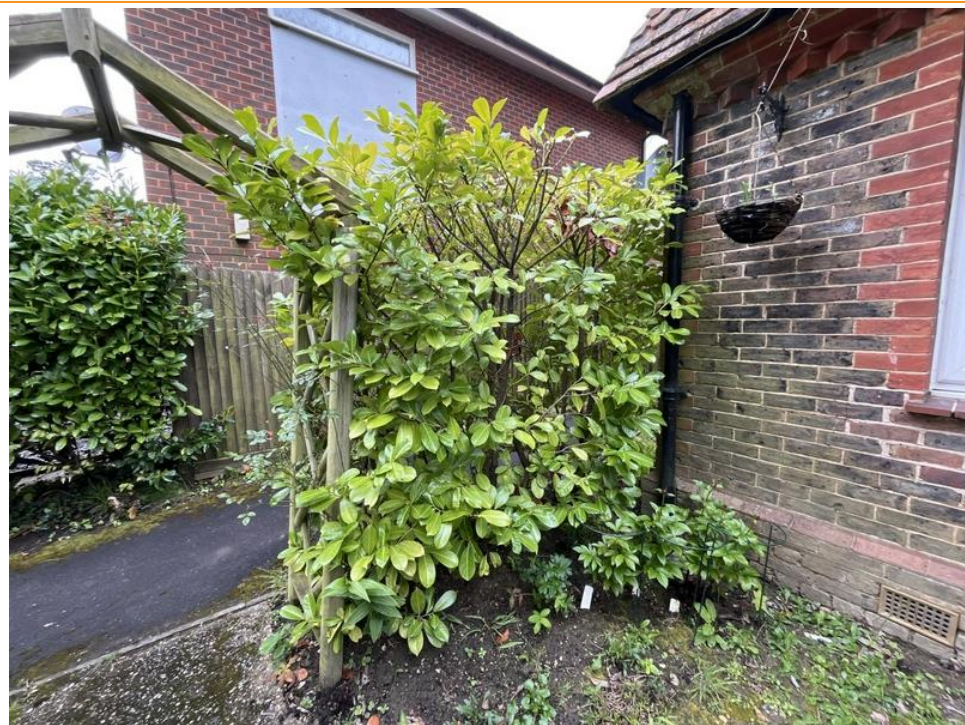
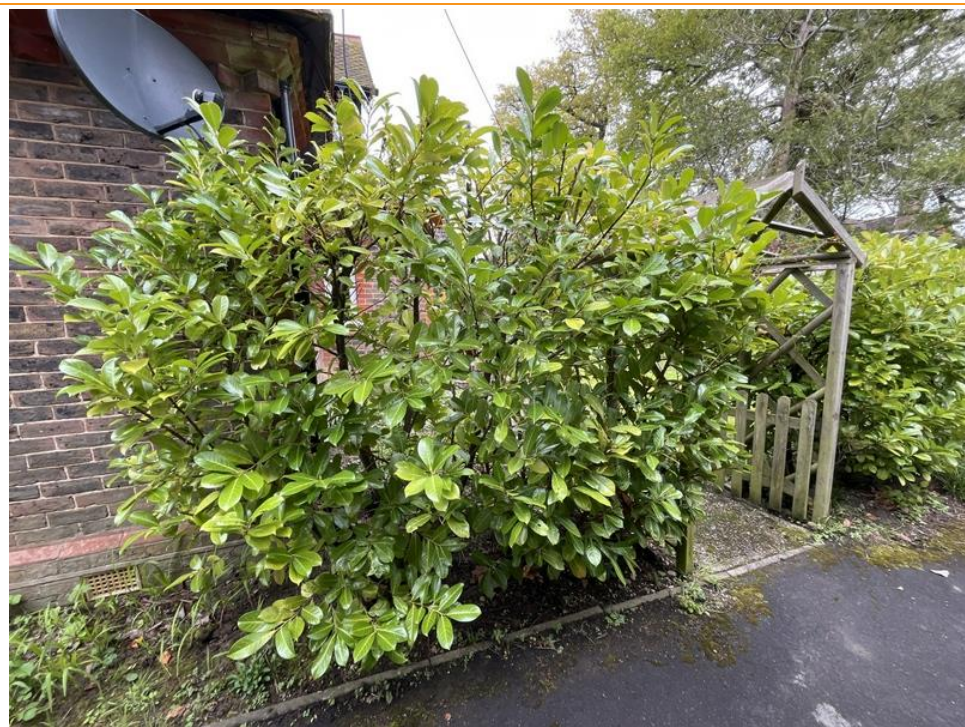
H1 - Laurel (Cherry)

| Tree No: | Common Name | Age Class | Condition | Height (m) | Crown Spread (m) | Stem diam. (mm) | No. of Stems | Dist to bldg. (m) | Roots Implicated | Pruning History | Recommendation | Tree Work Constraints | Notes | Owner address | Owner |
|---|---|---|---|---|---|---|---|---|---|---|---|---|---|---|---|
| H1 | Laurel (Cherry) | Early Mature | Fair | 2.50 | 1.25 | 50 | 3 | 0.50 | Yes | Subject to historic crown reduction management. | Fell and treat stump with eco plugs (broadleaved). | There are no restrictions to the site or to the tree - scheduled rates may apply. | Implicated due to distance. | 30 Brushwood Road<br>Horsham<br>RH12 4PE | PH |

| Tree No: | Species | Works Required | CA | TPO | Ownership |
|---|---|---|---|---|---|
| H1 | Laurel (Cherry) | Fell and treat stump with eco plugs (broadleaved) | No | No | PH |

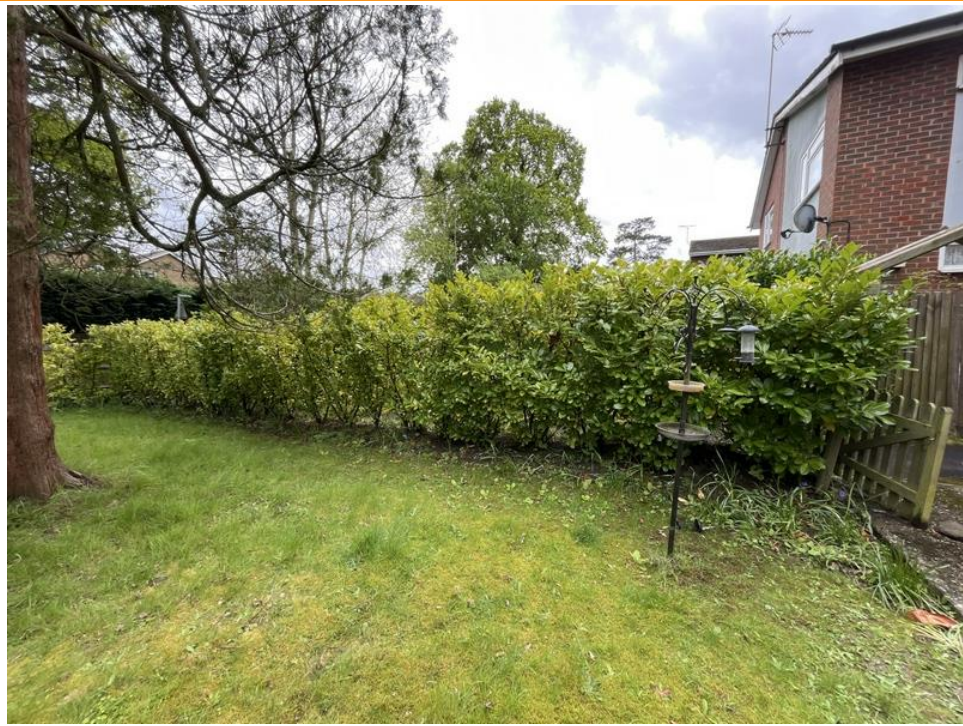
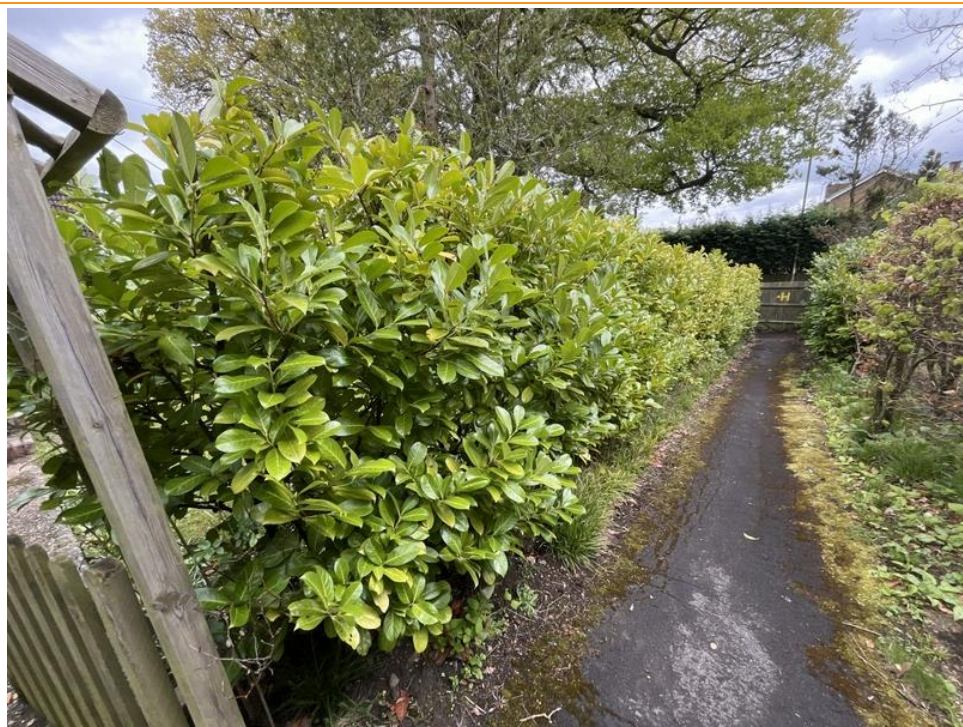
H2 - Laurel (Cherry)

| Tree No: | Common Name | Age Class | Condition | Height (m) | Crown Spread (m) | Stem diam. (mm) | No. of Stems | Dist to bldg. (m) | Roots Implicated | Pruning History | Recommendation | Tree Work Constraints | Notes | Owner address | Owner |
|---|---|---|---|---|---|---|---|---|---|---|---|---|---|---|---|
| H2 | Laurel (Cherry) | Early Mature | Fair | 2.50 | 1.25 | 50 | 20 | 4.00 | Yes | Subject to historic crown reduction management. | No work required. | There are no restrictions to the site or to the tree - scheduled rates may apply. | Estimated stem count and diameters. Although roots were found from this species no implicated due to distance in relation to damage. | 30 Brushwood Road<br>Horsham<br>RH12 4PE | PH |

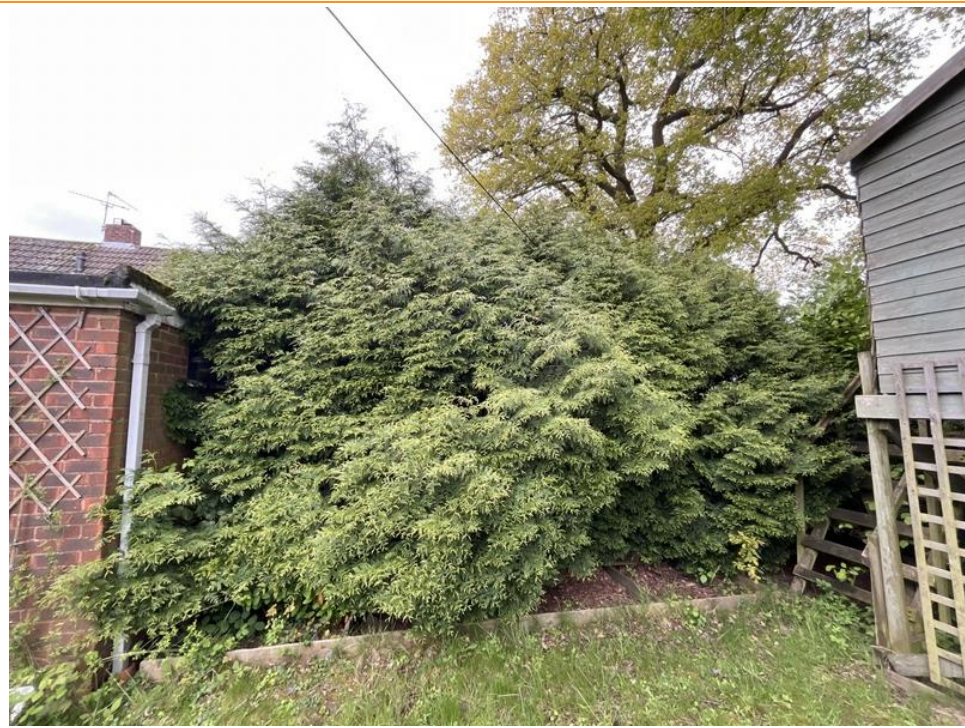
H3 - Cypress

| Tree No: | Common Name | Age Class | Condition | Height (m) | Crown Spread (m) | Stem diam. (mm) | No. of Stems | Dist to bldg. (m) | Roots Implicated | Pruning History | Recommendation | Tree Work Constraints | Notes | Owner address | Owner |
|---|---|---|---|---|---|---|---|---|---|---|---|---|---|---|---|
| H3 | Cypress | Early Mature | Fair | 6.00 | 5.00 | 150 | 8 | 1.60 | No | No significant past works. | No work required. | There are no restrictions to the site or to the tree - scheduled rates may apply. | Although not currently involved, going forward management may be required. Estimated stem count and diameters. | 30 Brushwood Road<br>Horsham<br>RH12 4PE | PH |

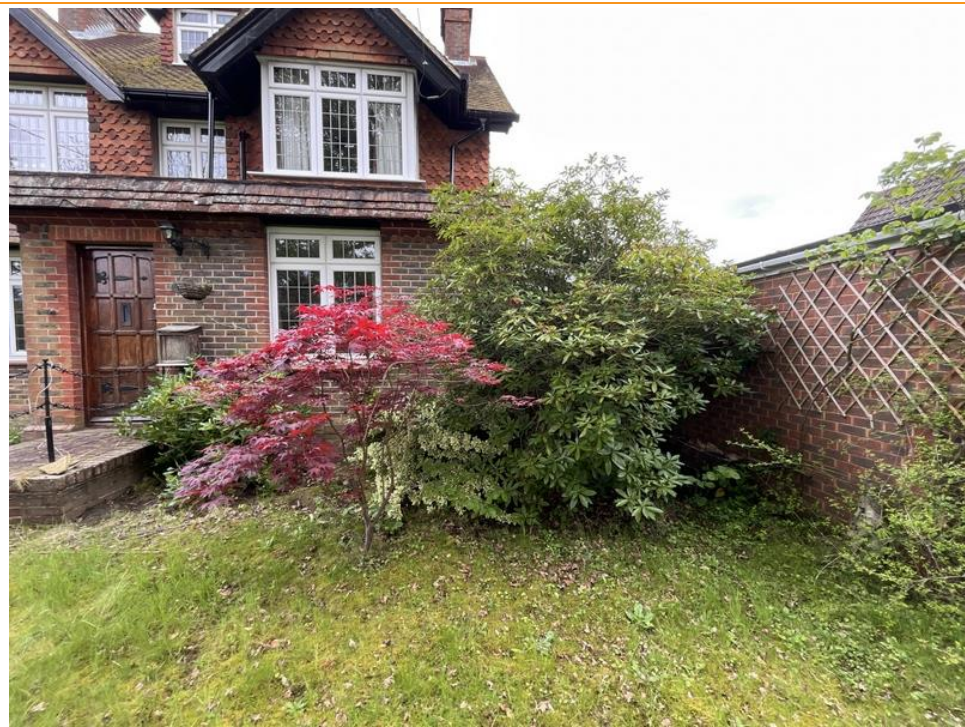
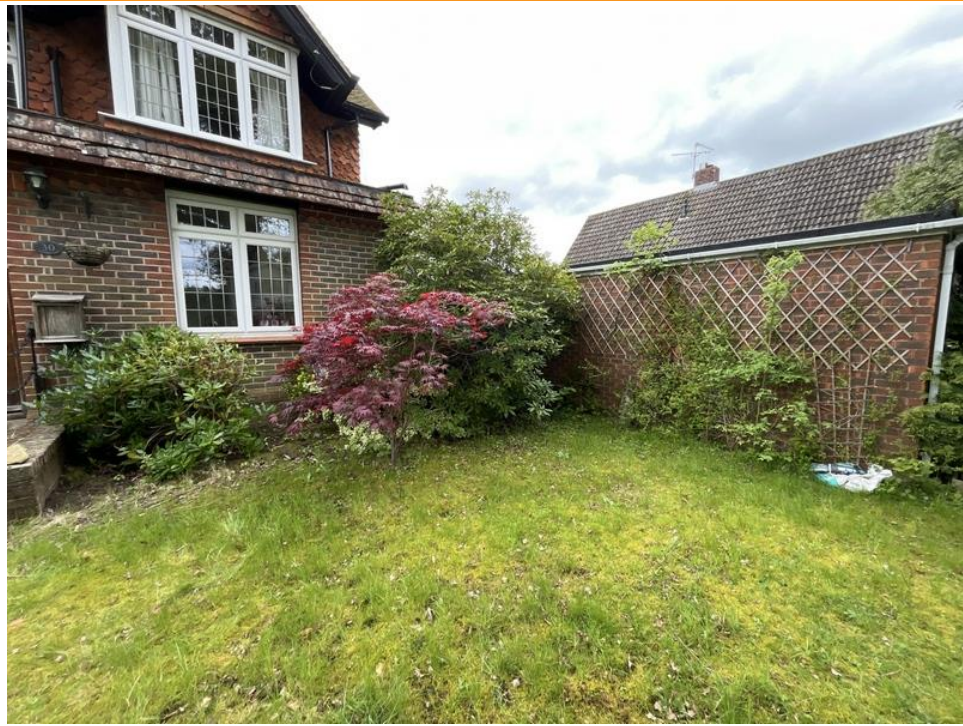
SG1 - Mixed species shrubs

| Tree No: | Common Name | Age Class | Condition | Height (m) | Crown Spread (m) | Stem diam. (mm) | No. of Stems | Dist to bldg. (m) | Roots Implicated | Pruning History | Recommendation | Tree Work Constraints | Notes | Owner address | Owner |
|---|---|---|---|---|---|---|---|---|---|---|---|---|---|---|---|
| SG1 | Mixed species shrubs | Early Mature | Fair | 3.00 | 1.50 | 50 | 10 | 0.20 | No | Subject to historic crown reduction management. | No work required. | There are no restrictions to the site or to the tree - scheduled rates may apply. | Includes Rhododendron, Japanese Maple, Jasmine and Rose within group. Estimated DBH range of 10mm – 50mm. | 30 Brushwood Road<br>Horsham<br>RH12 4PE | PH |

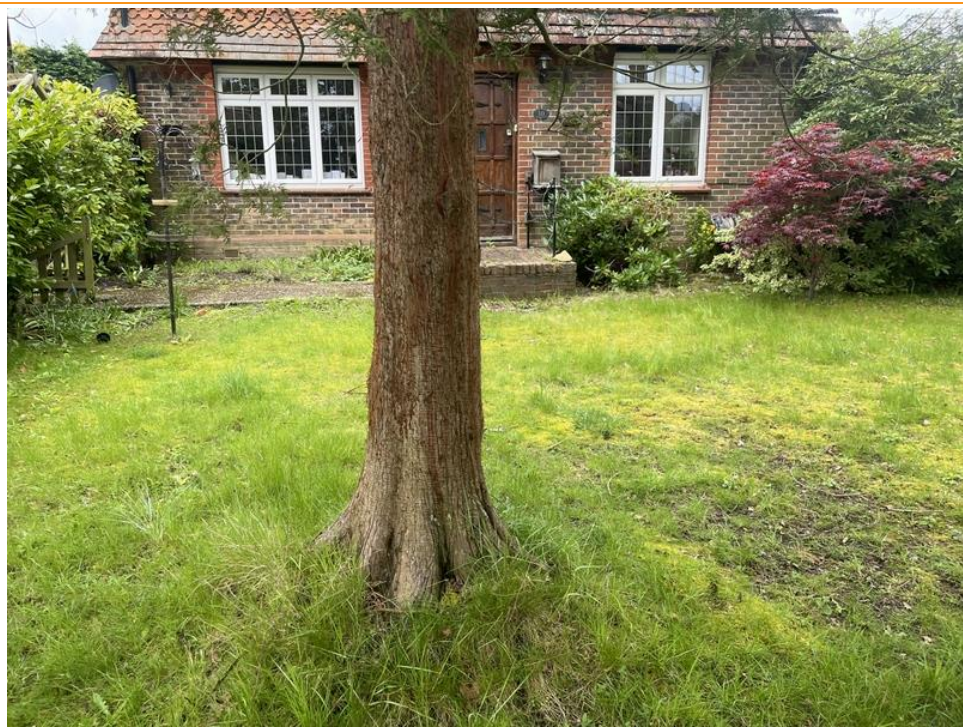
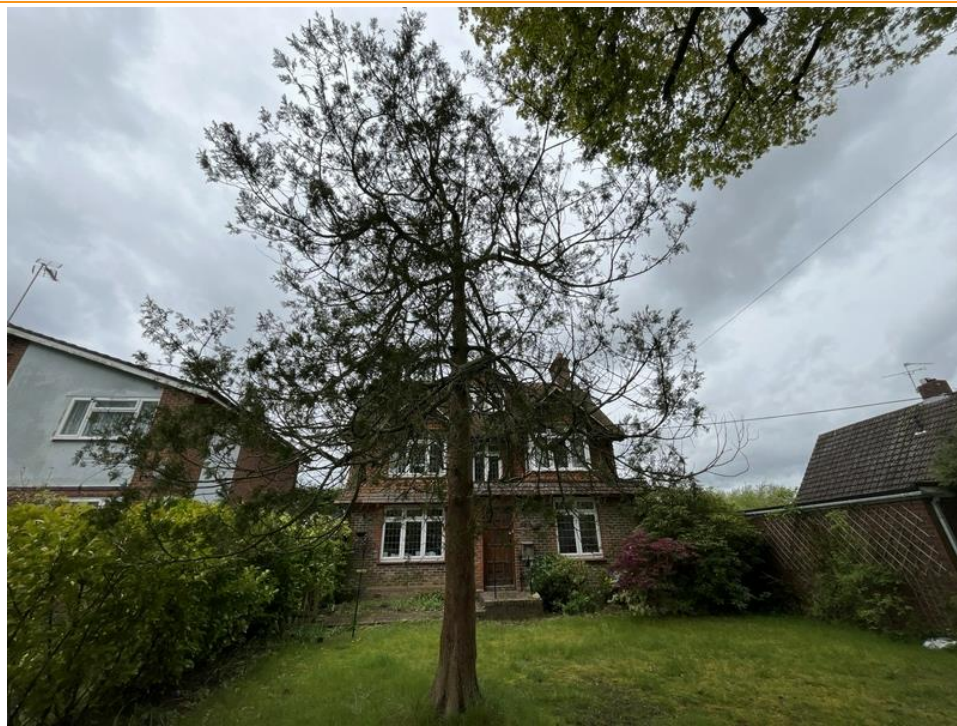
T1 - Cypress

| Tree No: | Common Name | Age Class | Condition | Height (m) | Crown Spread (m) | Stem diam. (mm) | No. of Stems | Dist to bldg. (m) | Roots Implicated | Pruning History | Recommendation | Tree Work Constraints | Notes | Owner address | Owner |
|---|---|---|---|---|---|---|---|---|---|---|---|---|---|---|---|
| T1 | Cypress | Early Mature | Fair | 10.00 | 5.50 | 325 | 1 | 7.20 | No | Topped more than 5 years ago | Fell close to ground level (approx. 50mm) (conifer). | There are restrictions to the site or to the tree - contractor should quote. Access through side passage. | None to add. | 30 Brushwood Road<br>Horsham<br>RH12 4PE | PH |

| Tree No: | Species | Works Required | CA | TPO | Ownership |
|---|---|---|---|---|---|
| T1 | Cypress | Fell close to ground level (approx. 50mm) (conifer) | No | No | PH |

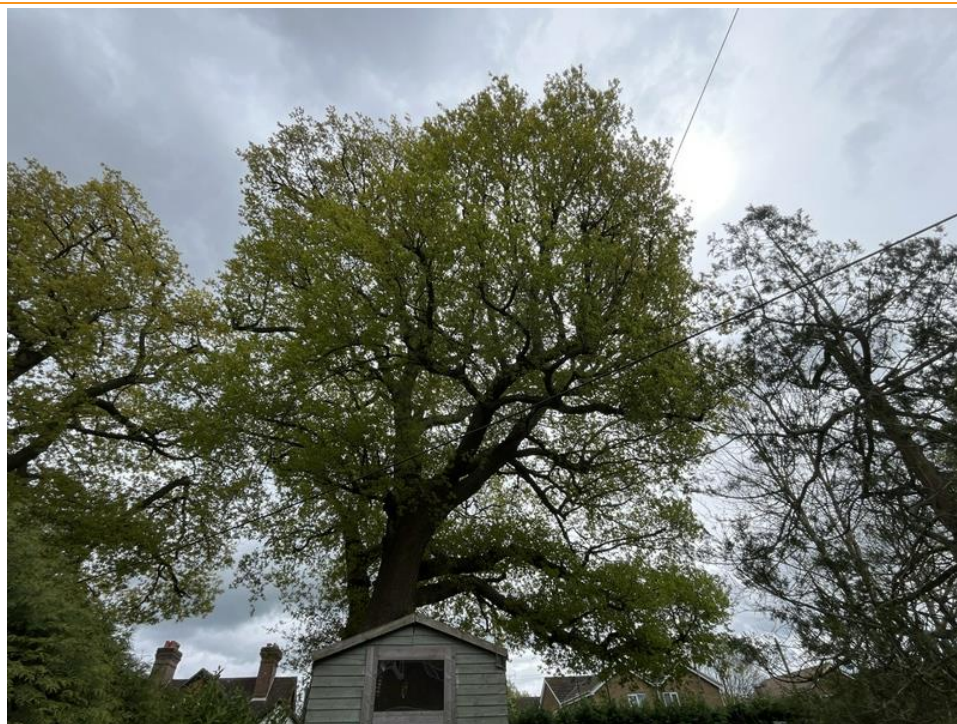
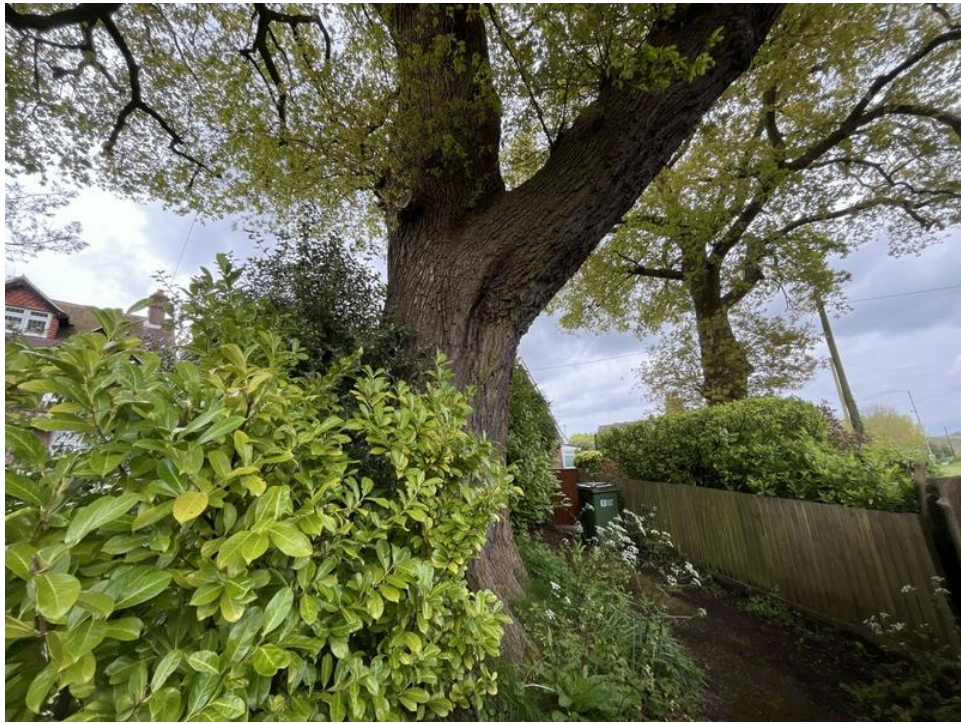
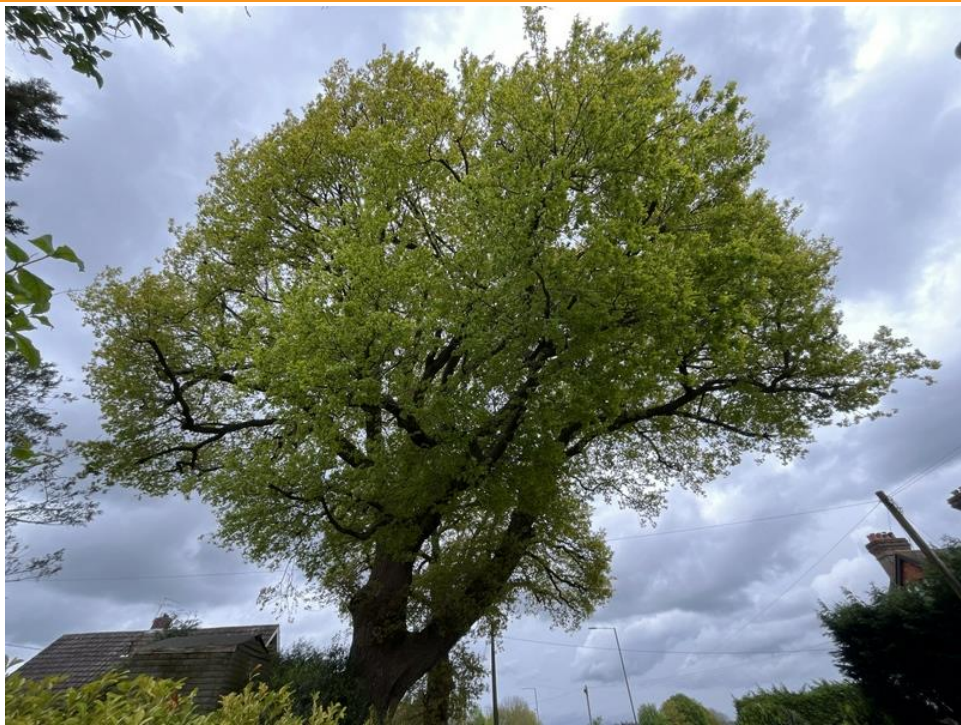
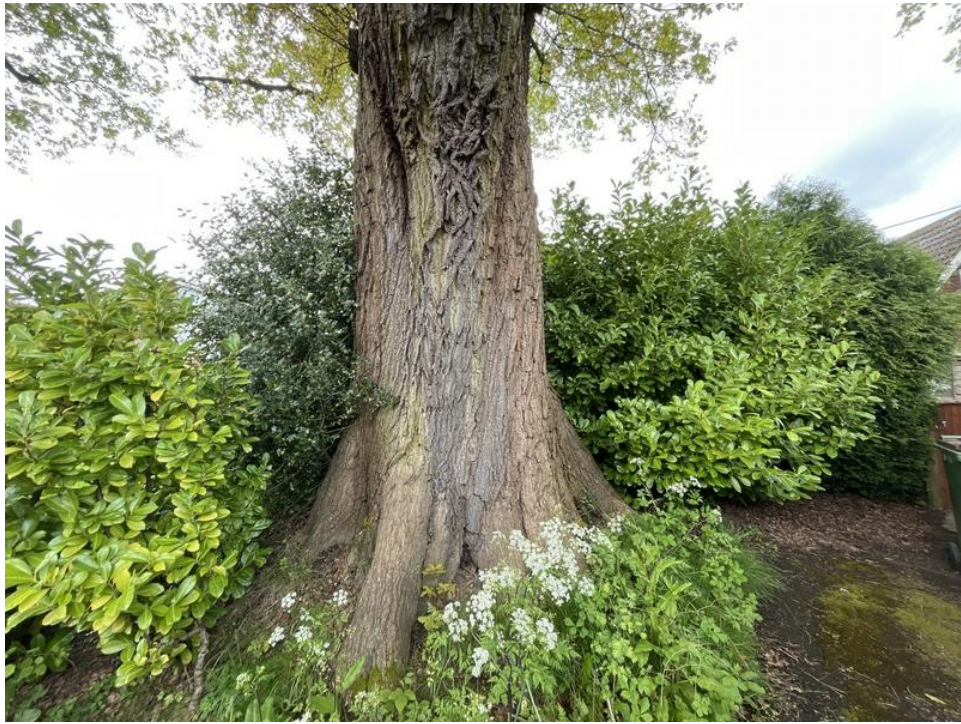
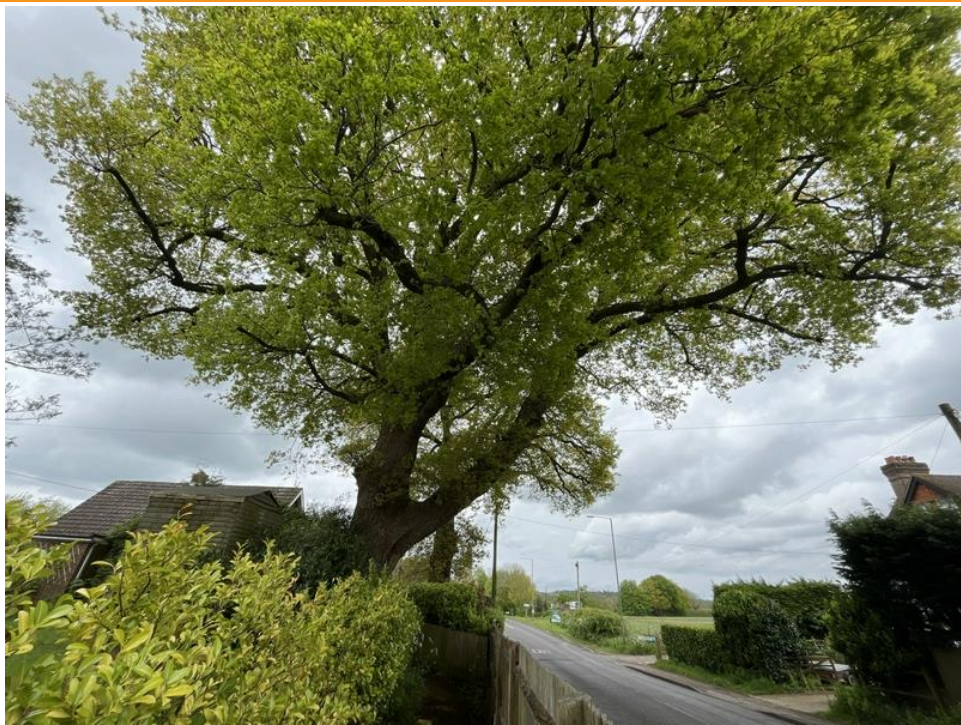
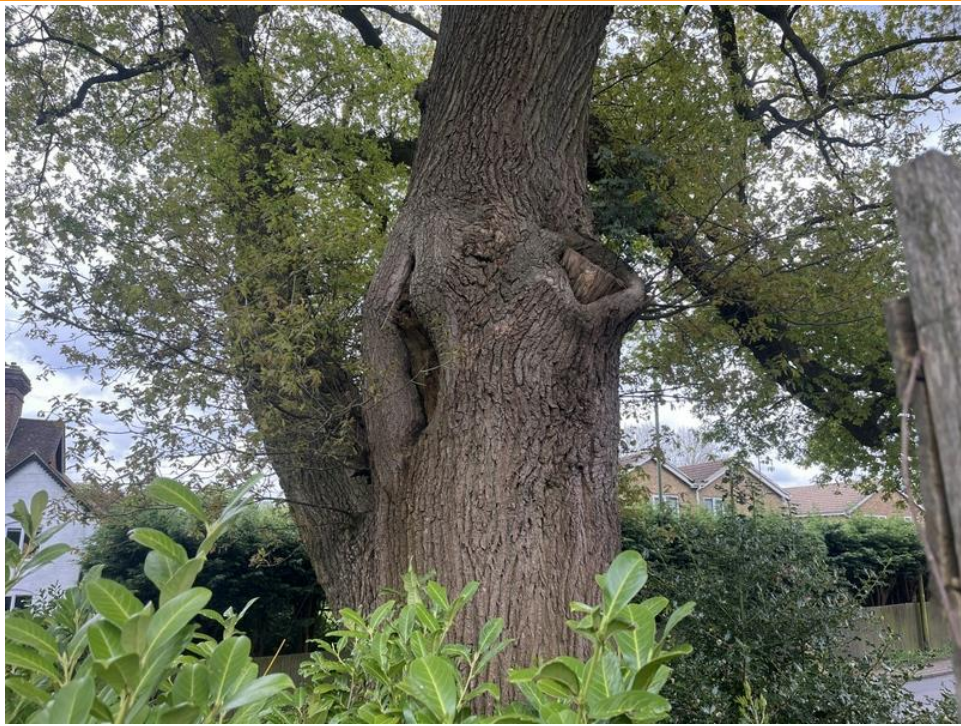
T2 - Oak

A review of Horsham Council's website has confirmed that T2 (Oak) of the implicated vegetation is subject to a Tree Preservation Order. There are no Conservation Area controls.

| Tree No: | Common Name | Age Class | Condition | Height (m) | Crown Spread (m) | Stem diam. (mm) | No. of Stems | Dist to bldg. (m) | Roots Implicated | Pruning History | Recommendation | Tree Work Constraints | Notes | Owner address | Owner |
|---|---|---|---|---|---|---|---|---|---|---|---|---|---|---|---|
| T2 | Oak | Mature | Fair | 26.00 | 20.00 | 1200 | 1 | 15.50 | Yes | Subject to historic crown reduction management. | Fell and treat stump with eco plugs (broadleaved). | There are restrictions to the site or to the tree - contractor should quote. Adjacent to highway. Obstructions- wooden structure. Phone/power lines through crown. Access through side passage. No access from front. | Very large mature Oak. Large diameter branch over road. Stem diameter estimated. | 30 Brushwood Road<br>Horsham<br>RH12 4PE | PH |

| Tree No: | Species | Works Required | CA | TPO | Ownership |
|---|---|---|---|---|---|
| T2 | Oak | Fell and treat stump with eco plugs (broadleaved) | No | Yes | PH |

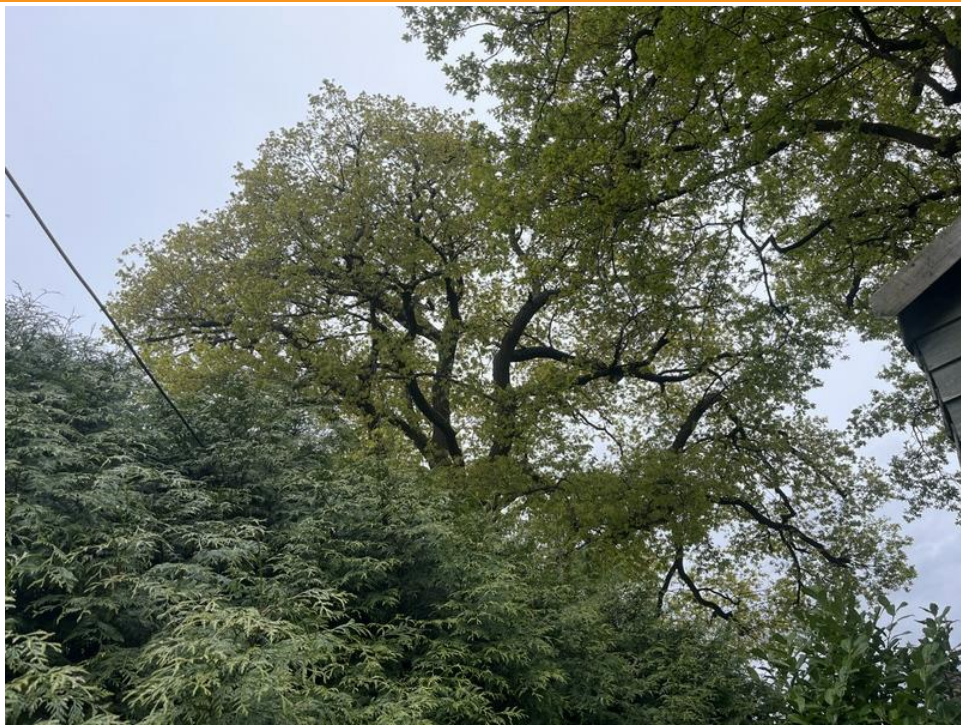
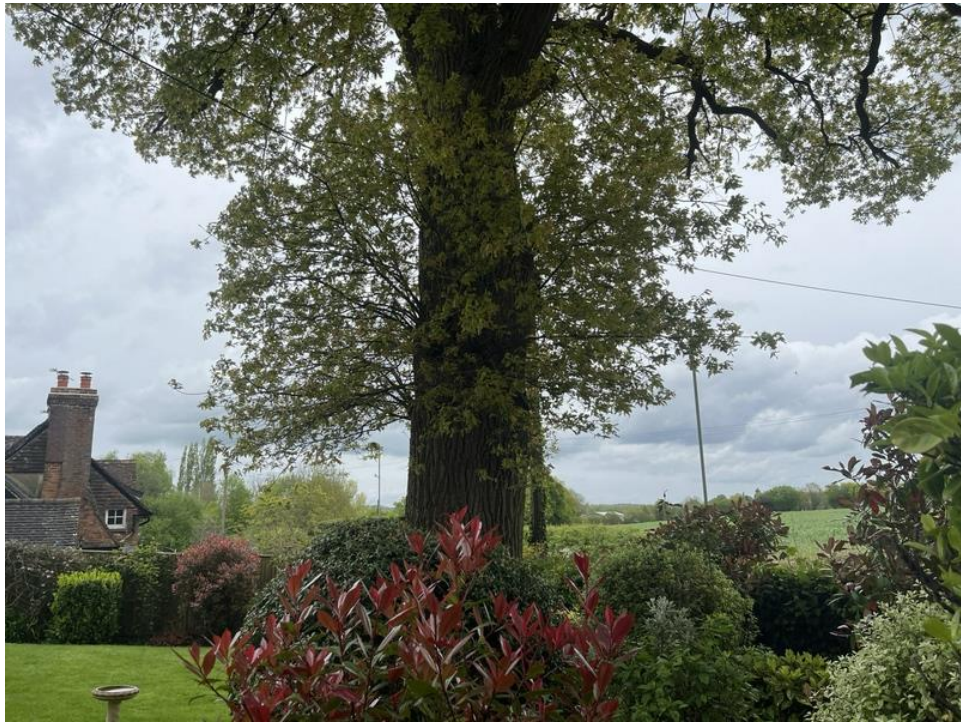
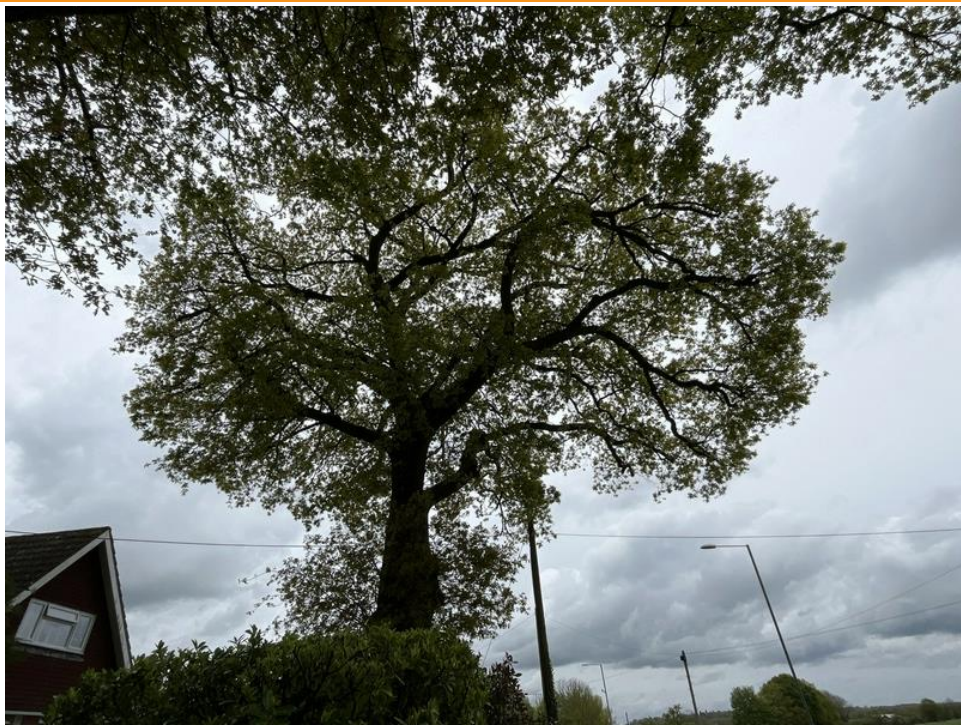
T3 - Oak

| Tree No: | Common Name | Age Class | Condition | Height (m) | Crown Spread (m) | Stem diam. (mm) | No. of Stems | Dist to bldg. (m) | Roots Implicated | Pruning History | Recommendation | Tree Work Constraints | Notes | Owner address | Owner |
|---|---|---|---|---|---|---|---|---|---|---|---|---|---|---|---|
| T3 | Oak | Mature | Fair | 18.00 | 12.00 | 850 | 1 | 22.00 | Yes | Subject to historic crown reduction management. | No work required. | There are no restrictions to the site or to the tree - scheduled rates may apply. | Although not currently involved, crown reductions going forward may be required. Estimated values. Although roots were found from this species, it is unlikely it's from this tree. | 32 Brushwood Road<br>Horsham<br>RH12 4PE | P3P |

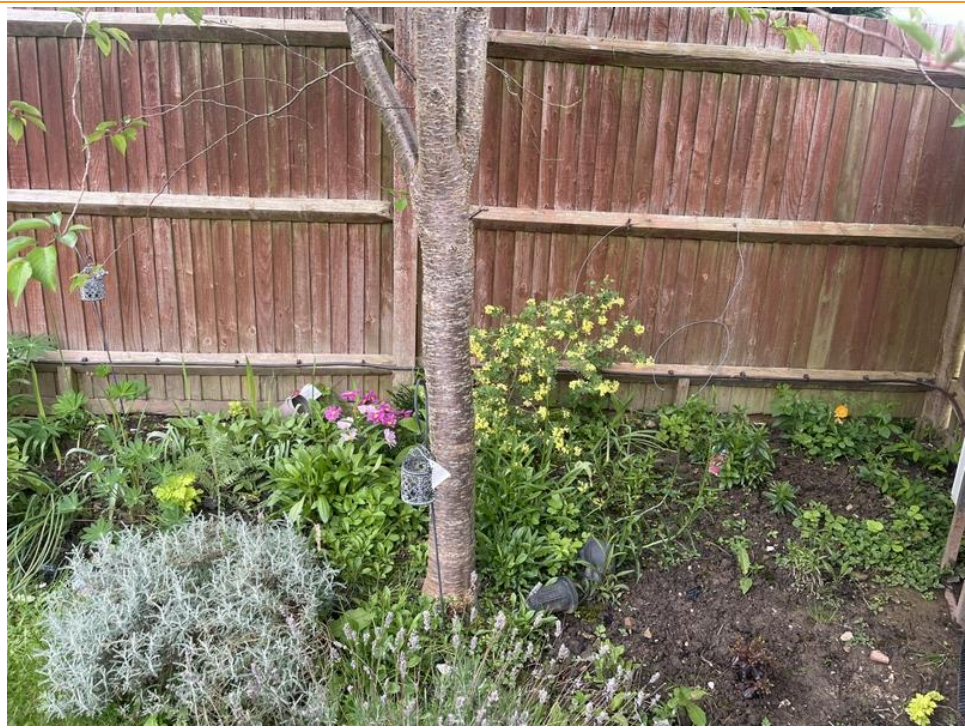
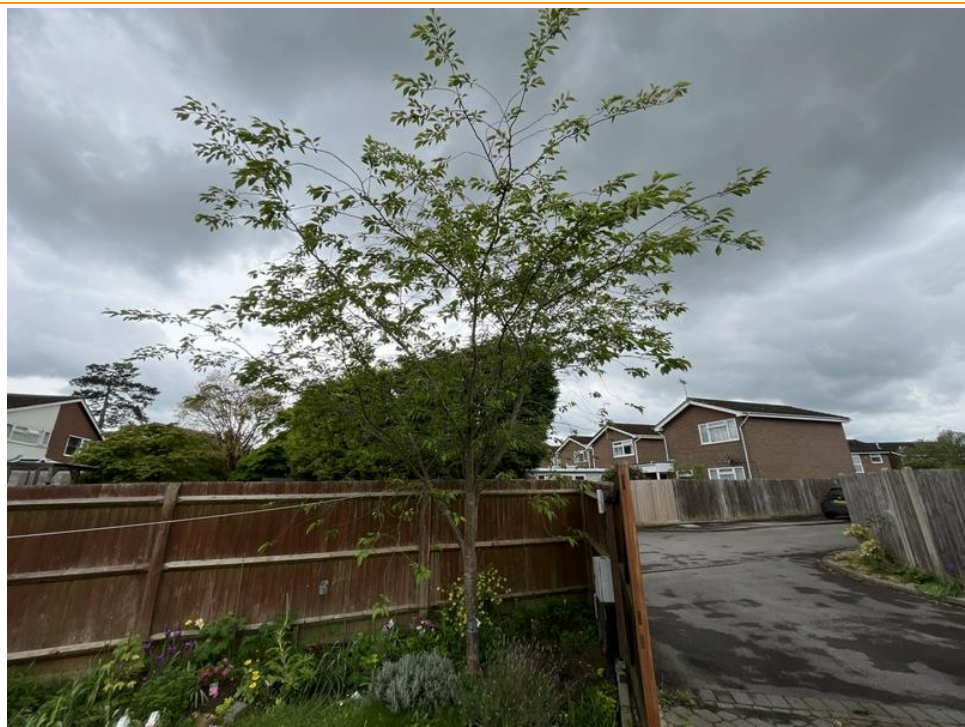
T4 - Cherry

| Tree No: | Common Name | Age Class | Condition | Height (m) | Crown Spread (m) | Stem diam. (mm) | No. of Stems | Dist to bldg. (m) | Roots Implicated | Pruning History | Recommendation | Tree Work Constraints | Notes | Owner address | Owner |
|---|---|---|---|---|---|---|---|---|---|---|---|---|---|---|---|
| T4 | Cherry | Semi-Mature | Fair | 4.50 | 6.00 | 125 | 1 | 9.30 | Yes | No significant past works. | No work required. | There are no restrictions to the site or to the tree - scheduled rates may apply. | Although roots were found from this species, it is unlikely it's from this tree. | 30 Brushwood Road<br>Horsham<br>RH12 4PE | PH |

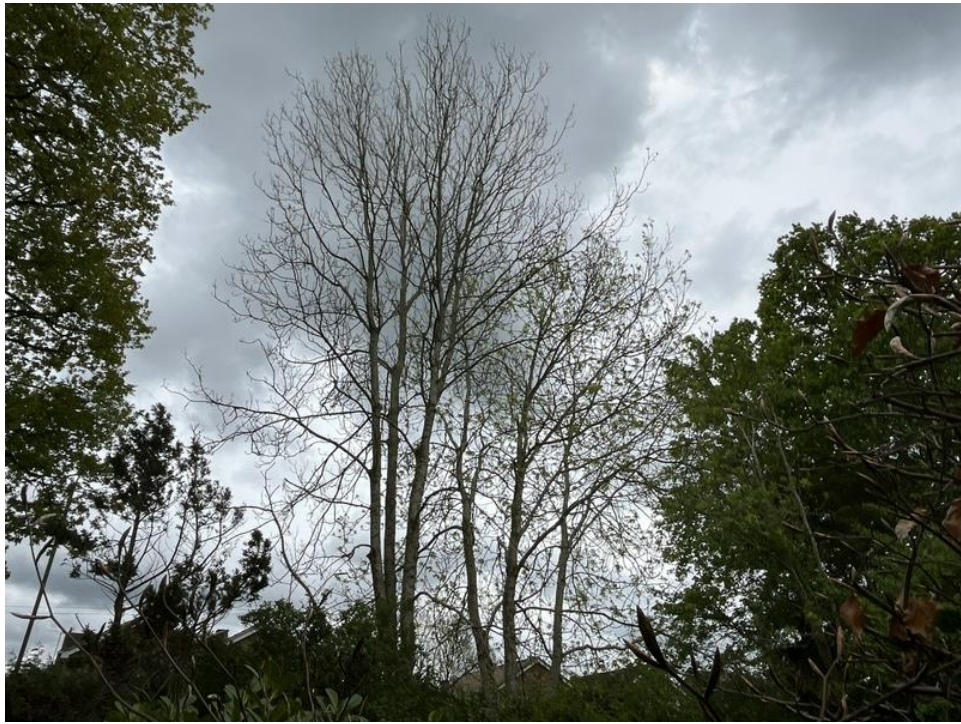
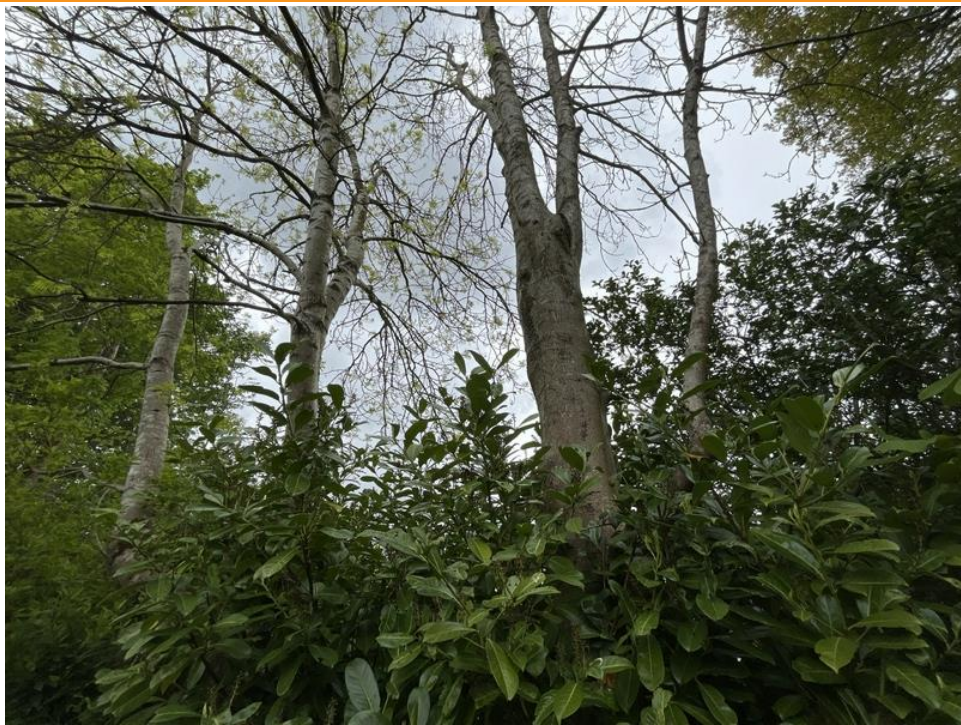
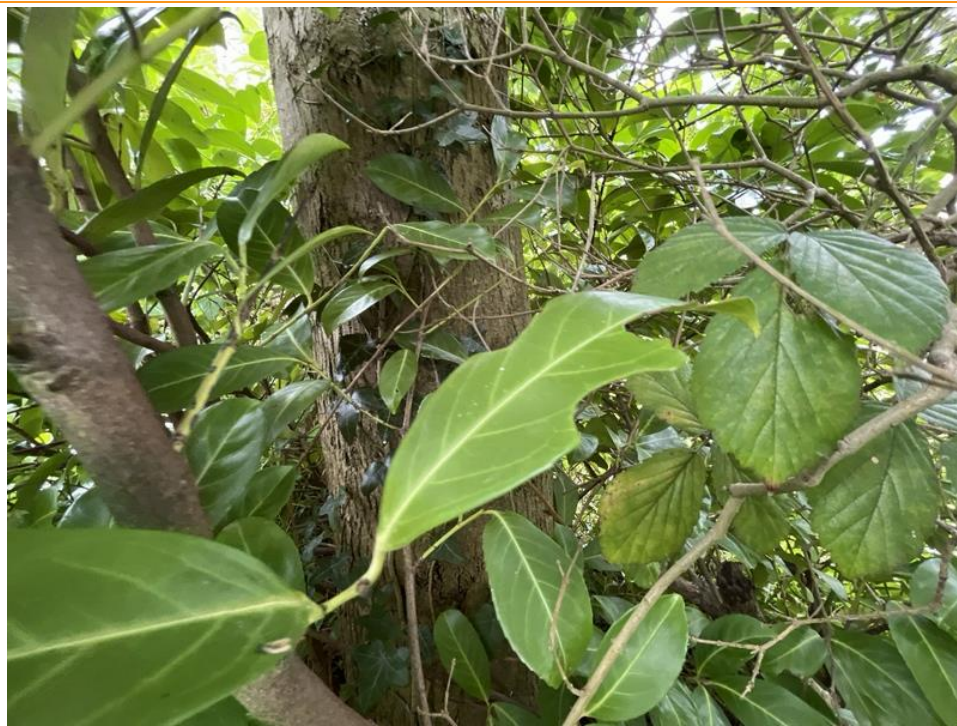
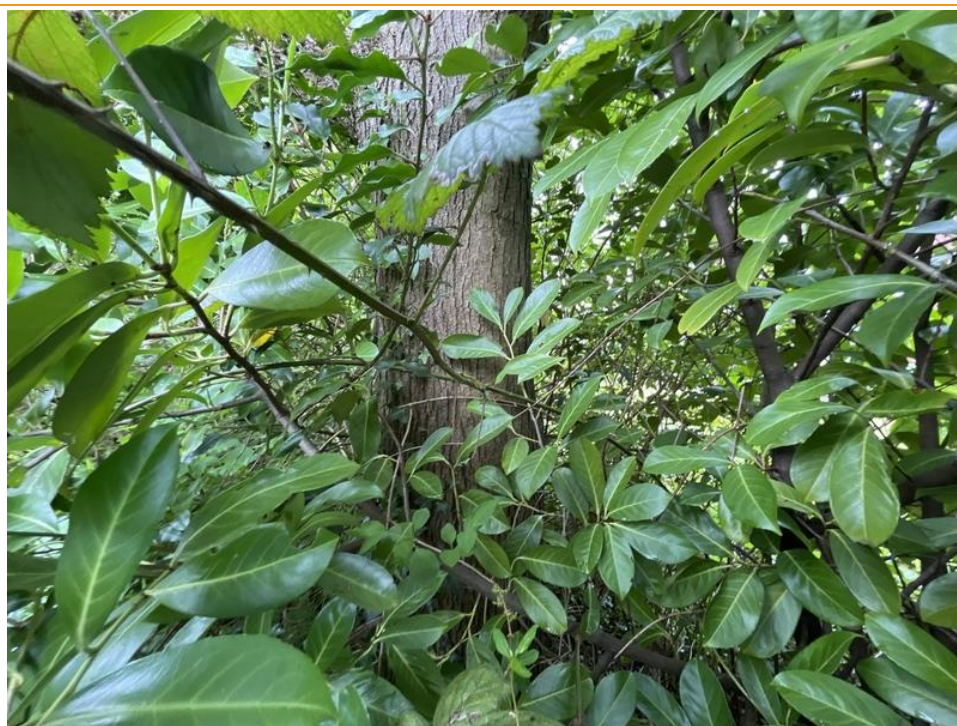
TG1 - Ash

| Tree No: | Common Name | Age Class | Condition | Height (m) | Crown Spread (m) | Stem diam. (mm) | No. of Stems | Dist to bldg. (m) | Roots Implicated | Pruning History | Recommendation | Tree Work Constraints | Notes | Owner address | Owner |
|---|---|---|---|---|---|---|---|---|---|---|---|---|---|---|---|
| TG1 | Ash | Early Mature | Fair | 16.00 | 9.00 | 400 | 2 | 21.50 | No | No significant past works. | No work required. | There are no restrictions to the site or to the tree - scheduled rates may apply. | Estimated values. On boundary- unknown owner. | Boundary Trees | UKN |

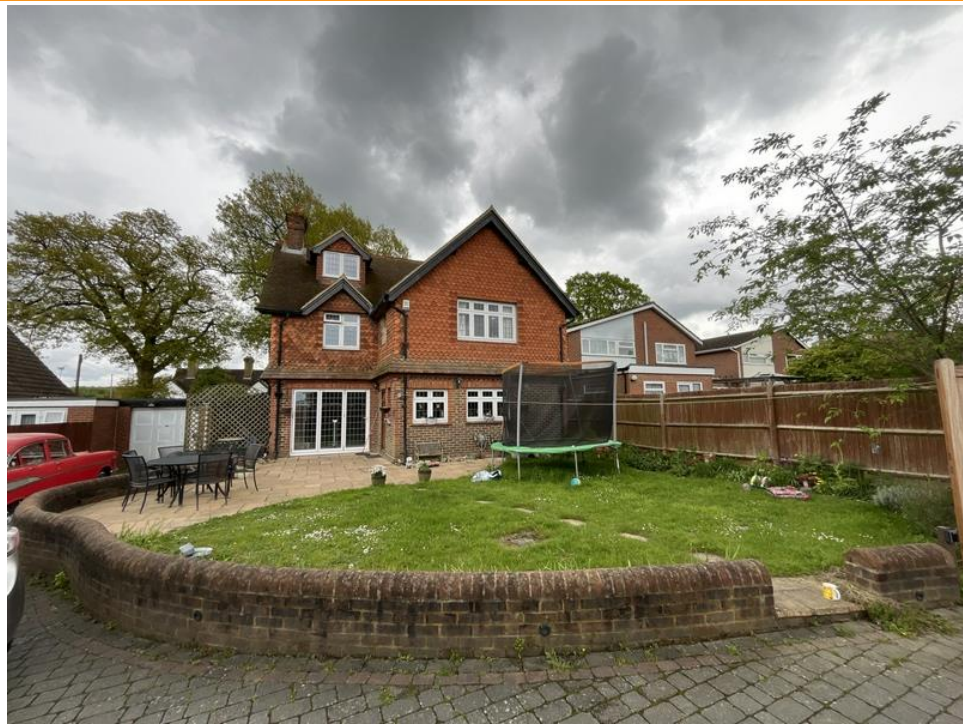
View of rear (lack of vegetation)
