# Site Investigation Report

163384.1.USI

Auger were commissioned by Sedgwick to undertake a site investigation and CCTV inspection of the underground drainage within the area of concern (AOC) at the property.

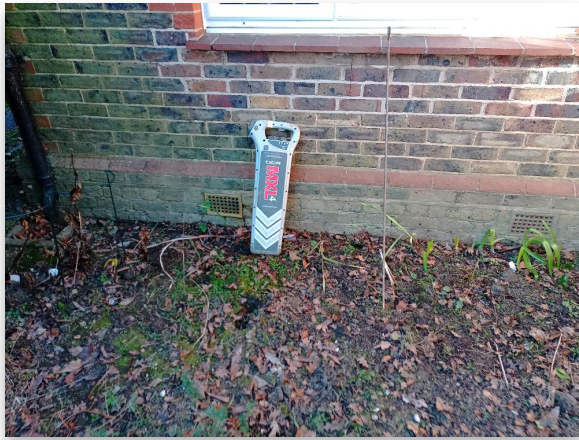
Fig 1.1: Trial Hole 1 Location

TH1 was completed in the proposed location, refusal was met at a depth of 2.4m due to encountering solid ground which our engineer was unable to auger through. Despite this the footing was revealed and soil and root samples were taken.

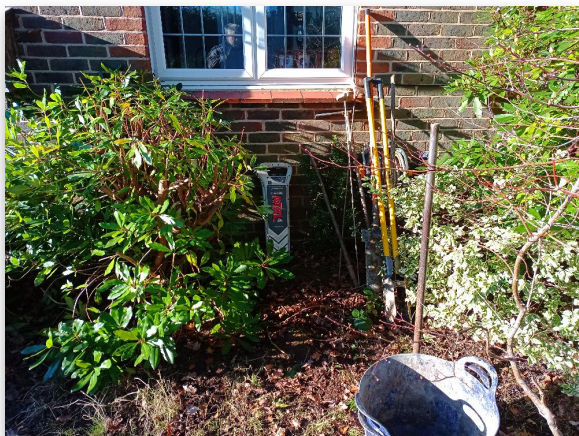
Fig 2.1: Trial Hole 2 Location

TH2 was completed in the proposed location, refusal was met at a depth of 2.3m due to encountering solid ground which our engineer was unable to auger through. Despite this the footing was revealed and soil and root samples were taken.

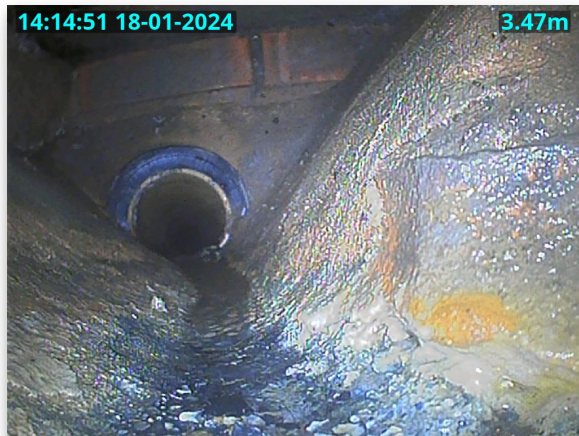
Fig 3.1: Buried Manhole

Perform a below ground break in, we will then complete a CCTV survey downstream to the buried manhole.

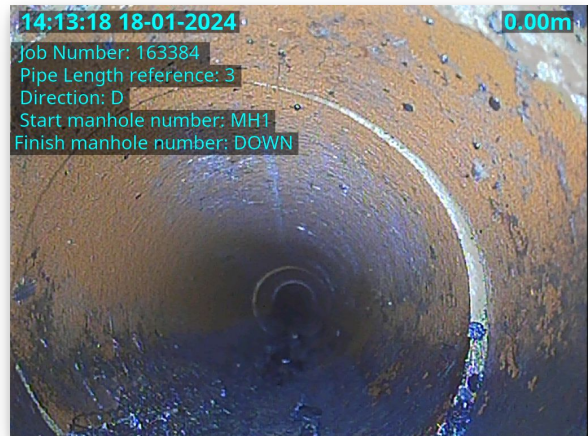
Our survey of line 3 revealed joint displacements and cracking.

Fig 3.2: Line 3 Displacement

Install 3.5m of 100mm liner directly downstream of MH1.

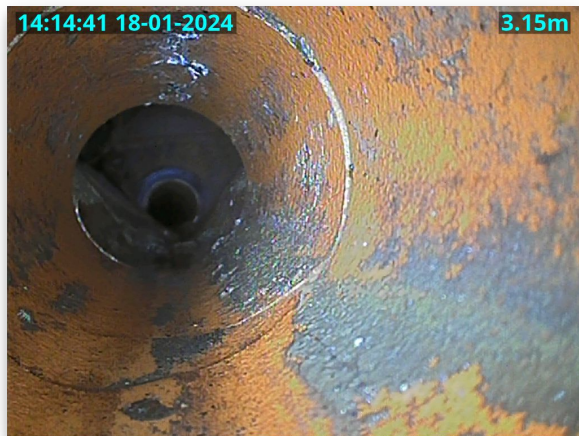
Our survey of line 1 revealed joint displacements.

Fig 3.3: Line 1 Cracking

Excavate and replace FWG and 1.5m of 100mm pipework at a depth no greater than 1.0m through paving slabs.

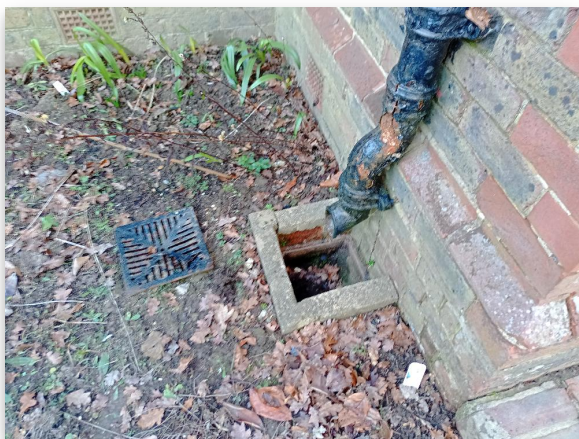
Both Rainwater gullies to the front of the property were found to be heavily root infested preventing a CCTV survey from being completed. The customer stated on site their desire to avoid any digging around these gullies due to their location within a flower bed, should future works that involve digging in this location be approved, we would advise the client appoints a gardener to remove any flowers/shrubs the policy holder requests to prevent damage.

Fig 4.1: Rainwater Gully

Excavate and replace RWG1 and 1m of 100mm pipework at a depth no greater than 1.0m through grass.

Excavate and replace RWG2 and 1m of 100mm pipework at a depth no greater than 1.0m through grass.
