# Arboricultural Level 3 Assessment: (Sonic Tomography and Microdrill)

Our Reference  
**227837**

Client  
**Upgrade Bikes Ltd**

Tree ID  
**T1 - Quercus Robur**

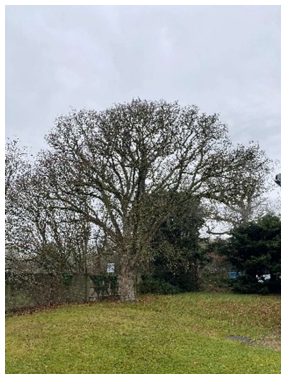
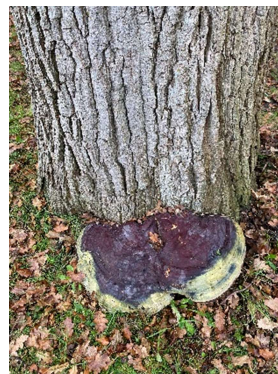
- Deadwood is present within the crown; however, it overhangs a low-use target area. A fungal fruiting body was identified at the base of the tree and confirmed as *Ganoderma resinaceum*. A significant change in resonance was detected around and above the fungal fruiting body, extending to approximately 1.0m height and measuring around 400mm in width. A further area of resonance change was identified on the north-north-west aspect, extending from ground level to approximately 600mm in height and approximately 500mm in width.

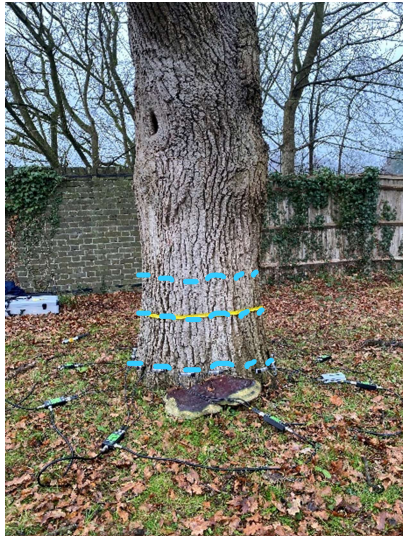
Photograph 1 below shows the position of each assessment level, indicated by blue dashed lines.

Photo 1. SOT assessment positions looking West

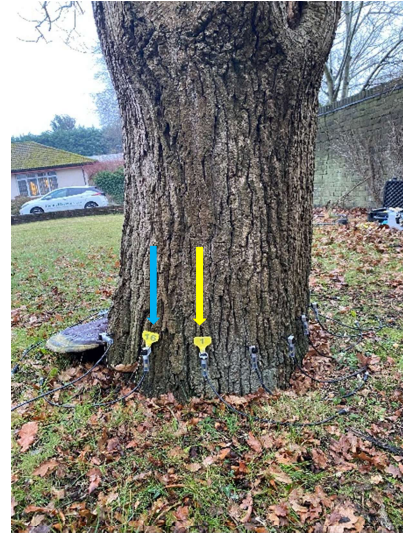
Photo 2. SOT sensor positions looking South  
Yellow arrow = sensor 1 at North Blue arrow = sensor 16

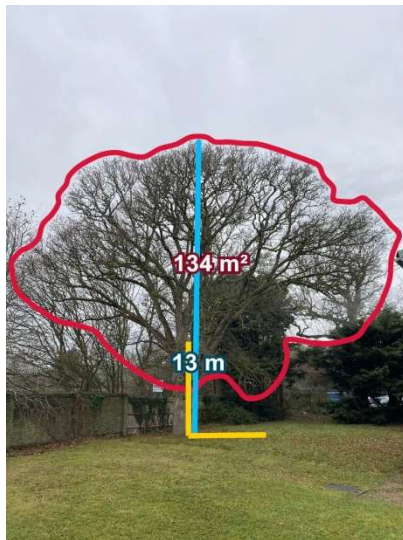
Photo 3. Looking North with dimensions & lean angle

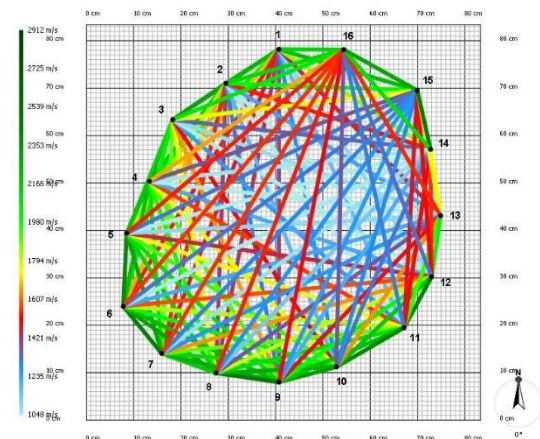
Image 4. 10cmH layer sound speed graph

An example of how the SOT data is processed is shown above in image 1 using the 10cmH layer. This shows that there are significant variations in the transfer of sound through the stem. The speed sound is transferred between sensors is coloured depending upon the time taken in meters per second.

The green lines indicate high sound transfer abilities between sensors indicating that the wood in these areas is generally free of defects. The darker red through to light blue lines indicate a slow transfer of sound suggesting decay is present within the wood.

The software identified no cracks within the planes assessed; cracks can disrupt the transfer of sound and have the potential to give false readings that may distort colours in the image.

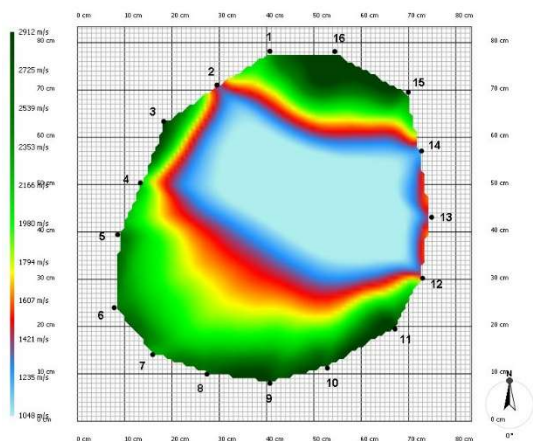
Image 5. 10cmH layer - 2D Map

The 2D layer images 5, 7 & 9 on the left provide a pictorial representation of the sound transfer between sensors. This gives a simplified view of the data gathered and indicates visually the suspected transition from unaffected to decayed wood across the section of stem assessed. These images show that there is significant decaying of the Oak trees heartwood, more pronounced near ground level.

10cmH layer **58%**

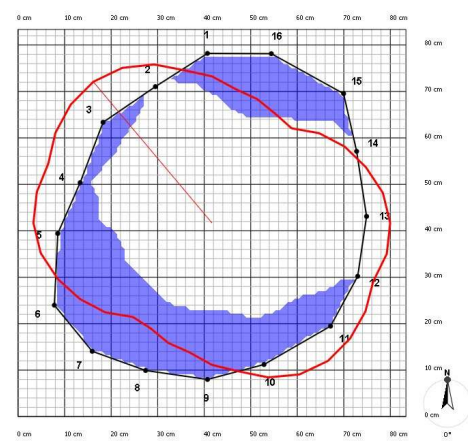
Image 6. 10mH layer – Biomechanical Layer Map

The biomechanical layer maps images 6, 8 & 10 above and to the right are generated by the software. These consider onsite measurements of the tree, calculations using photo 3 above and the SOT results.

Northwest for 10cm layers.

- **10 cm height layer: 275%**
- **40 cm height layer: 441%**
- **60 cm height layer: 310%**

To further improve the calculated safety factors and reduce mechanical loading, a crown reduction of approximately 2 metres is recommended and should be applied sympathetically in accordance with BS 3998, retaining the tree's natural form and functional leaf area. An Image of crown reduction dimensions is below. This work should be carried out within the next 12 months.

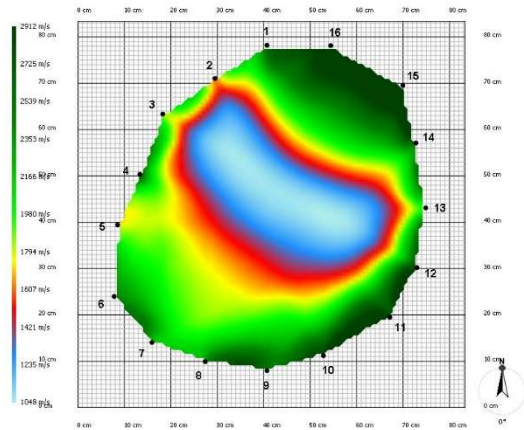
Image 7. 40cmH layer - 2D Map

40cmH layer **44%**

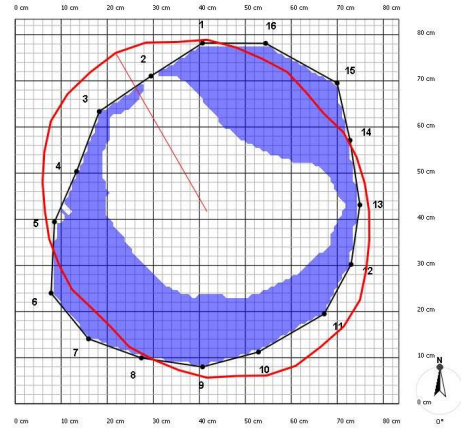
Image 8. 40cmH layer – Biomechanical Layer Map

Northwest for 40cm layers.

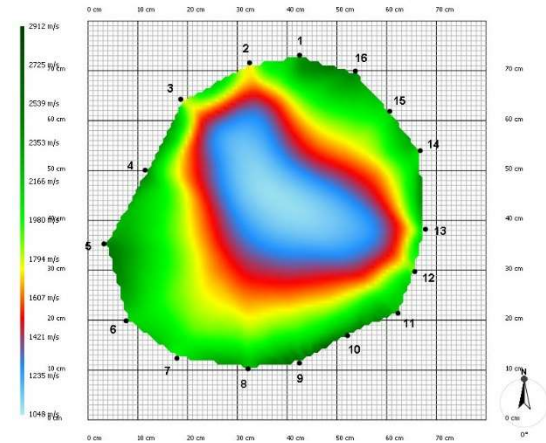
Image 9. 60cmH layer - 2D Map

60cmH layer **51%**

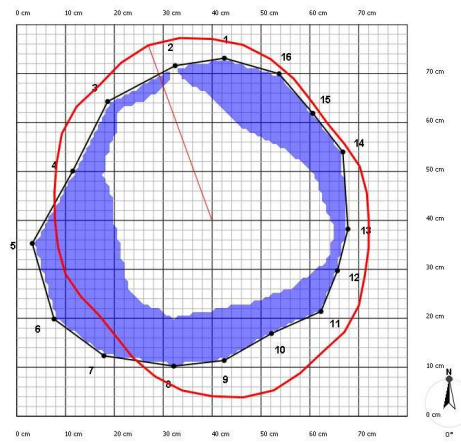
Image 10. 60cmH layer – Biomechanical Layer Map

Northwest for 60cm layers.

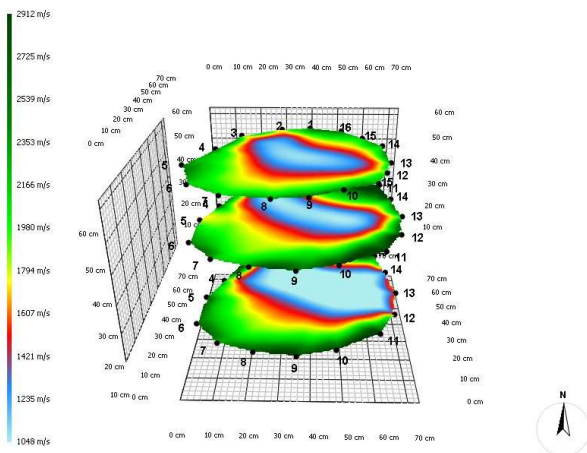
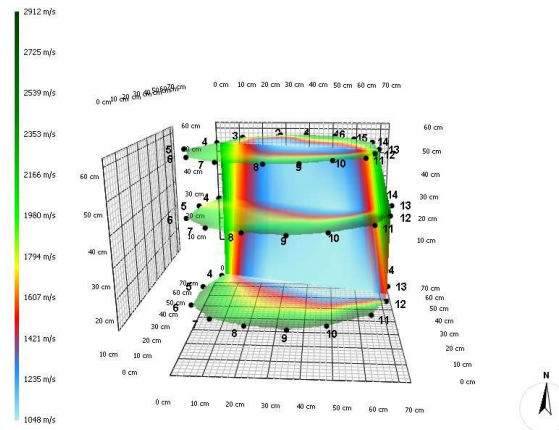
Image 11. Multilayer views

The Multilayer views (Images 11) are created by the software infilling the colours between the 2D layers. . The image shows the approximate locations of decay through all three layers.

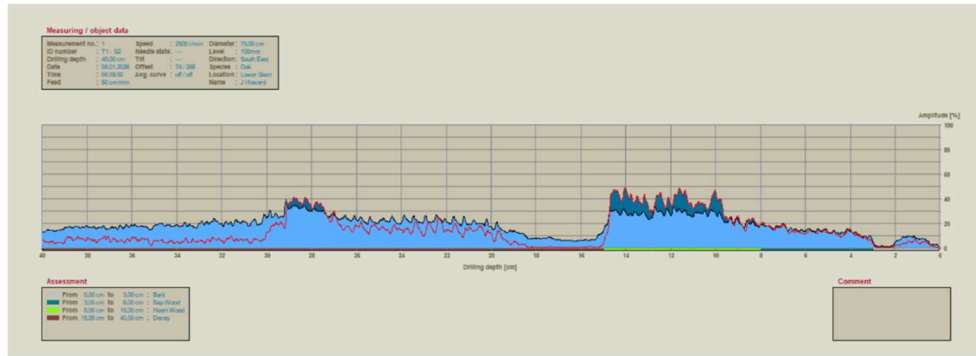
**Image 12. Microdrill Trace Results - 10cm Layer at Sensor 2**

Drill ID T1-S2 (Image 12) shows bark to approximately 3 cm, followed by sapwood from 3–8 cm. Heartwood is indicated between approximately 8 cm and 15 cm, where resistance values are moderate to high. From approximately 15 cm through to the maximum drilling depth of 40 cm, resistance values reduce significantly and remain consistently low, indicating a substantial zone of internal decay or hollowing occupying the majority of the inner stem radius at this orientation.

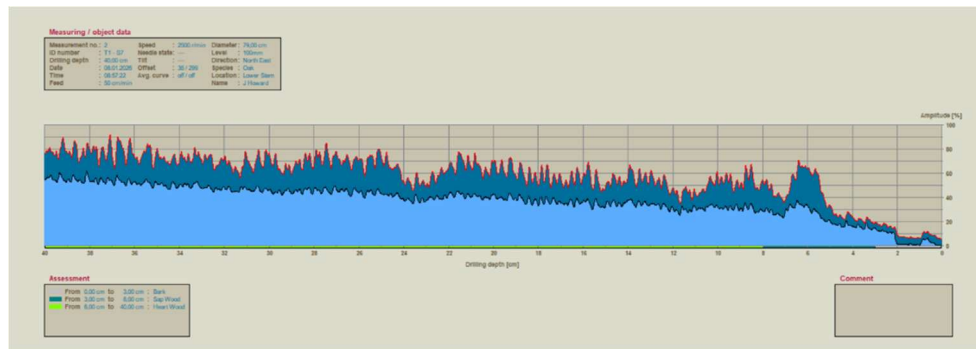
**Image 13. Microdrill Trace Results – 10cm Layer at sensor 7**

Drill ID T1-S7 (Image 13) presents a comparatively sound profile. Bark is recorded to approximately 3 cm, with sapwood extending from 3–8 cm. From approximately 8 cm to 40 cm, resistance remains consistently moderate to high, characteristic of intact heartwood. No sustained reductions in resistance are evident, and minor fluctuations are consistent with normal wood density variation rather than structural defects. This drilling indicates a largely intact load-bearing section of the stem at this orientation.

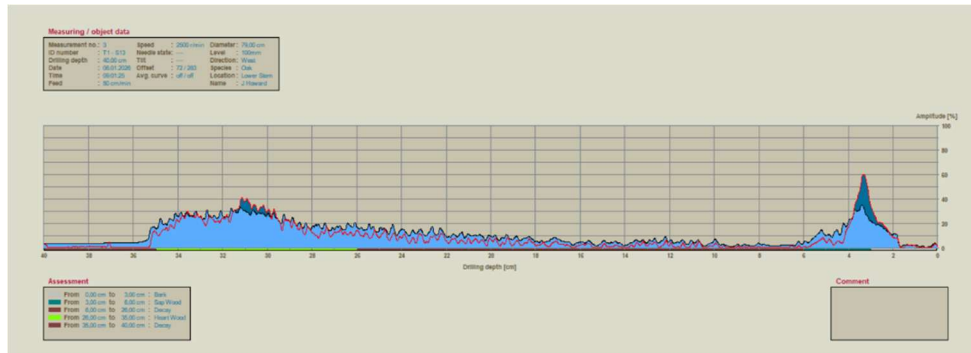
**Image 14. Microdrill Trace Results – 10cm Layer at sensor 13**

Drill ID T1-S13 (Image 14) indicates a mixed internal condition. Bark extends to approximately 3 cm, with sapwood present between 3 cm and 8 cm. A pronounced and sustained reduction in resistance occurs from approximately 8 cm to 28 cm, consistent with extensive internal decay. Resistance increases again between approximately 28 cm and 35 cm, suggesting a residual band of intact heartwood, before decreasing once more from 35 cm to 40 cm, indicating further internal degradation toward the opposite side of the stem.
