# Arboricultural Consultancy for Lloyds Bank

| Insured | Mrs Catherine McDonald-Bowyer | Address | 5 Southdown Terrace, Steyning, West Sussex, BN44 3YJ | | |
| Report Date | 11/11/2020 | | | | |

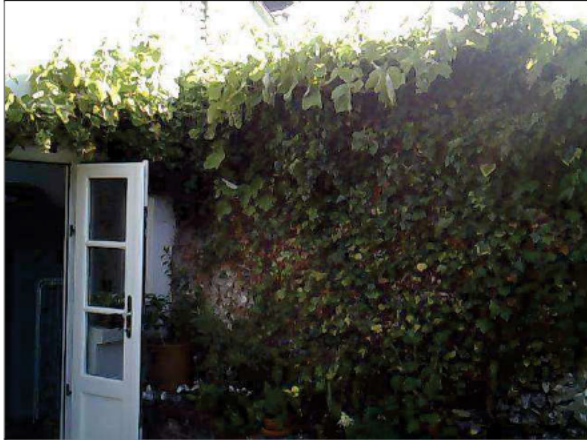
| Tree No. | Species | Age Cat | Approx. Height (m) | Distance to Building (m) * | Ownership | Action | Requirement |
|---|---|---|---|---|---|---|---|
| C1 | Mixed species climbers: Grape & Ivy. | 1 | 1,5 | 1,2 | C - Insured | Action to avoid future risk | Maintain at broadly current dimensions by way of regular pruning. |

C1 - Mixed species climbers

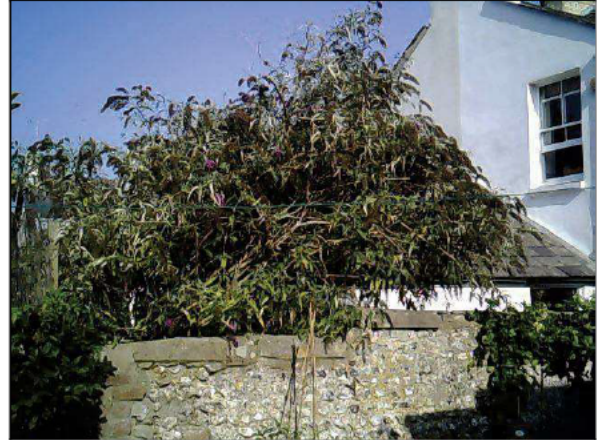
| Tree No. | Species | Age Cat | Approx. Height (m) | Distance to Building (m) * | Ownership | Action | Requirement |
|---|---|---|---|---|---|---|---|
| S1 | Buddleia | 1 | 2 | 2,3 | A - Third Party | Action to avoid future risk | Maintain at, or below current dimensions by way of regular pruning. |

S1 - Buddleia

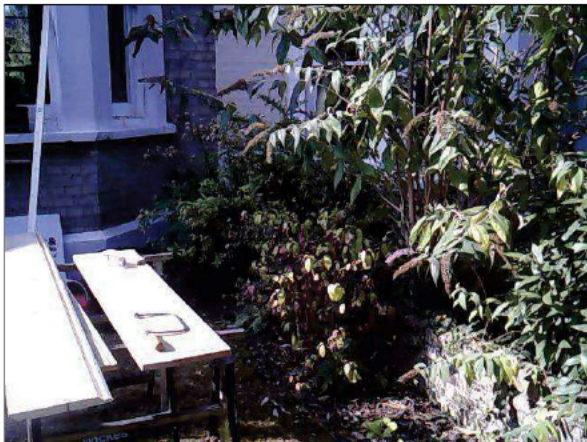
| Tree No. | Species | Age Cat | Approx. Height (m) | Distance to Building (m) * | Ownership | Action | Requirement |
|---|---|---|---|---|---|---|---|
| SG1 | Mixed species shrubs: Skimmia & Dogwood. | 1 | 1 | 0,2 | C - Insured | No action | No works. |

SG1 - Mixed species shrubs

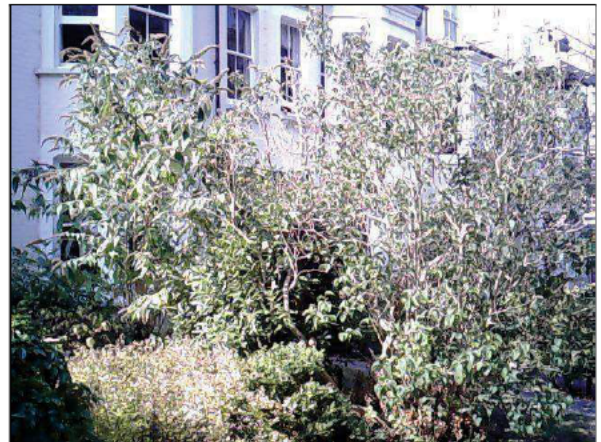
| Tree No. | Species | Age Cat | Approx. Height (m) | Distance to Building (m) * | Ownership | Action | Requirement |
|---|---|---|---|---|---|---|---|
| SG2 | Mixed species shrubs: Viburnum, Pyracantha, Buddleia, Bay Laurel & Lilac. | 1 | 3 | 1,3 | A - Third Party | Maintain as detailed | Remove Buddleia component close to ground level and treat stump(s) to inhibit regrowth. Maintain remaining shrubs at broadly current dimensions by way of regular pruning. |

SG2 - Mixed species shrubs

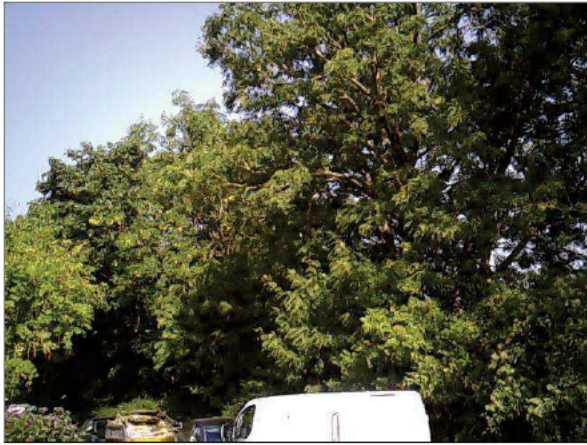
Our survey of the site identified the Ash component within TG1 and the Buddleia component within SG1, given their position relative to the damage it is our opinion that the roots identified will emanate from this vegetation and accordingly we have identified them as the principal cause of the subsidence damage.

| Tree No. | Species | Age Cat | Approx. Height (m) | Distance to Building (m) * | Ownership | Action | Requirement |
|---|---|---|---|---|---|---|---|
| TG1 | Mixed Species Group: Ash, Sycamore & Oak. | 1 | 15 | 12.5 | E - Boundary Veg (ownership to be confirmed) | Maintain as detailed | Remove the x3 closest Ash trees to the front of the property (close to ground level); do not treat stumps due to translocation risk. Where such a risk exists, we advise that any emergent regrowth is removed annually. Maintain retained section at broadly current dimensions by way of regular pruning. |

TG1 - Mixed species group

Consequently, where monitoring confirms the role of vegetation, then the complete removal of the advised Ash component within TG1 (see plan for details) in conjunction within the Buddleia component of SG1 will offer the most certain arboricultural solution likely to restore long-term stability.

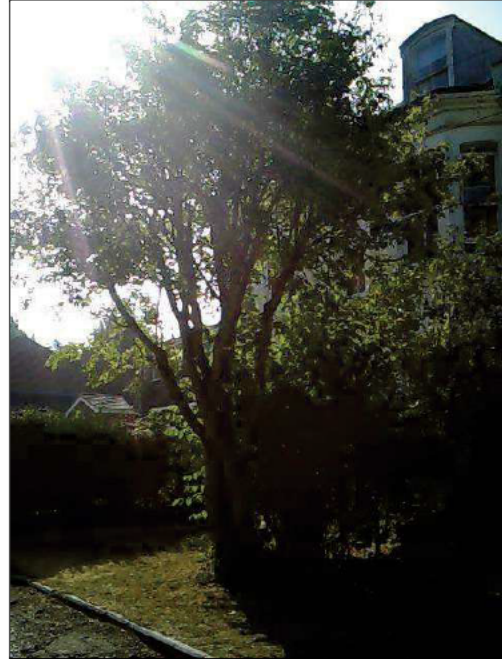
| Tree No. | Species | Age Cat | Approx. Height (m) | Distance to Building (m) * | Ownership | Action | Requirement |
|---|---|---|---|---|---|---|---|
| T1 | Laburnum | 1 | 3 | 9 | A - Third Party | No action | No works. |

T1 - Laburnum

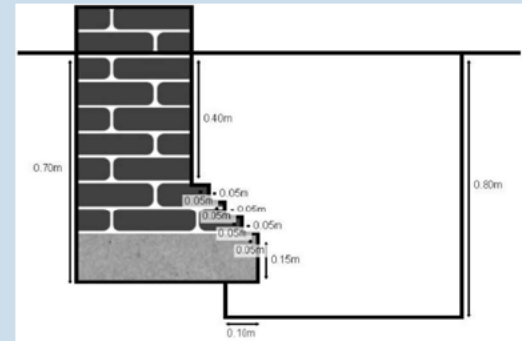
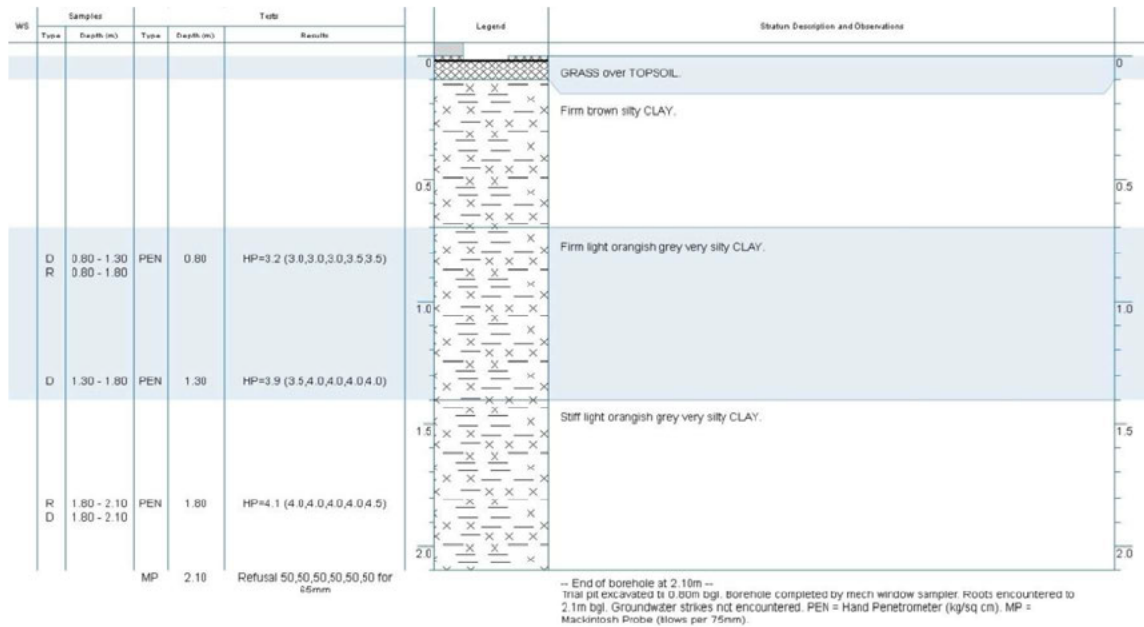
## TP/BH1 Foundation Detail and Borehole Log

Bay foundation comprised of brick wall to 550mm bgl, bearing on stepped concrete to 700mm bgl with a total projection of 200mm from the elevation. Underside of foundation (USF) was exposed to 100mm back from the face of the foundation and probed 500mm back from the face of the foundation.

Bay foundation was exposed and the underside of foundation (USF) recorded to be 0.7m bgl (TP/BH 1).

Hand Held Percussive Window Sampler and Mackintosh Probe refusal at 2.1m bgl due to stiffness within the clay (TP/BH 1). Borehole terminated. No further works undertaken.

Roots encountered to 2.1m bgl (TP/BH 1).
