**MANAGEMENT SURVEY FOR ASBESTOS-CONTAINING MATERIALS**

**SRP1121-EEG-XX-XX-T-O-0301-AsbestosManagementSurveyReport-ShootingField**

**CLIENT:** Arcadis UK (London)

**SITE:** Steyning Grammar School, Upper School, Shooting Field, Steyning, BN44 3RX

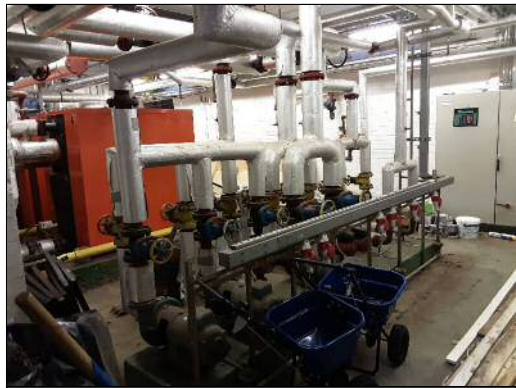
| Assessment details | | | | Comments | |
|---|---|---|---|---|---|
| Assessment no. | 0010 | Accessibility | Occasionally likely to be disturbed | | |

| Building | Floor/<br>Room | Assessment<br>Number | Location/<br>position | Product<br>type | Surface<br>treatment | Condition | Extent | Accessibility | Level of<br>identification | Asbestos<br>type | Material<br>risk | Priority<br>risk | Action |
|---|---|---|---|---|---|---|---|---|---|---|---|---|---|
| Block EFAA | Basement 1 /<br>450 Boiler room | 0010 | Gaskets to pipe<br>flange | Gaskets | Surface<br>Sealed | Good<br>Condition | 77no. | Occasionally<br>likely to be<br>disturbed | Identified | Chrysotile | ( 4 )<br>Very low | - | Manage |

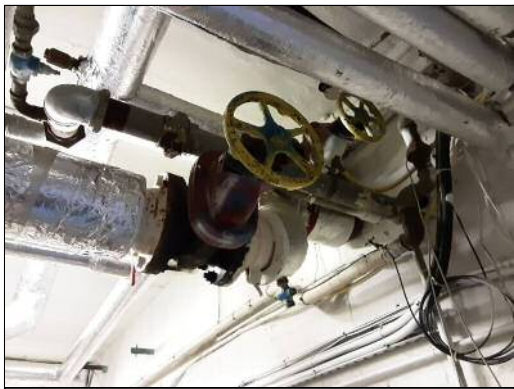
| Building | Floor/<br>Room | Assessment<br>Number | Location/<br>position | Product<br>type | Surface<br>treatment | Condition | Extent | Accessibility | Level of<br>identification | Asbestos<br>type | Material<br>risk | Priority<br>risk | Action |
|---|---|---|---|---|---|---|---|---|---|---|---|---|---|
| Block EFAA | Basement 1 /<br>450 Boiler room | 0011 | Thermal insulation<br>residue to<br>pipework | Hard Set<br>Lagging | Unsealed | Good<br>Condition | 2lm | Occasionally<br>likely to be<br>disturbed | Identified | Chrysotile +<br>Amosite | ( 7 )<br>Medium | - | Encapsulate |

| Assessment details | | | | Comments | Photograph |
|---|---|---|---|---|---|
| Building | Block EFAA | Floor/ room | Basement 1 / 450 Boiler room | Identified on pipework not covered by MMMF insulation, recommend encapsulation where pipework is exposed. Presumed to be to all pipes below MMMF insulation | |

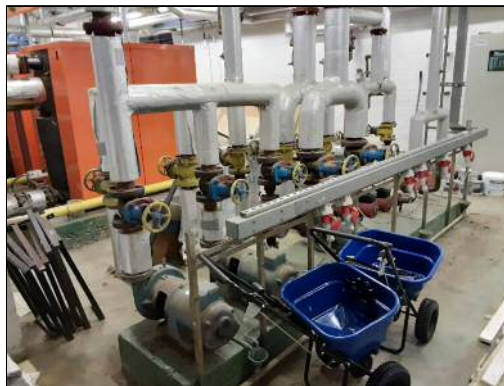
| Building | Floor/<br>Room | Assessment<br>Number | Location/<br>position | Product<br>type | Surface<br>treatment | Condition | Extent | Accessibility | Level of<br>identification | Asbestos<br>type | Material<br>risk | Priority<br>risk | Action |
|---|---|---|---|---|---|---|---|---|---|---|---|---|---|
| Block EFAA | Basement 1 /<br>450 Boiler room | 0013 | Thermal insulation<br>residue To<br>pipework | Hard Set<br>Lagging | Surface<br>Sealed | Good<br>Condition | 3lm | Occasionally<br>likely to be<br>disturbed | Strongly<br>Presumed (011) | Chrysotile +<br>Amosite | ( 6 ) Low | - | Manage |

| Assessment details | | | | Comments | Photograph |
|---|---|---|---|---|---|
| Building | Block EFAA | Floor/ room | Basement 1 / 450 Boiler room | Identified on pipework not covered by MMMF insulation, recommend encapsulation where pipework is exposed. Presumed to be to all pipes below MMMF insulation | |

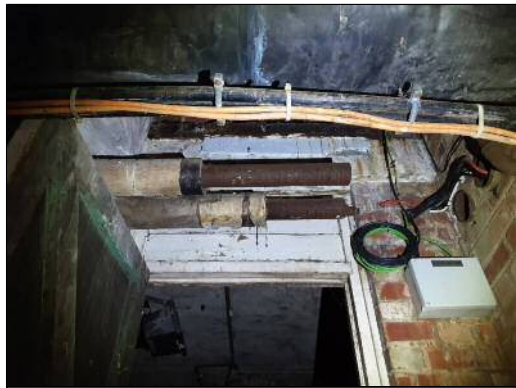
| Assessment details | | | | Comments | |
|---|---|---|---|---|---|
| Assessment no. | 0018 | Accessibility | Occasionally likely to be disturbed | | |

| Building | Floor/<br>Room | Assessment<br>Number | Location/<br>position | Product<br>type | Surface<br>treatment | Condition | Extent | Accessibility | Level of<br>identification | Asbestos<br>type | Material<br>risk | Priority<br>risk | Action |
|---|---|---|---|---|---|---|---|---|---|---|---|---|---|
| Block EFAA | Basement 1 /<br>450 Boiler room | 0018 | Cement panel<br>above oil tank<br>room entrance<br>door | Cement | Surface<br>Sealed | Low<br>Damage | 1no. | Occasionally<br>likely to be<br>disturbed | Identified | Chrysotile | ( 4 )<br>Very low | - | Manage |

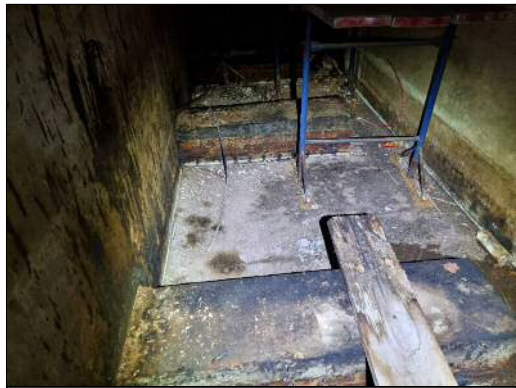
| Assessment details | | | | Comments | Photograph |
|---|---|---|---|---|---|
| Assessment no. | 0032 | Accessibility | Occasionally likely to be disturbed | | |

| Building | Floor/<br>Room | Assessment<br>Number | Location/<br>position | Product<br>type | Surface<br>treatment | Condition | Extent | Accessibility | Level of<br>identification | Asbestos<br>type | Material<br>risk | Priority<br>risk | Action |
|---|---|---|---|---|---|---|---|---|---|---|---|---|---|
| Block EFAA | Basement 1 /<br>449 Oil tank room | 0032 | Bitumen packers<br>to plinths | Bitumen | Completely<br>Sealed | Good<br>Condition | 4lm | Occasionally<br>likely to be<br>disturbed | Identified | Chrysotile | ( 2 )<br>Very low | - | Manage |

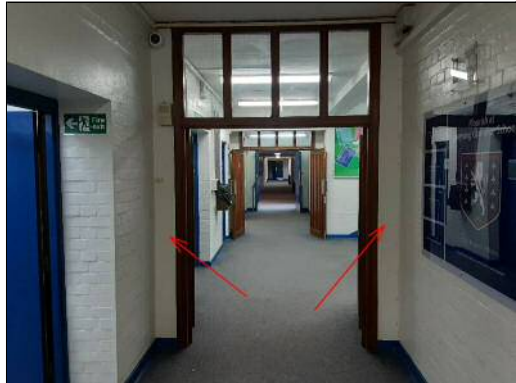
| Assessment details | | | | Comments | Photograph |
|---|---|---|---|---|---|
| Building | Block EFAA | Floor/ room | Ground Floor / Corridor 1 | Panels to both sides of corridor doors. Panels are lightly damaged and paint flaking, recommend Panels are encapsulated. | |

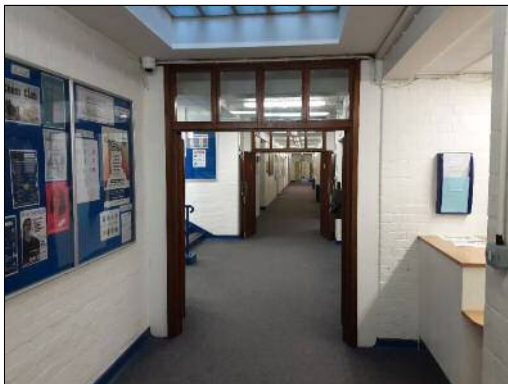
| Assessment details | | | | Comments | Photograph |
|---|---|---|---|---|---|
| Building | Block EFAA | Floor/ room | Ground Floor / Corridor 1 | Panels to both sides of corridor doors. Panels are lightly damaged and paint flaking, recommend Panels are encapsulated. | |

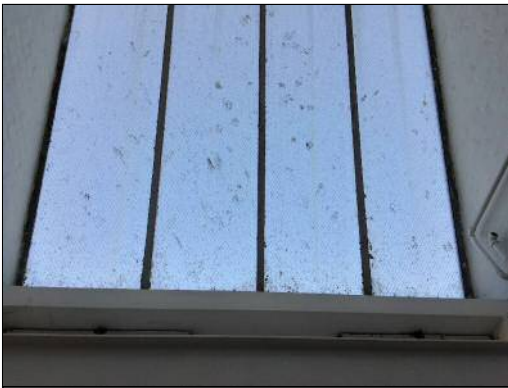
| Assessment details | | | | Comments | Photograph |
|---|---|---|---|---|---|
| Assessment no. | 0109 | Accessibility | Occasionally likely to be disturbed | | |

| Assessment details | | | | Comments | Photograph |
|---|---|---|---|---|---|
| Building | Block EFAA | Floor/ room | Ground Floor / Room 79A store | Unable to sample without making damage to the glass skylight | |

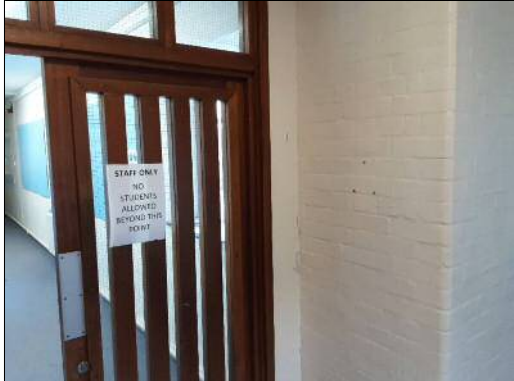
| Assessment details | | | | Comments | Photograph |
|---|---|---|---|---|---|
| Assessment no. | 0248 | Accessibility | Occasionally likely to be disturbed | | |

| Assessment details | | | | Comments | Photograph |
|---|---|---|---|---|---|
| Building | Block EFAA | Floor/ room | 1st Floor / Corridor 1 | To both sides of door, paint is flaking, recommend encapsulation | |

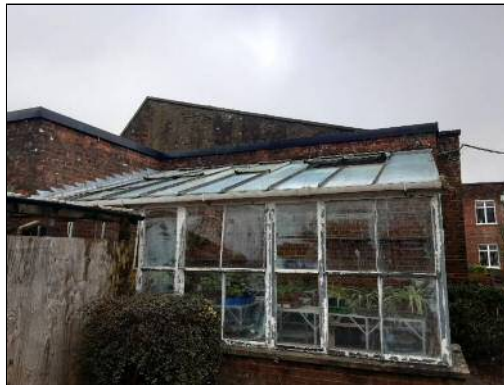
| Assessment details | | | | Comments | Photograph |
|---|---|---|---|---|---|
| Assessment no. | 0279 | Accessibility | Occasionally likely to be disturbed | | |

| Building | Floor/<br>Room | Assessment<br>Number | Location/<br>position | Product<br>type | Surface<br>treatment | Condition | Extent | Accessibility | Level of<br>identification | Asbestos<br>type | Material<br>risk | Priority<br>risk | Action |
|---|---|---|---|---|---|---|---|---|---|---|---|---|---|
| Block<br>EFAA | External /<br>EFAA externals | 0279 | Rope seal To<br>green house<br>skylights | Textiles | Surface<br>Sealed | Good<br>Condition | 32lm | Occasionally<br>likely to be<br>disturbed | Presumed | Chrysotile | ( 4 )<br>Very low | - | Manage |

| Assessment details | | | | Comments | Photograph |
|---|---|---|---|---|---|
| Building | Block EFAA | Floor/ room | External / EFAA externals | Unable to sample rope without making significant damage. | |
