**MARK AND JO ROBINSON**

MILL FARM, MILL LANE, ITCHINGFIELD, HORSHAM,  
WEST SUSSEX RH13 0NP

**Preliminary Contamination Risk Assessment**

February 2026

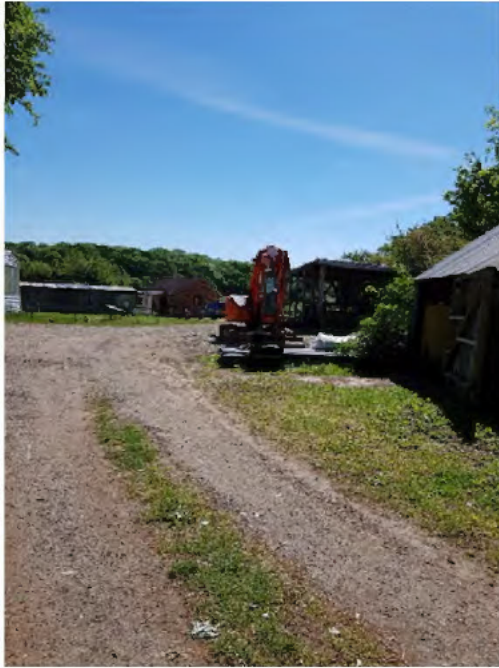
**Photograph 1:**

The site is accessed from Mill Lane to the west of the site via a new access route which cuts across the northwest corner of a field before joining the original shared access from a neighbouring residential property on Mill Lane.

The access up to and around the buildings (pictured left) is surfaced with compressed road planings. There is little hard surfacing across the site, grass surrounds the buildings.

The access road leads to a cluster of farm buildings.

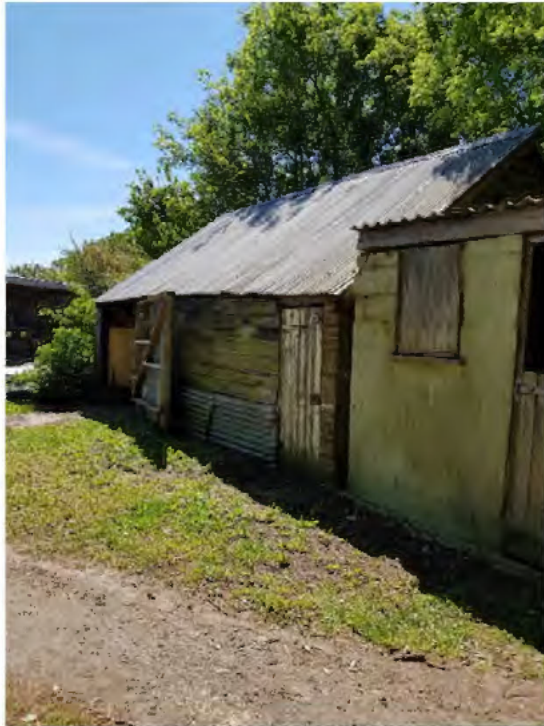
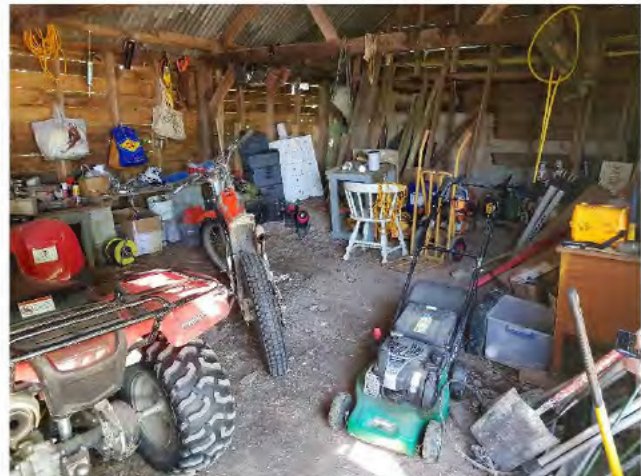
**Photographs 4 and 5:**

A brick and wooden clad building with corrugated metal roof currently used to store household maintenance equipment, lawn mower and bikes.

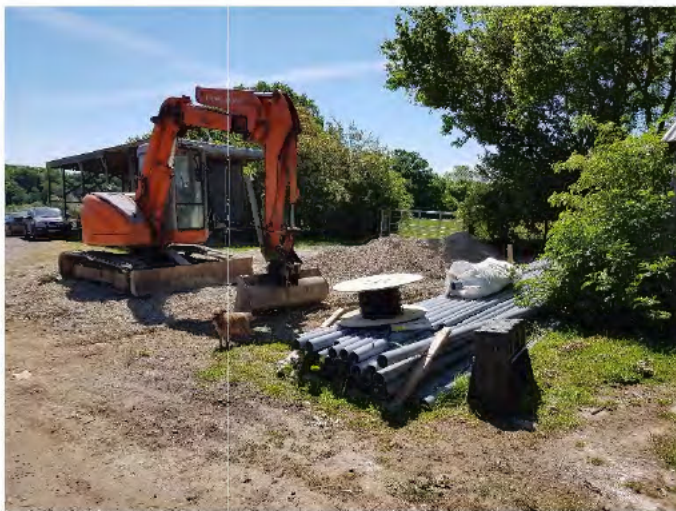
**Photograph 6:**

To the south of the access road, east of the above row of buildings and west of the hay barn, is a small storage area and access gate into the field to the southwest of the farmyard.

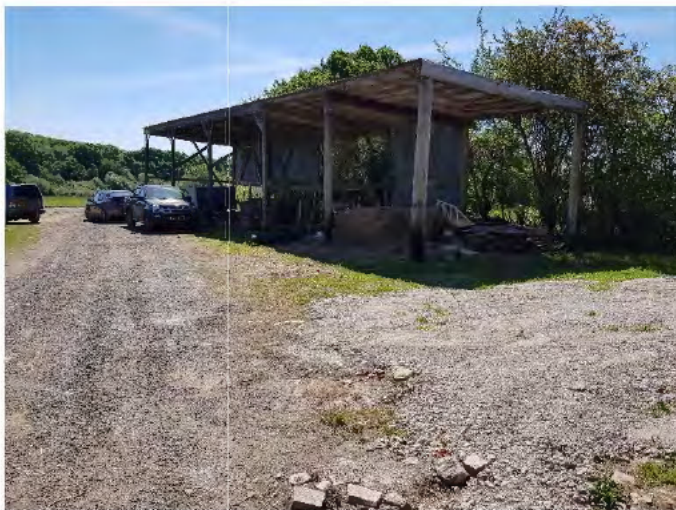
**Photograph 7:**

'Hay' barn constructed from timber and corrugated metal roofing sheets, used for general storage of items including bicycles, two trailers, hay bales and wood.

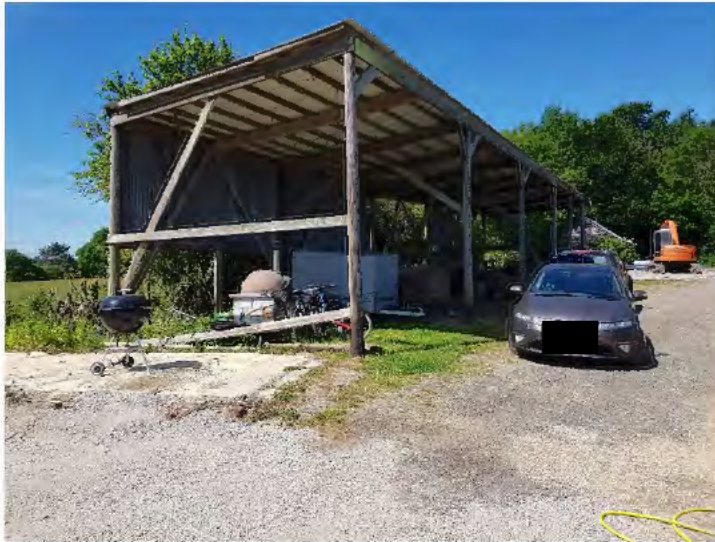
**Photograph 8:**

- 9.6 A pre-demolition asbestos survey was undertaken by Pass Consulting in July 2019. Asbestos containing materials were identified on and around a single garage located to the east of the haybarn (on site). This material has been removed from the site by the current site owner and occupier. No remaining asbestos containing materials were observed during the site walkover assessment undertaken on 19 May 2020.

To the east of the hay barn is the remaining concrete base of a single garage. The garage included asbestos containing materials and has been removed from the site.

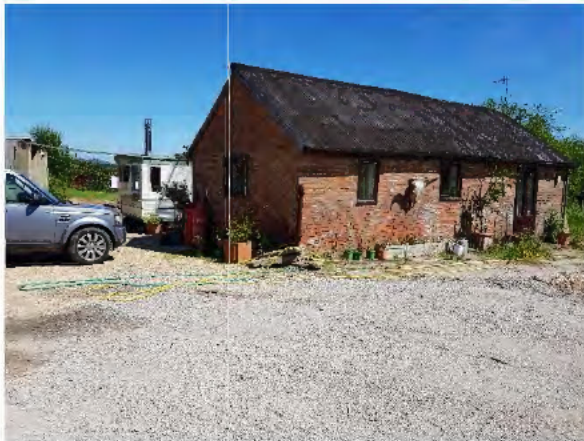
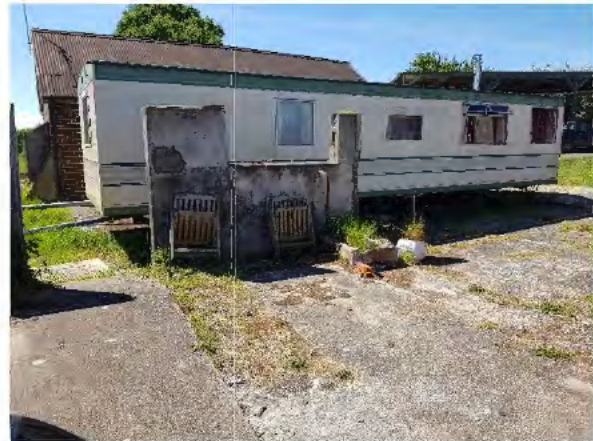
**Photographs 9 and 10:**

To the northeast of the hay barn is a single storey brick building with corrugated metal roofing and a static caravan. This building and the caravan are currently being used as a dwelling by the site owner.

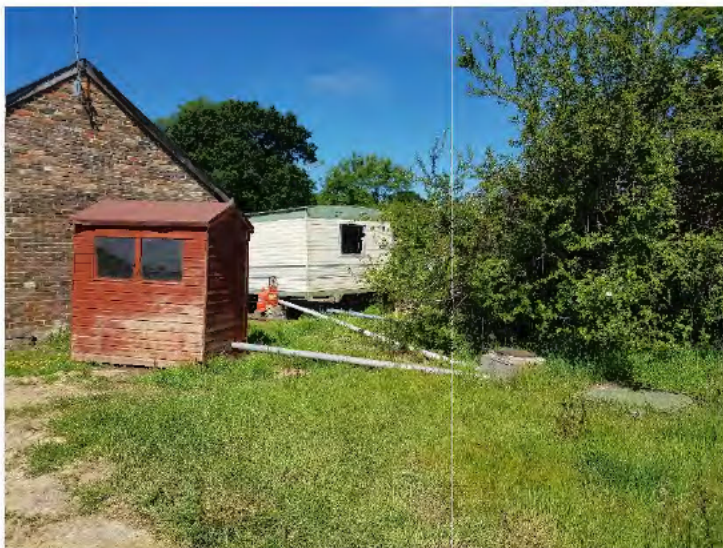
**Photograph 11:**

To the east of the existing dwelling is a Klargester (domestic sewage treatment plant) which is to be retained and connected to the new dwelling.

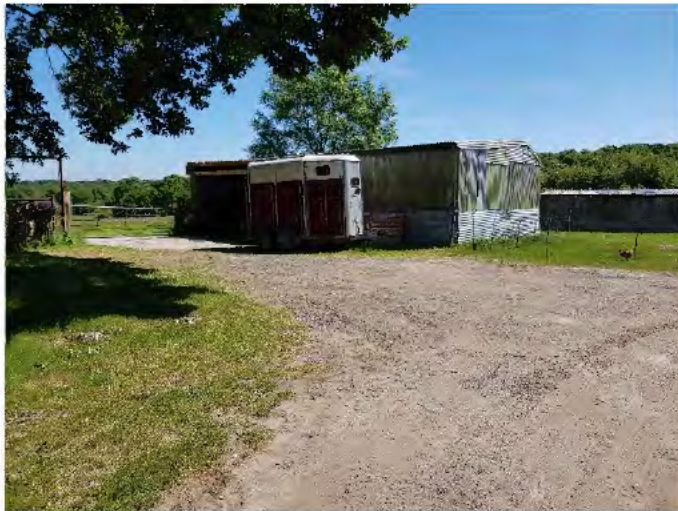
**Photograph 14:**

To the west of this stable building, north of the site access road, is a corrugated metal building currently used for the storage of household items. This building has a compressed dirt floor.

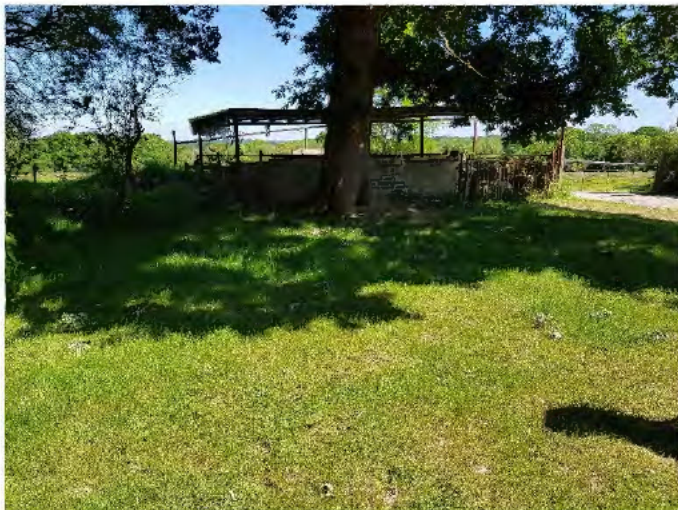
**Photograph 15:**

The final building is small cattle shelter within the field to the north of the access road.

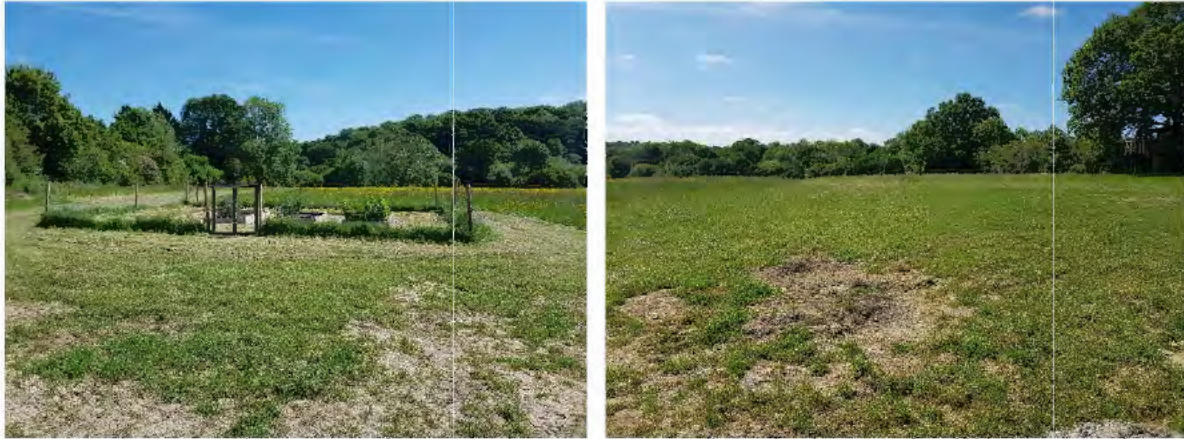
**Photograph 16 and 17:**

The proposed dwelling is to be built to the south and east of the existing farm buildings, within the northwest corner of a field left to pasture. To the east of the proposed footprint is a small allotment garden, developed by the current site occupiers.

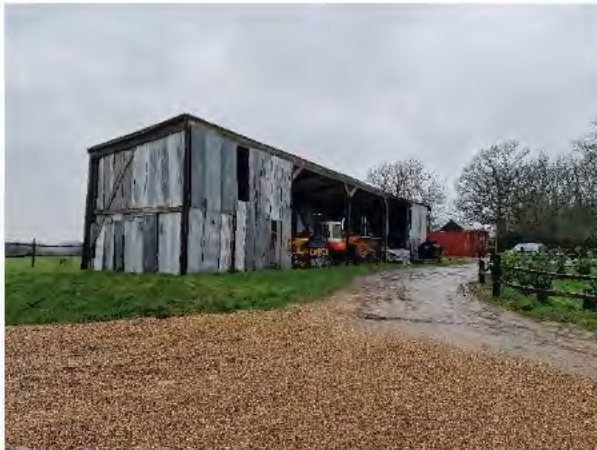
**Photograph 1 - 3: Hay Barn**

Hay barn located to the east of the site, to be removed to make way for the redevelopment of the site.

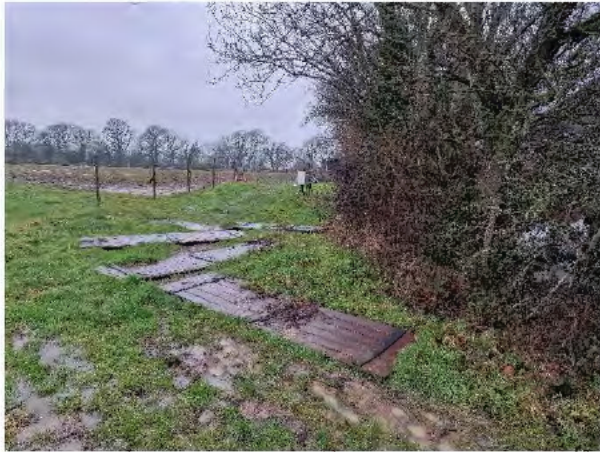
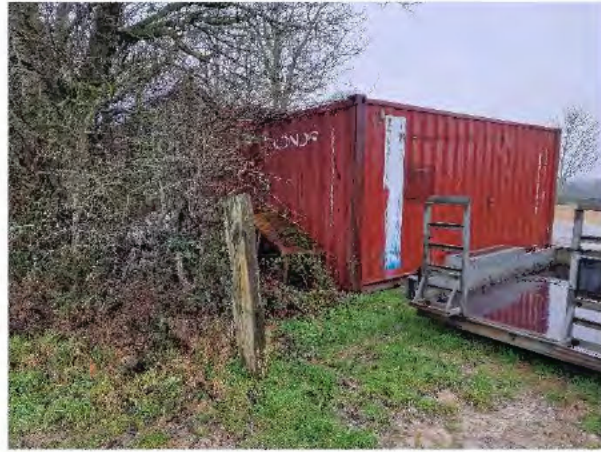
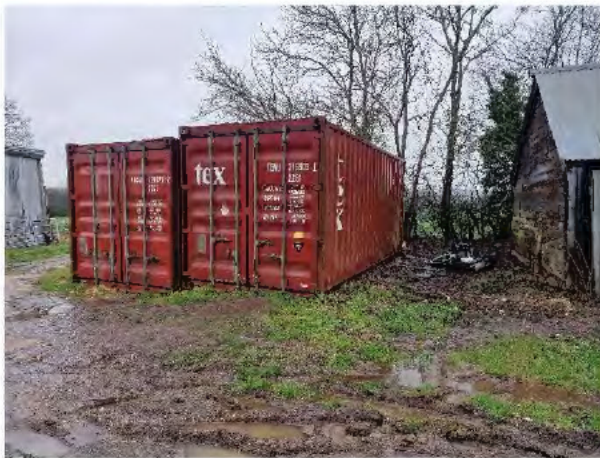
### Photographs 5 – 7: Storage Area and Field

Adjacent to the field entrance is a storage area presently with two shipping containers located to the west of the gate.

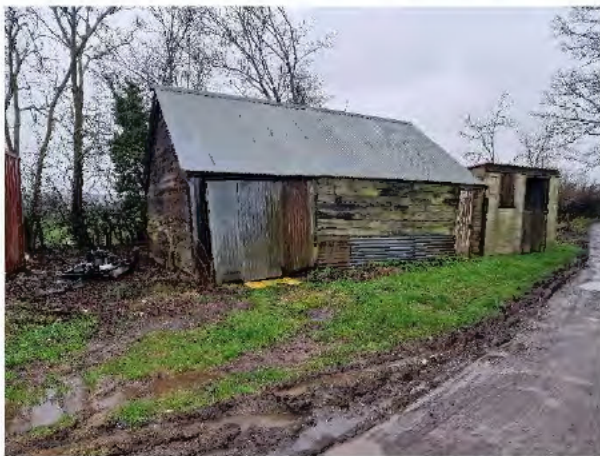
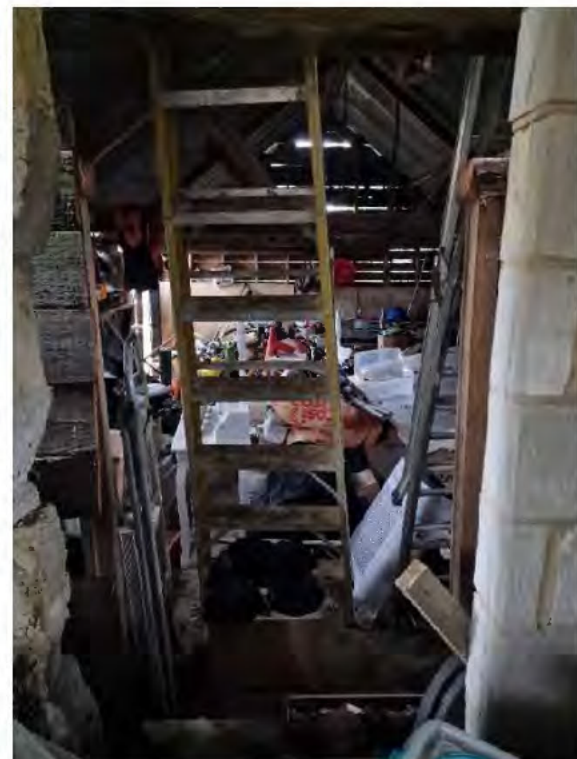
### Photographs 8 and 9:

Brick and wooden clad building with corrugated metal roof and concrete floor used to store household maintenance equipment.

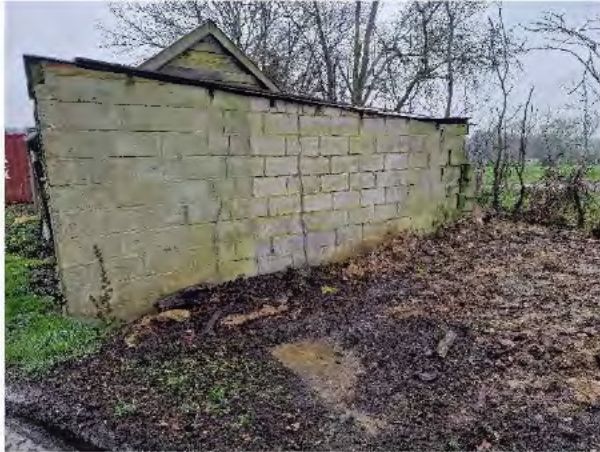
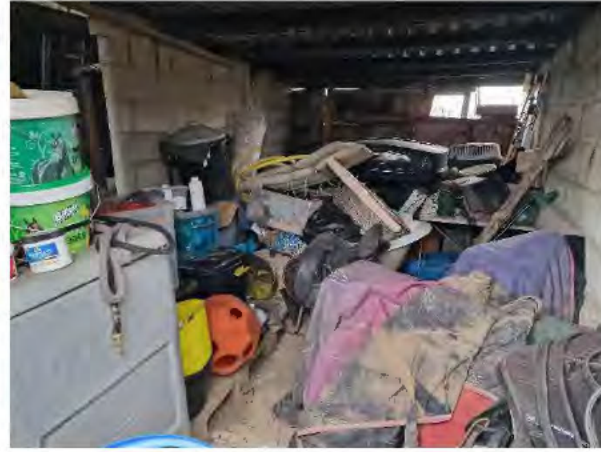
**Photographs 10 and 11:** A concrete block stable with single pitched corrugated metal roof and concrete floor used to store equestrian and other miscellaneous items.
