# Visual Tree Assessment - VTA (Tree Survey)

Huffwood Trading Estate,  
Partridge Green,  
Horsham,  
RH13 8AU

Survey Reference: 16032026

Survey Inspection date: 16th March 2026

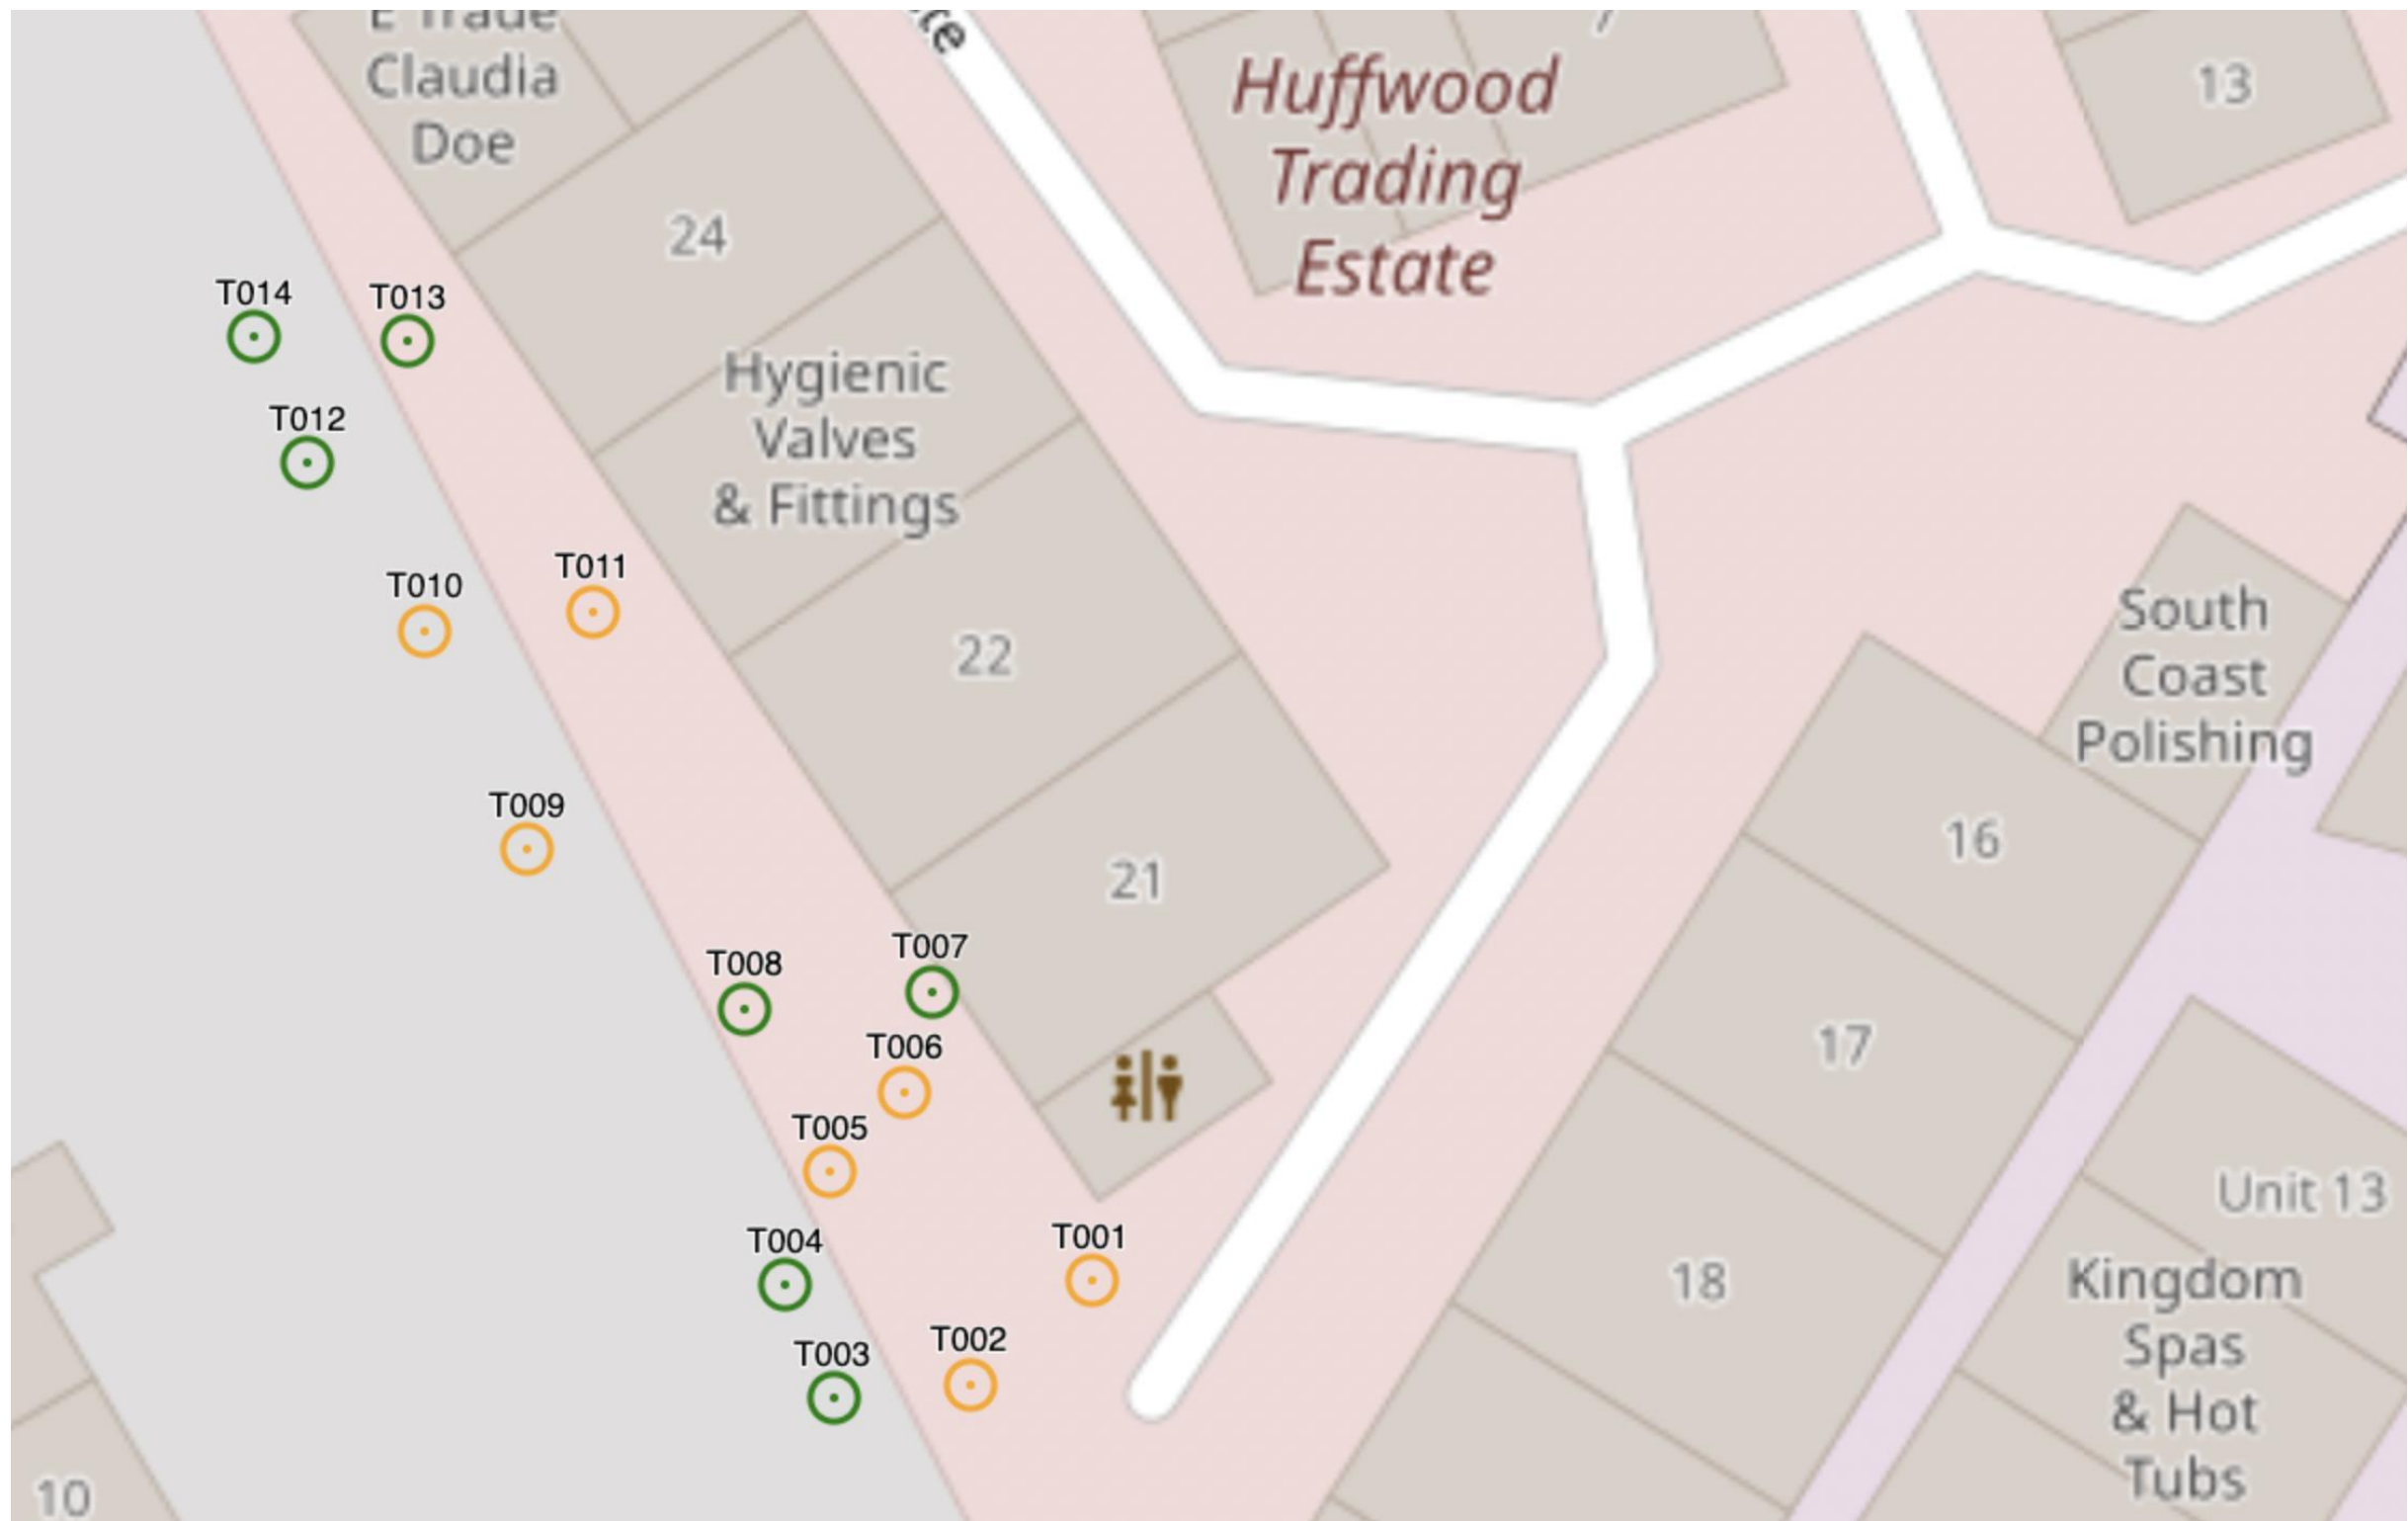
Overlay tree position is correct however map display shows boundary line further in.
