## Asbestos Demolition Report

High Barn  
Crays Lane  
Goose Green  
Pulborough  
RH20 2LR

Reference: C-10078

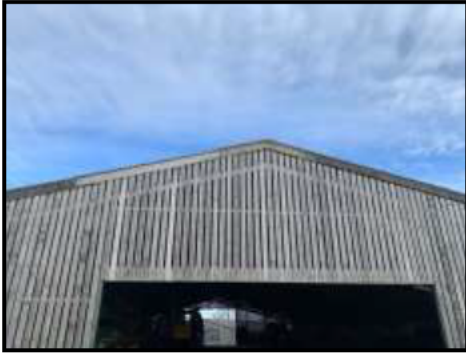
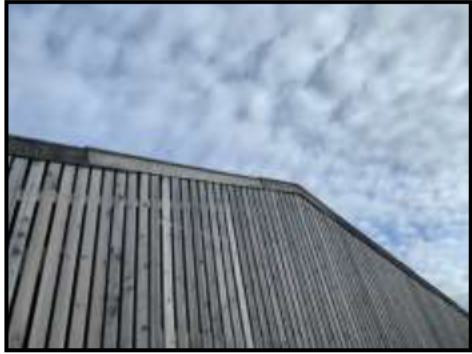
| Substrate | Different in appearance from the other end capping (Light grey) | Accessibility | - | | |
| Comments | <p>Corrugated cement roof sheeting including ridge vents. Cement end capping. Timber cladding onto block walls. Timber and metal beams within. Timber and steel constructed doors. Plastic and metal rainwater goods. Small amount of cement debris and old slate roofing tiles found within the barn.</p> <p>Visually different in appearance from the other end capping (Light grey to the front entrance elevation only), other end capping cement products are a darker grey in appearance.</p> | | | | |

| Recommendation | No action required | | | | |

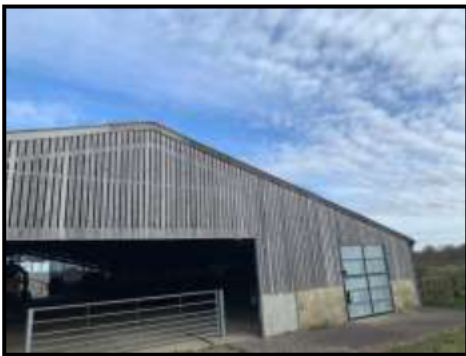
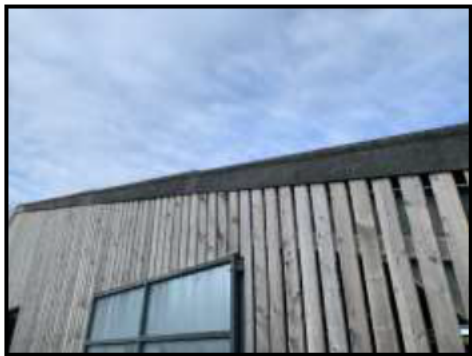
| Condition | Good Condition | | 0 | | |
| Substrate | Bolted (Dark Grey) | Accessibility | High | | |
| Comments | Corrugated cement roof sheeting including ridge vents. Cement end capping. Timber cladding onto block walls. Timber and metal beams within. Timber and steel constructed doors. Plastic and metal rainwater goods. Small amount of cement debris and old slate roofing tiles found within the barn. | | | | |

| Recommendation | <b>Remove - NON-Licensed Material Removal by an asbestos contractor. This material is not licensed however may still be notifiable to the HSE prior to removal works taking place. All works must conform to the Control of Asbestos Regulations 2012.</b> | | | | |

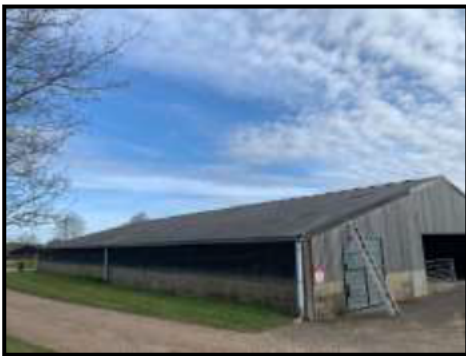
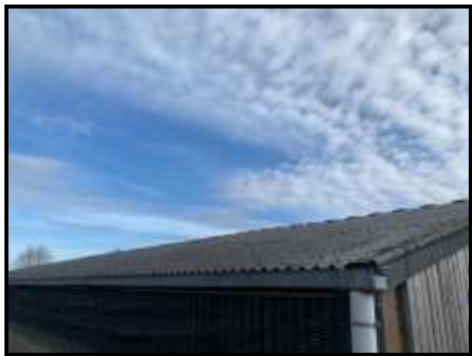
| Condition | Low Damage | | 1 | | |
| Substrate | Including ridge vents | Accessibility | High | | |
| Comments | Corrugated cement roof sheeting including ridge vents. Cement end capping. Timber cladding onto block walls. Timber and metal beams within. Timber and steel constructed doors. Plastic and metal rainwater goods. Small amount of cement debris and old slate roofing tiles found within the barn.<br>Including ridge vents | | | | |

| Recommendation | <b>Remove - NON-Licensed Material Removal by an asbestos contractor. This material is not licensed however may still be notifiable to the HSE prior to removal works taking place. All works must conform to the Control of Asbestos Regulations 2012.</b> | | | | |

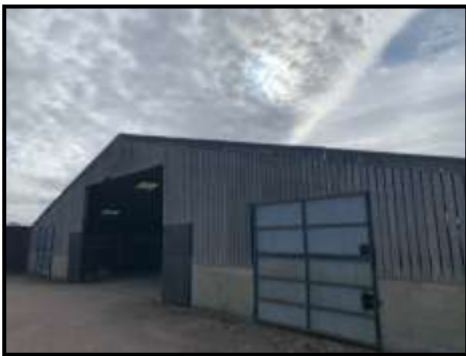
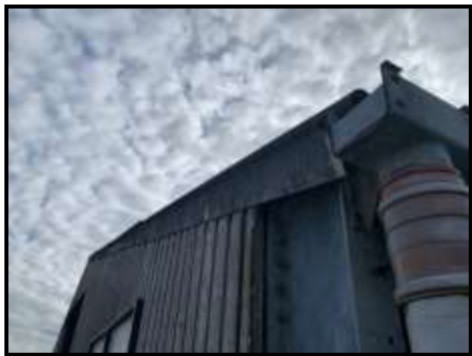
| Condition | Low Damage | | 1 | | |
| Comments | Corrugated cement roof sheeting including ridge vents. Cement end capping. Timber cladding onto block walls. Timber and metal beams within. Timber and steel constructed doors. Plastic and metal rainwater goods. Small amount of cement debris and old slate roofing tiles found within the barn. | | | | |

| Recommendation | <b>Remove - NON-Licensed Material Removal by an asbestos contractor. This material is not licensed however may still be notifiable to the HSE prior to removal works taking place. All works must conform to the Control of Asbestos Regulations 2012.</b> | | | | |

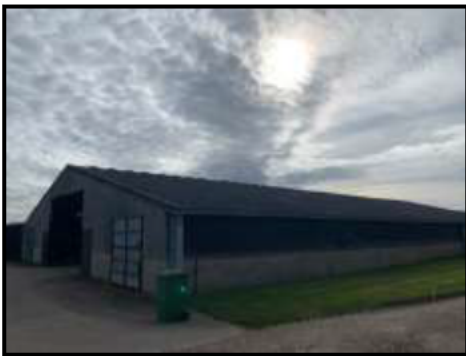
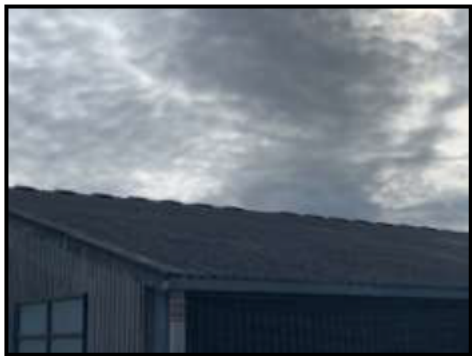
| Condition | Low Damage | | 1 | | |
| Comments | Corrugated cement roof sheeting including ridge vents. Cement end capping. Timber cladding onto block walls. Timber and metal beams within. Timber and steel constructed doors. Plastic and metal rainwater goods. Small amount of cement debris and old slate roofing tiles found within the barn. | | | | |

| Recommendation | <b>Remove - NON-Licensed Material Removal by an asbestos contractor. This material is not licensed however may still be notifiable to the HSE prior to removal works taking place. All works must conform to the Control of Asbestos Regulations 2012.</b> | | | | |

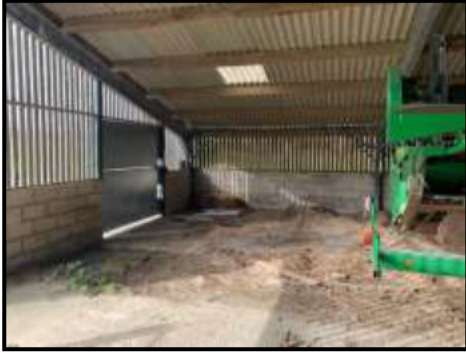
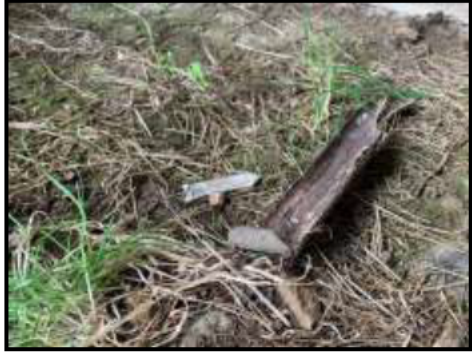
| Substrate | Small amounts of cement debris found within barn. | Accessibility | - | | |
| Comments | Corrugated cement roof sheeting including ridge vents. Cement end capping. Timber cladding onto block walls. Timber and metal beams within. Timber and steel constructed doors. Plastic and metal rainwater goods. Small amount of cement debris and old slate roofing tiles found within the barn.<br>Small amounts of cement debris found within barn. | | | | |

| Recommendation | No action required | | | | |

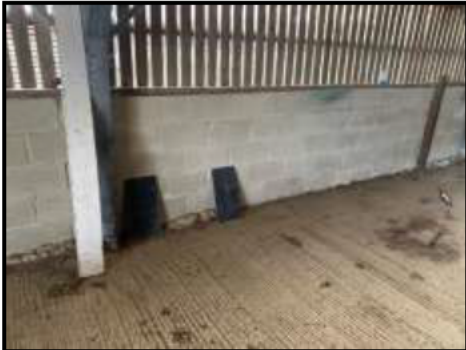
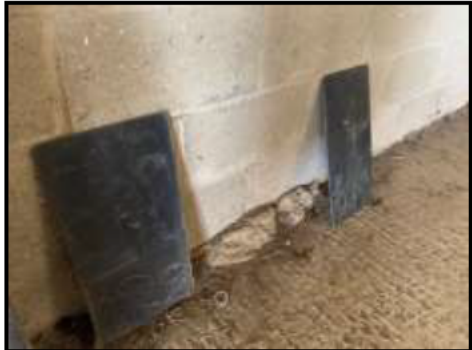
| Condition | Low Damage | | 1 | | |
| Substrate | X2 redundant cement roofing slates found within the barn. | Accessibility | Low | | |
| Comments | Corrugated cement roof sheeting including ridge vents. Cement end capping. Timber cladding onto block walls. Timber and metal beams within. Timber and steel constructed doors. Plastic and metal rainwater goods. Small amount of cement debris and old slate roofing tiles found within the barn.<br>X2 redundant cement roofing slates found within the barn. | | | | |

| Recommendation | Remove - NON-Licensed Material Removal by an asbestos contractor. This material is not licensed however may still be notifiable to the HSE prior to removal works taking place. All works must conform to the Control of Asbestos Regulations 2012. | | | | |

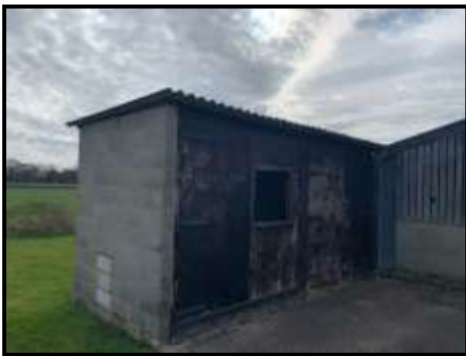
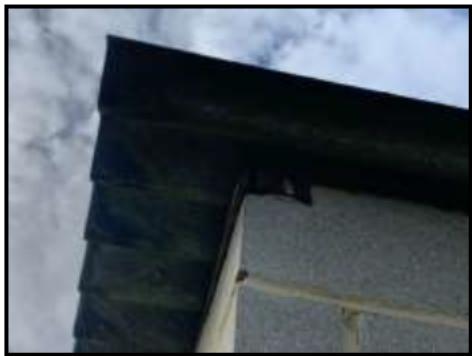
| Condition | Low Damage | | 1 | | |
| Substrate | Bolted | Accessibility | High | | |
| Comments | Corrugated cement roof sheeting. Block and timber walls. Concrete floor. | | | | |

| Recommendation | Remove - NON-Licensed Material Removal by an asbestos contractor. This material is not licensed however may still be notifiable to the HSE prior to removal works taking place. All works must conform to the Control of Asbestos Regulations 2012. | | | | |
