# FIRE RISK APPRAISAL OF THE EXTERNAL WALLS (PAS 9980:2022)

## HORSHAM GATE TWO

NORTH STREET, HORSHAM,  
RH13 5TU

RB-EX8IGM

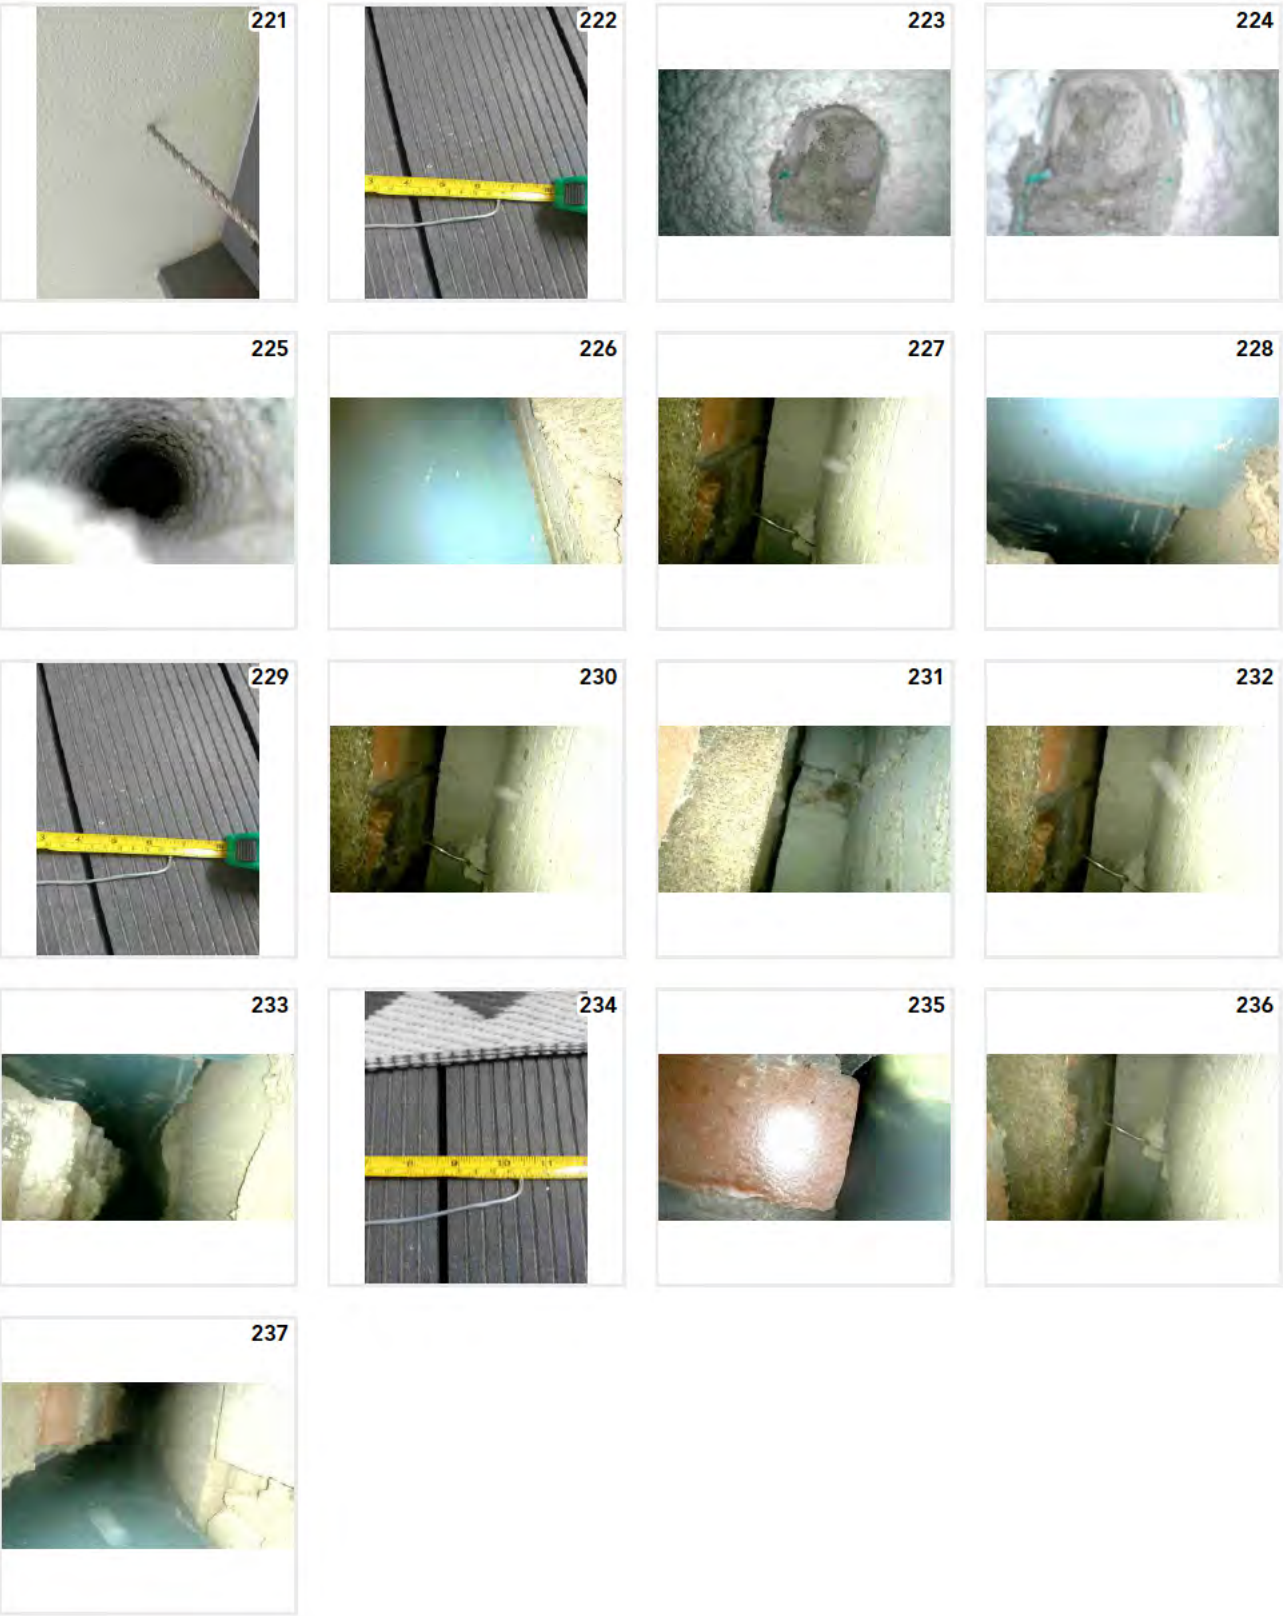
Concrete column junction at Compartment Wall location. A concrete column is wrapped with blue rigid PUR insulation. Masonry closes the cavity at the compartment wall.

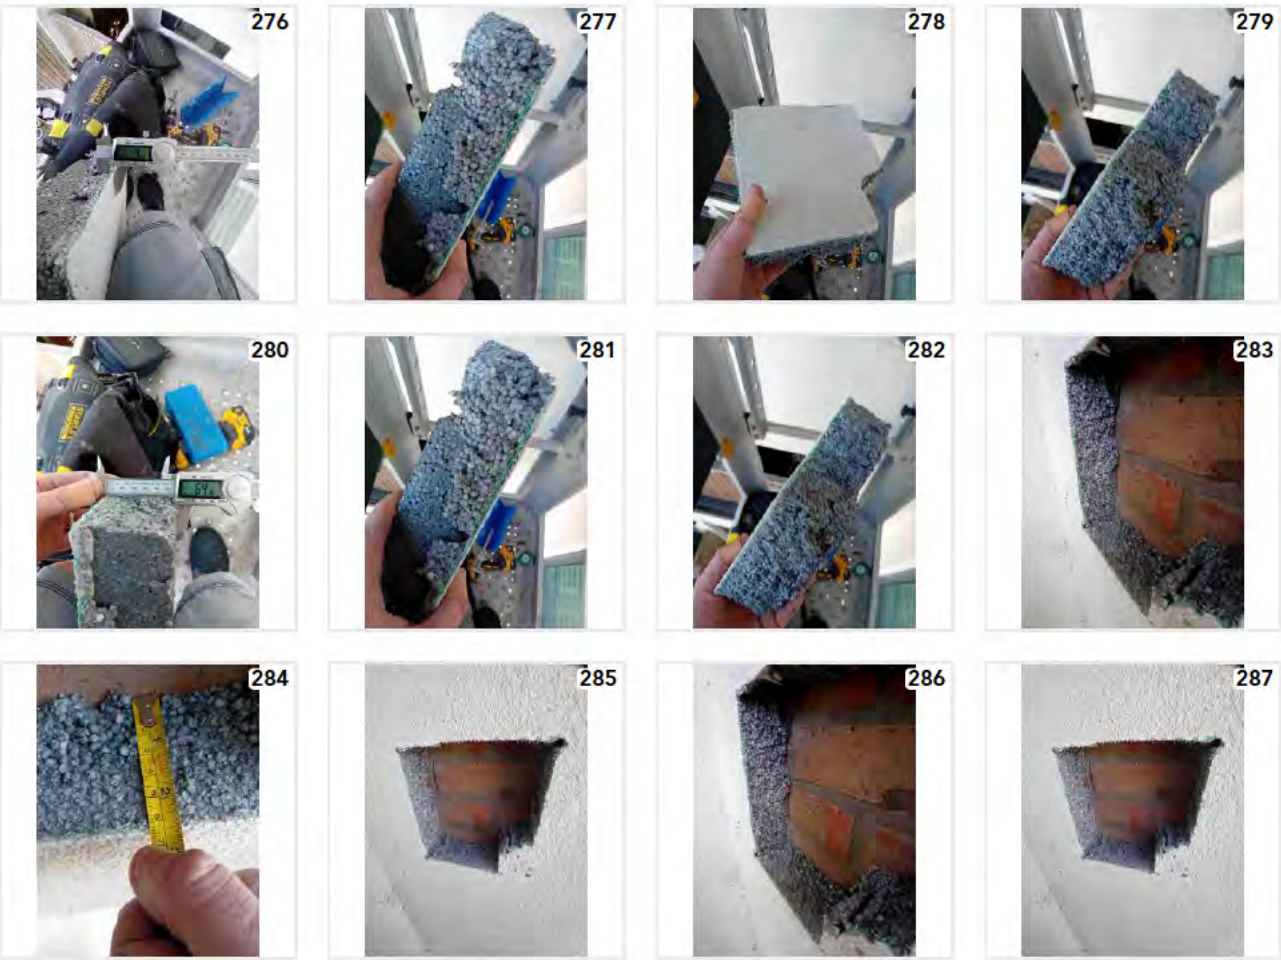
Nothing seen closing the cavity at the compartment wall.

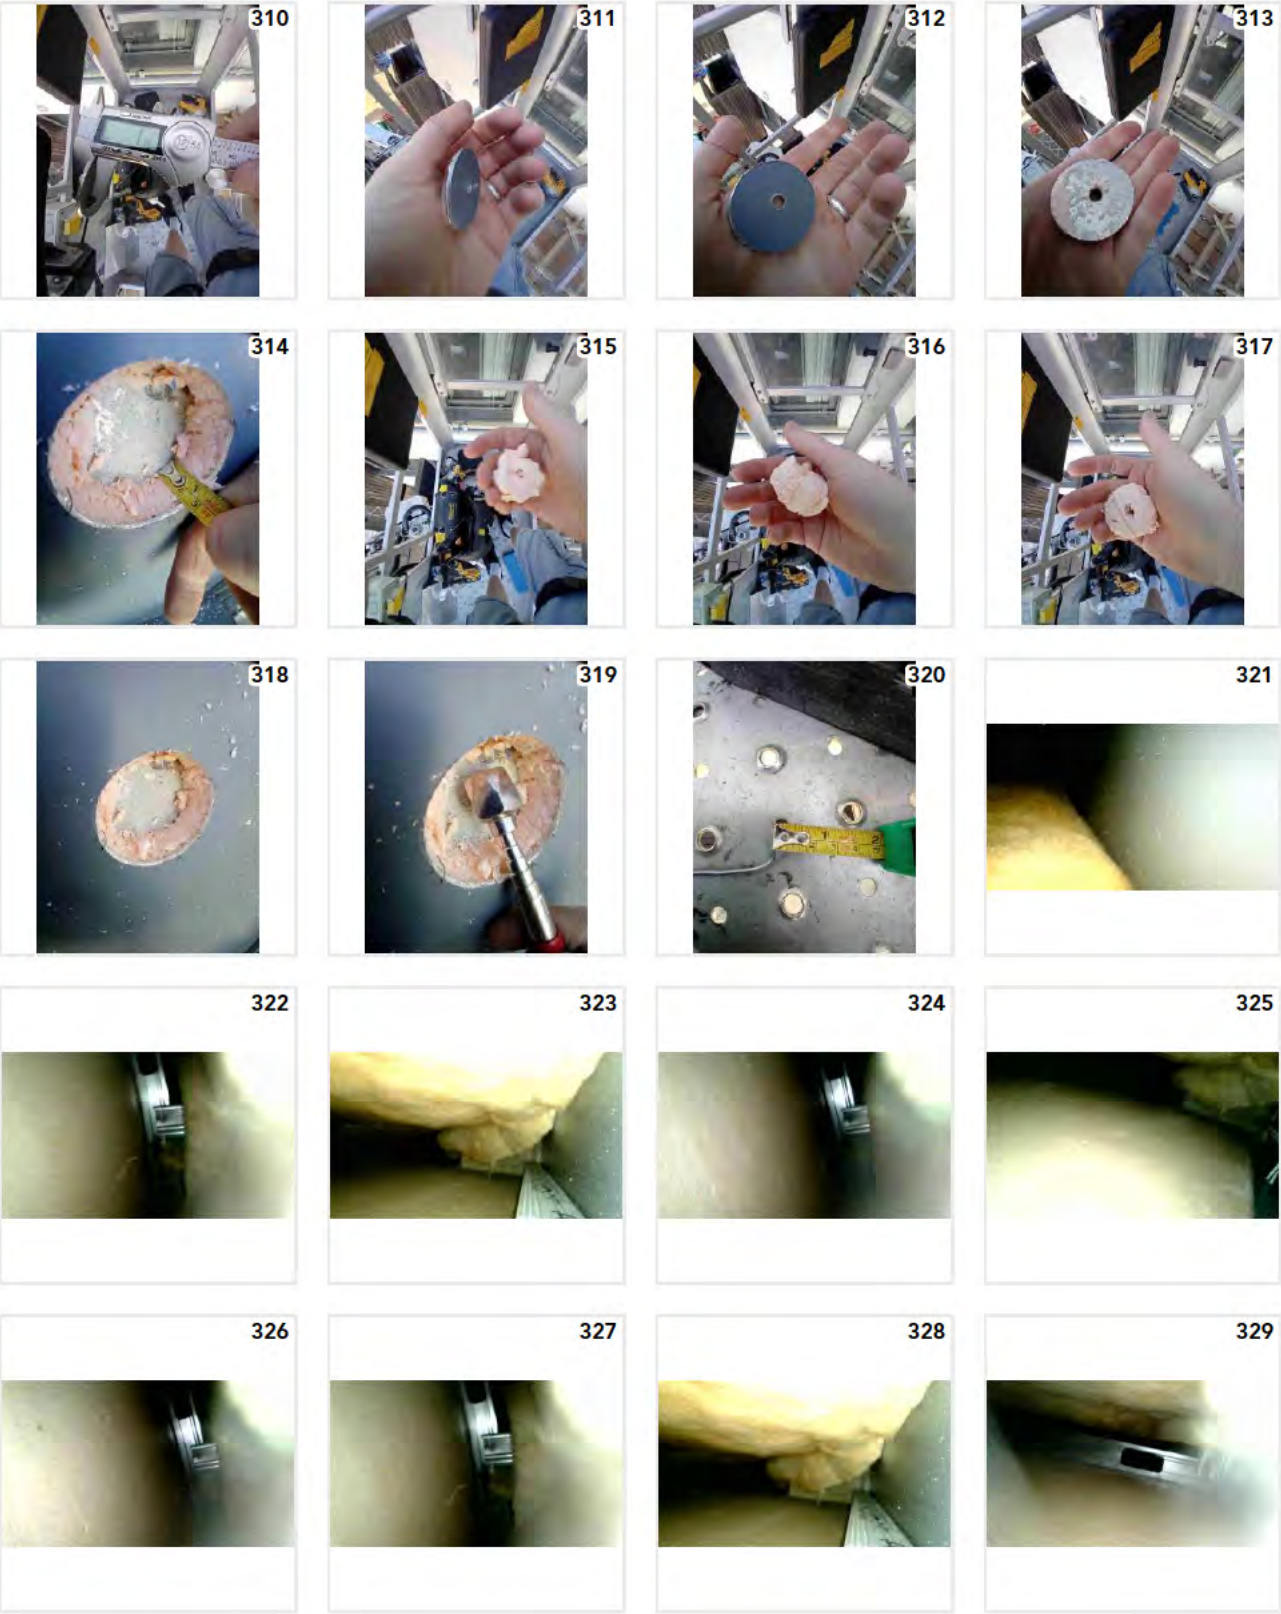
Glass wool insulation partially fills the cavity behind the aluminium spandrel panel.

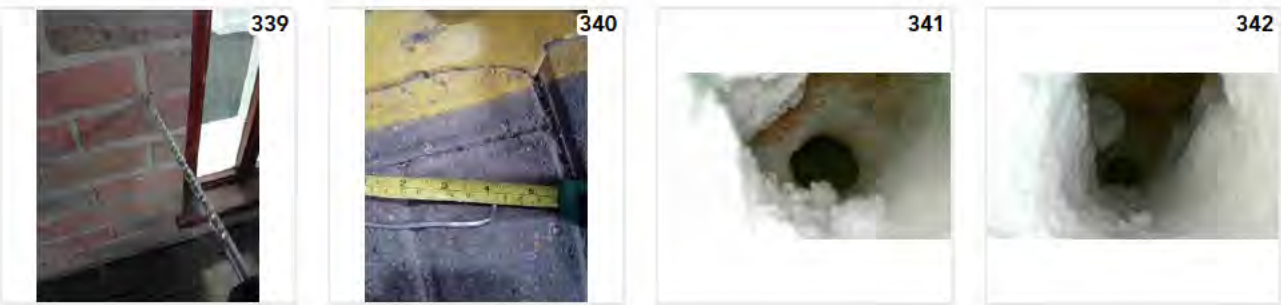
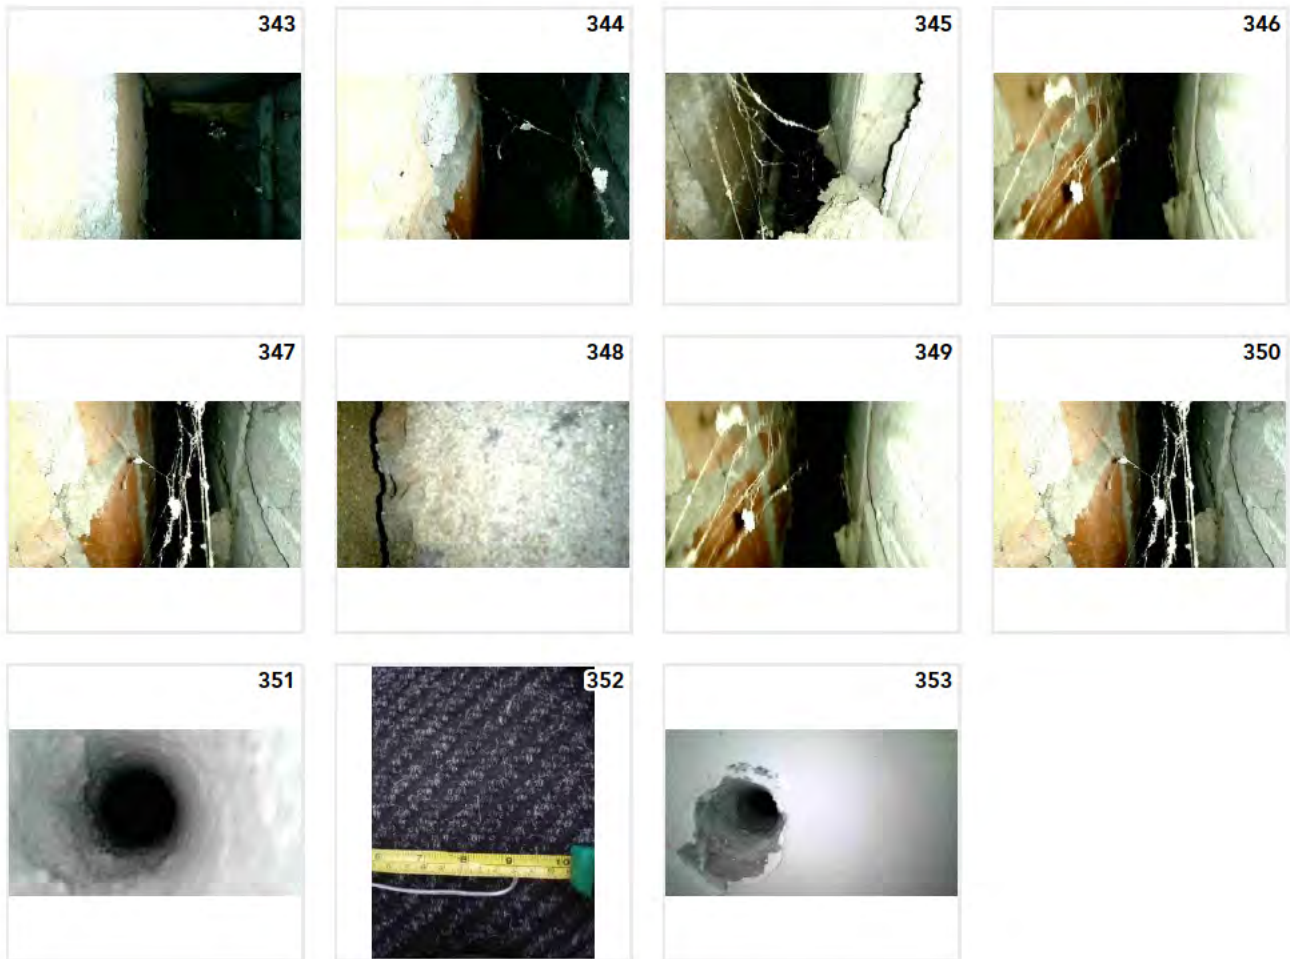
Brickwork closes beside the window frame, the window frame itself is timber at 60mm thickness.
