## Heritage and Design and Access Statement - repairs following flood

Jessamine Cottage, Gay Street  
Pulborough, West Sussex RH20 2HL

Date: 30<sup>th</sup> May 2026

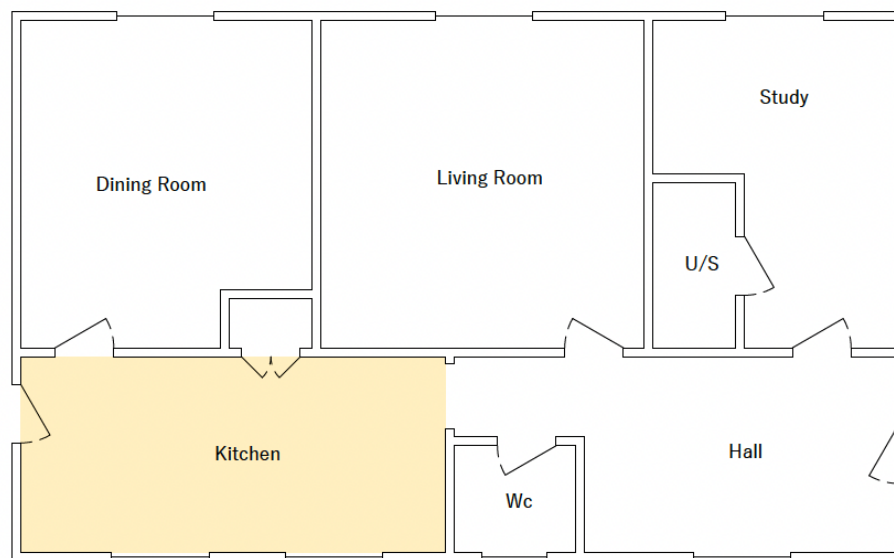
Fig (ii) – kitchen floor floor to be replaced in limecrete

It is proposed to replace the existing modern slate tiled floor, (photo iv) and assumed concrete floor to the kitchen, with a limecrete floor, (fig ii). It is assumed that the existing foundations will be extremely shallow. It is therefore extremely important to ensure that the new floor does not undermine the existing shallow footings. It is proposed to either chamfer at a 45 degrees angle from the wall as indicated in Fig(iii), or if the foundations are found to be too shallow for this, then the floor will be stepped in by 200mm and then chamfered at 45 degrees from here. The make up will consist of a breathable geotextile membrane on levelled and compacted ground, a 80-100mm layer of recycled foamed glass insulation, followed by another layer of geotextile membrane and with a 100mm NHL5 limecrete slab, with a 30mm cork board to the external perimeter walls, with a 50mm NHL 2:1 mix lime screed topping, finished with a new slate floor to match the original with joints pointed in a lime mortar. Note: the slate floor will not be laid until the limecrete floor has fully cured, and any sealer applied will be a natural stone breathable sealer so as not to trap the moisture in.
