**DESIGN AND ACCESS STATEMENT**

**GARLANDS  
BILLINGSHURST  
WEST SUSSEX  
RH14 9BH**

Doc Ref: 260717/DA

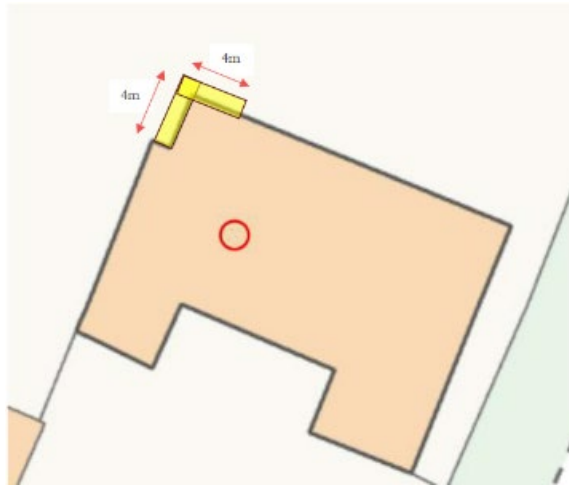
Figure 1 - Site plan showing area of underpinning

- 4.1 Crack damage has occurred to the rear left-hand area of the single-storey rear addition and to the left flank wall of the building. The pattern of damage is consistent with downward rotational movement affecting the foundations.

- 4.5 The recorded movement has resulted in cracking of approximately 20mm between the left flank wall, which has rotated outwards, and the internal partition wall.

- 4.6 Having regard to the investigation findings, monitoring data and engineering assessment, underpinning to the affected rear corner, together with targeted masonry reinforcement, is considered the most appropriate method of stabilising the structure and repairing movement-related damage.

- 5.1 The underpinning works will be undertaken externally. To allow safe access to the affected foundation, the existing brick-paved path will be carefully lifted, set aside and reinstated on completion of the works.
- 5.2 The proposed extent of underpinning is shown on the plan below.
