Garlands  
Billingshurst  
West Sussex  
RH14 9BH

## **ENGINEERS SITE REPORT**

### **Observations and Recommendations:**

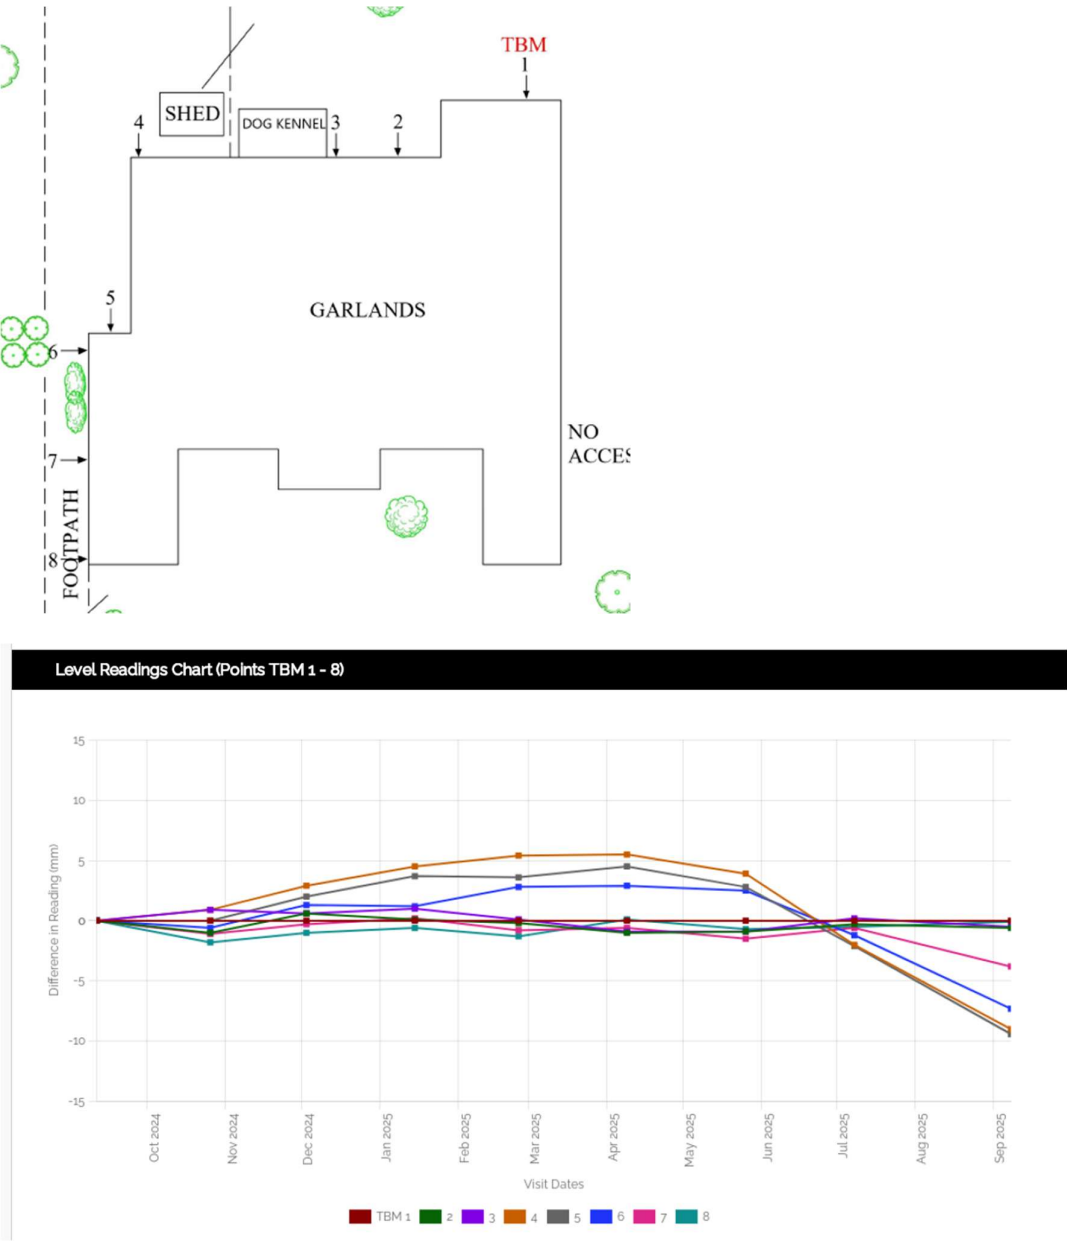
Level Monitoring

Level monitoring has been ongoing at approximately 2 month intervals since September 2024. A plan showing the stations and a graph showing the movement is reproduced below.

The readings show a typical cyclical pattern of movement associated with clay shrinkage subsidence with about 15mm downward movement occurring during Summer 2025 so

far at Stations 4 & 5, around 9mm at Station 6 and about 3mm at Station 7. The remaining stations are stable.

Station 4 is at the rear left corner of the Addition. Stations 5 & 6 are on the rear left corner of the original house and Station 7 is on the left wall of the original house, closer to the front than illustrated on the Plan.

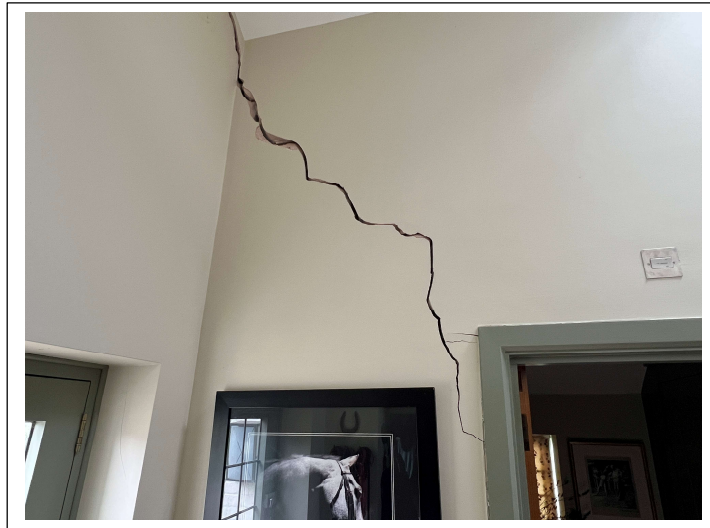
### **Hall**

- Diagonal crack above left side of door, tapering open with height and extending along sloping ceiling/wall junction on left wall of Addition. Open c.20mm.
- Cracks above beam opening to lobby area (original house) extending above and below bedroom window and across sloping ceiling to window light.
- Crack across limestone quarry floor tiles from WC door and tapering to closure by lobby junction

The main change in damage is the cracking deriving from the rotation of the left flank wall. This has increased the main cracking on the internal partition wall between hall and wc from 2.5mm to c.20mm. Other cracks are broadly similar in magnitude, including the limestone floor.

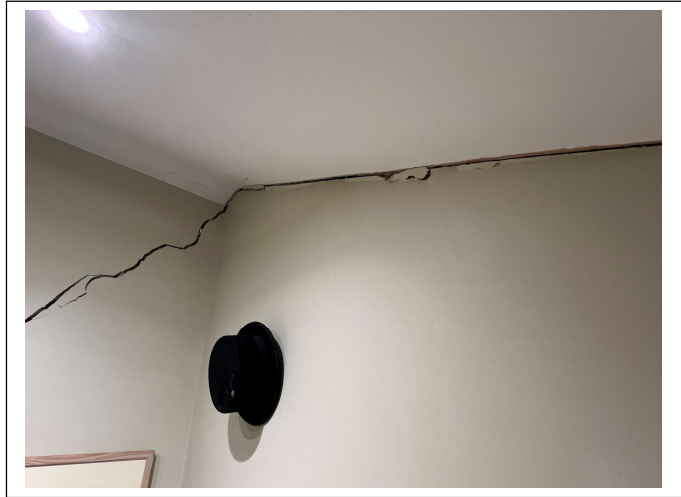
### **WC**

- Vertical crack above and below rear wall window, translating to horizontal cracking at sloping ceiling/rear wall junction
- Above crack extends along left wall/sloping ceiling junction, tapering open and translating to diagonal crack on internal wall to side of door. Open c.20mm.

The monitoring shows about 15mm downward movement this summer but this has translated into cracking around 20mm between the left flank wall (which has rotated outwards) and the internal partition wall. This is due to simple geometry, with the fulcrum of movement being the crack in the floor tiles which is a shorter distance from the flank wall than the height of the cracking.

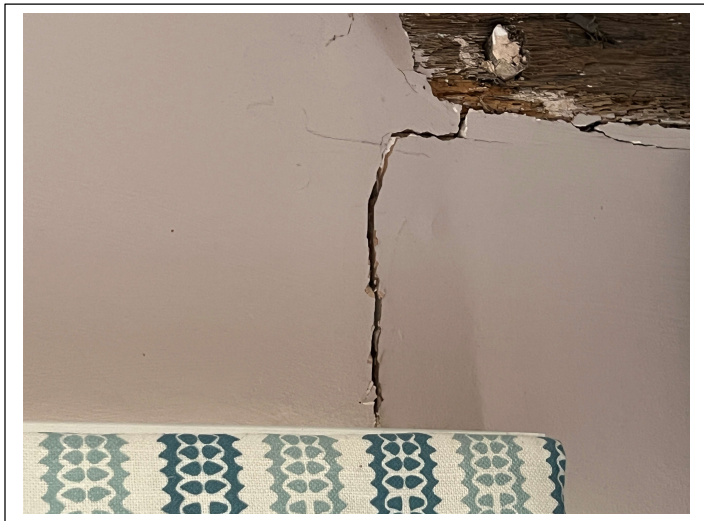
Bedroom (1<sup>st</sup> floor above lobby)

- Minor cracking above and below left flank window
- Diagonal crack below right side of rear window

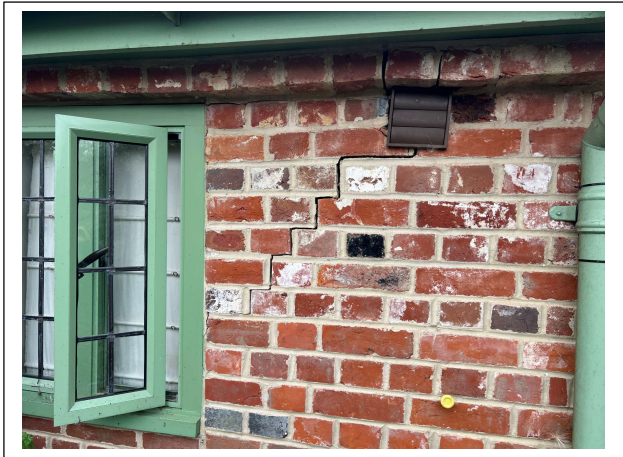
#### External

- Stepped crack below left corner of lobby window extending around corner as stepped crack
- Stepped crack above left side of door to Addition
- Stepped crack to left side of rear WC window and vertical crack below right side
- Tilt to left corner measured at 1 in 75.

The external cracking on the rear wc wall was previously measured at 3mm and is now about 6mm open, again indicating further rotation due to subsidence.

There are a number of potential solutions including further tree mitigation and/or underpinning and/or a masonry reinforcement solution and/or root barrier. However, before these can be looked at in details, further site investigations are required:

- a) To establish the depth of desiccation and
- b) To find out the foundation details for the original house and soil conditions below.

Care needs to be taken with any solution since we essentially have a flexible original house and a rigid rear Addition. I would not recommend any further tree works at this stage until these further investigations have been completed. Monitoring should continue.
