# Gale Tree Consultancy

## Tree Condition Report

Belwethers, Pulborough, RH20 2DR

Ref: TCR/727/26

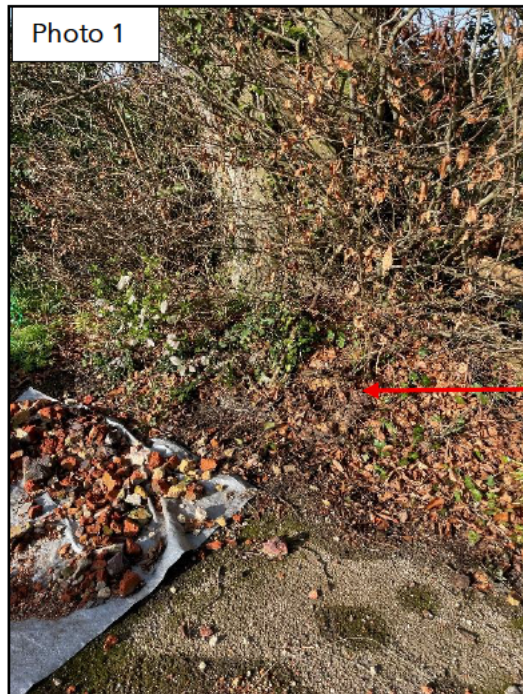
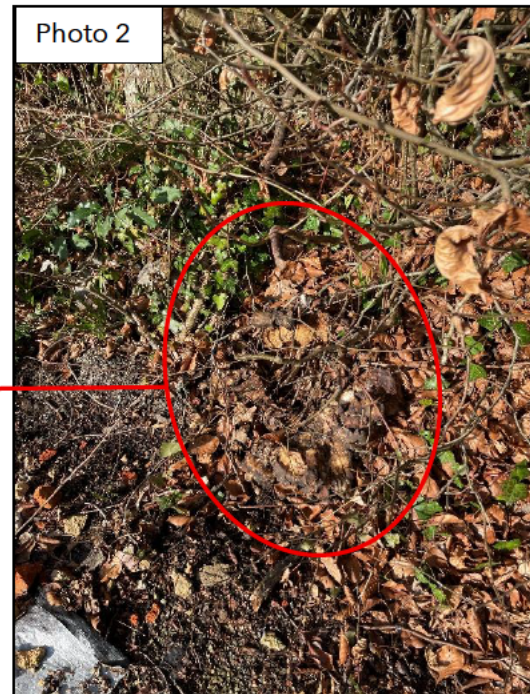
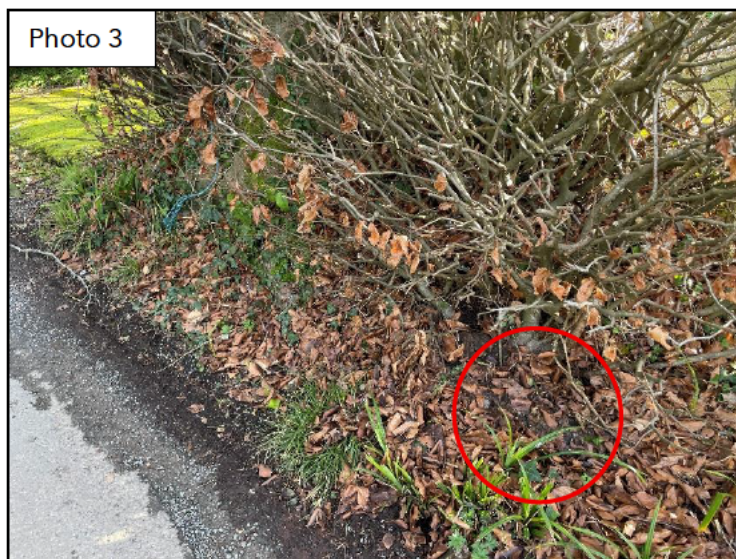
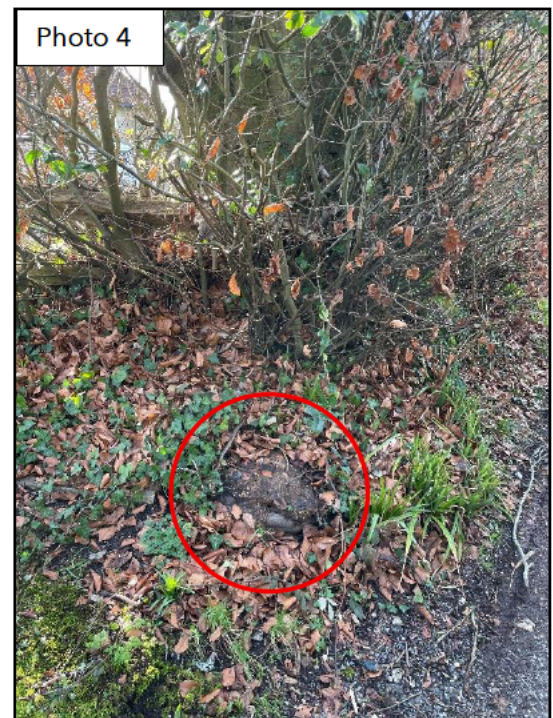
- On the east, southwest and north buttress roots are degrading remains of the decay polypore *Meripilus giganteus* (Giant polypore) - see Photos 1, 2, 3 and 4 in Appendix 4

- The decay fungus *Meripilus giganteus* (Giant polypore) causes a white rot<sup>2</sup> to form on the underside of the structural roots, root crown<sup>3</sup> and lower stem area. During its early colonisation, the fungus can also form a "soft rot"<sup>4</sup>

- The fungus also has the ability to degrade the pectin, the substance that binds or glues the cells together within the wood fibres
- The resulting decayed wood becomes brittle and liable to fracture both longitudinally and across the grain which makes the tree prone to failure

*Meripilus giganteus* fruiting bodies, circled red, on the east, southwest and north buttress roots

- Based on this, my recommendation is for the tree to be felled within six months of the report's date
- However, if the tree is retained, the dead branches should be removed and the declining branches pruned back to sound wood within six months of the report's date and reassessed in two years from the report's date

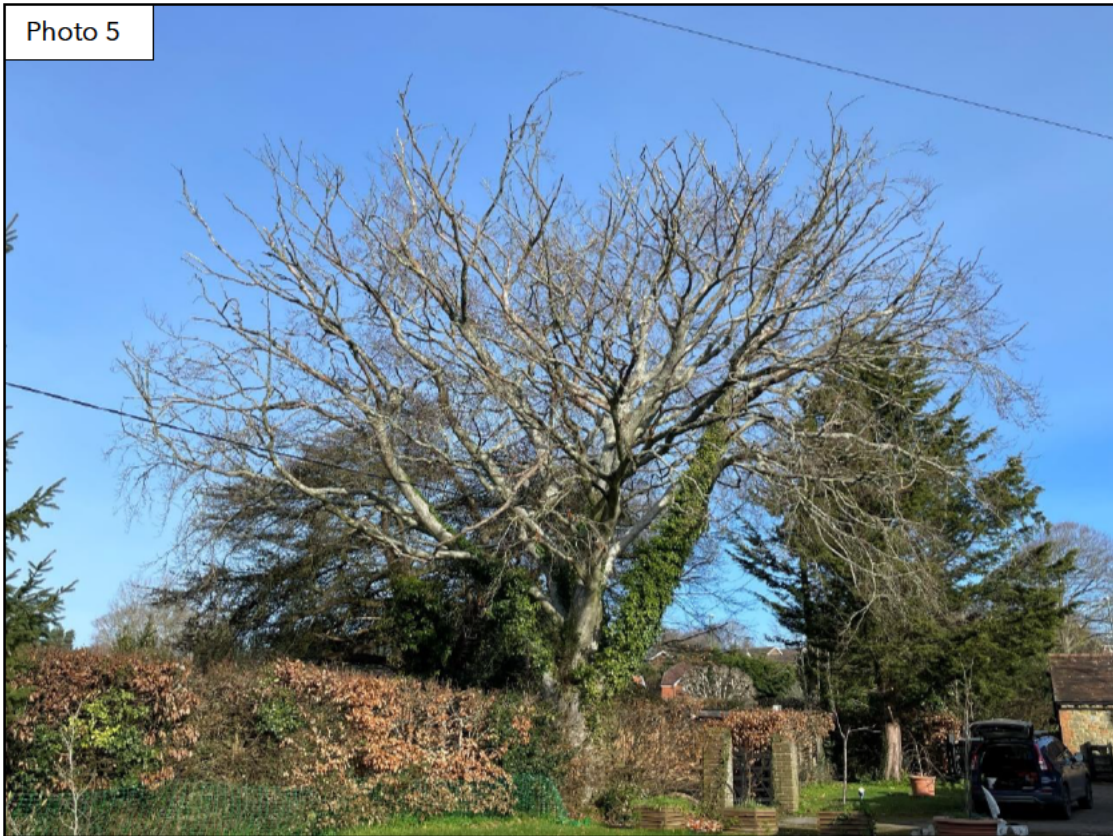
- Throughout the crown there is extensive deadwood and declining branches with the west SSS being the only part of the crown that appears free from any significant decline - see Photo 5 in Appendix 4

- The extent of dead and declining branches is, in my opinion, the result of the fungus impacting on the tree's ability to perform the basic function of moving water and nutrients around the system and as such further decline should be expected

Extensive decline clearly visible throughout the crown of the tree
