## Lanes Group plc - CCTV Report - Defect Grade Summary

**Inspection Standard:** MSCC5 Sewers & Drainage GB (SRM5 Scoring)

**Site:** Novartis, Horsham

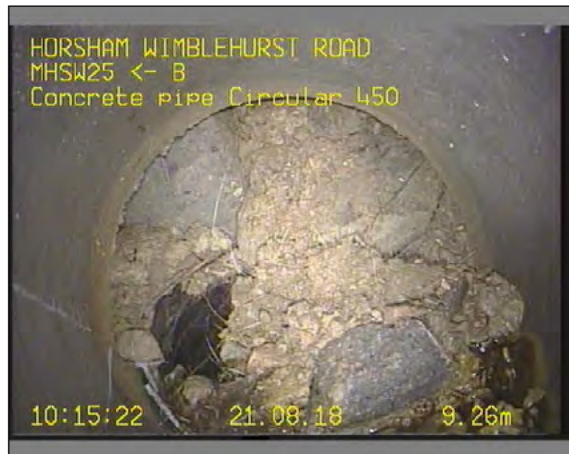
Photo: 3\_3\_9\_A.JPG

9.26m, Survey abandoned Remarks: POSSIBLE COLLAPSE

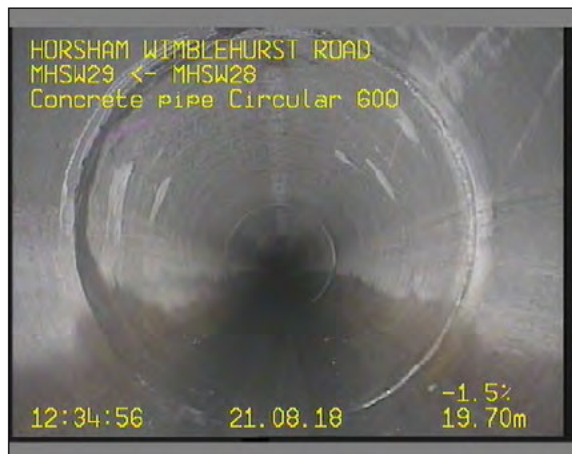
Photo: 7\_7\_27\_A.JPG

| 1:435 | Position | Code | Observations and Remarks | MPEG | Photo | Grade |
|---|---|---|---|---|---|---|
| | | 19.70 | ISJ | Infiltration, seeping at joint, from 6 to 12 o'clock | 00:01:29 | 7_7_27_A.JPG<br>G (Serv) 0 |

19.7m, Infiltration, seeping at joint, from 6 to 12 o'clock

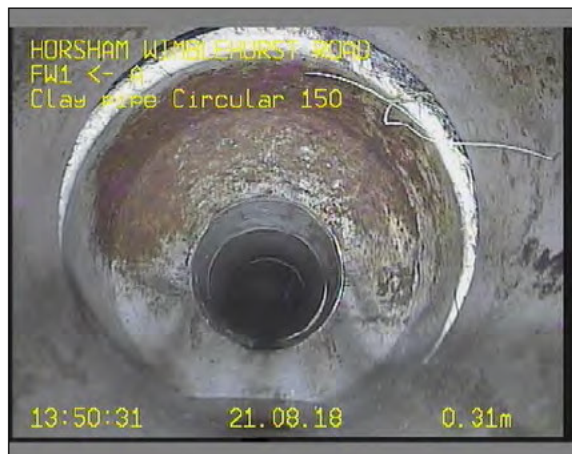
Photo: 9\_9\_35\_A.JPG  
0.31m, Joint displaced, medium

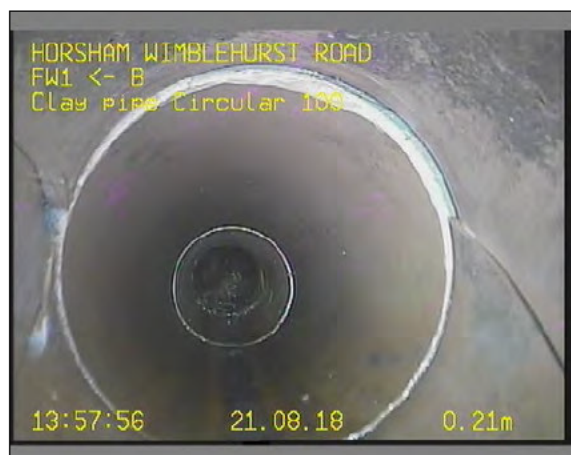
| 1:50 | Position | Code | Observations and Remarks | MPEG | Photo | Grade |
|---|---|---|---|---|---|---|
| | 0.21 | FLJ | Fracture, longitudinal at joint, at 8 o'clock | 00:00:24 | 10_10_45_A.J PG | (Struct) 3 |

Photo: 10\_10\_45\_A.JPG  
0.21m, Fracture, longitudinal at joint, at 8 o'clock

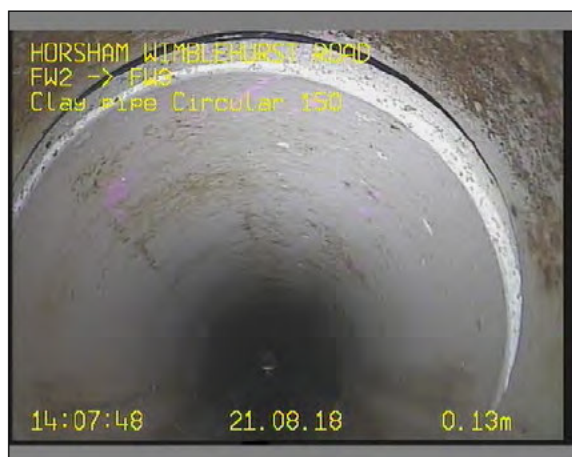
Photo: 12\_12\_53\_A.JPG  
0.13m, Joint displaced, medium

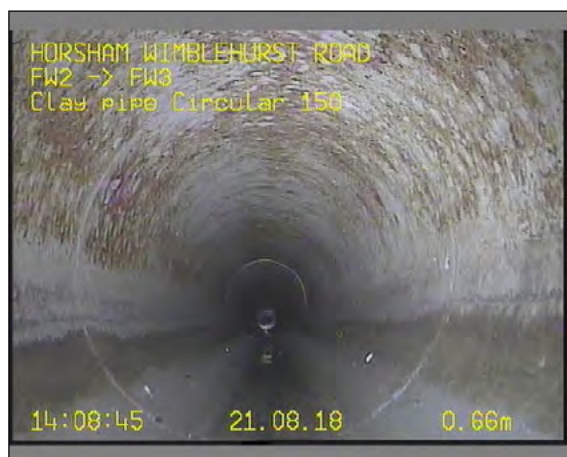
| 1:50 | Position | Code | Observations and Remarks | MPEG | Photo | Grade |
|---|---|---|---|---|---|---|
| | 0.66 | CC | Crack, circumferential, from 12 to 12 o'clock | 00:00:58 | 12_12_54_A.J<br>PG | (Struct) 2 |

Photo: 12\_12\_54\_A.JPG  
0.66m, Crack, circumferential, from 12 to 12 o'clock

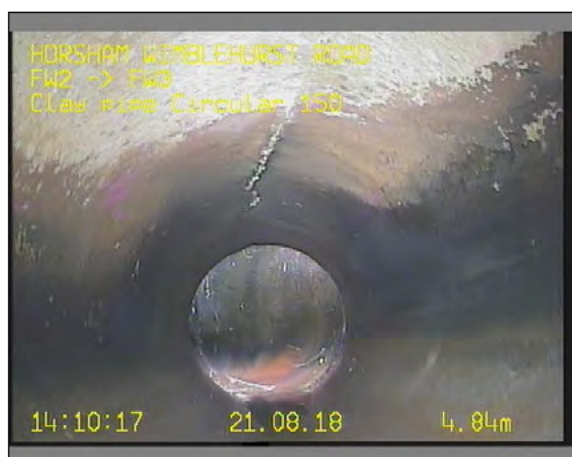
| 1:50 | Position | Code | Observations and Remarks | MPEG | Photo | Grade |
|---|---|---|---|---|---|---|
| | 4.84 | CL | Crack, longitudinal, at 12 o'clock | 00:02:13 | 12_12_55_A.J<br>PG | (Struct) 2 |

Photo: 12\_12\_55\_A.JPG  
4.84m, Crack, longitudinal, at 12 o'clock

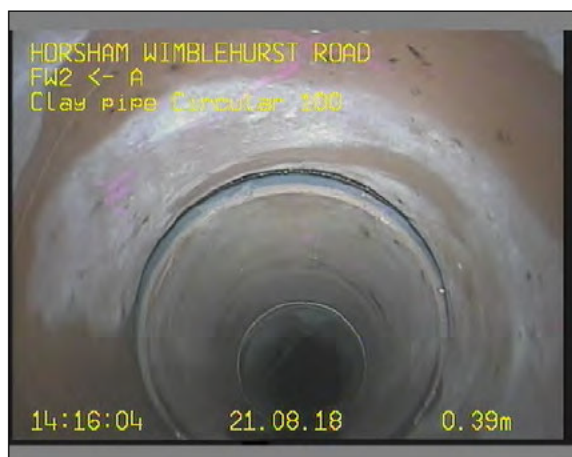
| 1:60 | Position | Code | Observations and Remarks | MPEG | Photo | Grade |
|---|---|---|---|---|---|---|
| | 0.39 | CC | Crack, circumferential, from 6 to 12 o'clock | 00:00:38 | 13_13_60_A.J PG | (Struct) 2 |

Photo: 13\_13\_60\_A.JPG  
0.39m, Crack, circumferential, from 6 to 12 o'clock

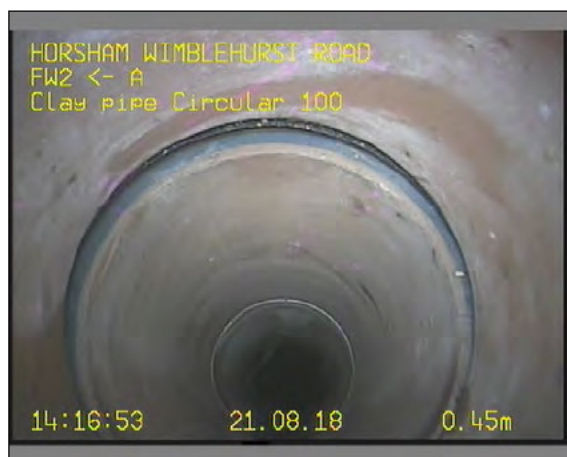
Photo: 13\_13\_61\_A.JPG  
0.45m, Joint displaced, medium

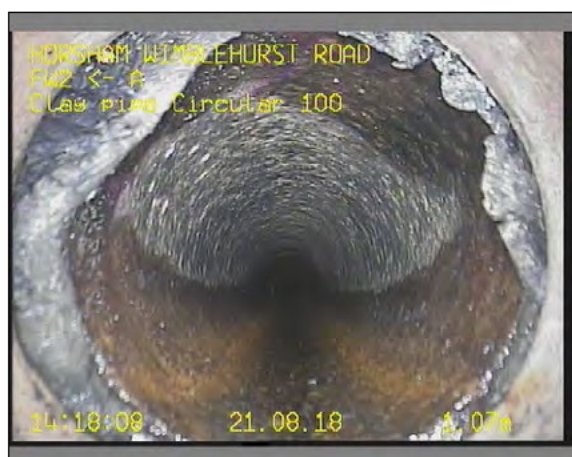
Photo: 13\_13\_62\_A.JPG  
1.07m, General remark Remarks: CONCRETE AROUND JOINT

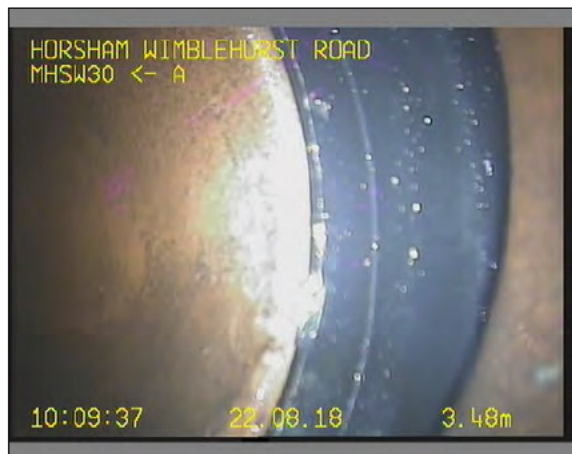
Photo: 14\_14\_70\_A.JPG  
3.48m, Joint displaced, medium

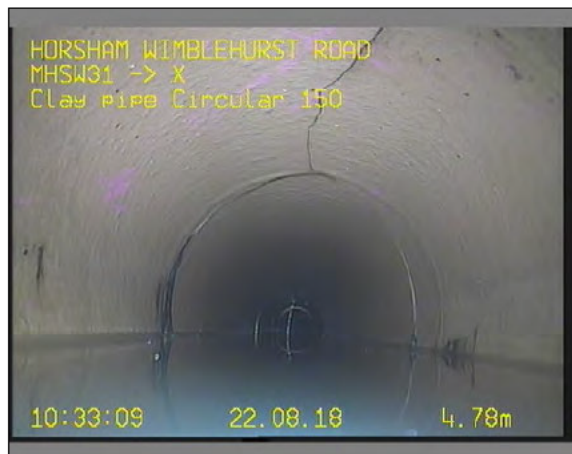
| 1:135 | Position | Code | Observations and Remarks | MPEG | Photo | Grade |
|---|---|---|---|---|---|---|
| | | 4.76 | FL | Fracture, longitudinal, at 12 o'clock | 00:00:56 | 16_16_84_A.J PG (Struct) 3 |

Photo: 16\_16\_84\_A.JPG  
4.76m, Fracture, longitudinal, at 12 o'clock

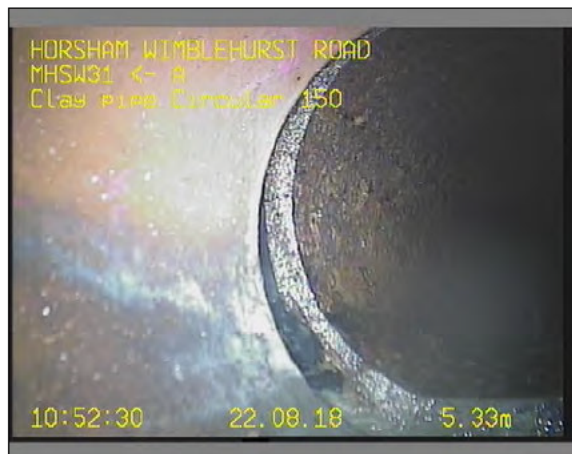
Photo: 17\_17\_95\_A.JPG  
5.33m, Joint displaced, medium

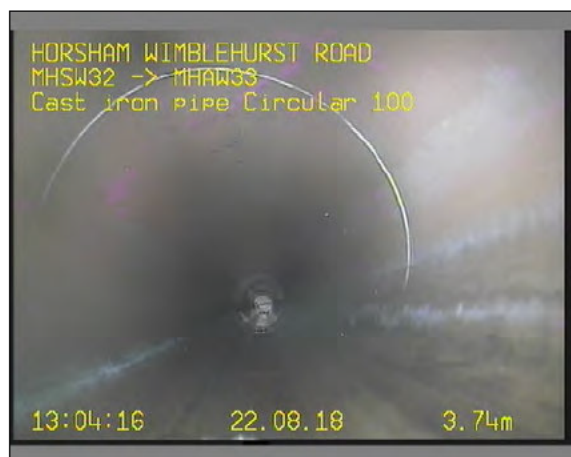
| 1:60 | Position | Code | Observations and Remarks | MPEG | Photo | Grade |
|---|---|---|---|---|---|---|
| | 3.76 | CC | Crack, circumferential, from 12 to 12 o'clock | 00:01:23 | 21_21_118_A.JPG | (Struct) 2 |

Photo: 21\_21\_118\_A.JPG  
3.76m, Crack, circumferential, from 12 to 12 o'clock

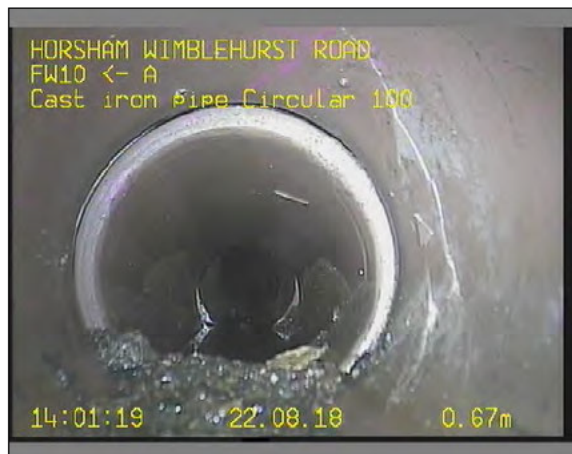
| 1:75 | Position | Code | Observations and Remarks | MPEG | Photo | Grade |
|---|---|---|---|---|---|---|
| | 0.67 | CC | Crack, circumferential, from 12 to 5 o'clock | 00:00:22 | 22_22_122_A.JPG | (Struct) 2 |

Photo: 22\_22\_122\_A.JPG  
0.67m, Crack, circumferential, from 12 to 5 o'clock

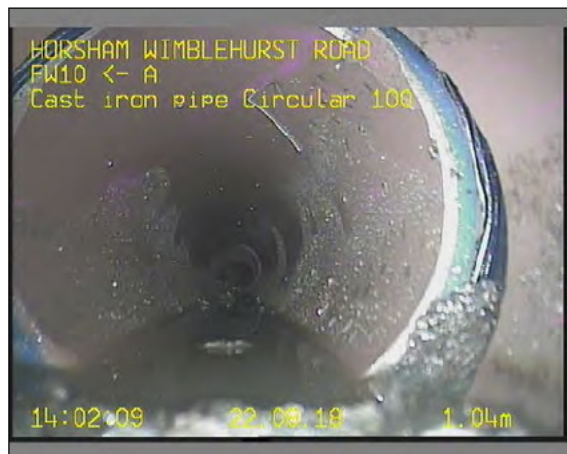
Photo: 22\_22\_124\_A.JPG  
1.04m, Open joint, medium

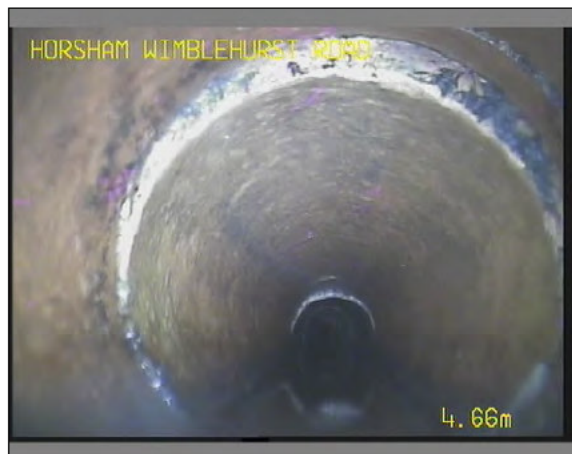
Photo: 29\_29\_167\_A.JPG

| 1:75 | Position | Code | Observations and Remarks | MPEG | Photo | Grade |
|---|---|---|---|---|---|---|
| | | 4.66 | FC | Fracture, circumferential, from 12 to 6 o'clock | 00:01:09 | 29_29_167_A.JPG (Struct) 3 |

4.66m, Fracture, circumferential, from 12 to 6 o'clock

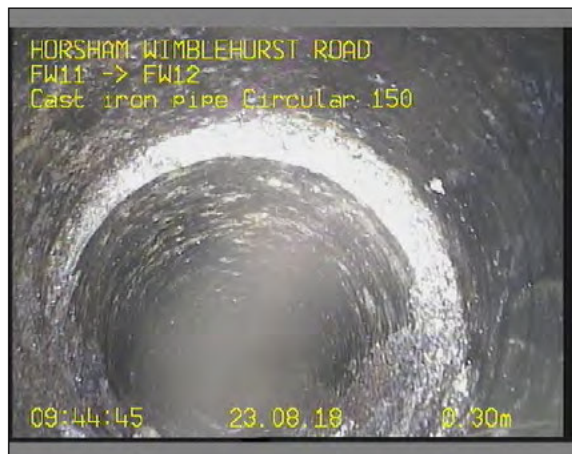
Photo: 31\_31\_179\_A.JPG  
0.3m, Joint displaced, medium

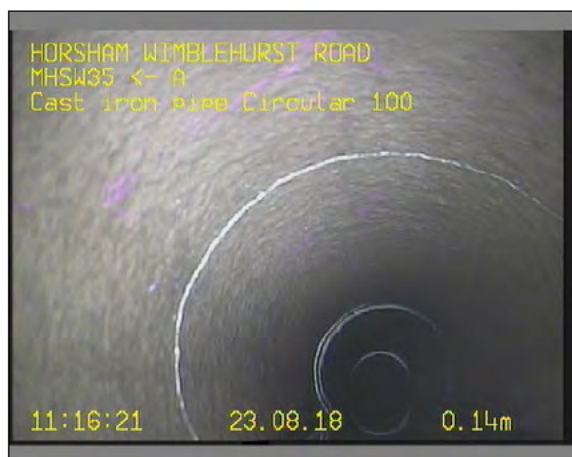
| 1:135 | Position | Code | Observations and Remarks | MPEG | Photo | Grade | | |
|---|---|---|---|---|---|---|---|---|
| | | 0.16 | CC | Crack, circumferential, from 12 to 12 o'clock | 00:00:18 | 33_33_190_A.JPG | (Struct) 2 | |

Photo: 33\_33\_190\_A.JPG  
0.16m, Crack, circumferential, from 12 to 12 o'clock

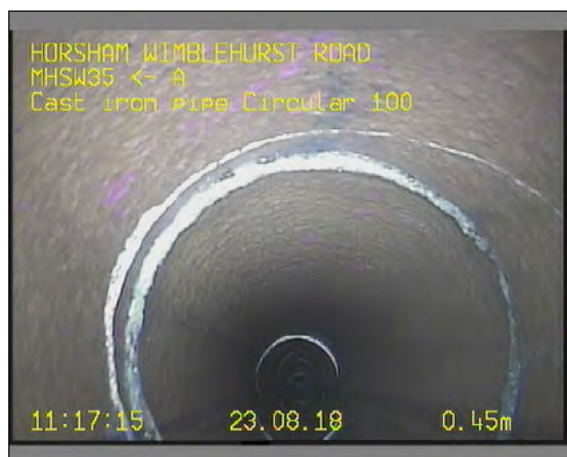
| 1:135 | Position | Code | Observations and Remarks | MPEG | Photo | Grade | | |
|---|---|---|---|---|---|---|---|---|
| | | 0.45 | FCJ | Fracture, circumferential at joint, from 6 to 3 o'clock | 00:00:44 | 33_33_191_A.JPG | (Struct) 3 | |

Photo: 33\_33\_191\_A.JPG  
0.45m, Fracture, circumferential at joint, from 6 to 3 o'clock

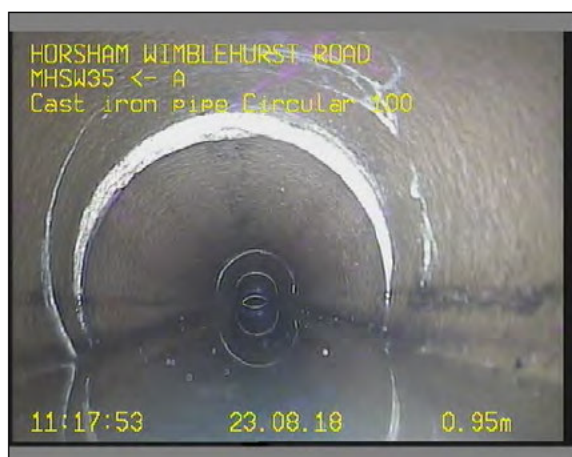
| 1:135 | Position | Code | Observations and Remarks | MPEG | Photo | Grade | | |
|---|---|---|---|---|---|---|---|---|
| | | 0.95 | CCJ | Crack, circumferential at joint, from 12 to 12 o'clock | 00:01:01 | 33_33_192_A.JPG | (Struct) 2 | |

Photo: 33\_33\_192\_A.JPG  
0.95m, Crack, circumferential at joint, from 12 to 12 o'clock

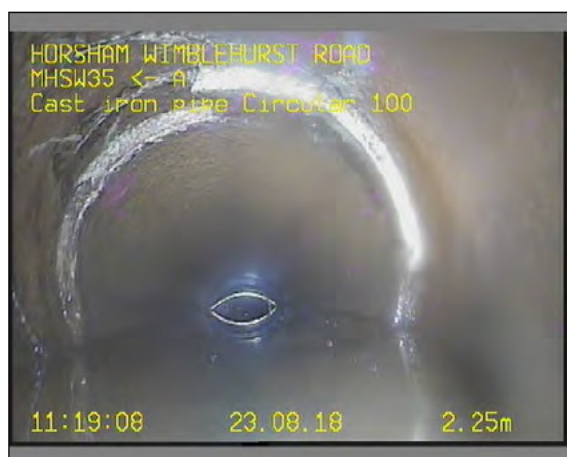
| 1:135 | Position | Code | Observations and Remarks | MPEG | Photo | Grade | | |
|---|---|---|---|---|---|---|---|---|
| | | 2.25 | B | Broken pipe, from 12 to 12 o'clock | 00:01:39 | 33_33_194_A.JPG | (Struct) 4 | |

Photo: 33\_33\_194\_A.JPG  
2.25m, Broken pipe, from 12 to 12 o'clock

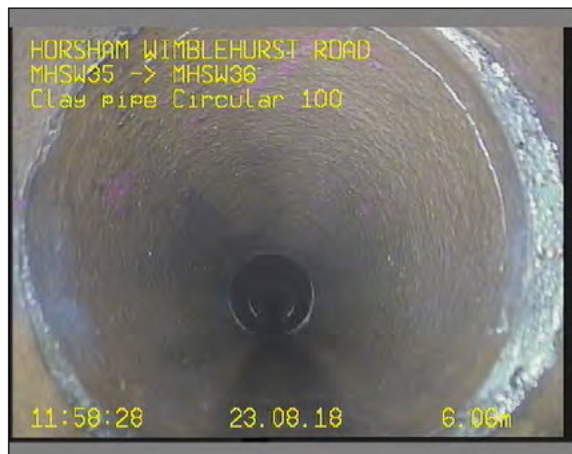
Photo: 35\_35\_217\_A.JPG

| 1:210 | Position | Code | Observations and Remarks | MPEG | Photo | Grade |
|---|---|---|---|---|---|---|
| | 6.06 | CCJ | Crack, circumferential at joint, from 11 to 3 o'clock | 00:01:41 | 35_35_217_A.JPG | (Struct) 2 |

6.06m, Crack, circumferential at joint, from 11 to 3 o'clock

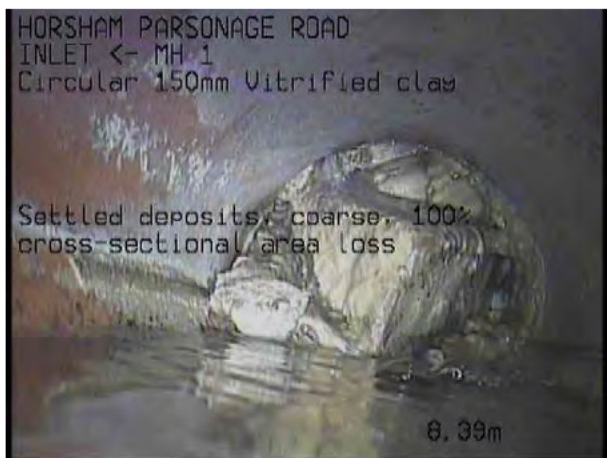
INLETX\_c6f02a9d-5b2a-48fa-8952-aea8cd00a46d\_20210518\_152508\_028.jpg, 00:02:15, 8.39 m

Finish node type, manhole, reference number: INLET,  
UNABLE TO REACH MH

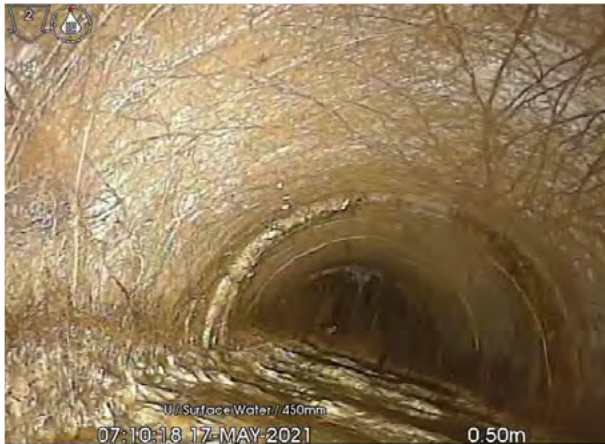
S  
21X\_8c00149b-c37e-4b90-9d39-705429272385\_20210518\_1  
55156\_682.jpg, 00:00:34, 0.50 m  
Settled deposits, hard or compacted, 40% cross-sectional area  
loss

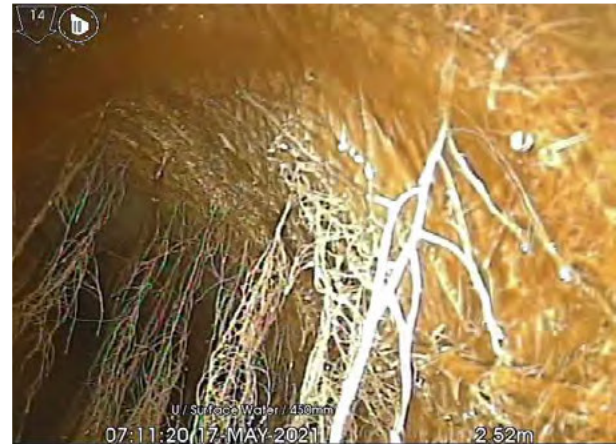
S  
21X\_3457e390-909a-4c8a-a44c-4650307ab933\_20210518\_1  
55216\_988.jpg, 00:01:37, 2.52 m  
Roots, mass, 25% % cross-sectional area loss

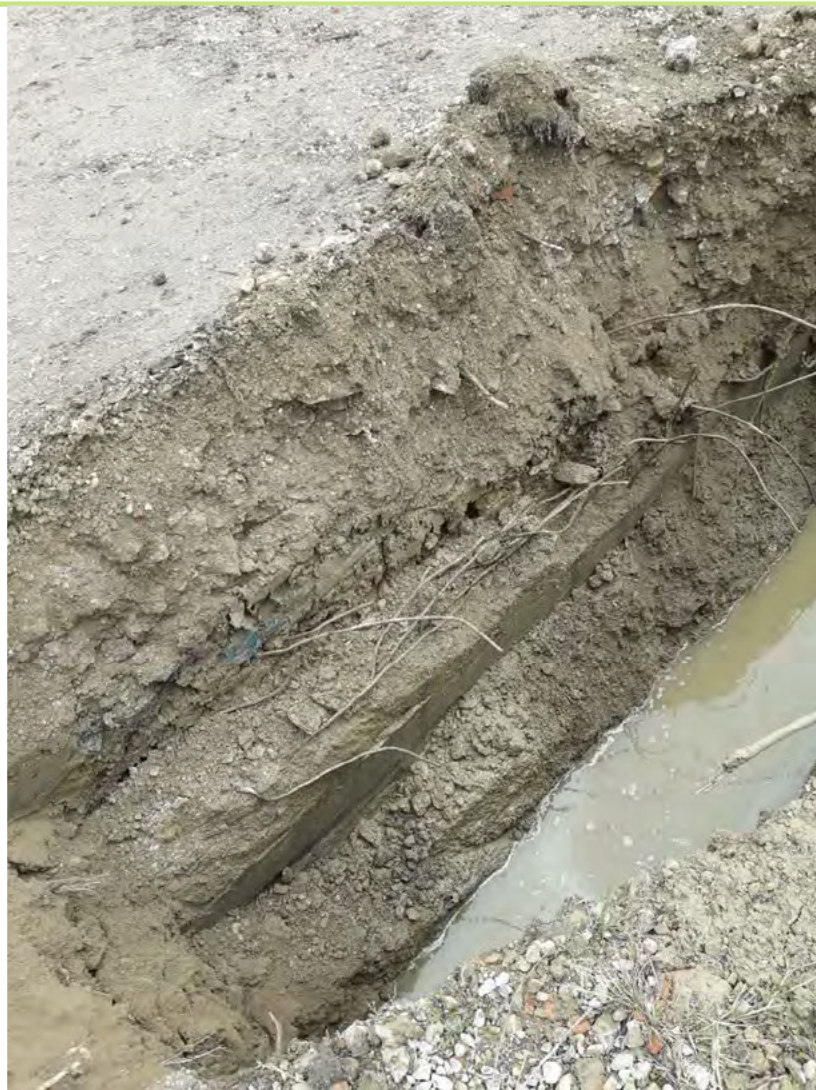
Plate 9: View showing the wall encountered within TT207.
