Steyping Grammar School  
Condition Survey of Eastern Boundary Ditch  
SRP1121-CTP-00-EX-T-C-8410  
DEIR Ref: n/a  
PM\_30\_10\_15  
May 2026  
B1641

Condition Survey of Eastern  
Boundary Ditch: Plan & Key  
to Image Locations

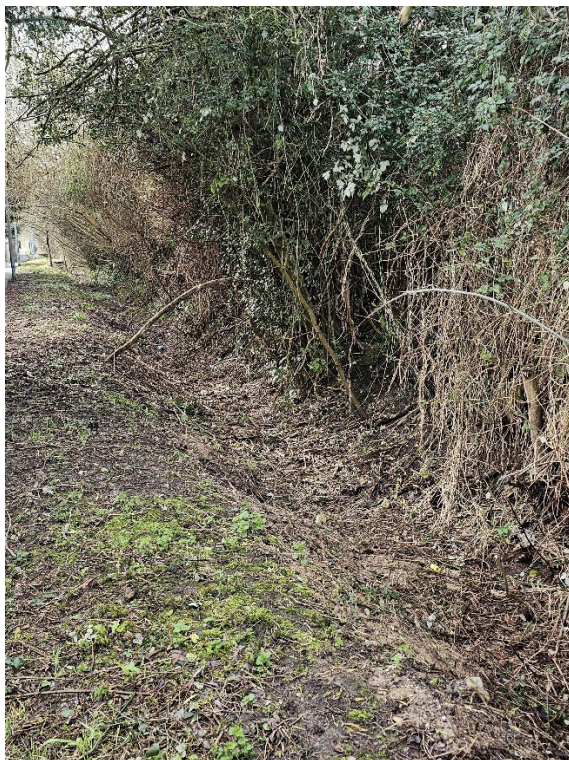
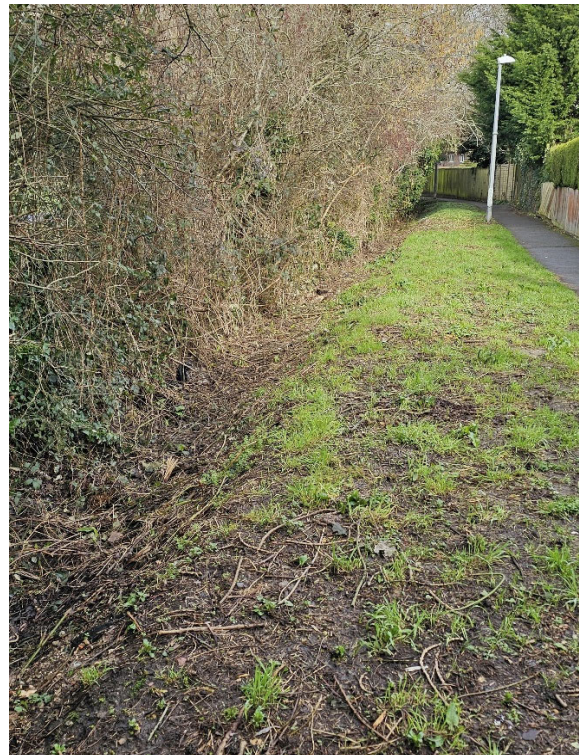
Views looking down (01) and up (02) the southern section of ditch

- 5.3 At the peak of the ditch there appear to be a rudimentary earth bund (Image 01), to which appears to have been added a pair of concrete pipes – possibly to try and alleviate water build up to the north. The pipes were partially blocked with organic matter.

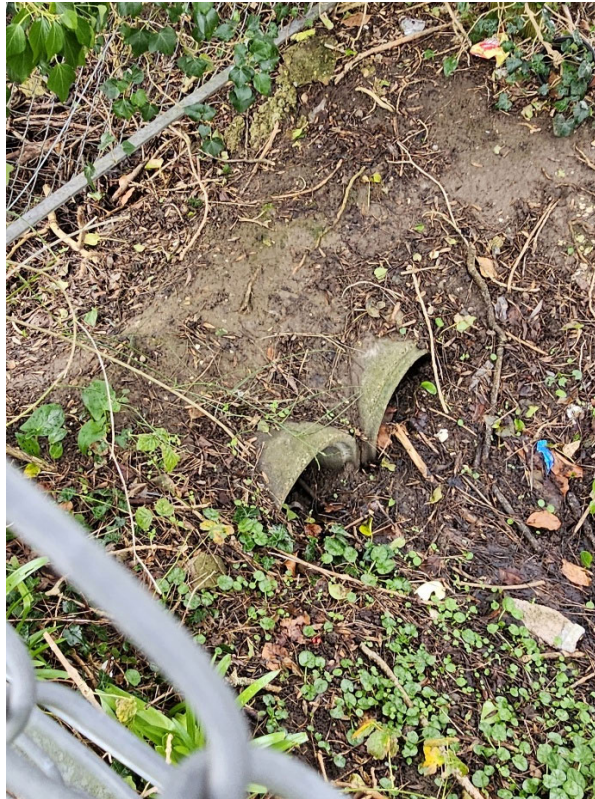
Image 03: Earth bund

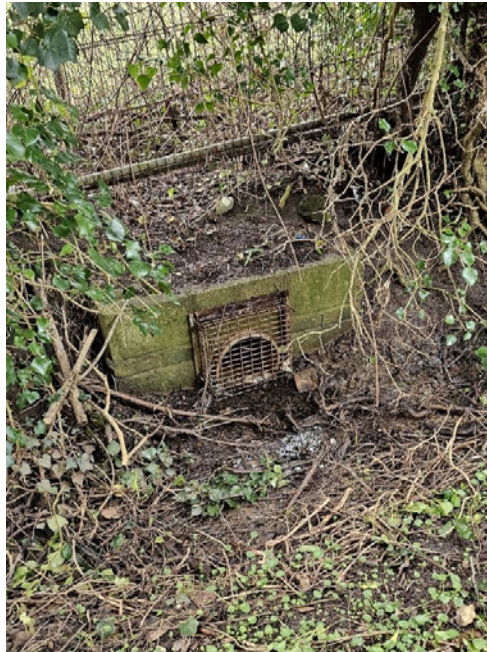
- 5.4 30m south of the peak, there is a 300mm clay pipe outfall set into a blockwork head wall, the outfall has a mesh cover. This outfall is believed to serve the historically culverted ditch, which runs the full width of the school site. This was one of few areas along this section where water was visible. The ditch at this location contains twigs, vegetation and a thick layer of decomposing organic matter.

Image 02: 300mm diameter surface water outfall

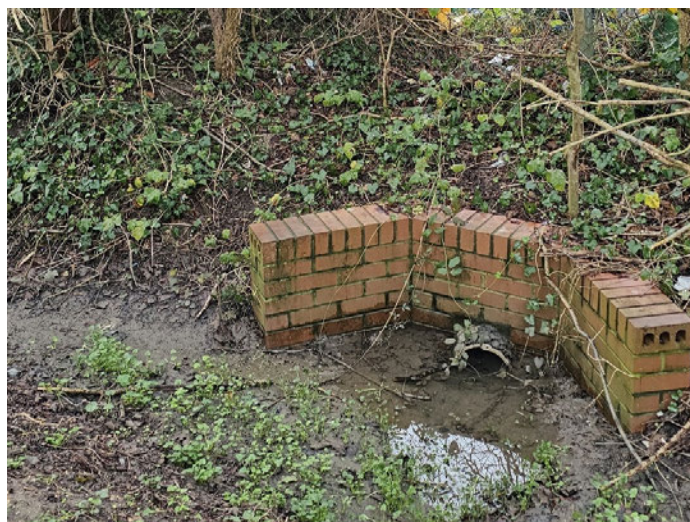
- 5.5 Adjacent to the northeastern tip of the primary school building is another surface water outfall (Image 05), assumed to serve the primary building. The outfall comprises a 225mm diameter plastic pipe set in a brickwork head wall, the pipe is partially submerged in water and silt.

Image 05: Brick headwall

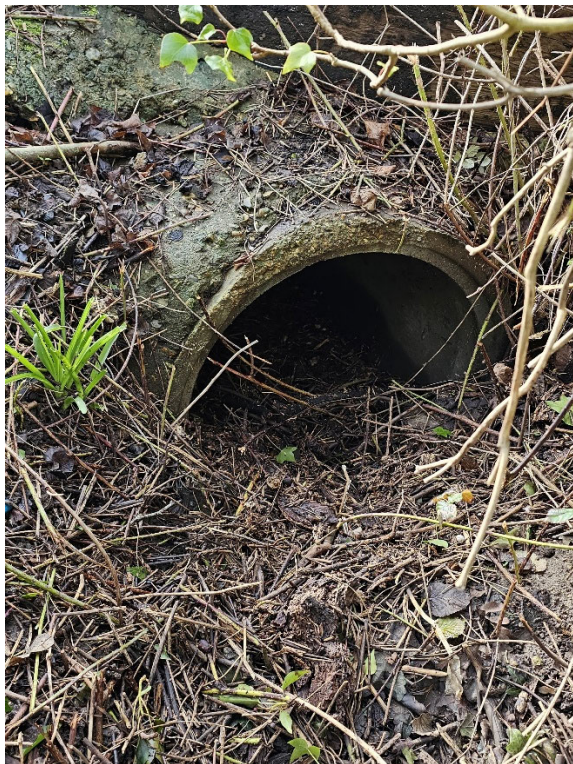
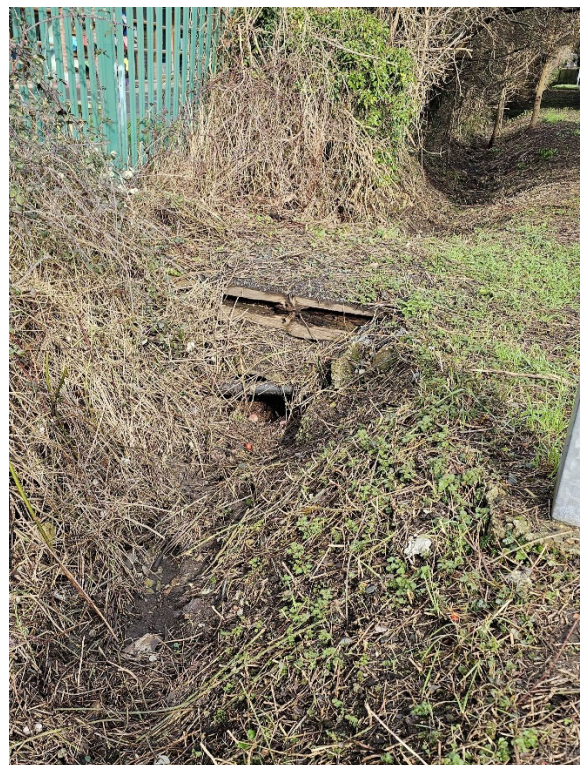
- 5.6 At the southernmost access into the primary school (located at about the centre of the primary school's eastern elevation) is a culverted bridge consisting of earth and timber over a 600mm diameter concrete pipe.
- 5.7 The pipe is partially blocked with earth and leaf litter and the 'bridge' appears to be in poor condition with rotting timbers and earth subsiding into the ditch. Directly adjacent to the northern bridge edge is an old, possibly iron, pipe spanning the ditch which has been broken and crudely repaired with a length of 100mm diameter plastic pipe.

Culvert below primary school access 'bridge'

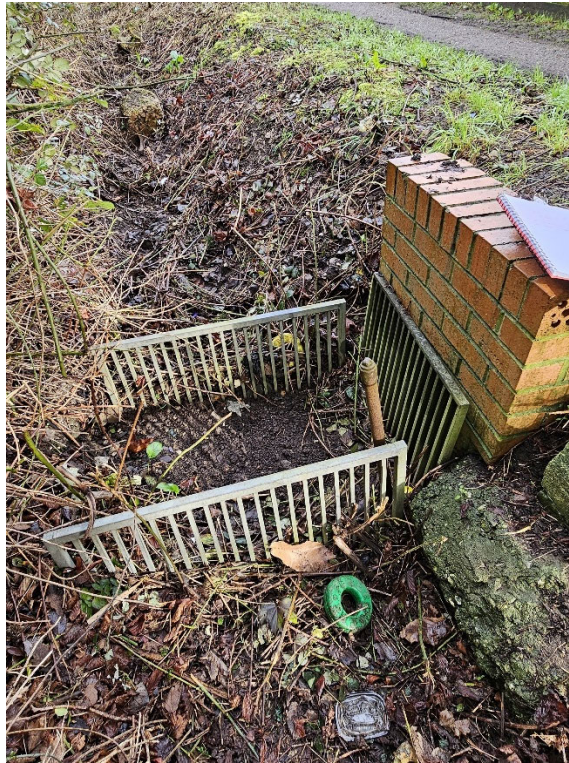
- 5.8 Another 30m south is an assumed surface water outfall from the rear of the houses on Shooting Field. The outfall has a series of metal grates protecting a 225mm diameter pipe, which is free of debris, built into a simple brick head wall. Litter is present along most of the length of the ditch along with sporadic large chunks of rubble up to the size of a football.

Image 08: Outfall from rear of houses on Shooting Field

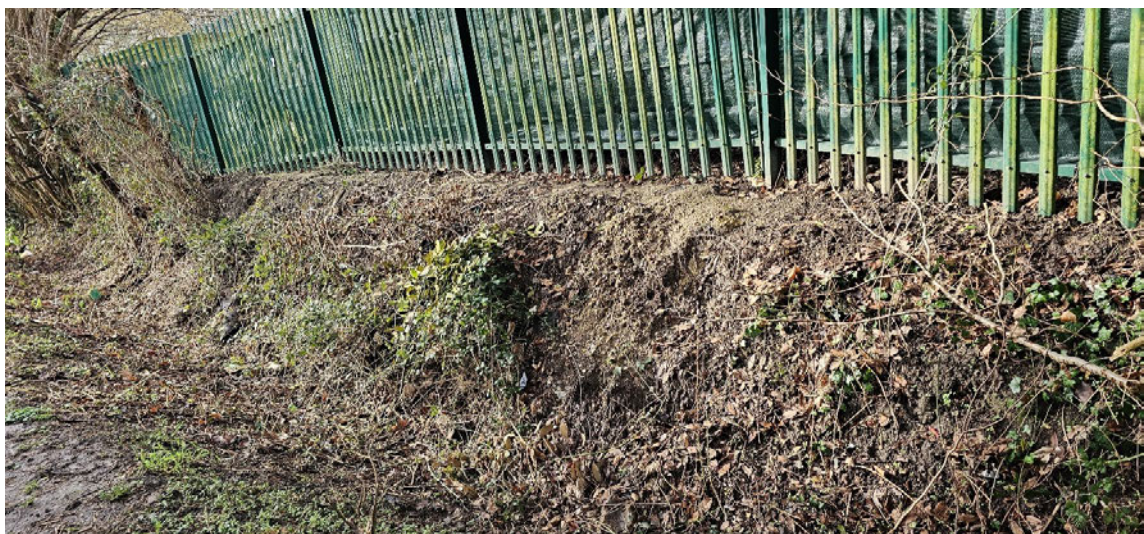
- 5.9 Just beyond the previous outfall is a section of embankment that appears to be made up of loose soil with no vegetation, which could be unstable.

Image 09: possible unstable embankment

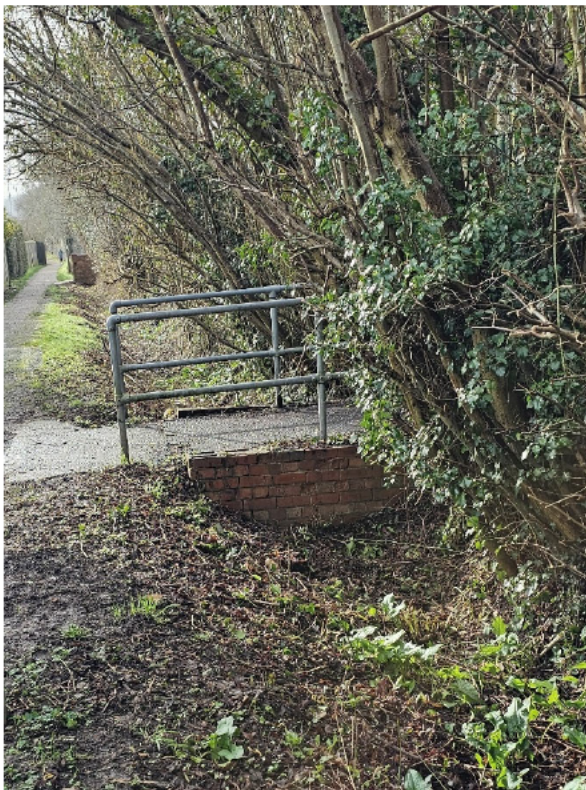
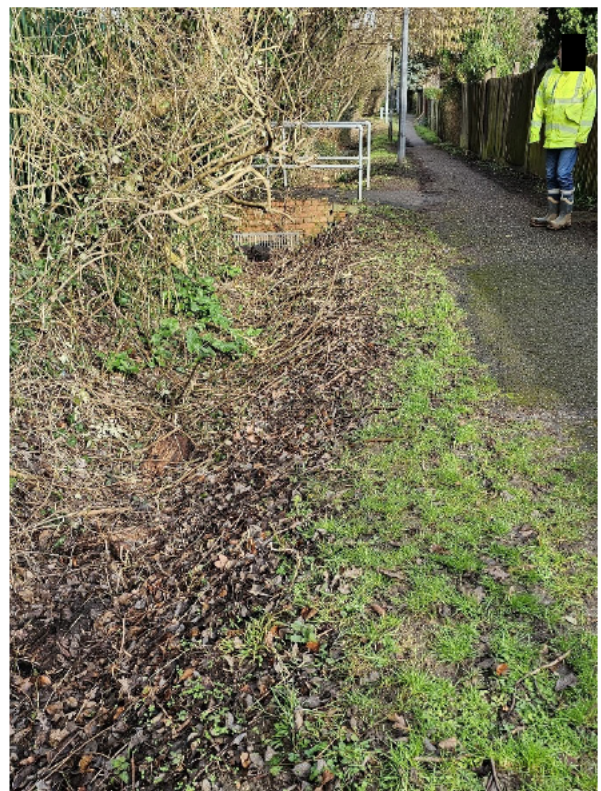
- 5.10 As we reach the southern end of the primary school site there are another two culverted access points, both constructed from brick with pipes built in.
- 5.11 The first, with the handrail, has a 450mm diameter concrete pipe and a grate covering the downstream end, and the second, southernmost bridge a 150mm diameter clay pipe – both appear to be completely blocked with organic matter.
- 5.12 As the ditch progresses further south, its profile gradually becomes less defined and there is less evidence of water.

Culverted primary school access 'bridge'

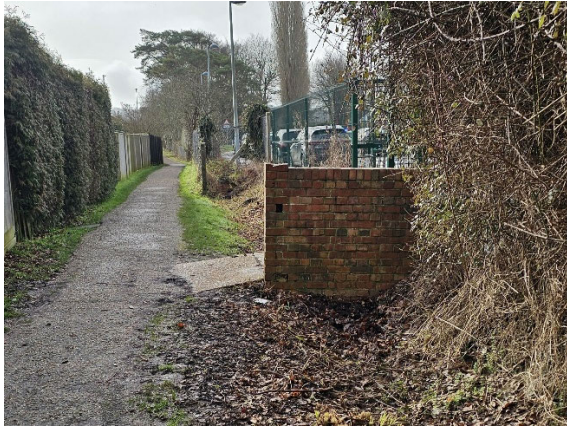
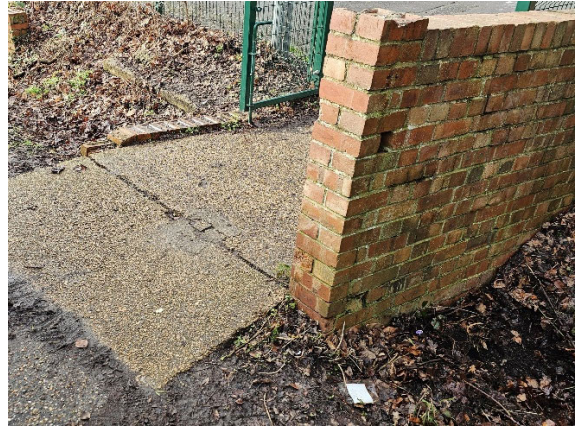
Southernmost culverted primary school access 'bridge'

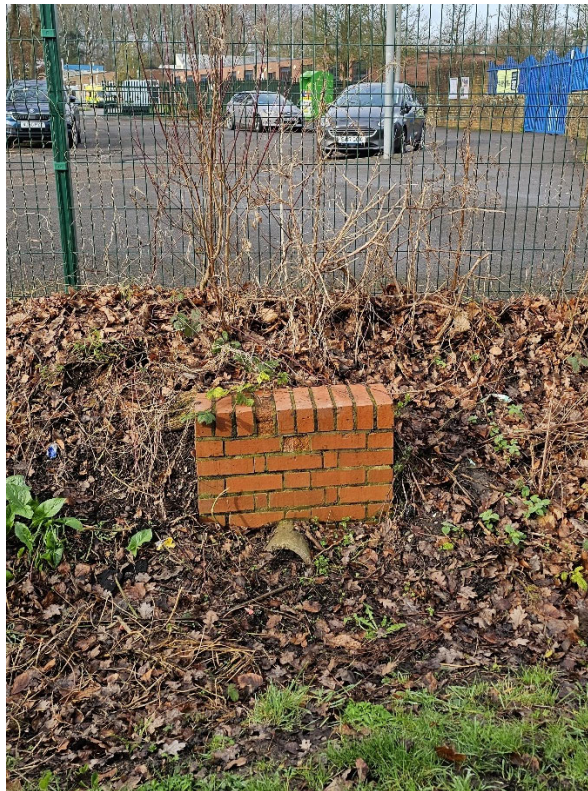
- 5.13 Adjacent to the primary school car park is the final exposed outfall, a 150mm diameter clay pipe and small brick headwall. This outfall serves a small area of car parking.

Image 14: Minor outfall from Grammar school car park

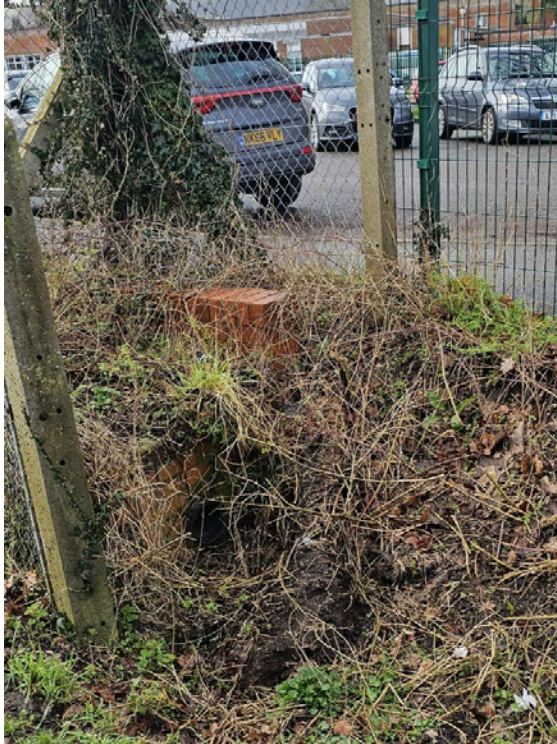
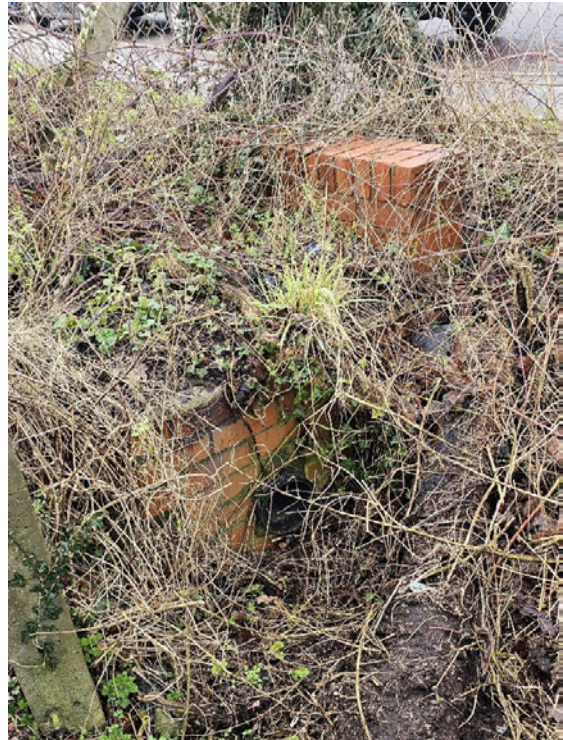
- 5.14 As the ditch becomes less defined at its lowest, southernmost point it meets a manhole projecting up from the base of the ditch. This manhole contains the outfall for the surface water drainage which runs from a catchpit situated on the eastern side of Horsham Road and picks up the Sports Centre surface water along with various other areas across the main built-up school site. The manhole also marks the start of the culverted continuation of the ditch, heading in a southerly direction via a 450mm diameter pipe.

Culverted primary school access 'bridge'

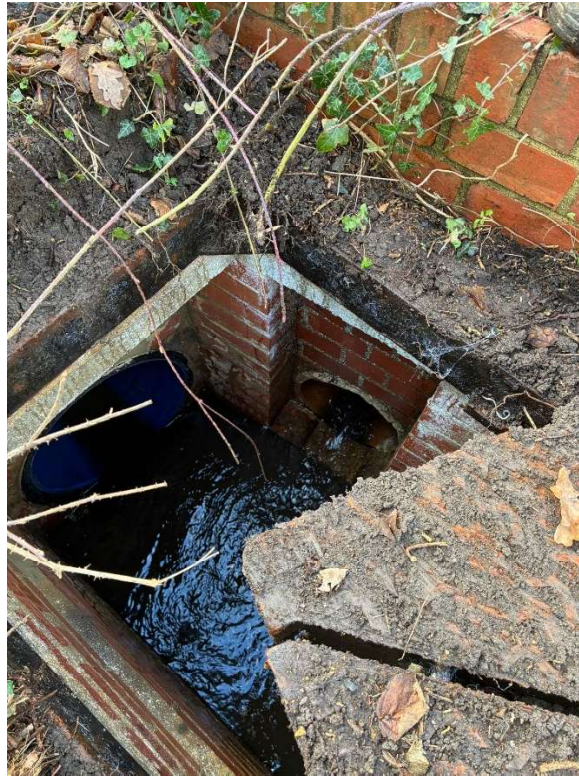
- 5.15 The 450mm diameter pipe is believed to enter the public surface water network at some point however, this remains unconfirmed and is not denoted on the Southern water network mapping. The brick wall of this manhole, projecting up from the base of the ditch has a single 150mm diameter pipe acting as an inlet for water from the ditch.

Image 17: 300mm diameter outfall  
from Sports Centre / School  
with 450mm diameter onward pipe

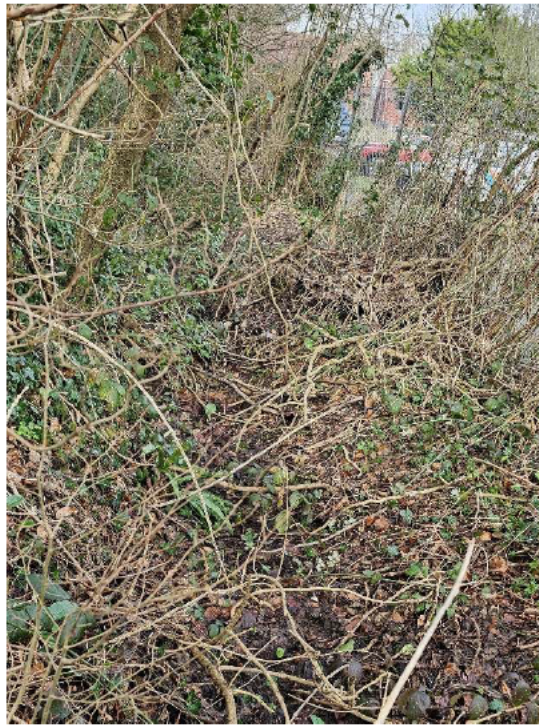
- 6.1 The northern ditch is deemed to start at the same point as the southern ditch (the earth bund, Image 01) but falls in a northerly direction towards the A283 Steyping bypass. Beyond the bund, the first 40m section of ditch is typically obscured by vegetation, twigs and organic matter. The profile is also poorly defined, but this may be a result of the obstructions

Image 18: Looking north from start of northern ditch

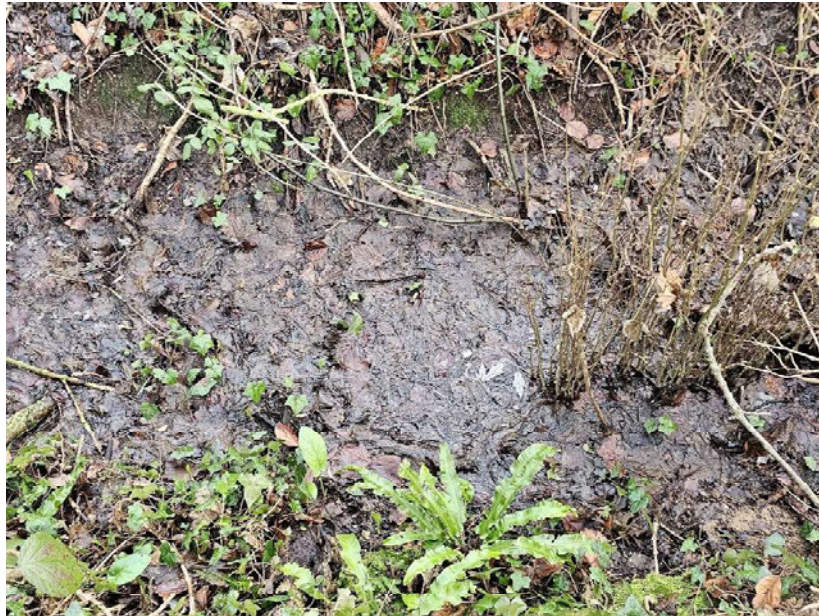
- 6.2 In localised patches where the vegetation thins out there are visible signs of water in the base of the ditch.

Image 19: water in the base of the ditch

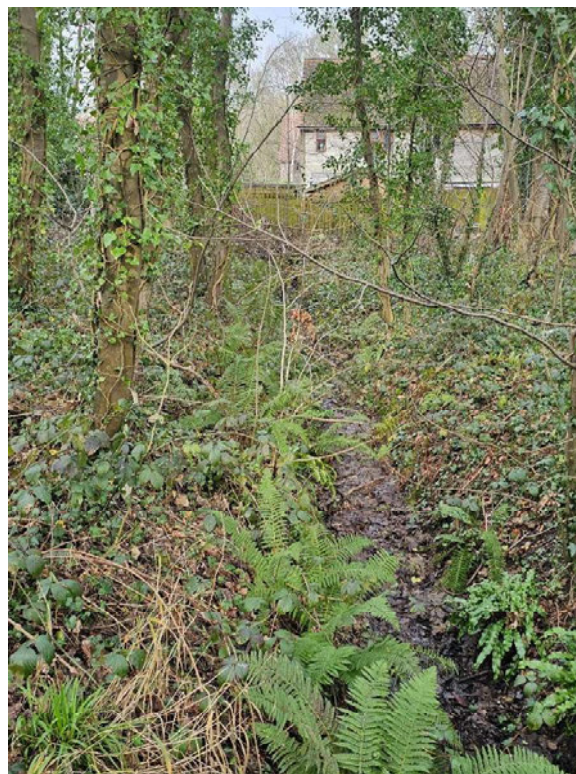
- 6.3 Around 30m from the rear of the properties on Reads Walk the ditch becomes more defined with evidence of water and vegetation linked to damp environments

Image 20: The ditch becoming more clearly defined

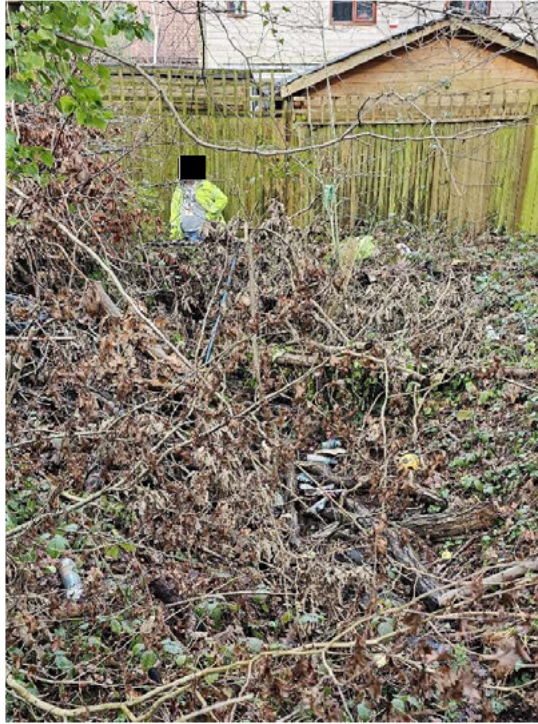
6.3 Moving further north the ditch becomes obstructed by garden waste and litter just beyond the boundary of the housing on Reads Walk. Predominately consisting of tree branches and garden waste there are also plastic children's toys, motorcycle tyres and various aerosol cans in this pile.

Image 21: Garden waste and litter to the rear of a property on Reads Walk

- 7.1 The northern section of the ditch from the proposed outfall, several meters north of the existing 300mm diameter surface water outfall, down to the watercourse adjacent the A283 will become a fundamental element of the Steyning Grammar School surface water drainage strategy. We would therefore recommend that the base of the ditch is cleared of obstructions from the proposed headwall location down to the junction with the watercourse into which it feeds. The upper section of the ditch must be cleared of vegetation, and soft organic matter, clearly defining the ditch all the way to the culvert below Reads Walk. It is possible that the makeshift scaffold structure could remain, however the ditch below must be both cleared and maintained.

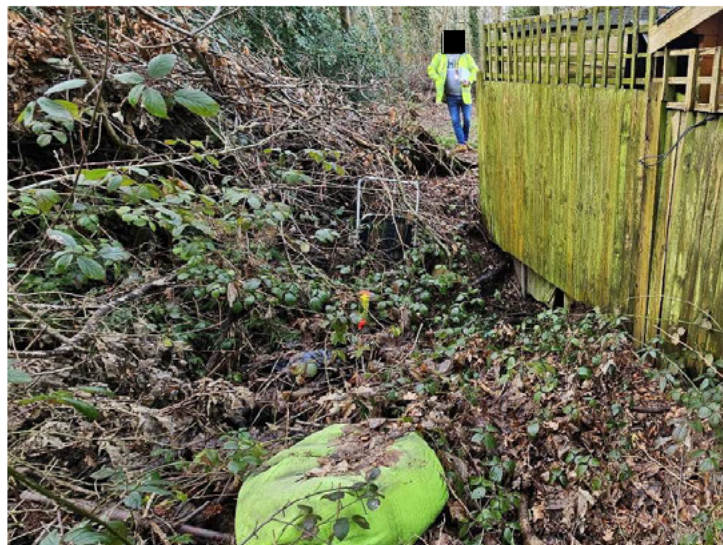
6.4 It appears that one of the properties on reads Walk has constructed a makeshift platform over the ditch using scaffold tubes and timber boards, the ditch also appears to be partially blocked with earth.

Image 22: Fence panel spanning the ditch to the rear of property on Reads Walk

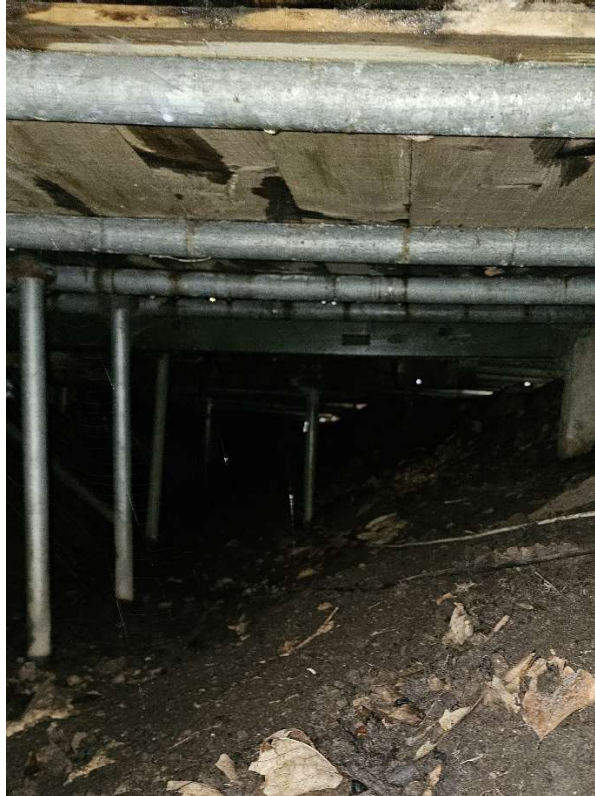
Image 23: Makeshift platform over the ditch,  
to the back garden of property on Reads Walk.  
The culvert below Reads Walk is beyond.

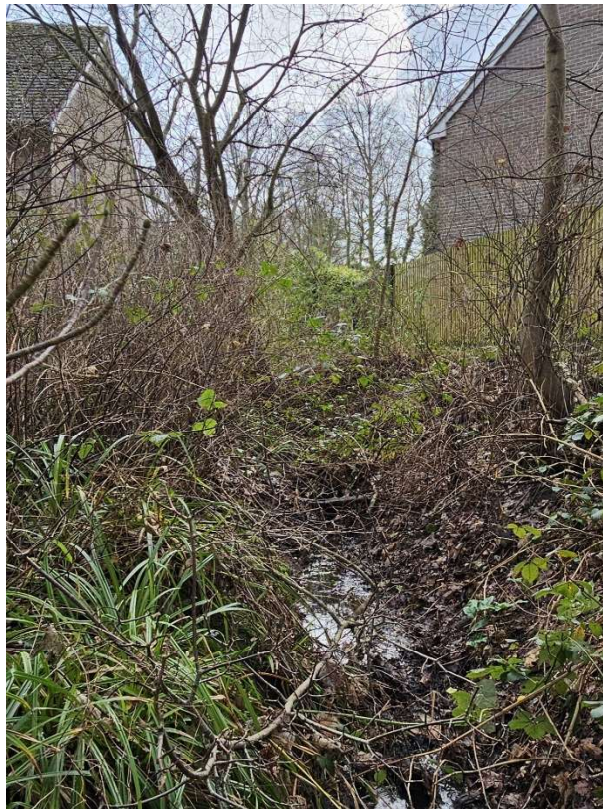
To the south of the culvert, it appears to mainly be overgrown vegetation making access to the culvert difficult, however based on the amount of water present it can be assumed that the upstream ditch and culvert are functioning to a certain extent. With some clearance to this southern side, further inspection could be made to confirm.

Image 24: Ditch to the south of Reads Walk, looking south. Too overgrown to approach the culvert below Reads Walk

- 7.1 To the south of the Read Walk culvert the vegetation must be cleared to the section immediately downstream of the culvert, with an additional visit to ascertain the integrity of the culvert and ditch locally. Once the lower portion of the ditch has been cleared of larger obstruction little further intervention should be required.

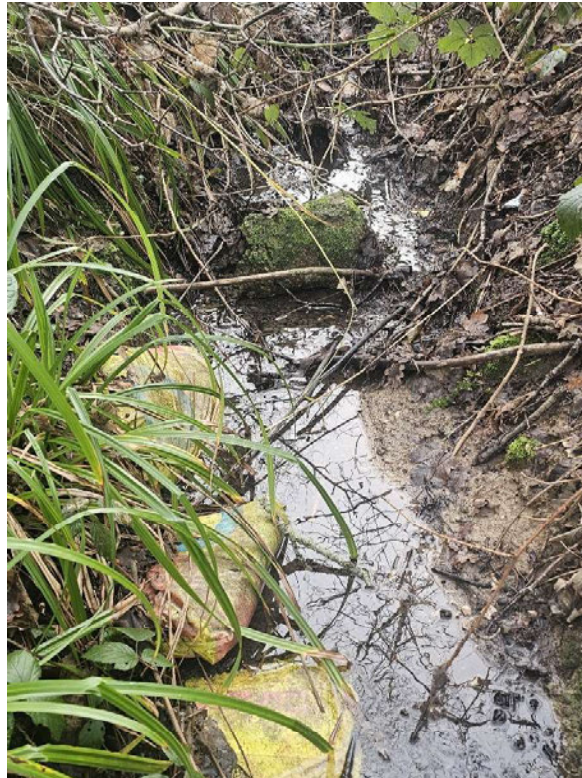
- 6.6 There are several minor obstructions to this area, from dumped bags of cement to logs and makeshift log bridges, all of which could be easily cleared. It is worth noting that the fall of the land to either side of the ditch does fall towards the ditch quite steeply and that obstructions in this area would be unlikely to cause wider issues – water would typically build up until it flowed around the obstruction without affecting the wider area in any meaningful way.

Image 25: Bags of cement dumped in the ditch  
to the rear of properties on Reads Walk

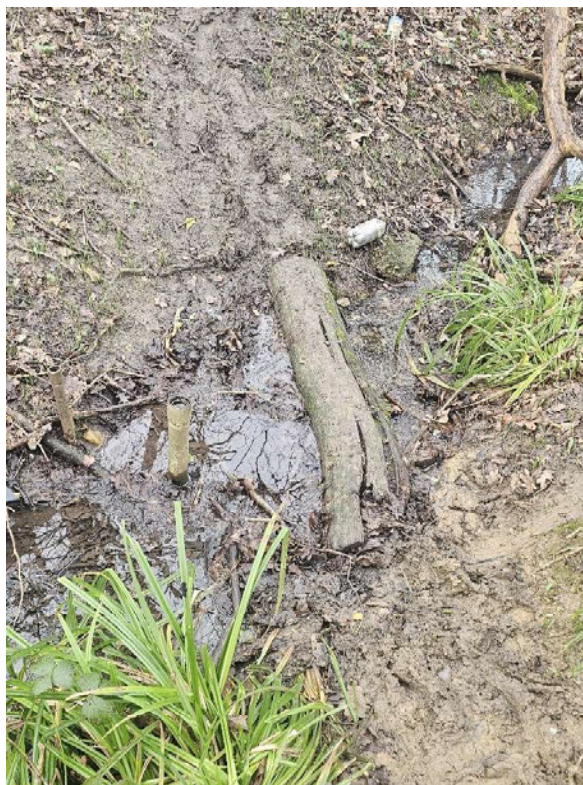
Image 26: log 'bridge' and evidence of possible makeshift dam

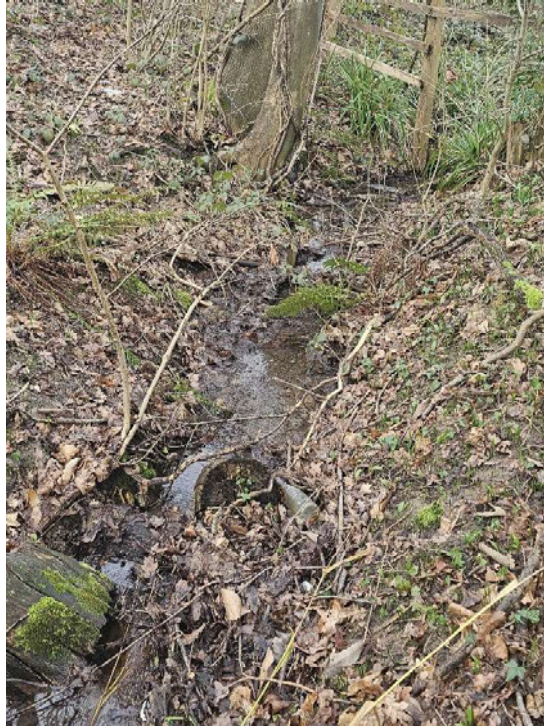
Image 27: Looking north, logs blocking ditch before it intersects the ditch running West / East Adjacent the A283

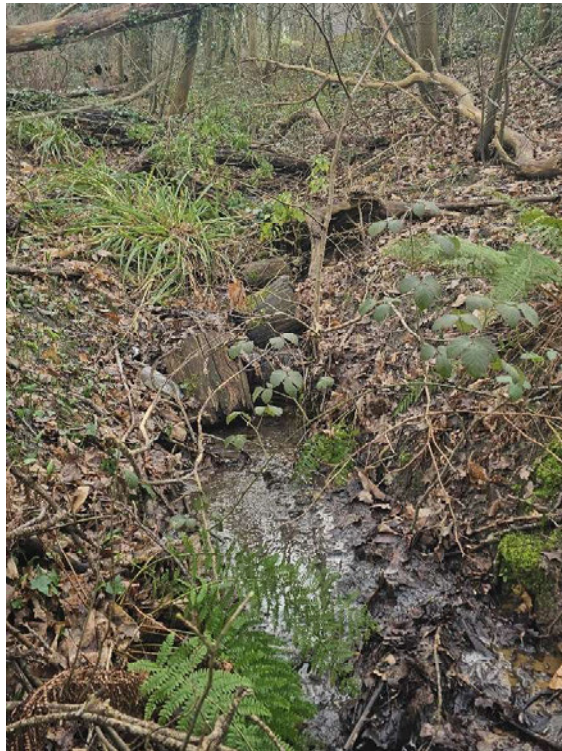
Image 28: Looking south, back up the ditch  
Logs blocking ditch before it intersects the ditch  
running West / East Adjacent the A283

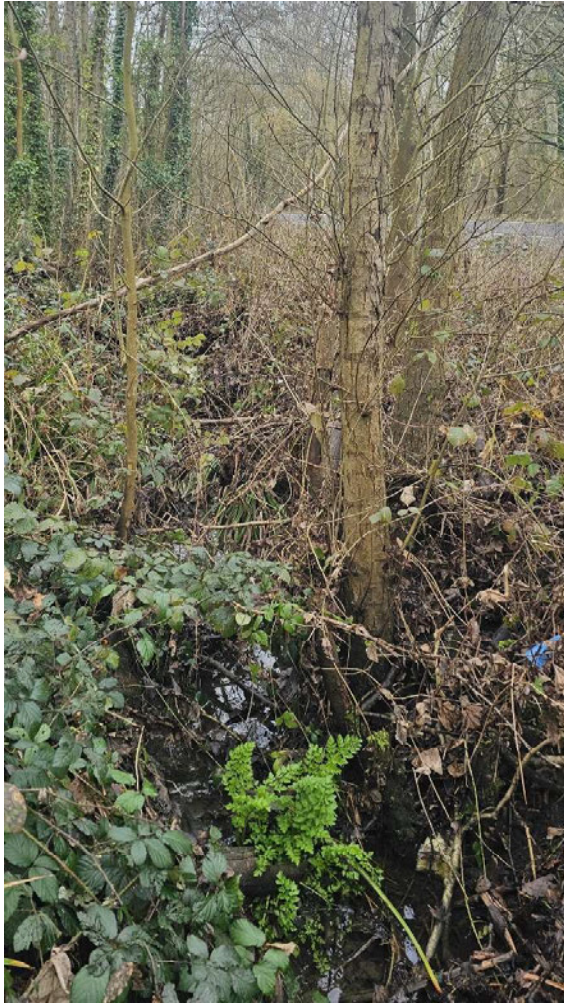
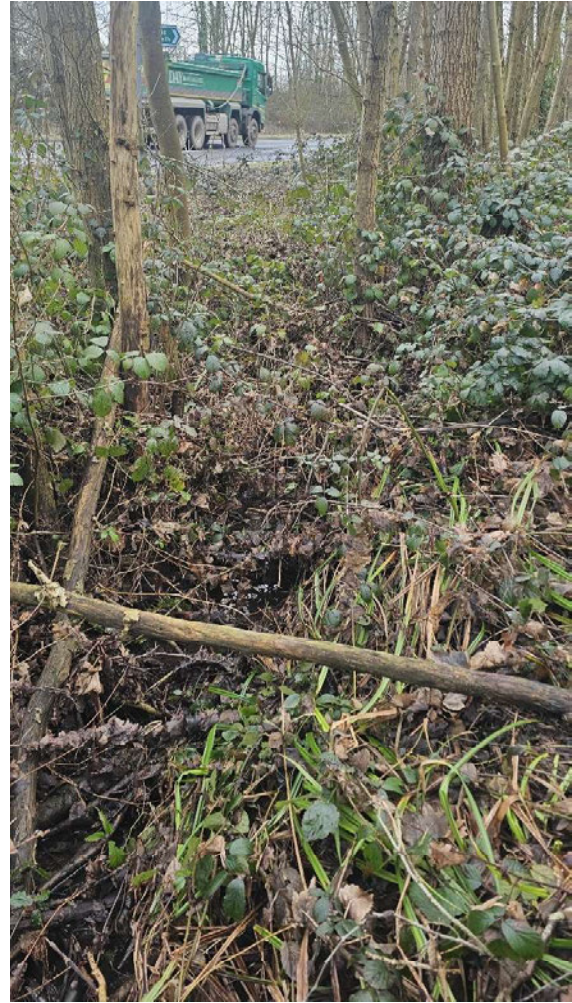
- 6.7 Approximately 90m north of the Reads Walk culvert, just beyond the boundary fence, the ditch reaches the water course running adjacent the A283 Steyning Bypass. This watercourse, whilst appearing somewhat overgrown appears to be functioning correctly and flows from west to east, with water visibly moving in that direction in a few locations.

Looking west (29) and east (30) along the watercourse adjacent the A283
