## Verification Report

Former Sony Facility  
Southwater  
Horsham  
RH13 9YT

June 2026

000440032.0002.0001

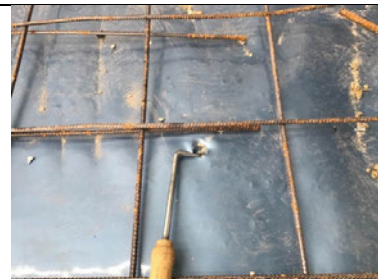
Damage found in the membrane at the time of our inspection.

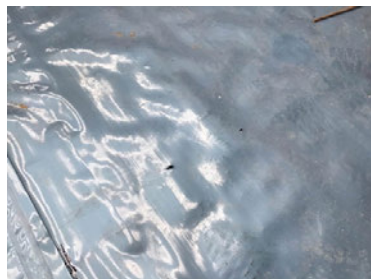
Damage found in the membrane at the time of our inspection.

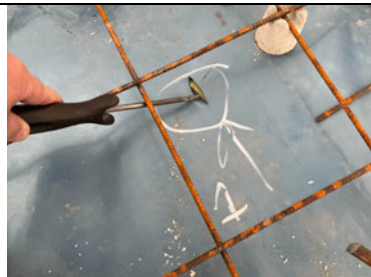
1. Recorded defect.

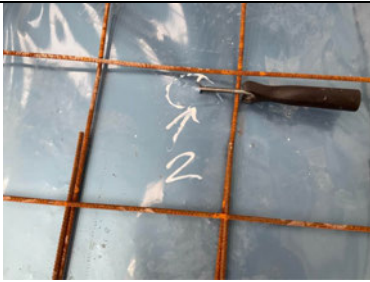
2. Recorded defect.

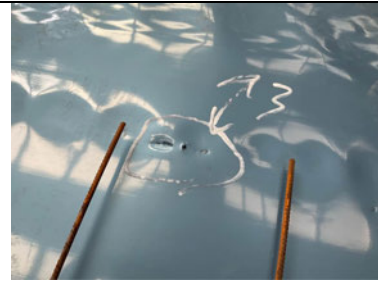
3. Recorded defect.

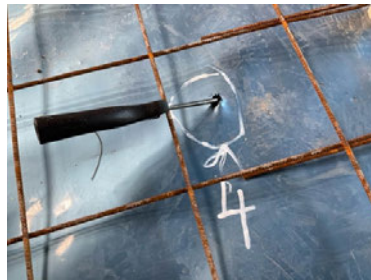
4. Recorded defect.

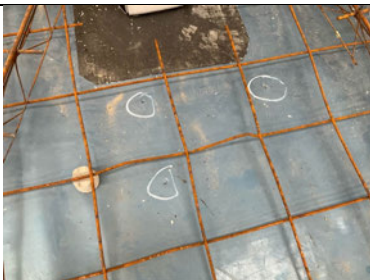
Recorded defects.

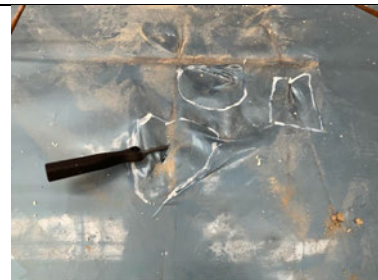
Recorded defects.

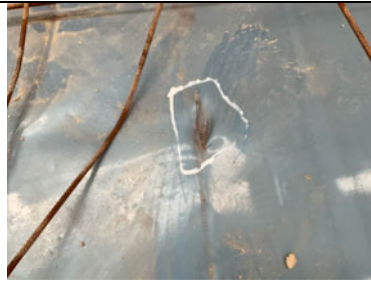
Recorded defect.

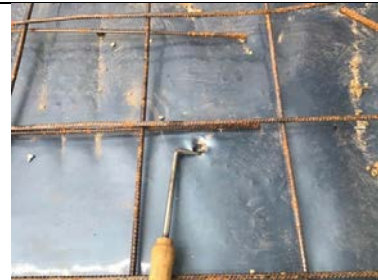
Damage found in the membrane at the time of our inspection.

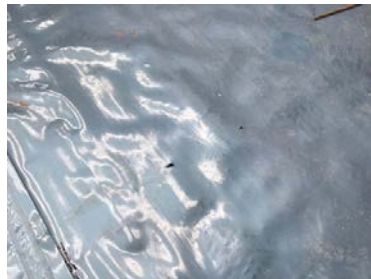
Damage found in the membrane at the time of our inspection.

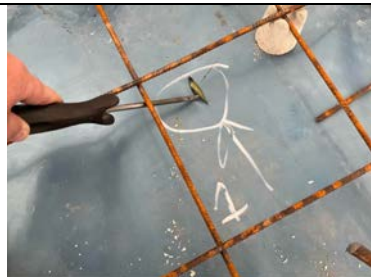
1. Recorded defect.

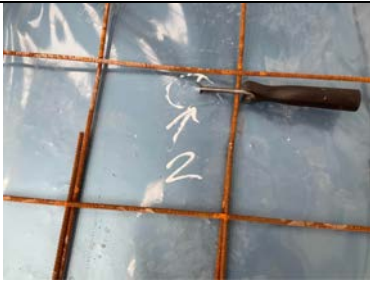
2. Recorded defect.

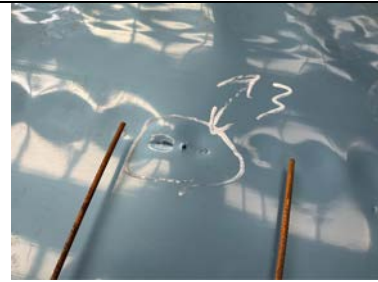
3. Recorded defect.

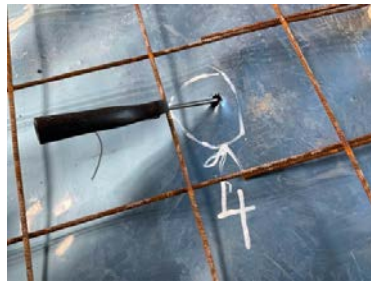
4. Recorded defect.

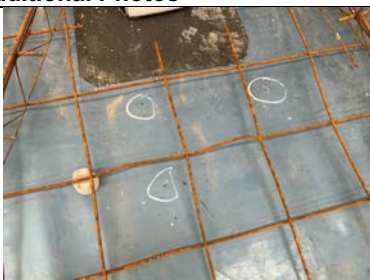
Recorded defects.

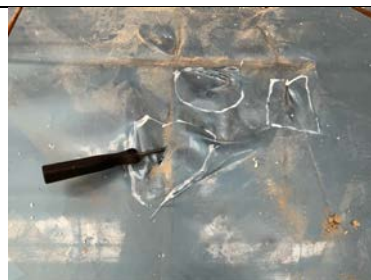
Recorded defects.

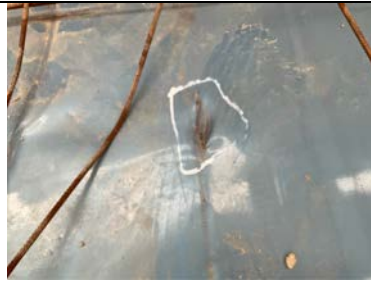
Recorded defect.
