## Refurbishment Survey (with MA + PA)

The Copes Worthing Road Southwater Horsham  
RH13 9AT

| Type of survey: | Refurbishment Survey (with MA + PA) | | |
| Date of survey: | 14 Oct 2025 | | |

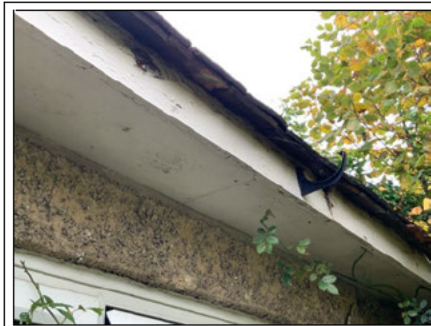
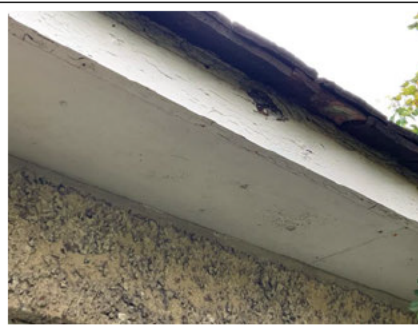
| Building | Floor | Location /Room | S,P,SP,AS<br>Sample No | Product Type | Condition | Surface Treatment | Asbestos Type | Quantity | Accessibility | Material Score | Priority Score | Total PA risk assessment score | Recommendation |
|---|---|---|---|---|---|---|---|---|---|---|---|---|---|
| Main | External | Soffits E04, Insulation board Soffits | S<br>CN002345 | Asbestos Cement | Low Damage | Surface Sealed | Chrysotile | 60lm | Usually inaccessible or unlikely to be disturbed | 4 | 1 | 5 | A - Urgent Removal |

| CN002345 (S) | Asbestos Cement (1) | Surface Sealed (1) | Low Damage (1) |

| Normal Occupancy | Score | Likelihood of disturbance | Score | Exposure Potential | Score | Maintenance Activity | Score |
|---|---|---|---|---|---|---|---|
| Recommendation | A - Urgent Removal | | | | | | |
