**HILLYBARN FARM, HILLYBARN ROAD, THE MOUNT,  
IFIELD, CRAWLEY, WEST SUSSEX, RH11 0LH**

**Preliminary Contamination Risk Assessment**

**January 2023**

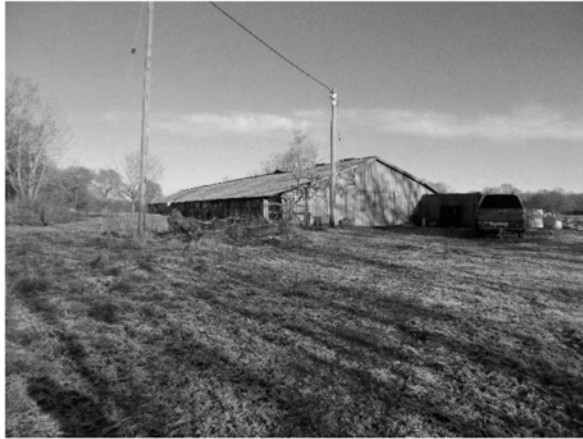
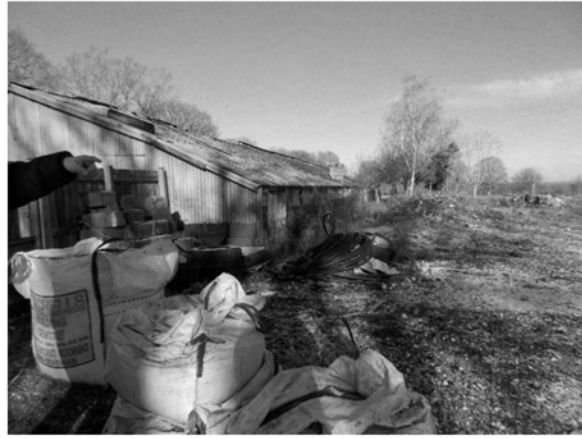
**Photographs 1 and 2:** Access up to the southern façade of the shed and building materials stored adjacent to the southeast corner of the shed.

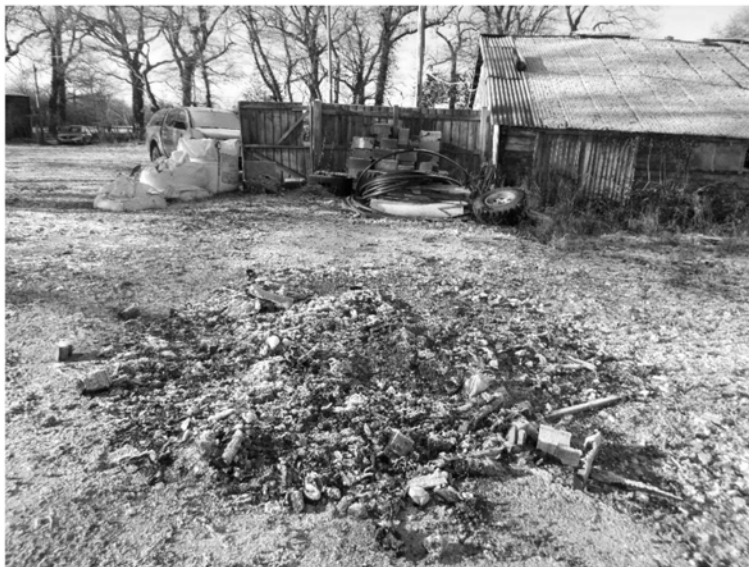
**Photograph 3:**

Bonfire residue adjacent to the southeast corner of the shed.

- 10.2 All waste and bonfire residue should be removed as part of the site's pre-development clearance, together with any affected underlying soil. The waste removal documents should be retained as evidence of this work.

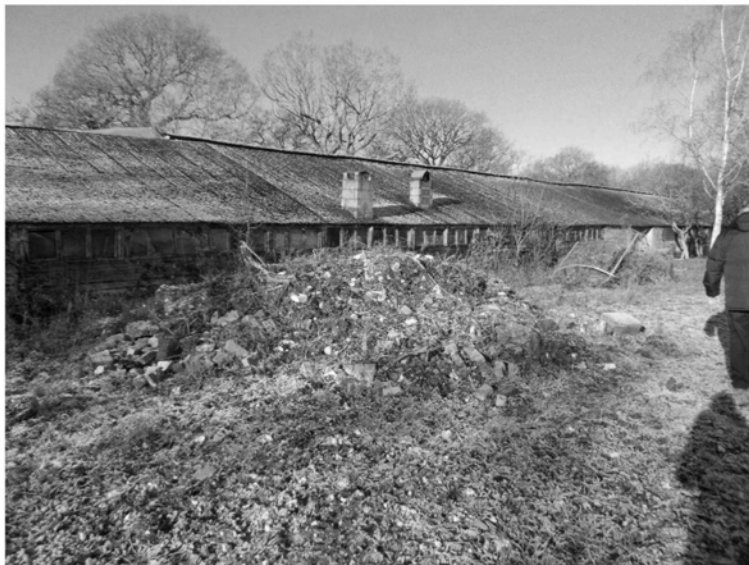
**Photograph 4:**

Mixed building rubble with some surface vegetation located adjacent to the southern end of the western façade of the shed.

Two chimneys located towards the centre of the shed on the eastern side of the building.

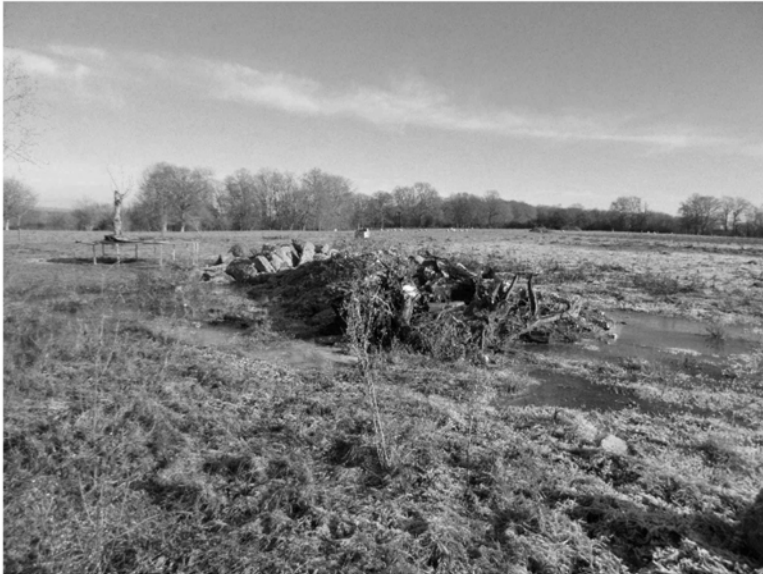
**Photograph 5:** Pile of brash (cut / felled wood), mixed soil and building rubble, large section of concrete slab / rubble.

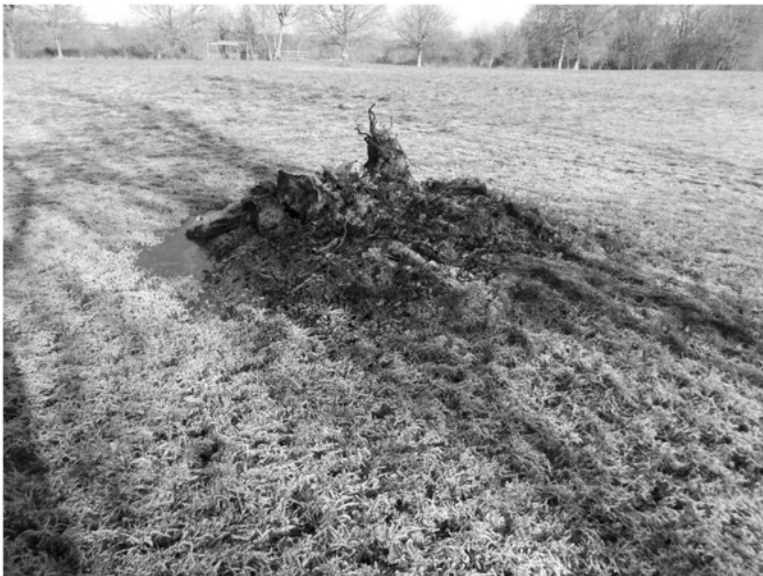
**Photograph 6:**

Bonfire residue with remaining wood waste located adjacent to the northeast corner of the shed.

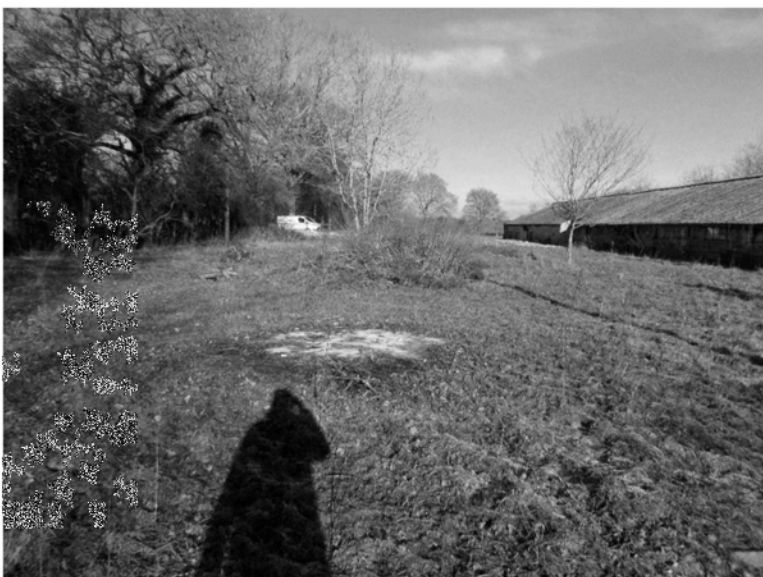
**Photograph 7:**

Bonfire residue and brash pile located to the west of the shed.

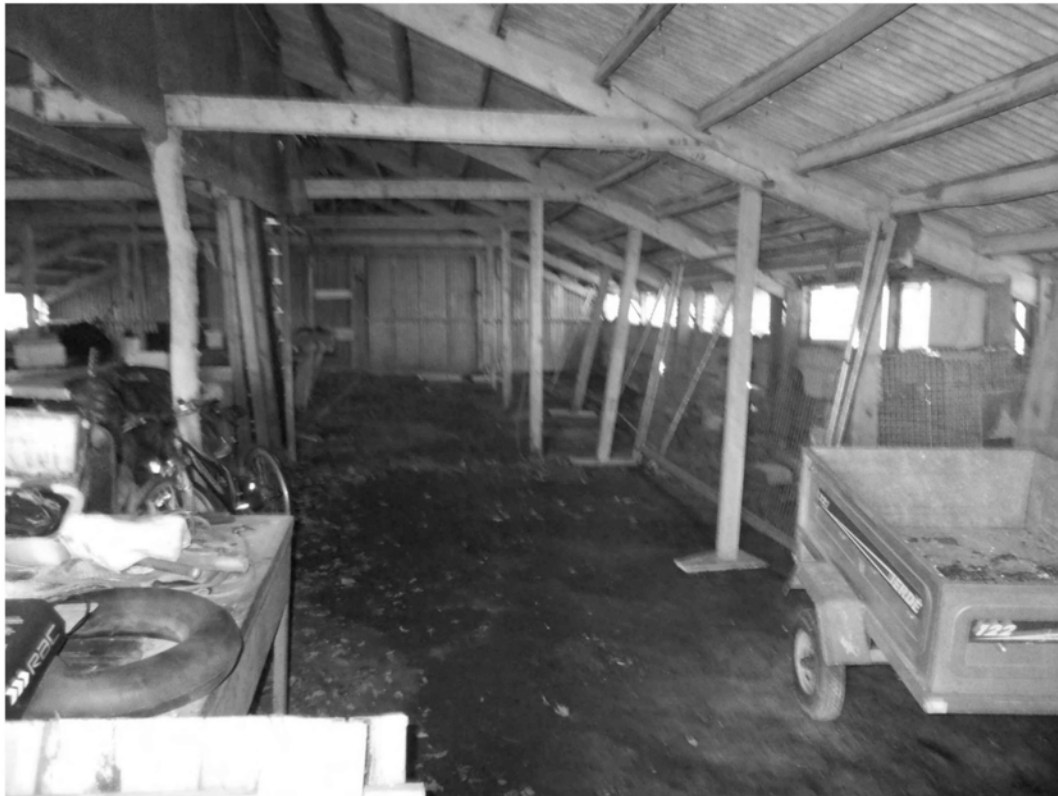
**Photograph 8:** Northern section of the shed with compressed dirt floor.

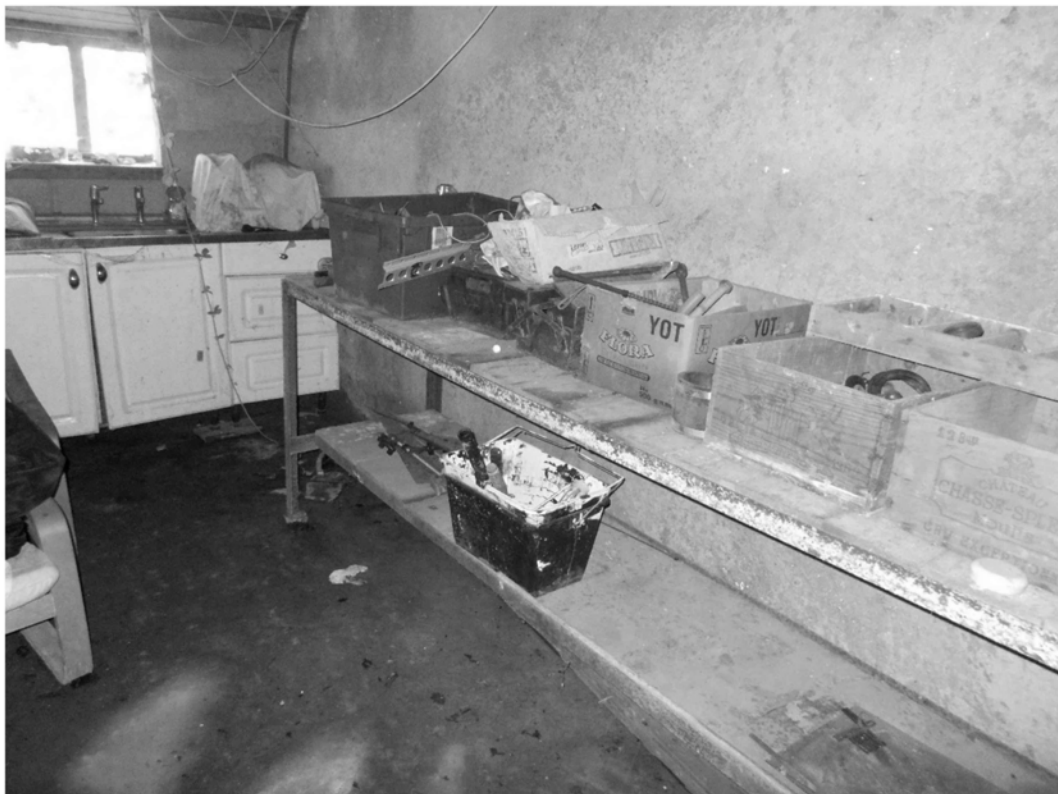
- 7.7 There may be some fill beneath the concrete flooring within the southern section of the building. Fill can be a potential source of contamination depending on the origin of the material used.

**Photograph 9:** Southern section of the shed with concrete flooring.
