The requested works are as part of a site Health & Safety survey. Historically, the tree has been maintained at a smaller size by way of re-pollarding.

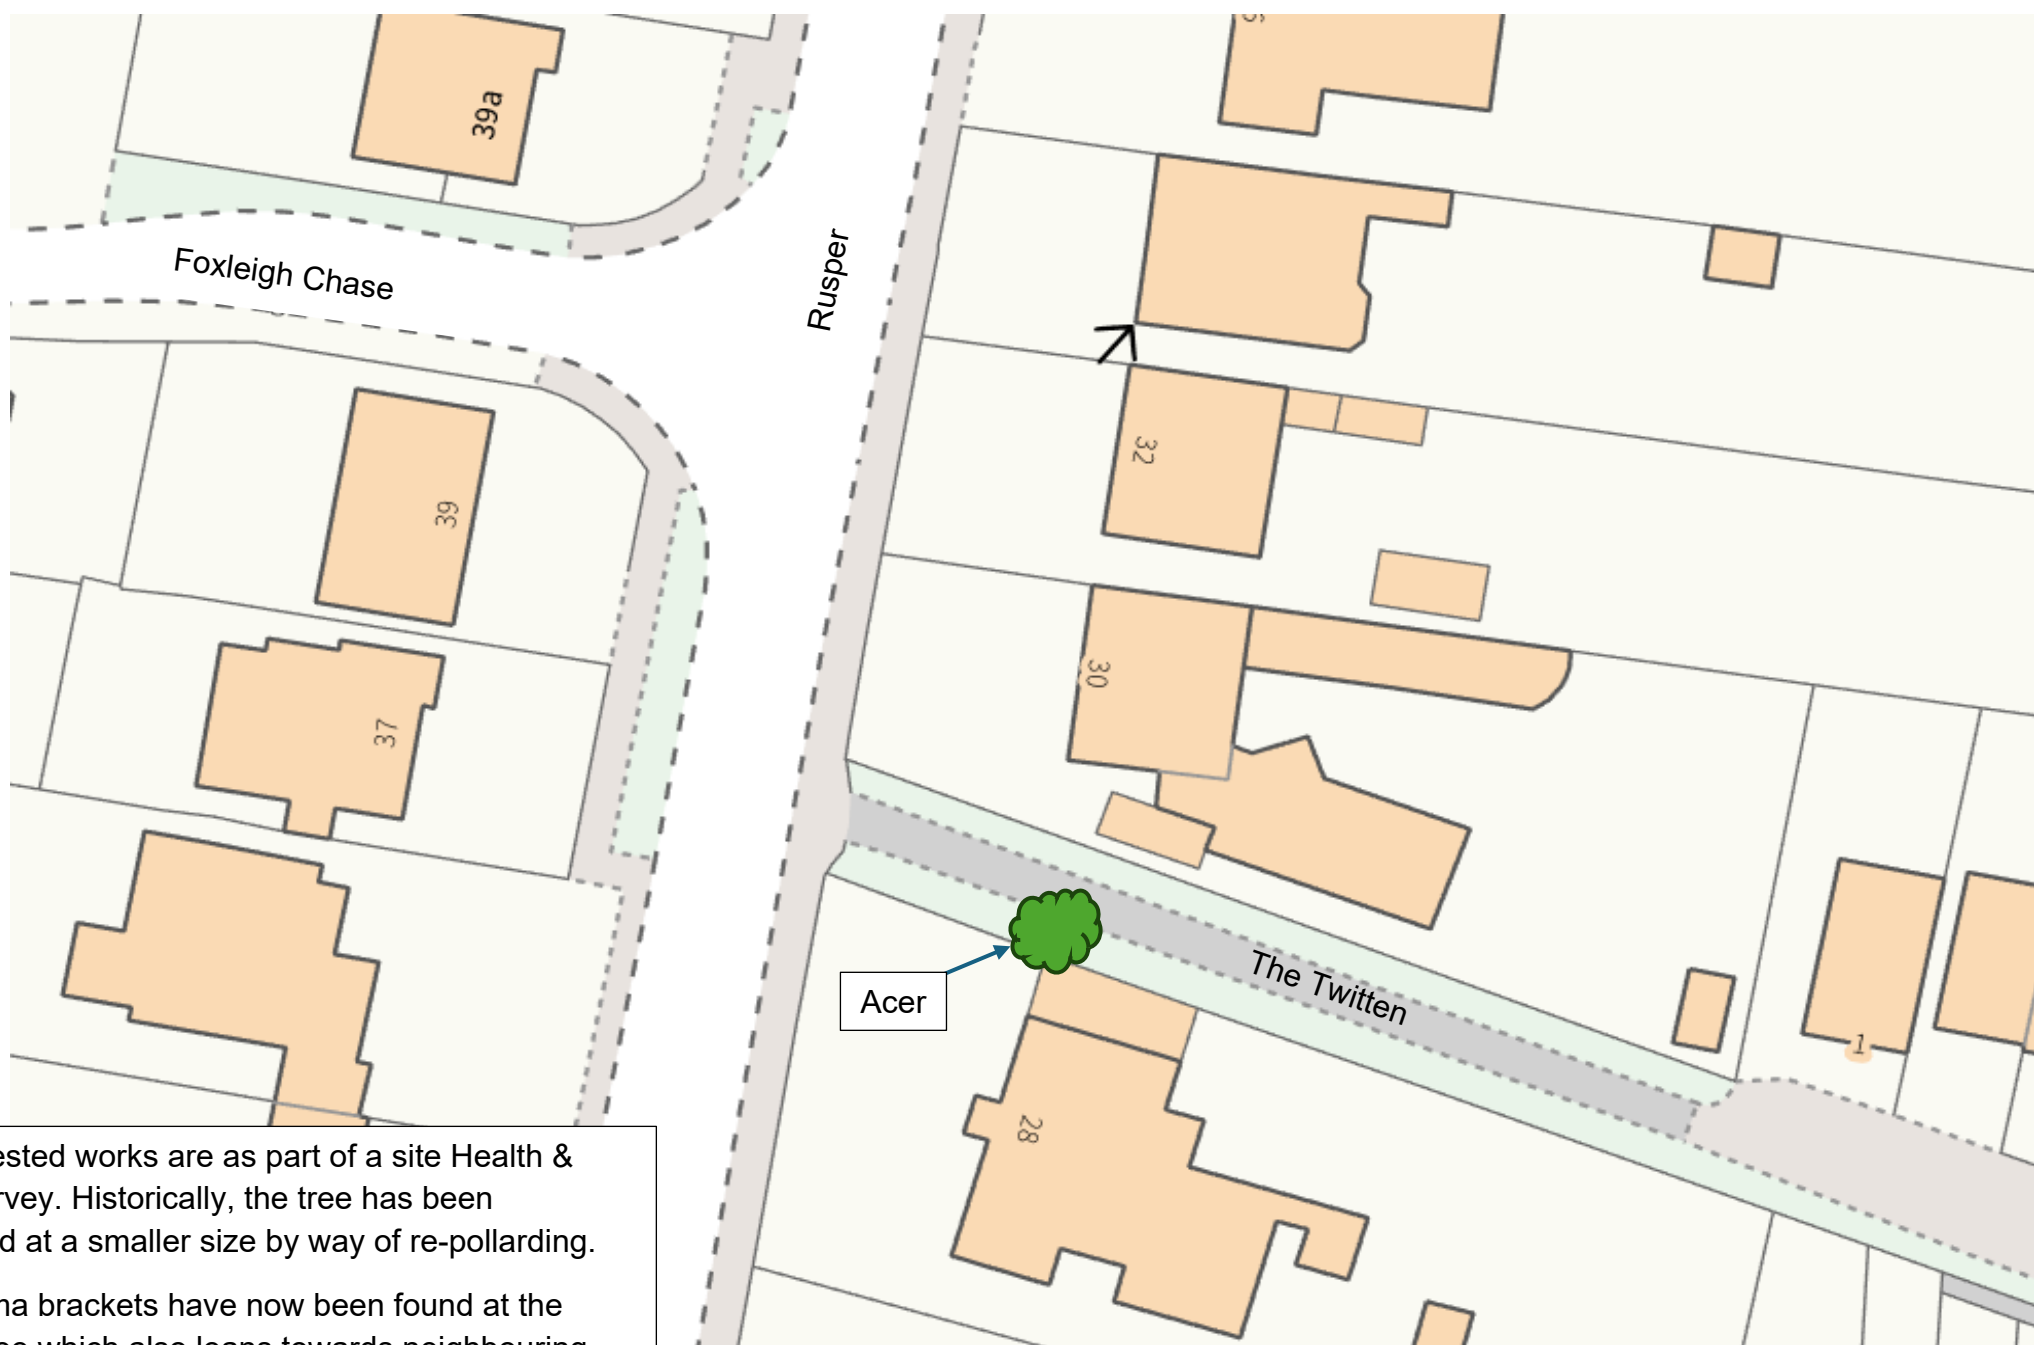
Ganoderma brackets have now been found at the base of tree which also leans towards neighbouring properties garage.

Survey found significant change in resonance in main stem when hit nylon tipped hammer.
