### DRAINAGE CCTV REPORT

# CCTV survey report

**Project Name** – Novartis site Horsham - CCTV Survey

**Project Number** – 60950

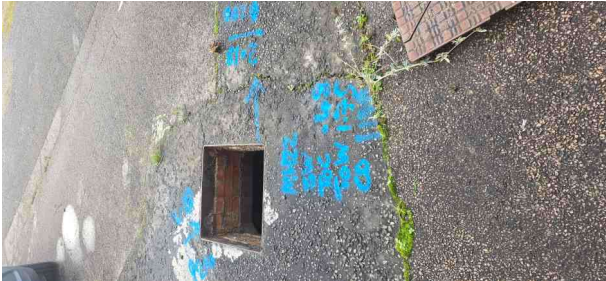
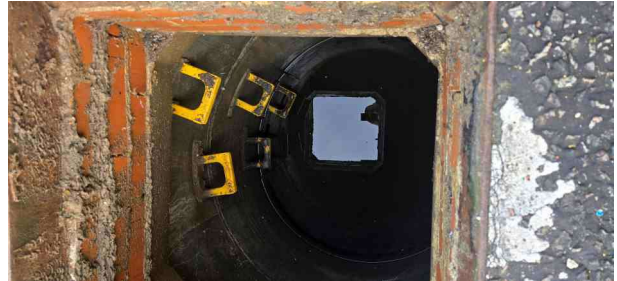
| Section | PLR | Description |
|---|---|---|
| 1 | MH22X | Survey abandoned |

MH22X\_85d67e76-ba9a-4451-bc9d-5637e654a12e\_20241125\_100811.jpg, 00:00:03, 0.00 m  
 General remark, LINE HOLDING, MH24 REQUIRES EMPTYING

MH22X\_36af7140-474c-43e1-a1e5-436e68e3ebf7\_20241125\_100827.jpg, 00:00:03, 0.00 m  
 General remark, LINE HOLDING, MH24 REQUIRES EMPTYING

| <b>Recommendations:</b> | INTERCEPTOR REQUIRES EMPTYING TO CLEAN | | | | |

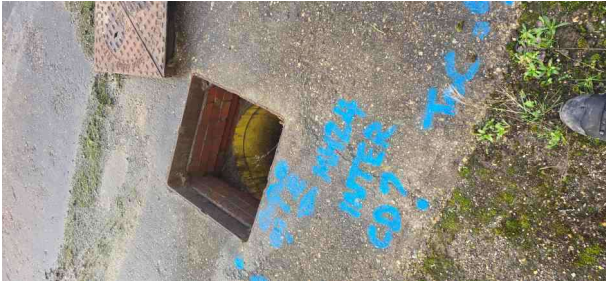
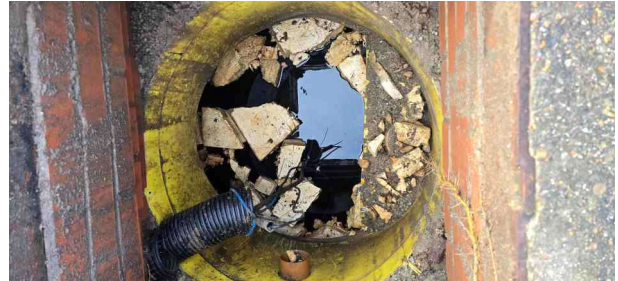
MH23X\_1657776c-ee6a-4a16-afa8-c539fb257ac9\_20241125\_100929.jpg, 00:00:03, 0.00 m  
 General remark, INTERCEPTOR REQUIRES EMPTYING TO SURVEY

MH23X\_b2a02f52-d2a0-40f8-8de7-244e290f80c2\_20241125\_100934.jpg, 00:00:03, 0.00 m  
 General remark, INTERCEPTOR REQUIRES EMPTYING TO SURVEY

| <b>Recommendations:</b> | REQUIRES SUCKING OUT TO EMPTY | | | | |

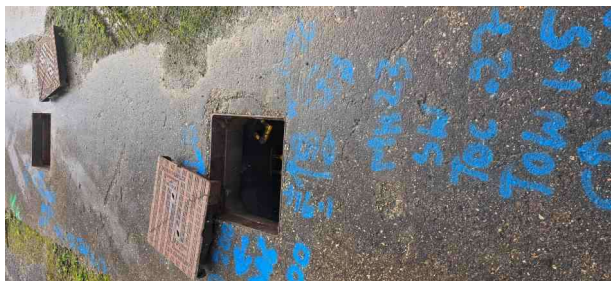
MH23X\_7e7af6c9-528c-478b-9e05-63c4d5869097\_20241125\_100835.jpg, 00:00:03, 0.00 m  
 General remark, INTERCEPTOR MH24 REQUIRES EMPTYING TO SURVEY

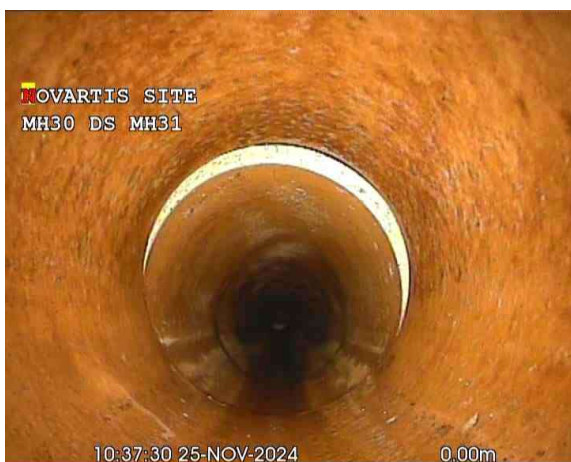
| Section | PLR | Grade | Description |
|---|---|---|---|
| 4 | MH30X | 4 | Joint displaced, large |

MH30X\_be1fa4e2-0bad-4938-8c7d-66491d64b79e\_20241125\_104944\_019.jpg, 00:00:10, 0.28 m  
 Joint displaced, large

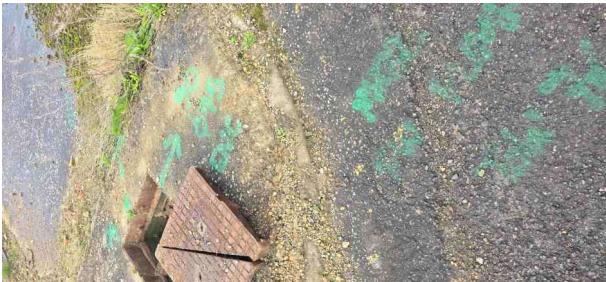
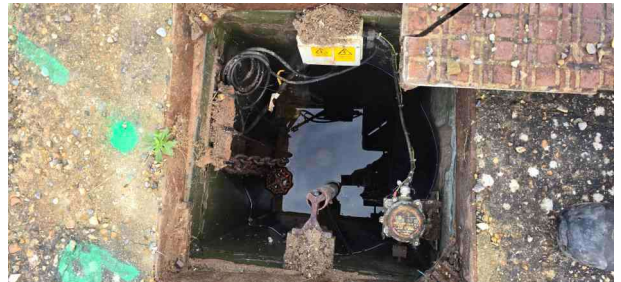
MH32X\_7bcfddd9-202f-4e2b-82db-48c6380e95e6\_20241125\_112750.jpg, 00:00:55, 14.78 m  
 Finish node, manhole, reference: MH32, PUMP IN CHAMBER, NOT WORKING

MH32X\_6476d4ac-80fb-4081-a5f3-cf29dca6fb3d\_20241125\_112757.jpg, 00:00:55, 14.78 m  
 Finish node, manhole, reference: MH32, PUMP IN CHAMBER, NOT WORKING

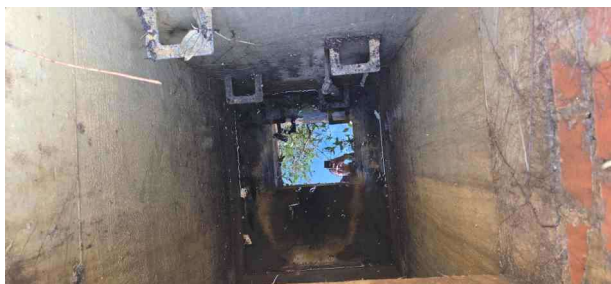
| Section | PLR | Description |
|---|---|---|
| 8 | MH27X | Survey abandoned |

MH27X\_752d7050-5c7c-4b6d-8922-7f7d2ea637d2\_20241125\_113301.jpg, 00:00:03, 0.00 m  
 General remark, REQUIRES SUCKING OUT TO SURVEY

| <b>Recommendations:</b> | REQUIRES SUCKING OUT | | | | |

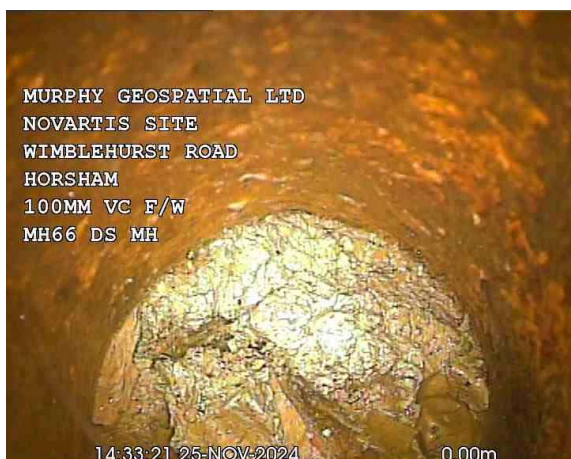
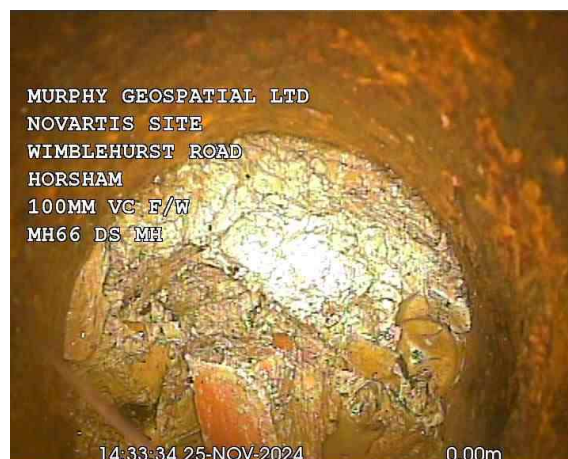
| Section | PLR | Grade | Description |
|---|---|---|---|
| 15 | MH66X | 5 | Collapsed drain or sewer, 100% cross-sectional area loss |

MH66X\_d5676fce-9e23-49c5-bd5e-e499d8c206ac\_20241125\_143652.jpg, 00:00:04, 0.00 m  
 General remark, LINE POSSIBLY COLAPSED

MH66X\_4c909935-10b8-4717-9372-7c1483778b32\_20241125\_143657.jpg, 00:00:04, 0.00 m  
 General remark, LINE POSSIBLY COLAPSED

| <b>Recommendations:</b> | LINE REQUIRES DIG UP TO REPAIR | | | | |
