# Gale Tree Consultancy

## Tree Condition Report

Field House, Rudgwick, RH12 3DD

Ref: TCR/653/25

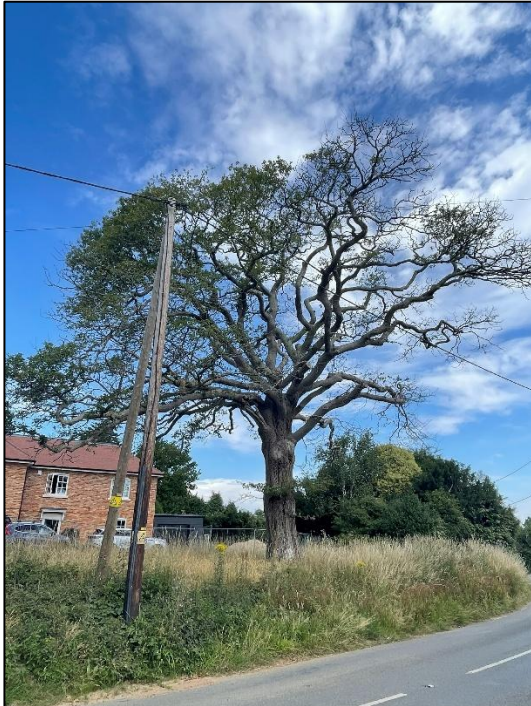
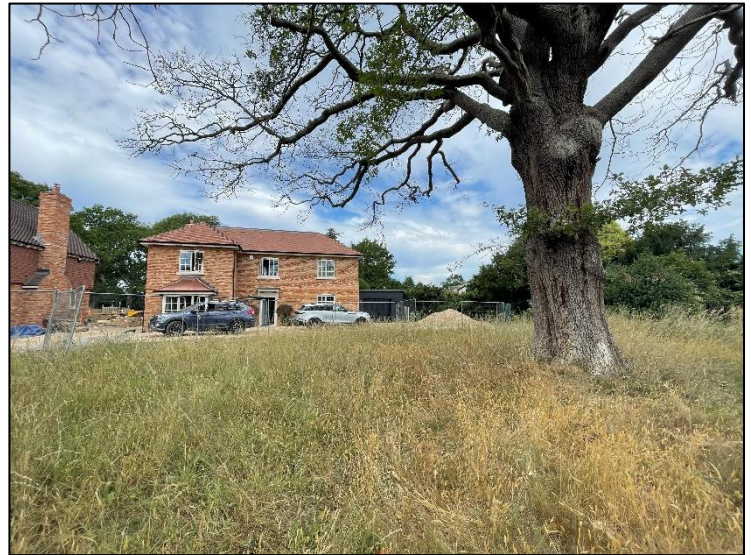
Hybrid oak adjacent to Church Street with the Heras fencing of the TPP clearly visible in the background

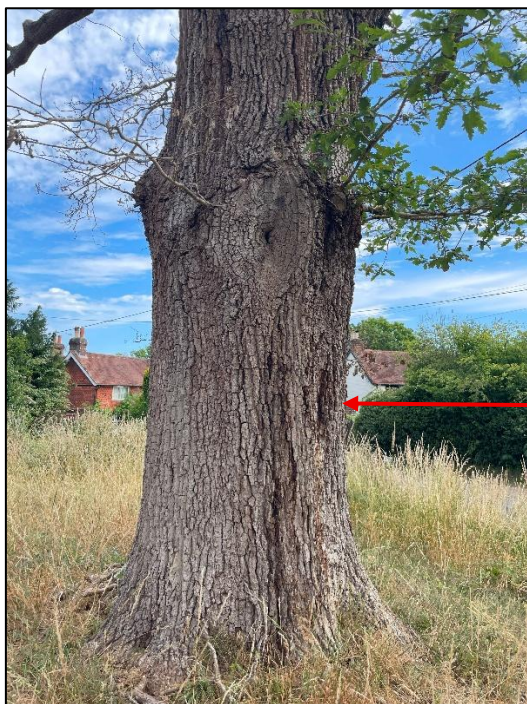
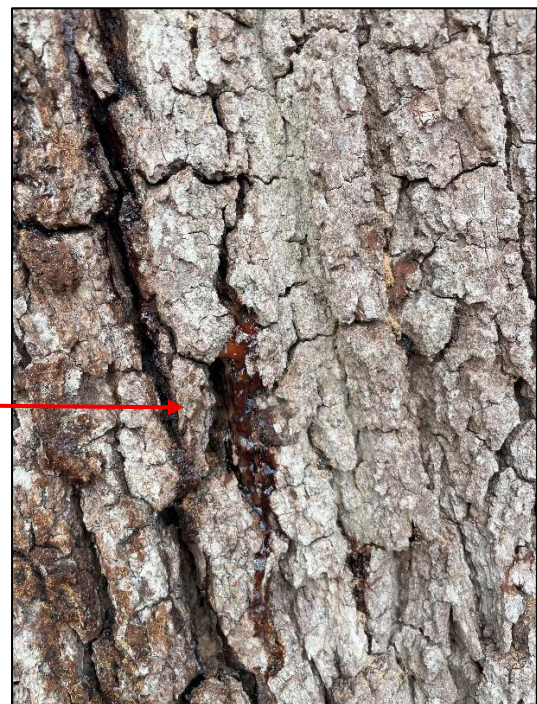
- On the south, southwest and west side of the stem, exudations were recorded up to a height of c.4m; these were giving off a fermenting smell, and were attracting hornets and wasps

- The exudations on the south, southwest and west side of the stem are being caused by bacterial wetwood, sometimes known as slime flux
- The bacteria is thought to enter the tree via damaged roots and is quickly taken up the stem where it grows in the spring wood. As the infection matures, some ferment and produce a gas which is expelled through cracks and fissures in the outer bark layer resulting in the exudates running down the bark

- In itself the condition is not always fatal, but if it enters the transpiration stream<sup>4</sup>, this can lead to wilt disease<sup>5</sup>; there is no cure or treatment available

Exudations and bleeding on the lower stem. Hornets and wasps were observed feeding on the fermenting liquid

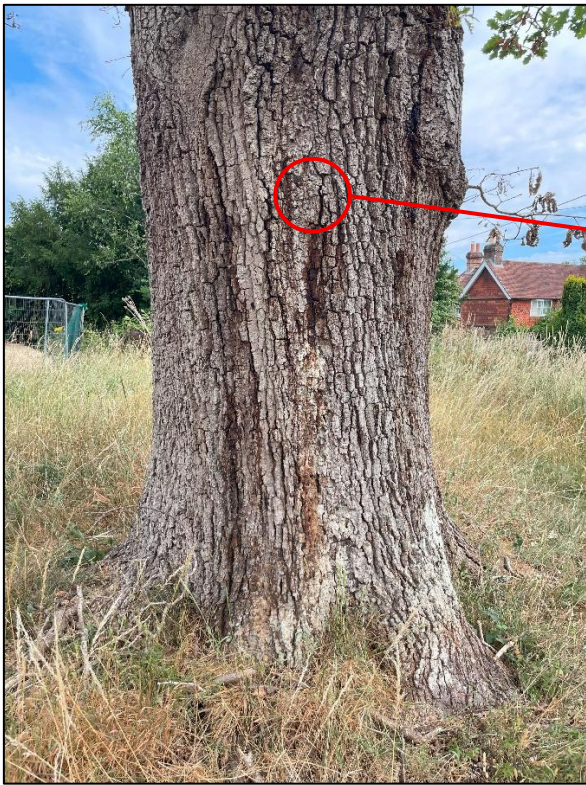
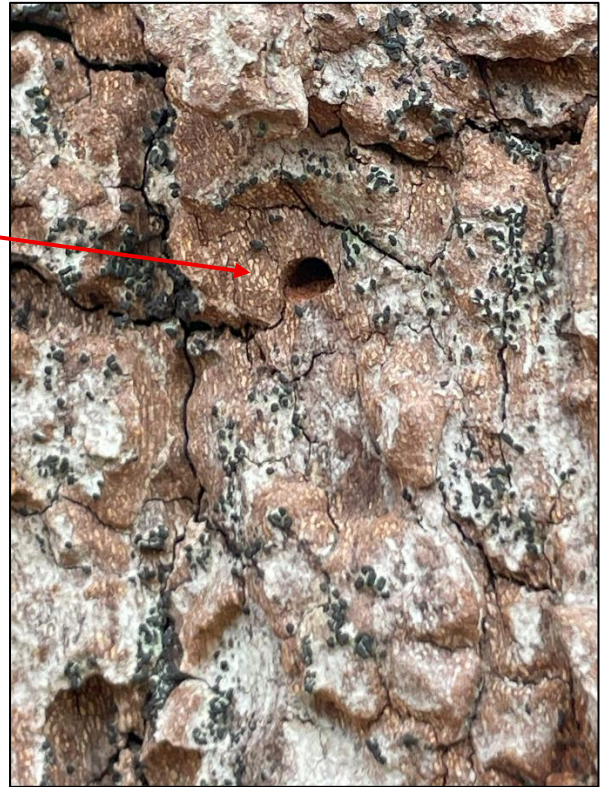
- 'D' shaped exit holes were noted on the stem, consistent with those made by the *Agrilus biguttatus* beetle (Oak splendour beetle)
- On the day of the assessment, the tree had approximately 25% leaf cover with extensive dead and declining wood being noted throughout the crown, and over Church Street

- The black staining on the north, south and northwest side of the tree is consistent with a condition known as Acute Oak Decline (AOD)
- AOD is a complex disease, thought to be associated with a certain bacterium, which affects native oak trees over 50 years old. It manifests itself on the stem as patches of black fluid/bleeds which results in the death of the underlying tissue

- Larval galleries of the buprestid beetle *Agrilus biguttatus*, are usually found beneath the bleeds and are identifiable by a 'D' shaped exit hole; the beetle and disease often occur together on the same tree

- Based on the above observations I am of the opinion that the decline of the tree is not down to a single pathogen
- The presence of the black staining and D shaped exit holes suggest acute oak decline is active within the tree, and that a bacterial wetwood is also present

'D' shaped exit holes consistent with the *Agrilus biguttatus* and associated exudations suggest acute oak decline

- At the minimum, remove deadwood from over Church Street
- If removal of the tree is the preferred choice, undertake within six months so any replacement can be planted during the dormant period
