## HERITAGE IMPACT ASSESSMENT

**Property Address:** Park Farm House, Wheatsheaf Road, Woodmancote,  
Henfield, West Sussex, BN5 9BA

**Report Date:** 6<sup>th</sup> September 2024

**Prepared by** Richard Pocock MSc MRICS

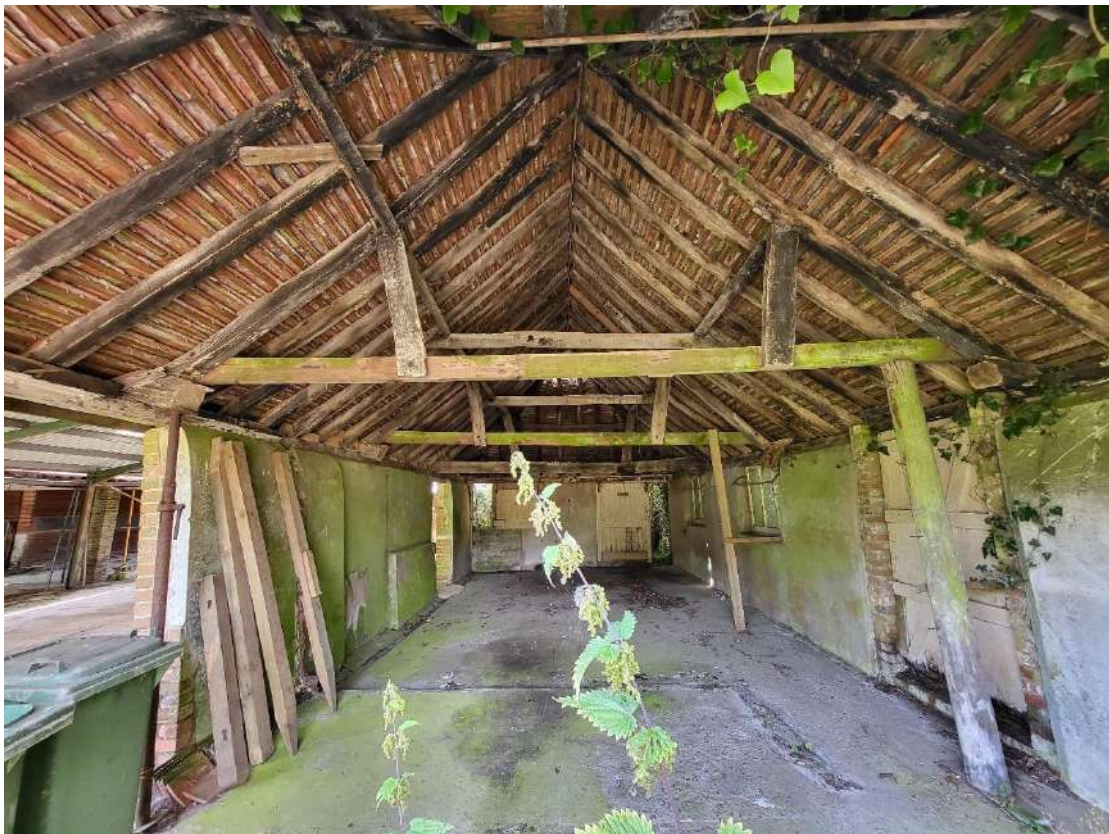
Internally, it would appear that the unit was probably always masonry and, indeed, some of the walls are of flint cobble and infill construction, with interior facings. Some later brickwork also survives, though the unit is somewhat of a derelict shell.
