**From:** Alex Smith [REDACTED]  
**Sent:** 07 August 2026 15:22  
**To:** Sam.Whitehouse  
**Cc:** [REDACTED]  
**Subject:** DISC/26/0217 - Former Fire Station, Hurst Road, Horsham - Conditions 5 & 6  
**Attachments:** C-36677 The Old Fire Station RH12 2ND Asbestos Demolition Report.pdf; 253128B Final Phase 2 Investigation Report.pdf

## Asbestos Demolition Report

The Old Fire Station  
Hurst Road  
Horsham  
RH12 2ND

Reference: C-36677

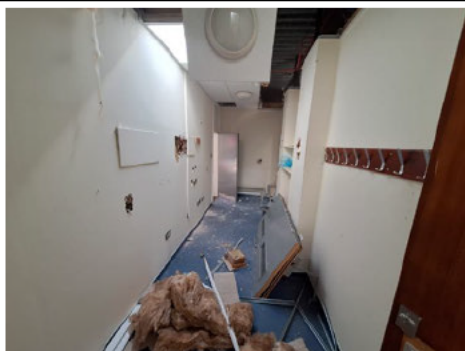
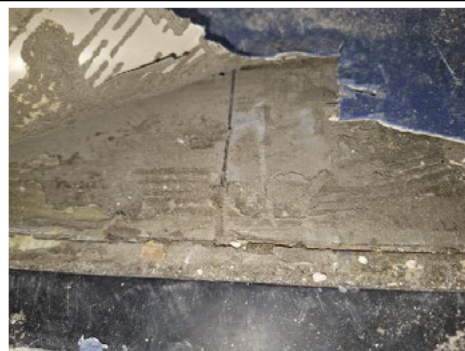
| Condition | Good Condition | | 0 |
| Comments | Metal sheeted roof, cellulose tiled suspended ceiling, plasterboard walls with a woodchip covering, concrete floor with linoleum.<br>Steel frame.<br>Timber doors and frames.<br>Plastic lagged copper pipework.<br>Timber door header panels.<br>Timber boxing.<br>MMMF insulation within ceiling void.<br>Bonded to concrete | | |

| Recommendation | Remove - NON-Licensed Material Removal by an asbestos contractor. This material is not licensed however may still be notifiable to the HSE prior to removal works taking place. All works must conform to the Control of Asbestos Regulations 2012. | | |

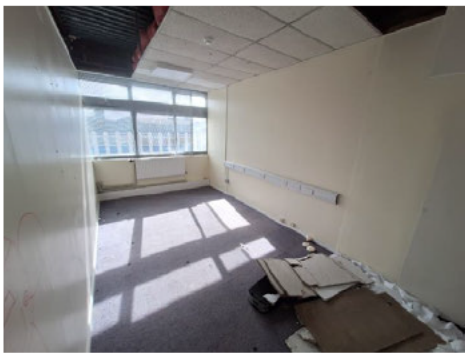
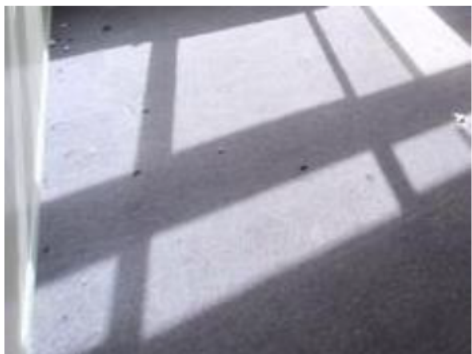
| Condition | Good Condition | | 0 | | |
| Comments | <p>Metal sheeted roof, cellulose tiled suspended ceiling, plasterboard walls, concrete floor with carpet.</p> <p>Timber door and frame.</p> <p>Plastic lagged copper pipework.</p> <p>Plasterboard door header panel.</p> <p>Bagged MMMF and cotton insulation within ceiling void.</p> <p>Bonded to concrete</p> | | | | |

| Recommendation | <b>Remove - NON-Licensed Material Removal by an asbestos contractor. This material is not licensed however may still be notifiable to the HSE prior to removal works taking place. All works must conform to the Control of Asbestos Regulations 2012.</b> | | | | |

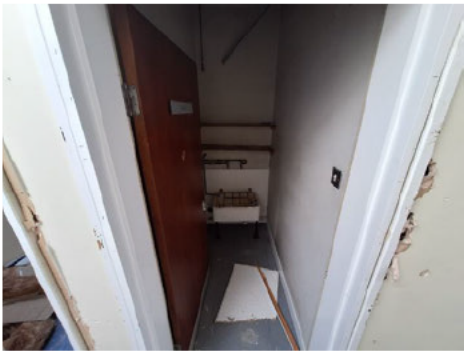
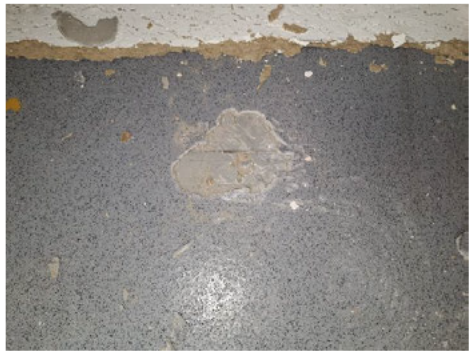
| Condition | Low Damage | | 1 | | |

| Recommendation | Remove - NON-Licensed Material Removal by an asbestos contractor. This material is not licensed however may still be notifiable to the HSE prior to removal works taking place. All works must conform to the Control of Asbestos Regulations 2012. | | | | |

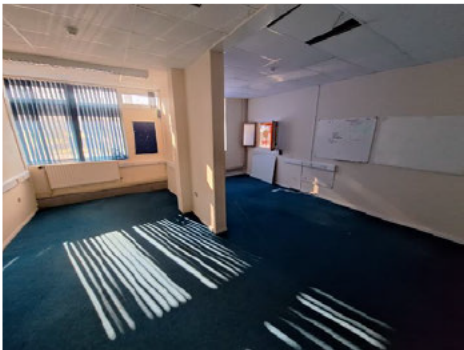
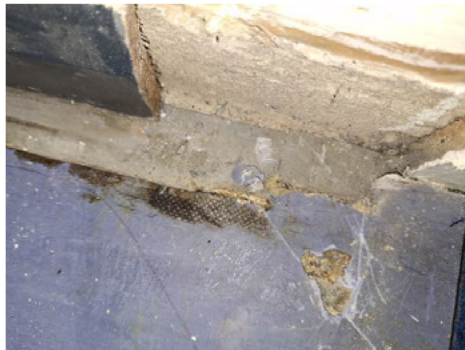
| Condition | Good Condition | | 0 | | |

| Recommendation | <b>Remove - NON-Licensed Material Removal by an asbestos contractor. This material is not licensed however may still be notifiable to the HSE prior to removal works taking place. All works must conform to the Control of Asbestos Regulations 2012.</b> | | | | |

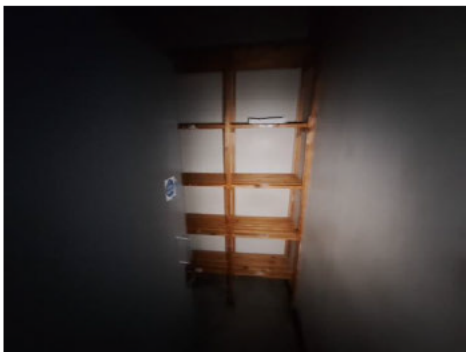
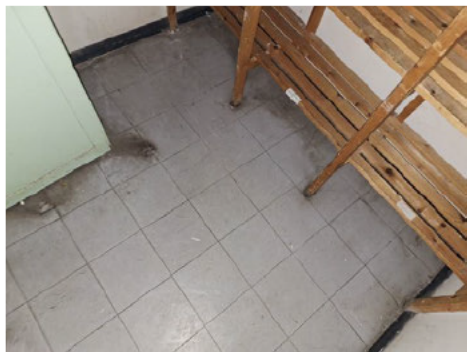
| Condition | Good Condition | | 0 | | |

| Recommendation | Remove - NON-Licensed Material Removal by an asbestos contractor. This material is not licensed however may still be notifiable to the HSE prior to removal works taking place. All works must conform to the Control of Asbestos Regulations 2012. | | | | |

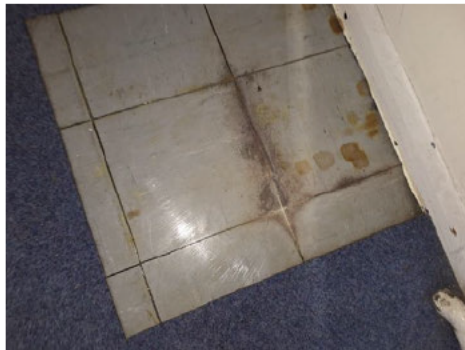
| Condition | Good Condition | | 0 | | |

| Recommendation | <b>Remove - NON-Licensed Material Removal by an asbestos contractor. This material is not licensed however may still be notifiable to the HSE prior to removal works taking place. All works must conform to the Control of Asbestos Regulations 2012.</b> | | | | |

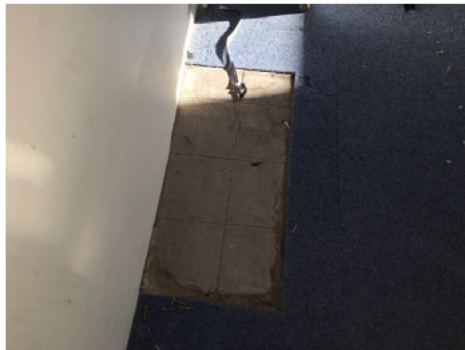
| Condition | Good Condition | | 0 | | |

| Recommendation | Remove - NON-Licensed Material Removal by an asbestos contractor. This material is not licensed however may still be notifiable to the HSE prior to removal works taking place. All works must conform to the Control of Asbestos Regulations 2012. | | | | |

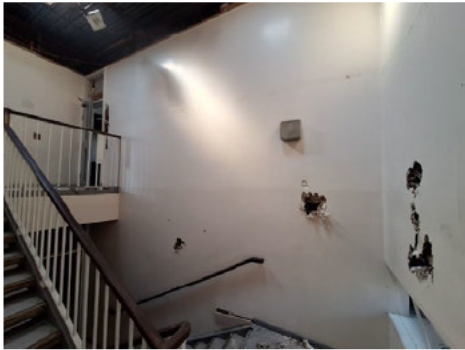
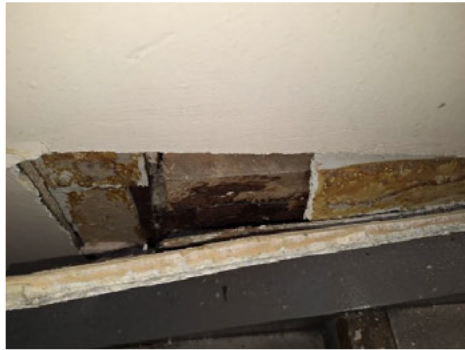
| Condition | High Damage | | 3 | | |

| Recommendation | <b>Remove - Licensed Material Removal by a licensed asbestos contractor. This material is licensed therefore is subject to a 14 notification to the HSE prior to removal works taking place. All works must conform to the Control of Asbestos Regulations 2012.</b> | | | | |

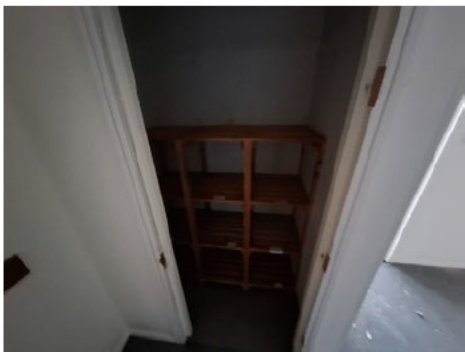
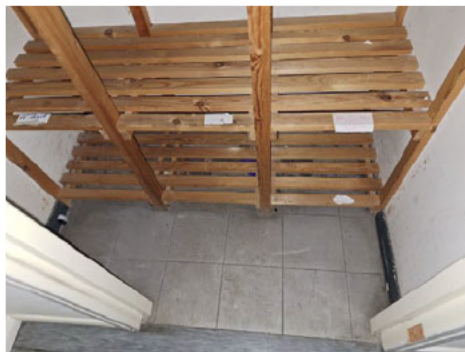
| Condition | Good Condition | | 0 | | |

| Recommendation | <b>Remove - NON-Licensed Material Removal by an asbestos contractor. This material is not licensed however may still be notifiable to the HSE prior to removal works taking place. All works must conform to the Control of Asbestos Regulations 2012.</b> | | | | |

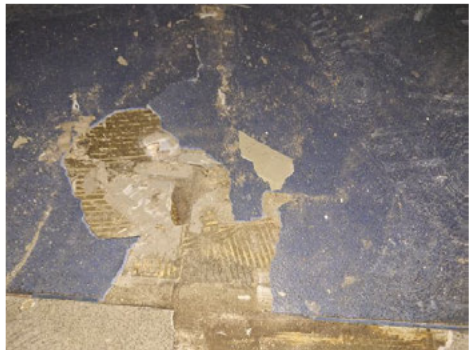
| Condition | Low Damage | | 1 | | |

| Recommendation | <b>Remove - NON-Licensed Material Removal by an asbestos contractor. This material is not licensed however may still be notifiable to the HSE prior to removal works taking place. All works must conform to the Control of Asbestos Regulations 2012.</b> | | | | |

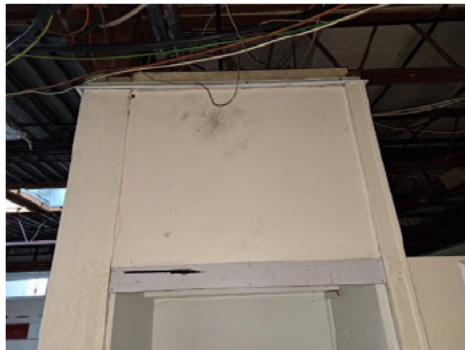
| Condition | Low Damage | | 1 | | |

| Recommendation | <b>Remove - NON-Licensed Material Removal by an asbestos contractor. This material is not licensed however may still be notifiable to the HSE prior to removal works taking place. All works must conform to the Control of Asbestos Regulations 2012.</b> | | | | |

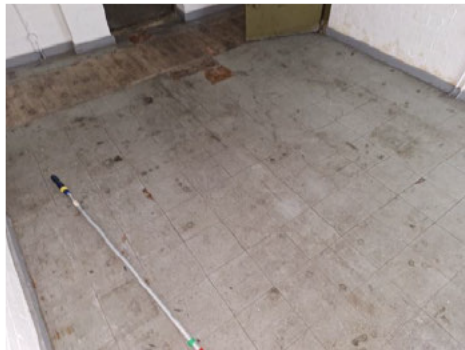
| Condition | Low Damage | | 1 | | |

| Recommendation | <b>Remove - NON-Licensed Material Removal by an asbestos contractor. This material is not licensed however may still be notifiable to the HSE prior to removal works taking place. All works must conform to the Control of Asbestos Regulations 2012.</b> | | | | |

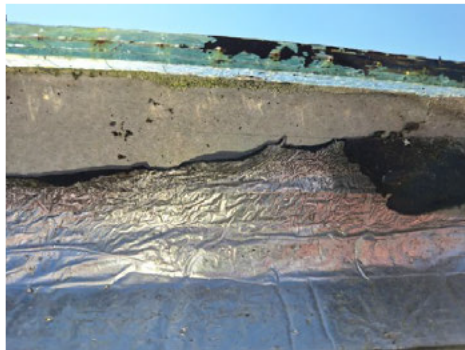
| Condition | Good Condition | | 0 | | |

| Recommendation | <b>Remove - NON-Licensed Material Removal by an asbestos contractor. This material is not licensed however may still be notifiable to the HSE prior to removal works taking place. All works must conform to the Control of Asbestos Regulations 2012.</b> | | | | |

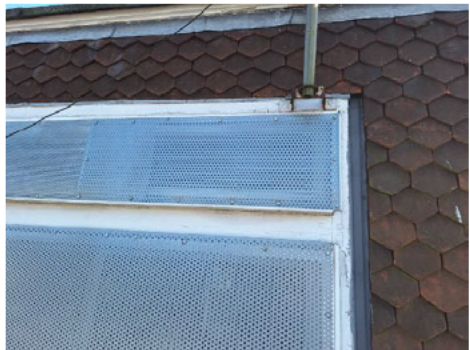
| Condition | Low Damage | | 1 | | |

| Recommendation | Remove - NON-Licensed Material Removal by an asbestos contractor. This material is not licensed however may still be notifiable to the HSE prior to removal works taking place. All works must conform to the Control of Asbestos Regulations 2012. | | | | |

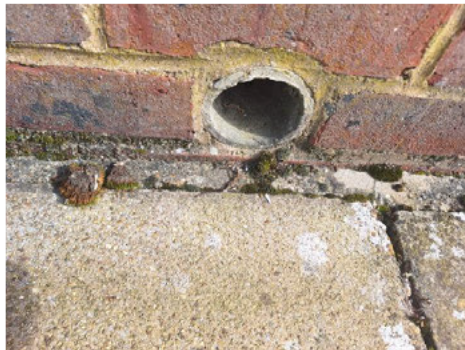
| Condition | Good Condition | | 0 | | |

| Recommendation | <b>Remove - NON-Licensed Material Removal by an asbestos contractor. This material is not licensed however may still be notifiable to the HSE prior to removal works taking place. All works must conform to the Control of Asbestos Regulations 2012.</b> | | | | |

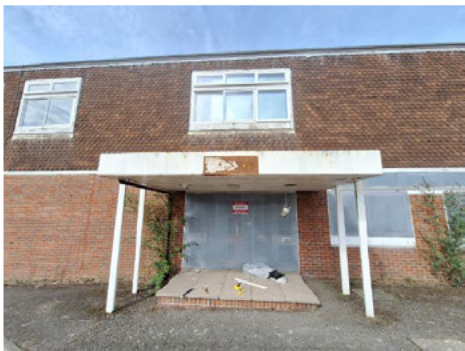
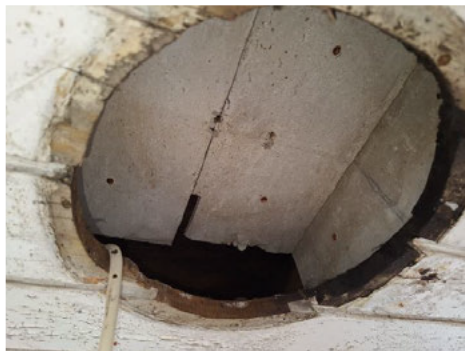
| Condition | Medium Damage | | 2 | | |

| Recommendation | <b>Remove - Licensed Material Removal by a licensed asbestos contractor. This material is licensed therefore is subject to a 14 notification to the HSE prior to removal works taking place. All works must conform to the Control of Asbestos Regulations 2012.</b> | | | | |
