# ARBORICULTURAL REPORT

## TREE CONDITION SURVEY

PUBLIC BRIDLEWAY  
ADJACENT TO CHANNELLS BROOK  
(BETWEEN RUSPER ROAD & WIMLAND ROAD)  
NORTH HORSHAM

JULY 2026  
Ref: 07038 / 2026

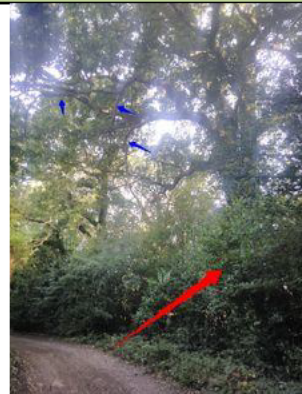
| Ref: | Species | Measurements | Survey Notes | Condition | Other Data | Recommendations | Photo |
|---|---|---|---|---|---|---|---|
| T001 | Pedunculate oak<br>( <i>Quercus robur</i> ) | Height (m): 20-25<br>Crown Radius (m): 9<br>DBH (cm): 100<br>Life Stage: Mature<br>Life Exp.: 40+ Years | Ivy clad tree, 2.5m back from bridleway. Several dead branches over bridleway to be removed. Broad crown. Foliage density normal. | Good | Public Amenity Value: High<br>Wildlife Value: High<br>Inspection Limitations: Dense vegetation | Remove deadwood within falling distance of bridleway.<br><br><b>Timescale:</b><br>16-Jan-2027<br>(6 Months) | |

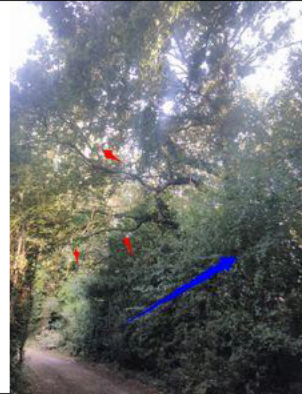
| Ref: | Species | Measurements | Survey Notes | Condition | Other Data | Recommendations | Photo |
|---|---|---|---|---|---|---|---|
| T002 | Pedunculate oak<br>( <i>Quercus robur</i> ) | Height (m): 15-20<br>Crown Radius (m): 8<br>DBH (cm): 80<br>Life Stage: Mature<br>Life Exp.: 40+ Years | Ivy clad tree, 2.5m back from bridleway. Prolific ivy on trunk into lower crown. Several dead branches over bridleway to be removed. Asymmetrical crown. Foliage density normal. | Good | Public Amenity Value: High<br>Wildlife Value: High<br>Inspection Limitations: Dense vegetation | Remove deadwood within falling distance of bridleway.<br><br><b>Timescale:</b><br>16-Jan-2027<br>(6 Months) | |

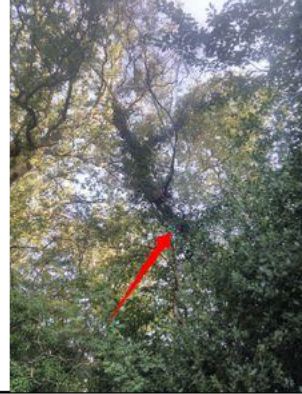
| Ref: | Species | Measurements | Survey Notes | Condition | Other Data | Recommendations | Photo |
|---|---|---|---|---|---|---|---|
| T003 | Silver birch<br>( <i>Betula pendula</i> ) | Height (m): 15-20<br>Crown Radius (m): 4<br>DBH (cm): 20<br>Life Stage: Dead | Recently deceased scorched birch within falling distance of bridleway. | Dead | Public Amenity Value: Low<br>Wildlife Value: Moderate<br>Inspection Limitations: Dense vegetation | Fell to ground level and stack.<br><br><b>Timescale:</b><br>16-Jan-2027<br>(6 Months) | |

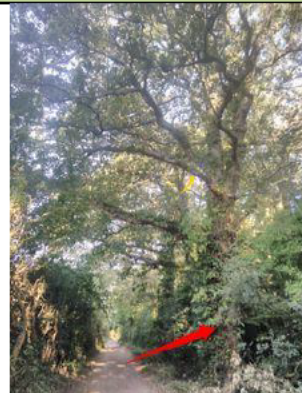
| Ref: | Species | Measurements | Survey Notes | Condition | Other Data | Recommendations | Photo |
|---|---|---|---|---|---|---|---|
| T004 | Pedunculate oak<br>( <i>Quercus robur</i> ) | Height (m): 20-25<br>Crown Radius (m): 9<br>DBH (cm): 120<br>Life Stage: Mature<br>Life Exp.: 40+ Years | Ivy clad tree, 1m back from bridleway. Tree suffered recent major branch failure -summer branch drop? Some smaller dead branches over bridleway to be removed. 3m long dead branch stub 1m above fallen branch appears stable and has habitat potential with cavity at tip. Broad crown. Foliage density normal. | Good | Public Amenity Value: High<br>Wildlife Value: High<br>Inspection Limitations: Dense vegetation | Remove deadwood within falling distance of bridleway. 3m long dead branch stub 1m above fallen branch appears stable and has habitat potential with cavity at tip - retain for habitat value (highlighted in yellow).<br><br><b>Timescale:</b><br>16-Jan-2027<br>(6 Months) | |

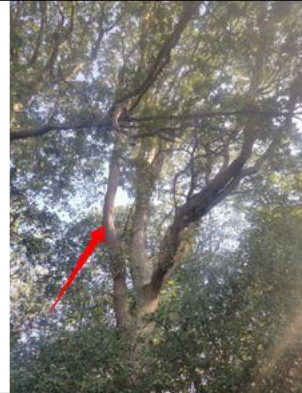
| Ref: | Species | Measurements | Survey Notes | Condition | Other Data | Recommendations | Photo |
|---|---|---|---|---|---|---|---|
| T005 | Pedunculate oak<br>( <i>Quercus robur</i> ) | Height (m): 25-30<br>Crown Radius (m): 9<br>DBH (cm): 80<br>Life Stage: Mature<br>Life Exp.: 40+ Years | Ivy clad tree, 3m back from bridleway. Several dead branches over bridleway to be removed. Broad, asymmetrical crown. Foliage density normal but clustered at tips. Large limb from 5.5m above ground level undermined by decay / necrotic bark. | Good | Public Amenity Value: High<br>Wildlife Value: High<br>Inspection Limitations: Dense vegetation | Remove deadwood within falling distance of bridleway. Reduce side branch undermined by decay to safe height - 6m above fork.<br><br><b>Timescale:</b><br>16-Jan-2027<br>(6 Months) | |

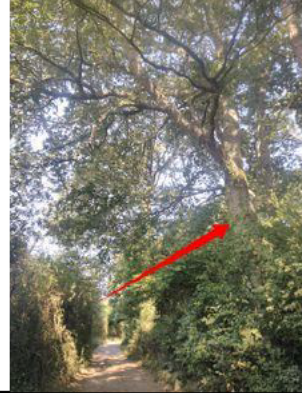
| Ref: | Species | Measurements | Survey Notes | Condition | Other Data | Recommendations | Photo |
|---|---|---|---|---|---|---|---|
| T008 | Pedunculate oak<br>( <i>Quercus robur</i> ) | Height (m): 25-30<br>Crown Radius (m): 9<br>DBH (cm): 100<br>Life Stage: Mature<br>Life Exp.: 40+ Years | 1.5m back from bridleway. Several small to medium sized dead branches over bridleway to be removed includes one or two larger branches in upper crown. Broad, asymmetrical crown. Foliage density normal. Epicormic shoots on lateral branches. | Good | Public Amenity Value: High<br>Wildlife Value: High<br>Inspection Limitations: Dense vegetation | Remove deadwood within falling distance of bridleway.<br><br><b>Timescale:</b><br>16-Jan-2027<br>(6 Months) | |

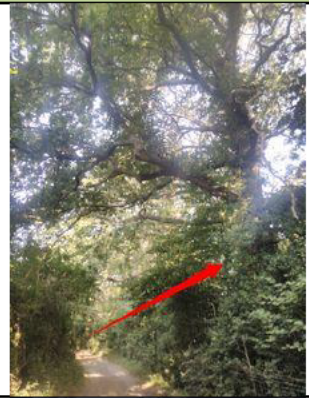
| Ref: | Species | Measurements | Survey Notes | Condition | Other Data | Recommendations | Photo |
|---|---|---|---|---|---|---|---|
| T009 | Pedunculate oak<br>( <i>Quercus robur</i> ) | Height (m): 15-20<br>Crown Radius (m): 8<br>DBH (cm): 76<br>Life Stage: Mature<br>Life Exp.: 40+ Years | Ivy clad tree, 1m back from bridleway. Several smaller dead branches over bridleway and larger dead branches adjacent to edge of bridleway to be removed. Broad, asymmetrical crown. Foliage density normal<br>Asymmetrical canopy. | Good | Public Amenity Value: High<br>Wildlife Value: High<br>Inspection Limitations: Dense vegetation | Remove deadwood within falling distance of bridleway.<br><br><b>Timescale:</b><br>16-Jan-2027<br>(6 Months) | |

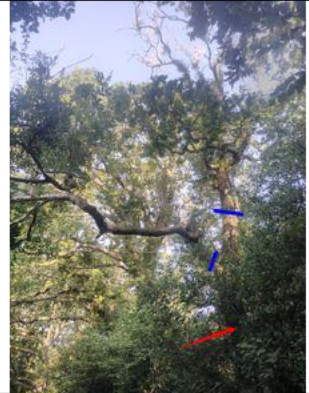
| Ref: | Species | Measurements | Survey Notes | Condition | Other Data | Recommendations | Photo |
|---|---|---|---|---|---|---|---|
| T010 | Common ash<br>( <i>Fraxinus excelsior</i> ) | Height (m): 15-20<br>Crown Radius (m): 5<br>DBH (cm): 60<br>Life Stage: Over Mature<br>Life Exp.: <10 years | Mature ivy clad Ash 2m from bridleway. Cavity and hollow trunk with habitat potential 6m above ground level. Upper canopy mostly dead.<br><br>Fungus:<br>Inonotus hispidus (Shaggy Polypore)<br><br>Pests and Diseases:<br>Ash Health Class 4 - 25%-0% remaining canopy | Poor | Public Amenity Value: Low<br>Wildlife Value: High<br>Inspection Limitations: Access | Top at 8m and remove lower branches leaving trunk as a monolith and dry cavity in hollow trunk where possible for habitat value.<br><br><b>Timescale:</b><br>16-Jul-2027<br>(1 Year) | |

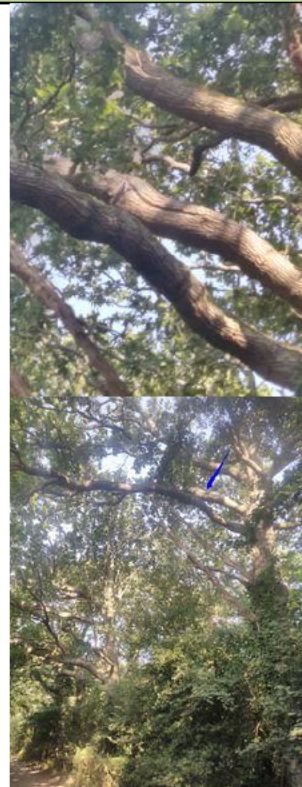
| Ref: | Species | Measurements | Survey Notes | Condition | Other Data | Recommendations | Photo |
|---|---|---|---|---|---|---|---|
| T011 | Pedunculate oak<br>( <i>Quercus robur</i> ) | Height (m): 25-30<br>Crown Radius (m): 9<br>DBH (cm): 80<br>Life Stage: Mature<br>Life Exp.: 20+ Years | Historic wounding and decay on South side of base. Elsewhere good bark intact. Good wound wood formation. Single stem. Dead branches on lower trunk. Foliage sparse and clustered. Significant dieback in crown. Large split limb over bridleway 8m above ground level. | Fair | Public Amenity Value: High<br>Wildlife Value: High<br>Inspection Limitations: Dense vegetation | Remove deadwood within falling distance of bridleway.<br>Reduce side branch undermined by crack to safe length - 3m.<br><br><b>Timescale:</b><br>16-Jan-2027<br>(6 Months) | |

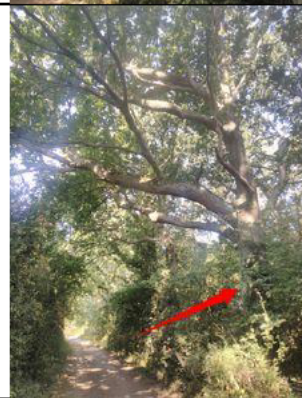
| Ref: | Species | Measurements | Survey Notes | Condition | Other Data | Recommendations | Photo |
|---|---|---|---|---|---|---|---|
| T012 | Pedunculate oak<br>( <i>Quercus robur</i> ) | Height (m): 15-20<br>Crown Radius (m): 7<br>DBH (cm): 58<br>Life Stage: Mature<br>Life Exp.: 40+ Years | Smaller tree, 1m back from bridleway. Several slender dead branches in crown and larger branches along edge of bridleway to be removed. Broad, asymmetrical crown. Foliage density normal | Good | Public Amenity Value: High<br>Wildlife Value: High<br>Inspection Limitations: Dense vegetation | Remove deadwood within falling distance of bridleway.<br><br><b>Timescale:</b><br>16-Jan-2027<br>(6 Months) | |

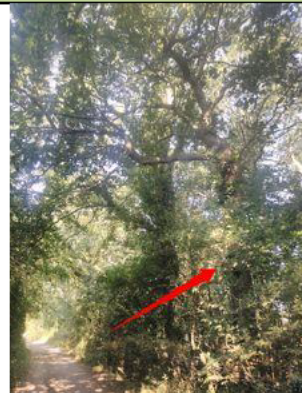
| Ref: | Species | Measurements | Survey Notes | Condition | Other Data | Recommendations | Photo |
|---|---|---|---|---|---|---|---|
| T013 | Pedunculate oak<br>( <i>Quercus robur</i> ) | Height (m): 10-15<br>Crown Radius (m): 6.5<br>DBH (cm): 46<br>Life Stage: Mature<br>Life Exp.: 40+ Years | Smaller tree, 1m back from bridleway. Several dead branches in crown and along edge of bridleway to be removed. Suppressed, asymmetrical crown. Foliage density normal | Good | Public Amenity Value: High<br>Wildlife Value: High<br>Inspection Limitations: Dense vegetation | Remove deadwood within falling distance of bridleway.<br><br><b>Timescale:</b><br>16-Jan-2027<br>(6 Months) | |

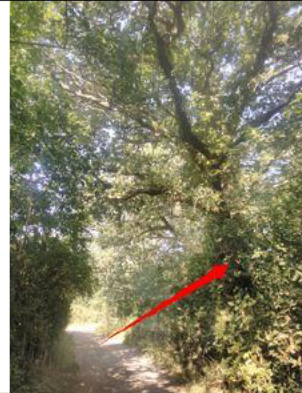
| Ref: | Species | Measurements | Survey Notes | Condition | Other Data | Recommendations | Photo |
|---|---|---|---|---|---|---|---|
| T014<br>(T068) | Pedunculate oak<br>( <i>Quercus robur</i> ) | Height (m): 15-20<br>Crown Radius (m): 6.5<br>DBH (cm): 850<br>Life Stage: Mature<br>Life Exp.: 40+ Years | Ivy clad tree. Prolific suckering epicormic growth on trunk. Foliage density normal. Prolific epicormic growth on branches. Minor dead wood throughout crown. One or two larger dead branches over bridleway. Includes low branch 6m above ground level over bridleway and undermined by decay. | Fair | Public Amenity Value: Moderate<br>Wildlife Value: Good<br>Inspection Limitations: Access | Remove deadwood and decaying branches over bridleway back to healthy growth.<br><br><b>Timescale:</b><br>16-Jul-2027<br>(1 Year) | |

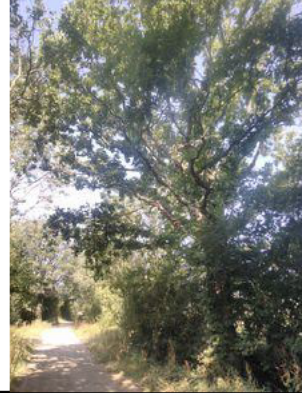
| Ref: | Species | Measurements | Survey Notes | Condition | Other Data | Recommendations | Photo |
|---|---|---|---|---|---|---|---|
| T015 | Pedunculate oak<br>( <i>Quercus robur</i> ) | Height (m): 10-15<br>Crown Radius (m): 7<br>DBH (cm): 55<br>Life Stage: Mature<br>Life Exp.: 40+ Years | Smaller tree, 1m back from bridleway. Base and trunk obscured by prolific ivy and epicormic shoots. Several slender dead branches in lower crown over bridleway to be removed. Broad, asymmetrical crown. Canopy formed primarily on epicormic shoots along branches. Foliage healthy but tree lacks vigour. | Good | Public Amenity Value: High<br>Wildlife Value: High<br>Inspection Limitations: Dense vegetation | Remove deadwood within falling distance of bridleway.<br><br><b>Timescale:</b><br>16-Jan-2027<br>(6 Months) | |

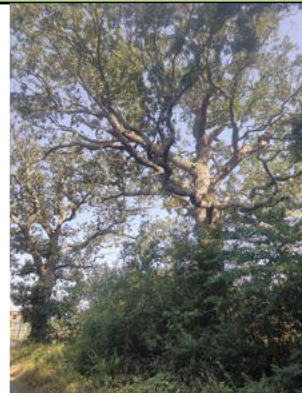
| Ref: | Species | Measurements | Survey Notes | Condition | Other Data | Recommendations | Photo |
|---|---|---|---|---|---|---|---|
| T016 | Pedunculate oak<br>( <i>Quercus robur</i> ) | Height (m): 15-20<br>Crown Radius (m): 8<br>DBH (cm): 850<br>Life Stage: Mature<br>Life Exp.: 20+ Years | Within dense hedgerow. Broad canopy. Foliage sparse and clustered. One or two larger dead branches over bridleway. | Fair | Public Amenity Value: Moderate<br>Wildlife Value: Good<br>Inspection Limitations: Access | Remove deadwood over bridleway back to live growth.<br><br><b>Timescale:</b><br>16-Jul-2027<br>(1 Year) | |

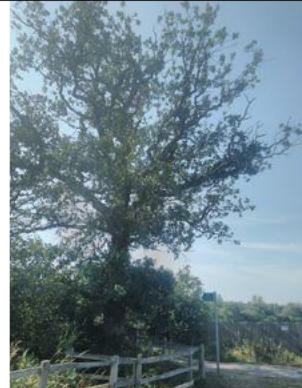
| Ref: | Species | Measurements | Survey Notes | Condition | Other Data | Recommendations | Photo |
|---|---|---|---|---|---|---|---|
| T017 | Pedunculate oak<br>( <i>Quercus robur</i> ) | Height (m): 10-15<br>Crown Radius (m): 6.5<br>DBH (cm): 90<br>Life Stage: Mature<br>Life Exp.: 20+ Years | Within dense vegetation. Retrenching canopy with significant dieback at tips. Foliage sparse and clustered. One or two larger dead branches over bridleway and publicly accessible verge. | Fair | Public Amenity Value: Moderate<br>Wildlife Value: Good<br>Inspection Limitations: Dense vegetation | Remove deadwood over bridleway and verge back to live growth.<br><br><b>Timescale:</b><br>16-Jul-2027<br>(1 Year) | |

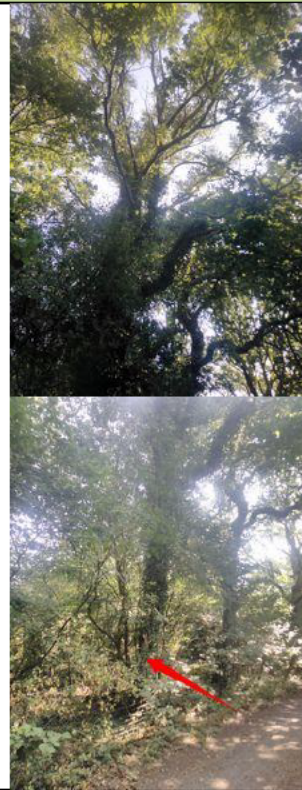
| Ref: | Species | Measurements | Survey Notes | Condition | Other Data | Recommendations | Photo |
|---|---|---|---|---|---|---|---|
| T018 | Common ash<br>( <i>Fraxinus excelsior</i> ) | Height (m): 15-20<br>Crown Radius (m): 7<br>DBH (cm): 52<br>Life Stage: Over Mature<br>Life Exp.: 20+ Years | Mature ivy clad tree. Broad crown. Prolific dieback throughout canopy. Long slender dead branches over bridleway. Removal of Deadwood required but tree has reduced life expectancy therefore more appropriate to fell.<br><br>Pests and Diseases:<br>Ash Health Class 2 - 75%-50% remaining canopy | Poor | Public Amenity Value: Good<br>Wildlife Value: Good<br>Inspection Limitations: Access | Fell to ground level.<br><br><b>Timescale:</b><br>16-Jul-2027<br>(1 Year) | |

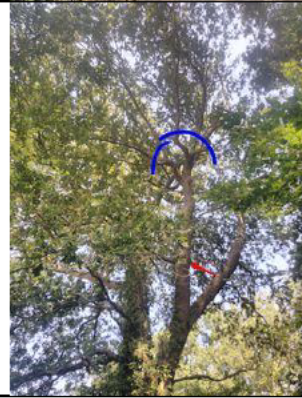
| Ref: | Species | Measurements | Survey Notes | Condition | Other Data | Recommendations | Photo |
|---|---|---|---|---|---|---|---|
| T019 | Pedunculate oak<br>( <i>Quercus robur</i> ) | Height (m): 20-25<br>Crown Radius (m): 10<br>DBH (cm): 95<br>Life Stage: Mature<br>Life Exp.: 40+ Years | Large ivy clad oak, 1m from bridleway. Base and trunk obscured by prolific ivy. Twin stem from 6m. Decay / habitat hole on branch on east side of canopy just beyond bridleway. The upper crown of this branch would affect path in the event of failure. Small to medium sized dead wood over bridleway. Foliage density normal. | Fair | Public Amenity Value: High<br>Wildlife Value: High<br>Inspection Limitations: Access | Remove deadwood within falling distance of bridleway. Reduce tips of decayed branch east side of crown by 5-6m pollarding to just above previous reduction points.<br><br><b>Timescale:</b><br>16-Jan-2027<br>(6 Months) | |

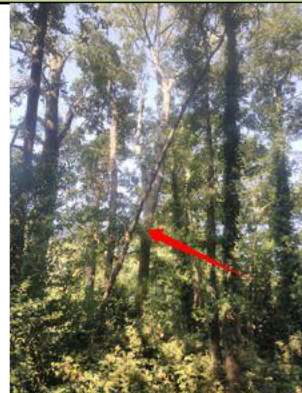
| Ref: | Species | Measurements | Survey Notes | Condition | Other Data | Recommendations | Photo |
|---|---|---|---|---|---|---|---|
| T020 | Alder<br>( <i>Alnus sp.</i> ) | Height (m): 5-10<br>Crown Radius (m): 0<br>DBH (cm): 10<br>Life Stage: Dead | Leaning dead slender trunk within falling distance of bridleway. | Dead | Public Amenity Value: Low<br>Wildlife Value: Low<br>Inspection Limitations: Dense vegetation | Fell to ground level<br><br><b>Timescale:</b><br>16-Jan-2027<br>(6 Months) | |

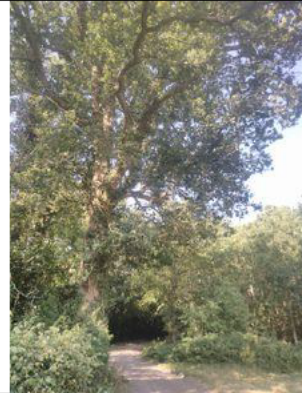
| Ref: | Species | Measurements | Survey Notes | Condition | Other Data | Recommendations | Photo |
|---|---|---|---|---|---|---|---|
| T021 | Pedunculate oak<br>( <i>Quercus robur</i> ) | Height (m): 15-20<br>Crown Radius (m): 8<br>DBH (cm): 100<br>Life Stage: Mature<br>Life Exp.: 20+ Years | Prominent tree. Base obscured by dense vegetation. Ivy clad. Broad canopy. Foliage density normal. One or two larger dead branches over bridleway includes broken branch hung in upper canopy. Prolific epicormic growth on branches. | Fair | Public Amenity Value: Moderate<br>Wildlife Value: Good<br>Inspection Limitations: Access | Remove deadwood over bridleway back to live growth.<br><br><b>Timescale:</b><br>16-Jul-2027<br>(1 Year) | |

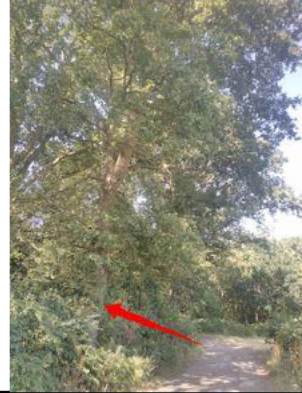
| Ref: | Species | Measurements | Survey Notes | Condition | Other Data | Recommendations | Photo |
|---|---|---|---|---|---|---|---|
| T022 | Pedunculate oak<br>( <i>Quercus robur</i> ) | Height (m): 15-20<br>Crown Radius (m): 7<br>DBH (cm): 60<br>Life Stage: Mature<br>Life Exp.: 40+ Years | Asymmetrical canopy. Foliage density normal. One or two larger dead branches over bridleway. | Fair | Public Amenity Value: Moderate<br>Wildlife Value: Good<br>Inspection Limitations: Access | Remove deadwood over bridleway back to live growth.<br><br><b>Timescale:</b><br>16-Jul-2027<br>(1 Year) | |

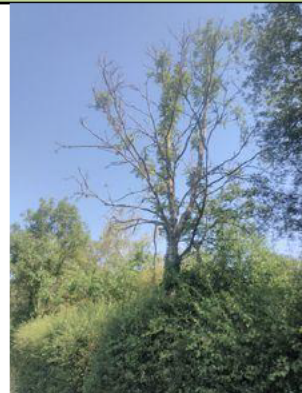
| Ref: | Species | Measurements | Survey Notes | Condition | Other Data | Recommendations | Photo |
|---|---|---|---|---|---|---|---|
| T023 | Ash<br>( <i>Fraxinus sp.</i> ) | Height (m): 10-15<br>Crown Radius (m): 2<br>DBH (cm): 25<br>Life Stage: Over Mature<br>Life Exp.: <10 years | Small ivy clad tree in dense hedge.<br><br>Pests and Diseases:<br>Ash Health Class 3 - 50%-25% remaining canopy | Poor | Public Amenity Value: Low<br>Wildlife Value: Low<br>Inspection Limitations: Dense vegetation | Fell to hedge height.<br><br><b>Timescale:</b><br>16-Jul-2027<br>(1 Year) | |

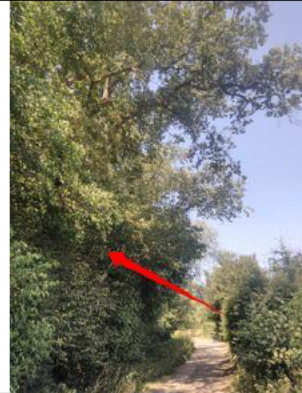
| Ref: | Species | Measurements | Survey Notes | Condition | Other Data | Recommendations | Photo |
|---|---|---|---|---|---|---|---|
| T024 | Pedunculate oak<br>( <i>Quercus robur</i> ) | Height (m): 15-20<br>Crown Radius (m): 9<br>DBH (cm): 65<br>Life Stage: Mature<br>Life Exp.: 40+ Years | 2m back from bridleway. Dead ivy stems on trunk. One or two small to medium sized dead branches over bridleway to be removed. Asymmetrical crown. Foliage density normal. Epicormic shoots on lateral branches. | Good | Public Amenity Value: High<br>Wildlife Value: High<br>Inspection Limitations: Dense vegetation | Remove deadwood within falling distance of bridleway.<br><br><b>Timescale:</b><br>16-Jan-2027<br>(6 Months) | |
