22<sup>nd</sup> April 2026

Our ref: GE23845/TG01/260422

**RE: Land North of East Street, Rusper – Remediation and Validation Plan**

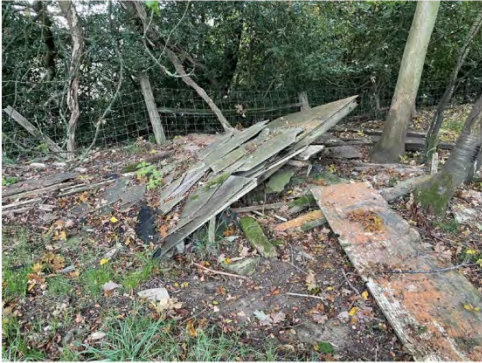
| <p><u>Stockpile 1:</u> 'View of stockpile 1, mainly potential asbestos containing material (old roofing sheets) within the southwestern area of the site.'</p> | <p><u>Stockpile 2:</u> 'View of stockpile 2, containing material of limestone brick, red brick, wood, asbestos sheeting, tile, ceramics, charcoal, asphalt, slate, glass, rubber, roofing, plastic piping, and concrete within the southwestern area of the site.'</p> |

Asbestos containing material was visually identified within Stockpile 1 and 2 within The Ground Investigation Report.

If asbestos is identified within the bulk samples, it is recommended that the stockpiles are removed in bulk from site as Hazardous waste, directly to a licenced acceptance facility, as opposed to processing the stockpiles on-site. This recommendation is based upon the volume of suspected asbestos containing material visible in the photographs within the Ground Investigation Report and to prevent potential cross contamination with surrounding soils.

The works should be completed under asbestos controls, working to an approved Asbestos Plan of Works. Appropriate dust suppression must be available during the removal works.

Following the removal of the stockpiles and any impacted soil, down to natural soil, a surface inspection should be completed to confirm no visible asbestos containing material remains.

Representative validation soil samples should then be obtained from the exposed surface on a 5m grid system across the stockpile footprints and screened for asbestos. The resulting analysis must confirm the absence of asbestos. The results will then be detailed within a Verification Letter Report.
