Upon  
The Structural Condition of Ancillary Building at  
Harwoods, West End Lane, Henfield, BN5 9RF

E.A.R.  
**Sheppard**  
CONSULTING CIVIL AND  
STRUCTURAL ENGINEERS

REF: H6344/RJB

DATE: 31 June 2025

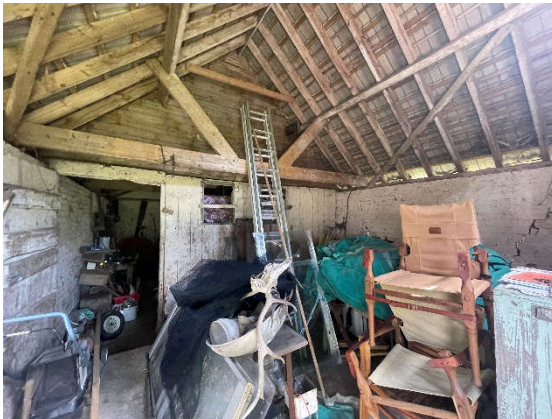
*Roof structure at South end of building*

- 2.02 From a structural perspective in relation to the timber sizes, the roof is relatively weak and it has suffered a degree of deflection and eaves level 'spread' under loading. I understand that the original covering was of plain clay tiles, which are heavier than the present interlocking concrete tiles and I anticipate that the majority of the roof displacement would have occurred prior to replacement of the roof covering. Movement of the roof has resulted in a certain amount of displacement of the eaves plates, which has been transferred into the walls. See further comments in External Walls below.

- 2.03 I note the intention to replace the concrete tiles with plain clay tiles, as original, which will require the roof to be strengthened in order to accept the increase load and prevent further displacement. I also note that it is proposed to incorporate a flat ceiling across the width of the building, which will allow the ceiling joists to provide the essential tie between the rafter feet on each side. This will form the mainstay of the strengthening work.

An additional measure to reduce future deflection of the rafters would be to incorporate collars, above the level of the existing purlins, between the rafter pairs on each side of the roof. One further improvement of the roof structure would be to introduce diagonal wind bracing, beneath the rafters, at each end of the building, to prevent longitudinal racking.

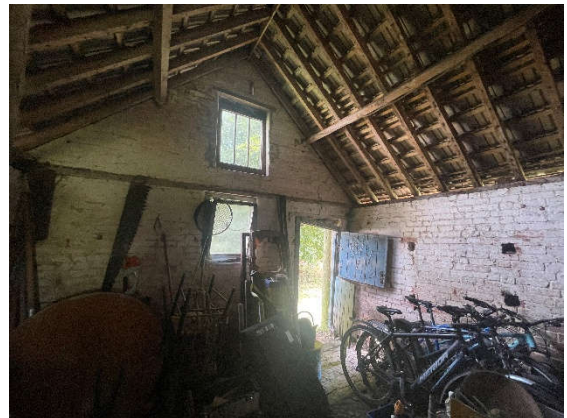
*Roof structure at North end of building*

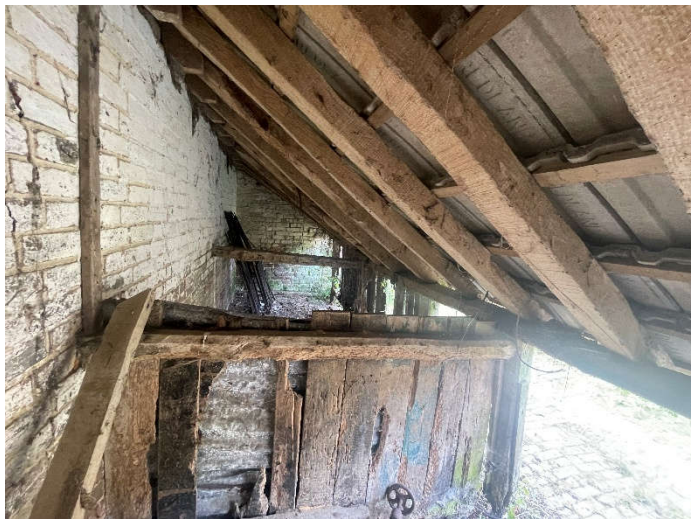
- 3.01 This small span section of roof comprises mono pitch rafters spanning from the western eaves plate of the main building down to a low level plate carried by intermediate posts, which have rotted out at their feet.

*Lean-to roof structure*

- 3.02 Whilst the majority of the rafters could be retained, or possibly repurposed into stud framing beneath the plate, the posts that currently carry the plate will need to be replaced. Furthermore, the ties between the low-level plate and the main building are in a poor condition and will also need to be replaced.

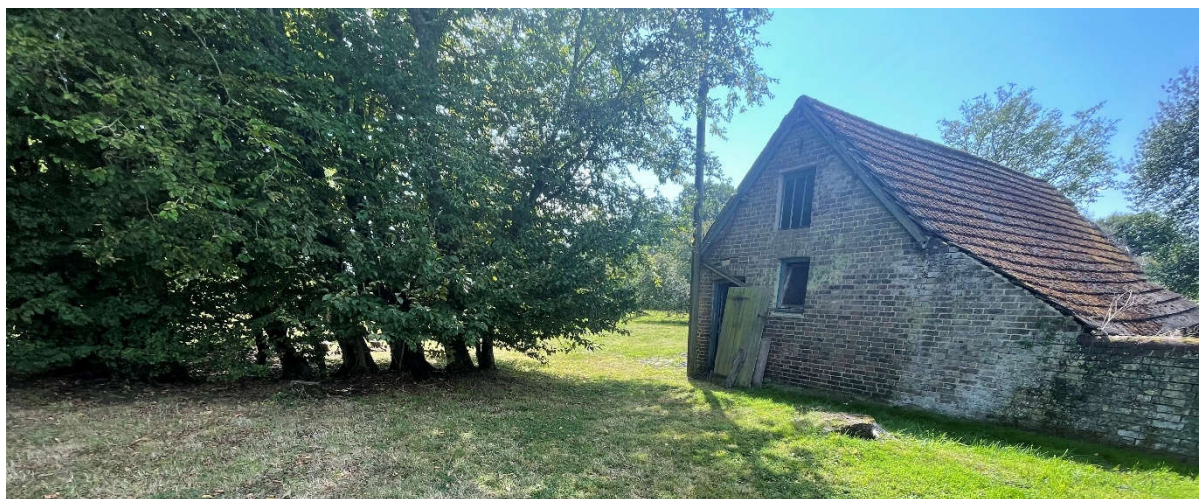
in moisture content. A potential aggravating factor is moisture extraction by the close proximity of a group of beech trees close to the north-east corner of the building.

*Trees close to north-east corner of building*

- 4.04 Whether or not remedial action by way of foundation underpinning is necessary will depend upon the plasticity of the subsoil, which will require ground investigation by a geotechnical engineering company, to include a borehole and laboratory analysis of subsoil samples.
- 4.05 The geological survey map of the area indicates the primary geology to be of Lower Greensand which I would not expect to have a particularly high plasticity index. However, it is possible that there are

- 4.06 In a worst-case scenario, underpinning of the foundations may be required and assuming that to be of mass concrete form and taking account of the close proximity of the trees, an underpinning depth of the order of 2.25m might be expected at the north-east corner, which could possibly be stepped up to a minimum of 1.0m moving away from that corner. That said, I should reiterate that whether or not underpinning is necessary will depend upon the outcome of a detailed ground investigation.

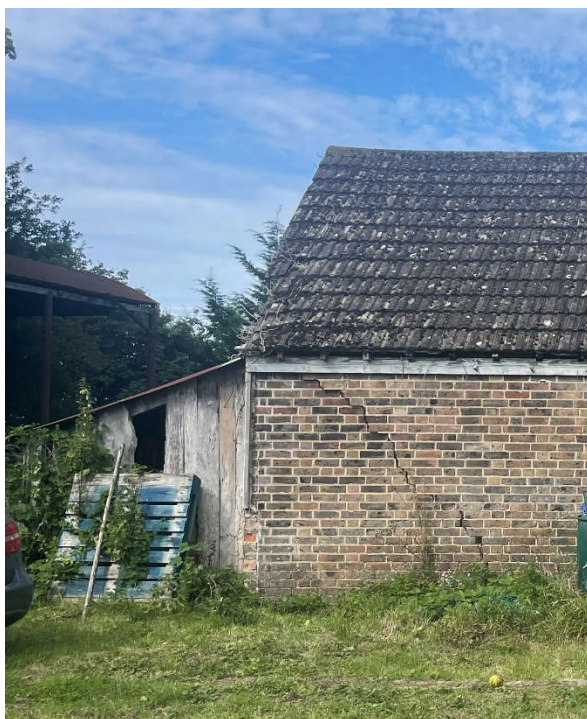
*Cracking to southern end of East elevation*

- 4.09 The pattern of the most significant fracture in the east elevation, towards its southern end, is not entirely consistent with subsidence of the site and I cannot rule out the possibility that the wall has been subject to impact damage at some time in the past. See photo under 4.03.

That said, I could not find any evidence of scarring on the wall to suggest where any point of impact may have occurred. Notwithstanding that, whatever the cause, the southern end of the wall will need to be rebuilt and properly toothed to the rest of the wall, in order to form a decent repair.

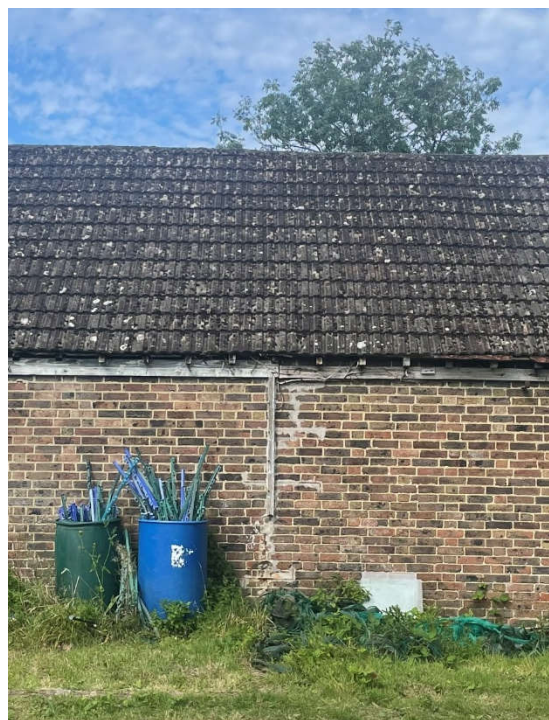
*Cracking at centre of East elevation*

- 4.10 Structural cracking approximately halfway across the east elevation has been poorly repaired with cementitious mortar and a couple of metal cramps. See photo under 4.03. There is evidence of further movement having occurred since that time and the fracture will require raking back each side and re-bonding with the adjoining brickwork.

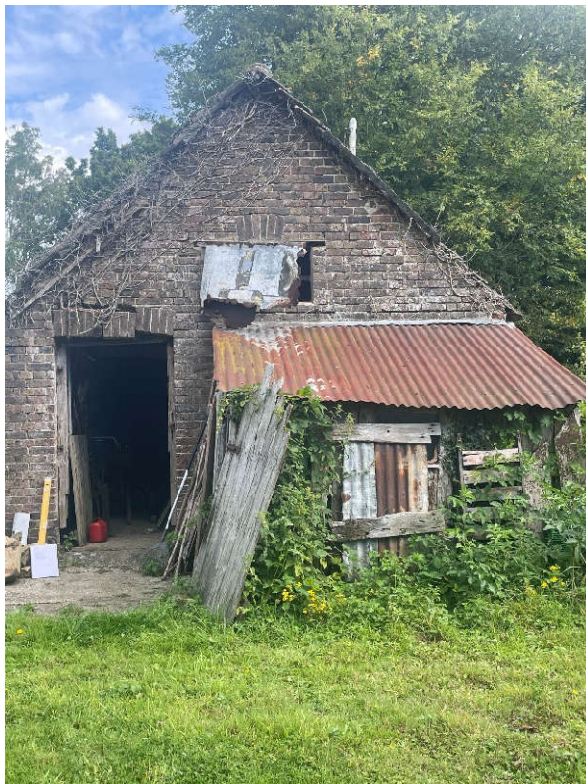
- 4.08 I suspect that it has been the roof spread that has moved the tops of the walls enough to displace the ends of the soldier arch lintels over the north and south door openings, causing them to collapse. Once the walls are suitably restrained, then re-forming the soldier arches is all that is required.

*Failed soldier arch over door in South elevation. See a narrow soldier courses as evidence of earlier window*

- 4.11 There was once a small narrow window in the south elevation, as evidenced by the 6 brick-on-end soldier arch, which has been widened, incorporating a crude timber lintel, that has decayed. See photo under 4.08. I would suggest that reforming the window to its original weight would be the most appropriate course of action.

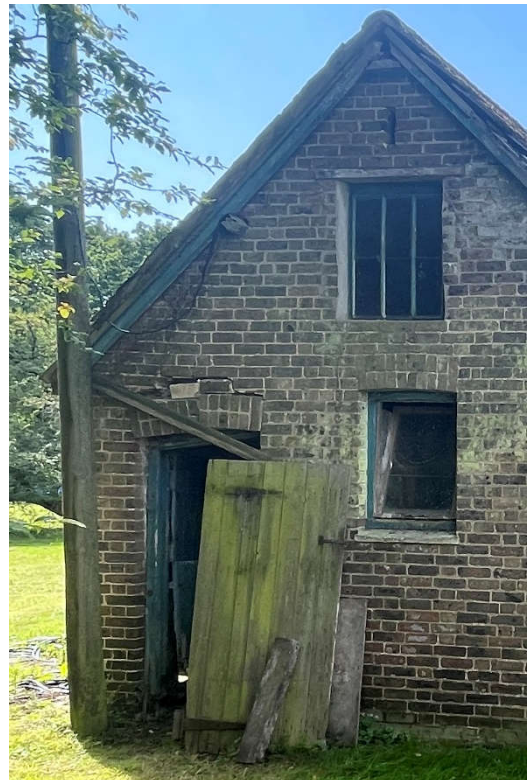
*Failed soldier arch over door in North elevation*

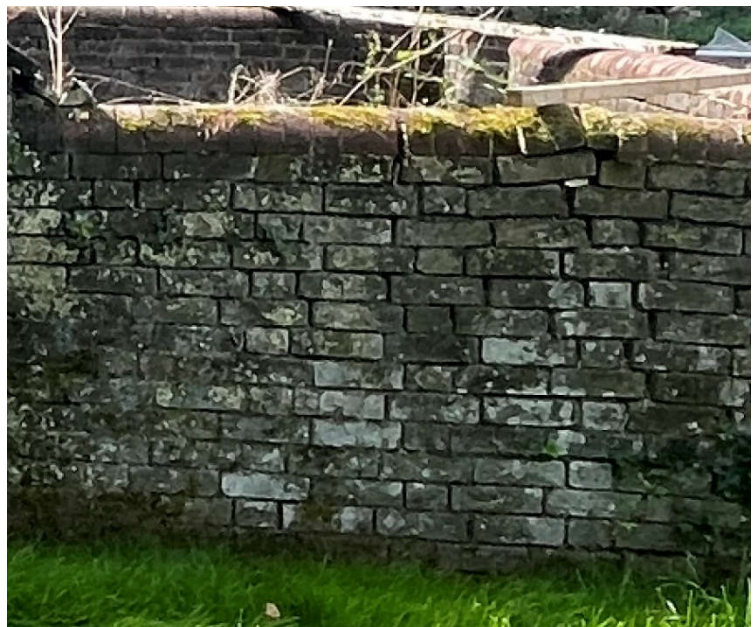
- 4.13 Walls forming the boundary to the piggery yard on the western side of the building are of similar thickness brickwork and bond as those to the main building, with a half round brick coping on their tops. They have suffered from a degree of settlement, causing opening of some of the brick joints, particularly on the north and south elevations. Vegetation growing into the brickwork, together with freeze/thaw action has also exacerbated that displacement.

*Typical condition of boundary wall to yard*

- 4.14 In my opinion, extending any underpinning (if required) from the main building would not be viable for these walls and despite the past opening of the joints, the walls remain serviceable, subject to

repair and repointing in compatible lime mortar. It would have to be accepted that future maintenance would be necessary from time to time.

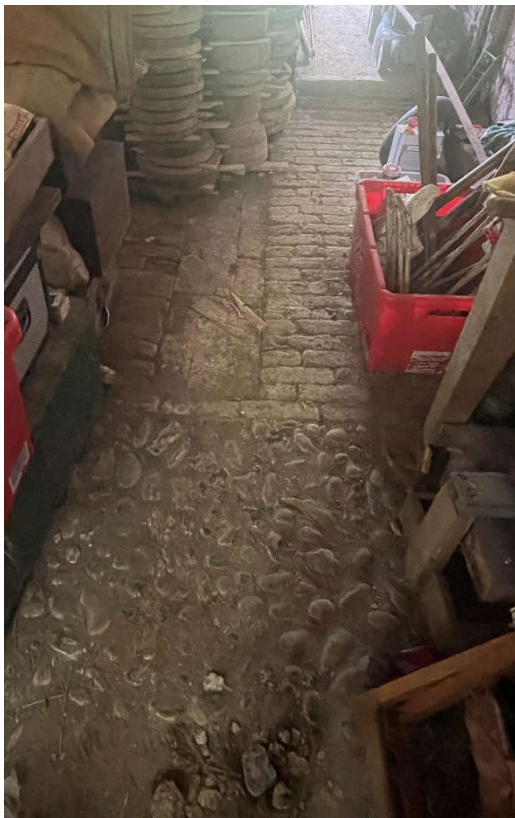
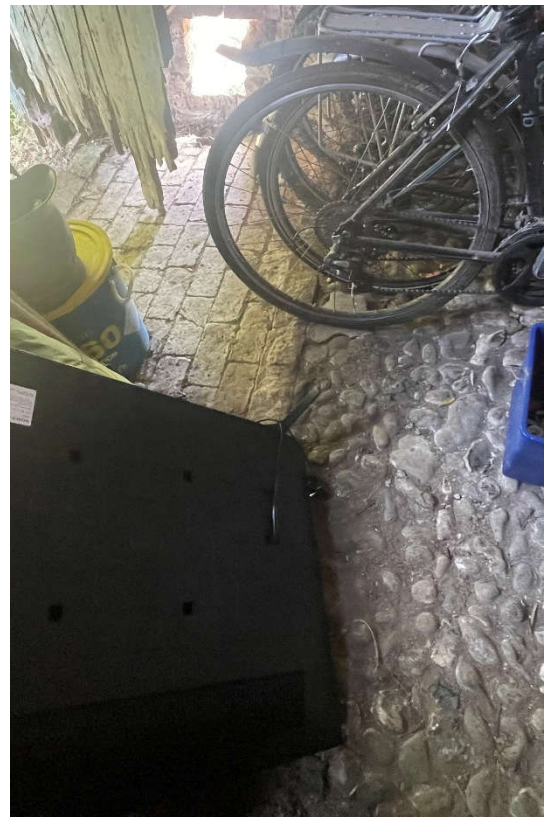
- 5.01 The present floor of the building is a mixture of concrete, brick and cobble and I suspect that there will be no meaningful subbase beneath any of these areas. Full inspection of the floor surfaces was not possible due to the presence of stored items within the building but the areas that could be seen did not reveal any significant cracking to suggest ongoing movement of the ground below, which is encouraging as far as the potential subsidence issue, previously referred to, is concerned.

*Areas of brick and cobble flooring*

- 5.02 Clearly, there will be a need for the floor to be insulated and I do not consider that screeding over and insulating on top of the existing surfaces would be structurally acceptable, as the integrity of the existing construction is unknown and there would be a risk of the screed cracking over time. The

present surfaces will need to be carefully lifted and, if required, could be reused as part of any external paving around the building.
