# Structural Inspection Report on Barn

Henfield Lodge  
Brighton Road  
Henfield  
BN5 9SU

Feb 2026

**Cassells Drummond** Building Structures Consultants

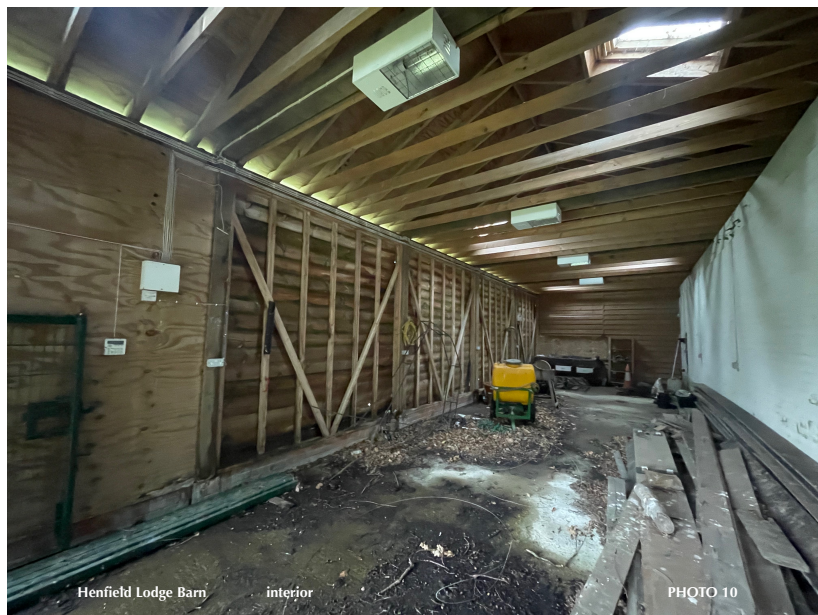
PHOTO 10

interior

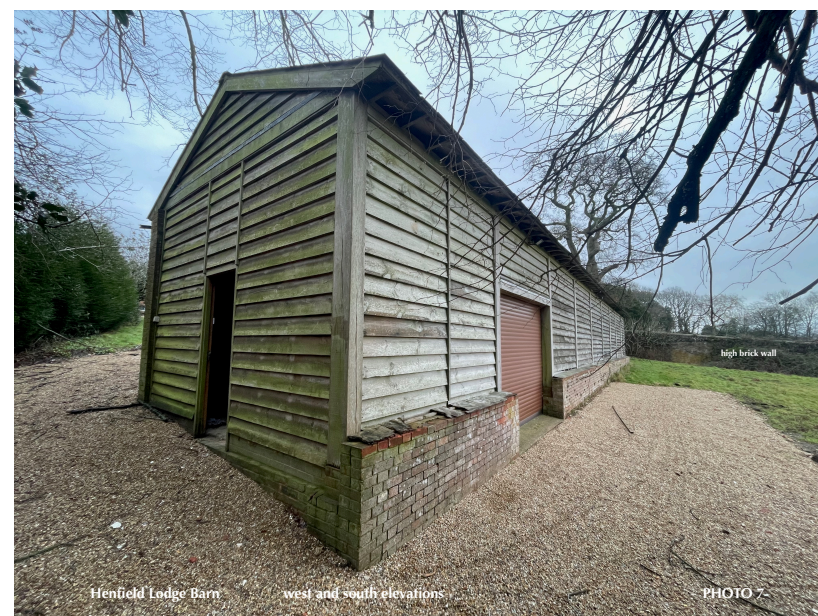
PHOTO 7

west and south elevations
