**HILLYBARN FARM, HILLYBARN ROAD, THE MOUNT,  
IFIELD, CRAWLEY, WEST SUSSEX, RH11 0LH**

**Preliminary Contamination Risk Assessment**

**January 2023**

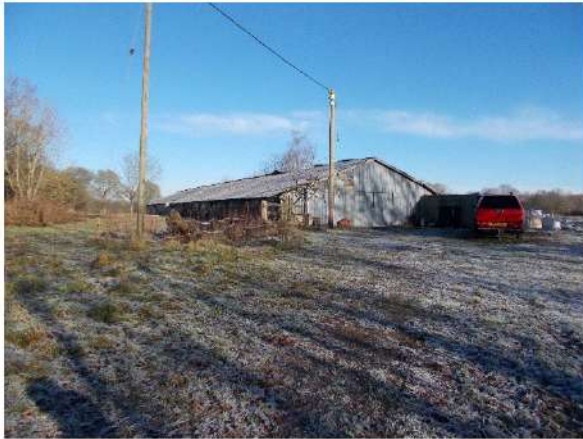
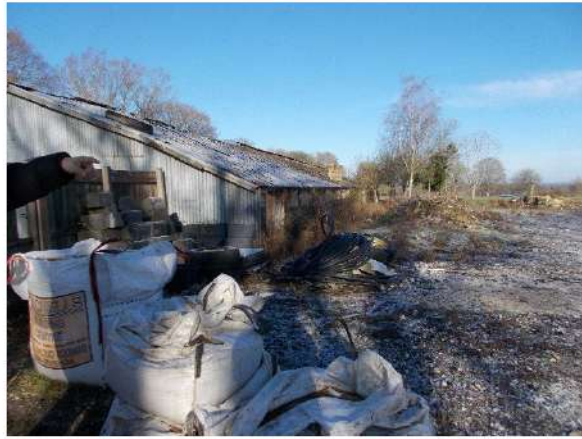
**Photographs 1 and 2:** Access up to the southern façade of the shed and building materials stored adjacent to the southeast corner of the shed.

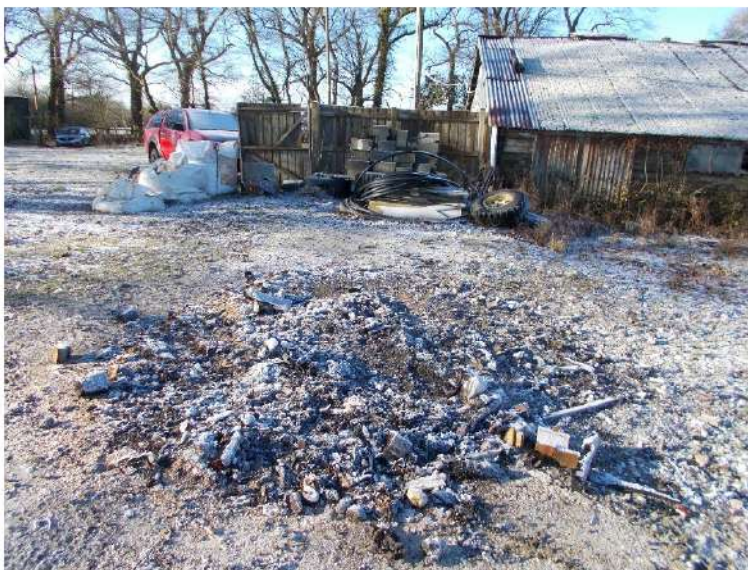
**Photograph 3:**

Bonfire residue adjacent to the southeast corner of the shed.

- 10.2 All waste and bonfire residue should be removed as part of the site's pre-development clearance, together with any affected underlying soil. The waste removal documents should be retained as evidence of this work.

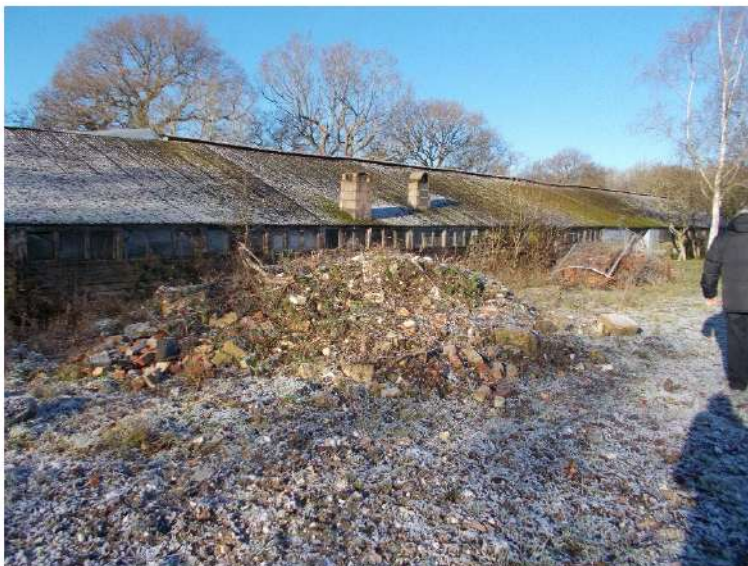
**Photograph 4:**

Mixed building rubble with some surface vegetation located adjacent to the southern end of the western façade of the shed.

Two chimneys located towards the centre of the shed on the eastern side of the building.

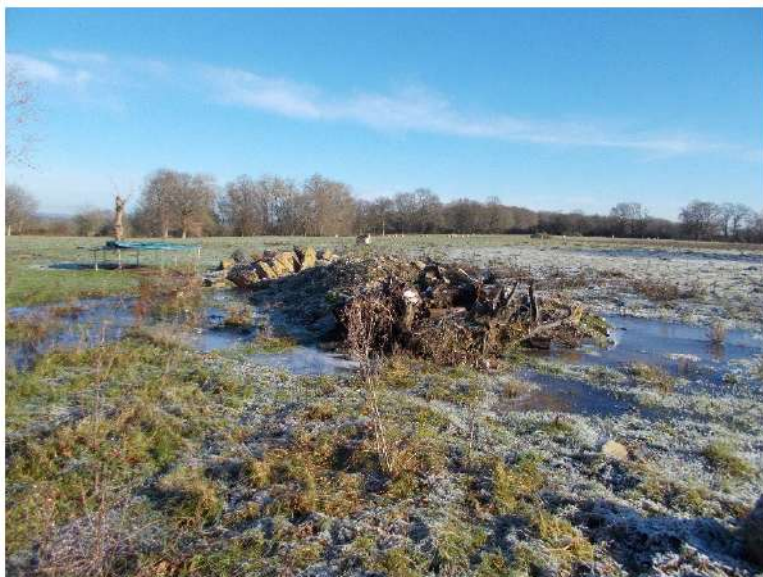
**Photograph 5:** Pile of brash (cut / felled wood), mixed soil and building rubble, large section of concrete slab / rubble.

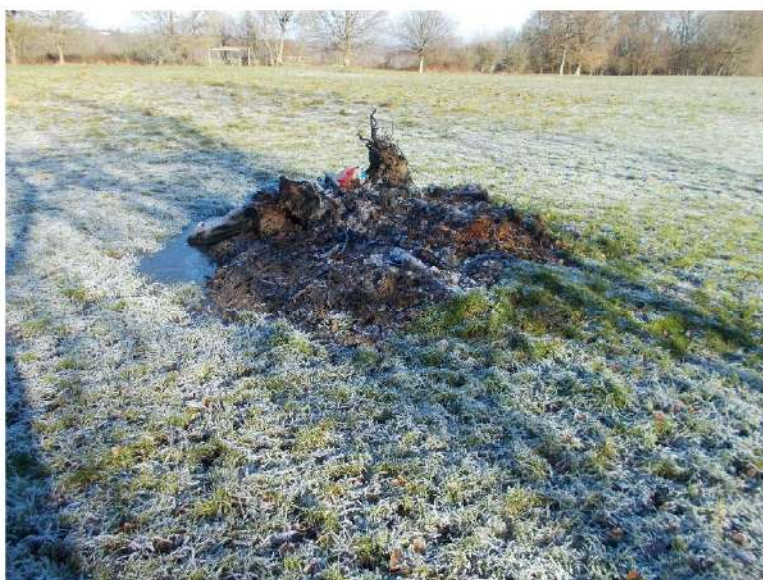
**Photograph 6:**

Bonfire residue with remaining wood waste located adjacent to the northeast corner of the shed.

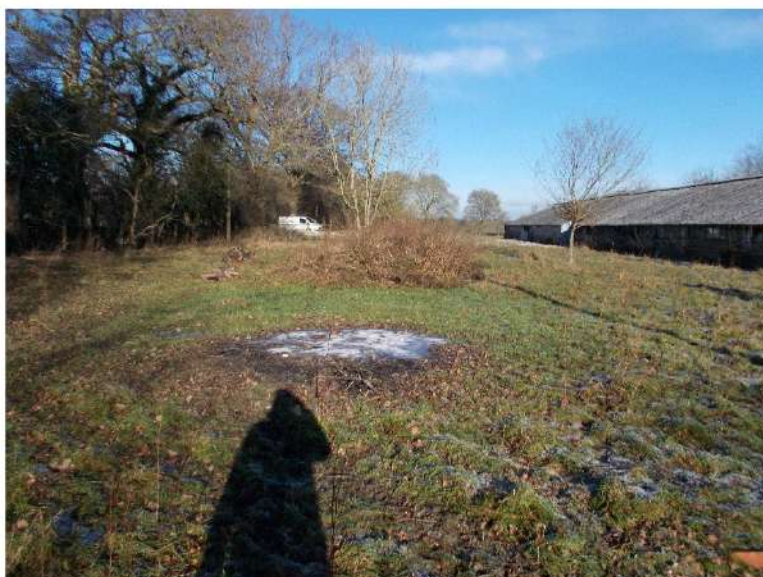
**Photograph 7:**

Bonfire residue and brash pile located to the west of the shed.

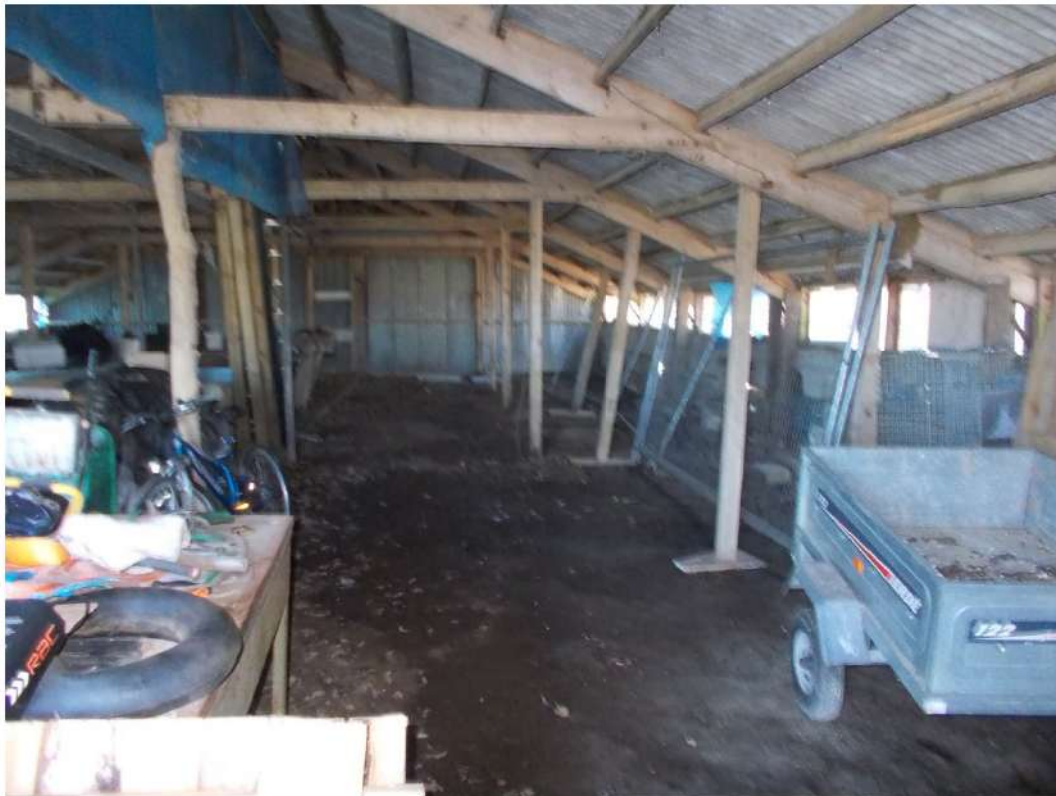
**Photograph 8:** Northern section of the shed with compressed dirt floor.

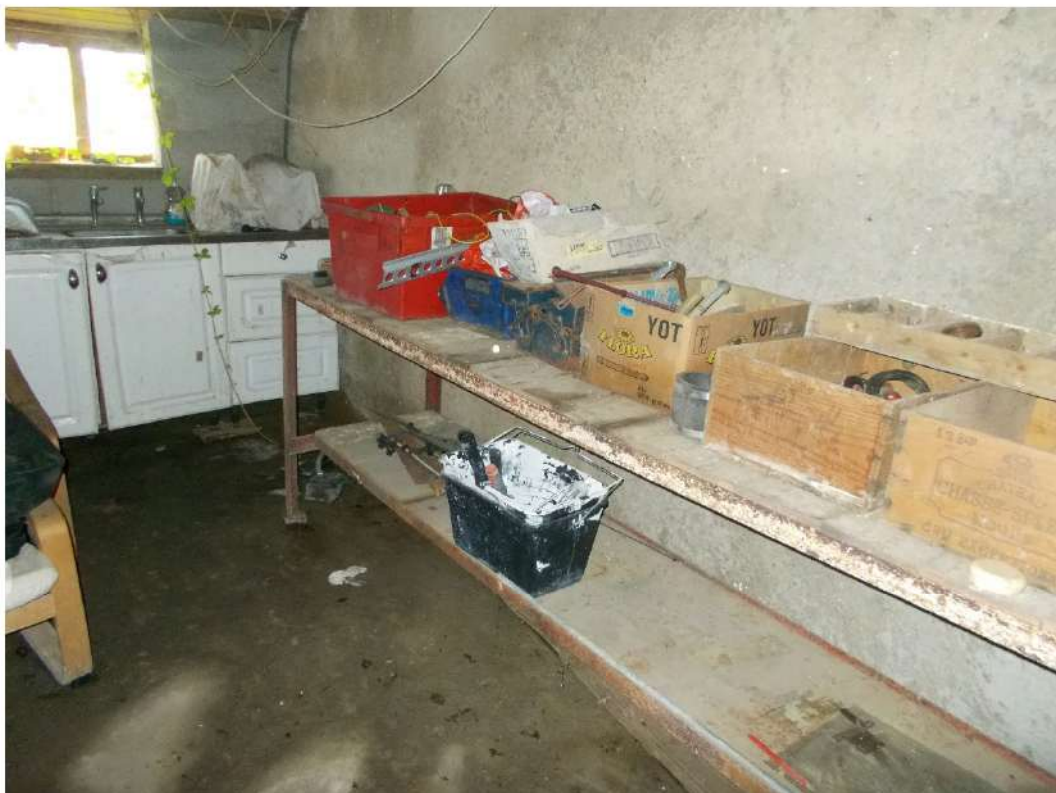
**Photograph 9:** Southern section of the shed with concrete flooring.
