# GeoShield Verification Report 1

GEO105886

Kilnwood Vale 3E  
Off Illett Way  
Faygate  
Horsham  
RH12 0AJ

Plots 583, 584, 585, 594, 595, 596 & 597 - Full Line Out

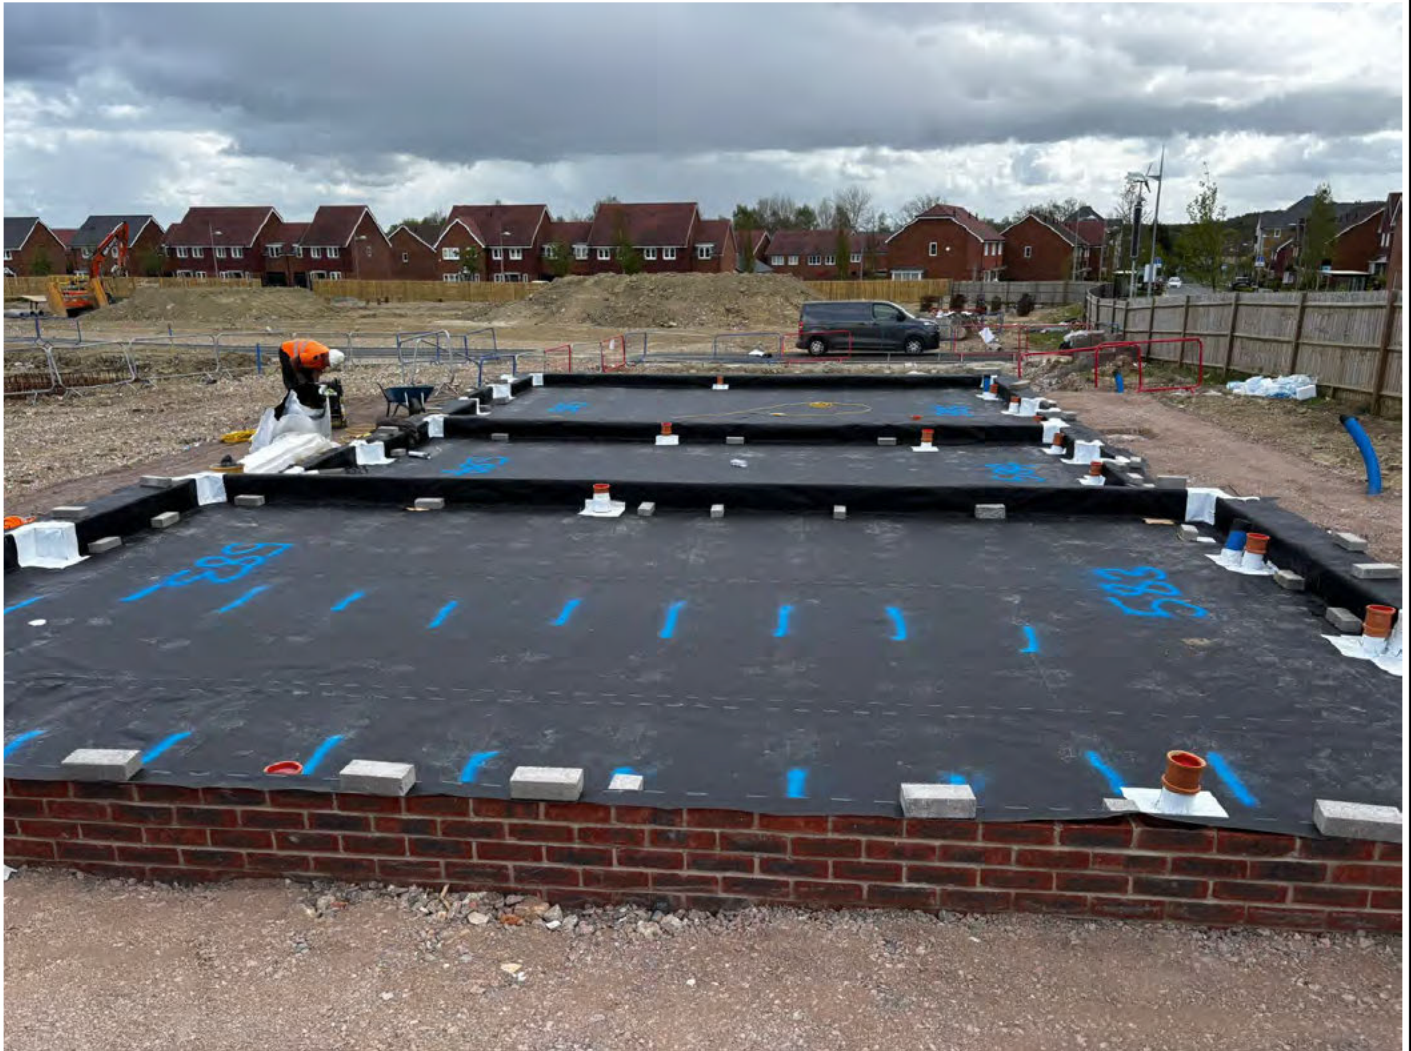
The photograph above displays an overview of Plot 583, 584 & 585 where today's verification inspection took place on site.

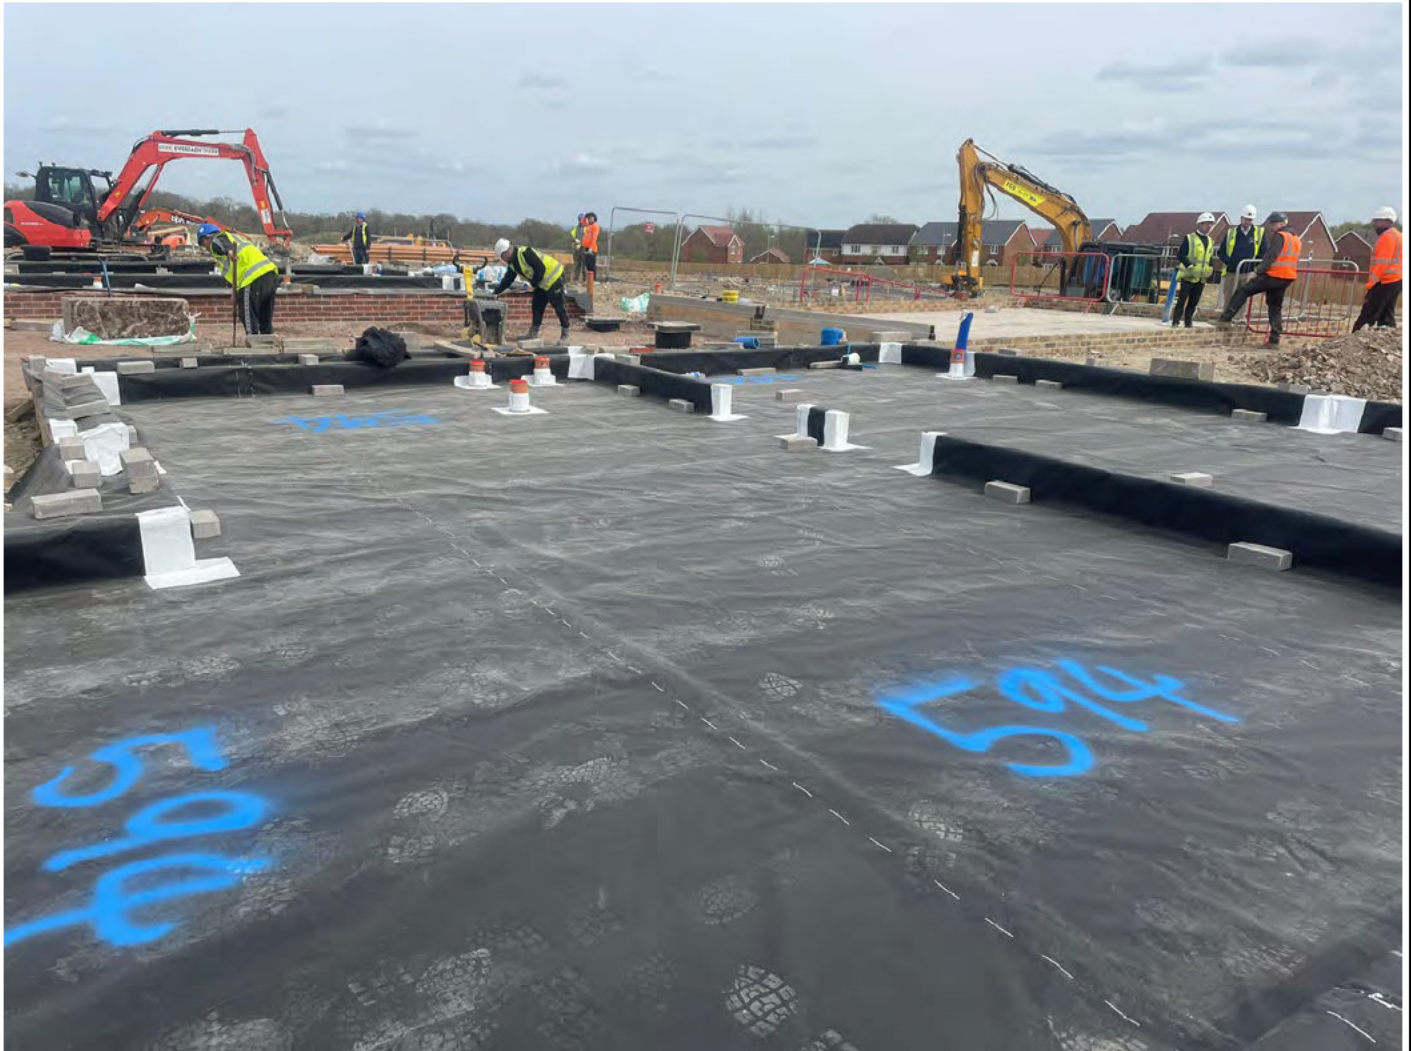
The photograph above displays an overview of Plot 594 where today's verification inspection took place on site.

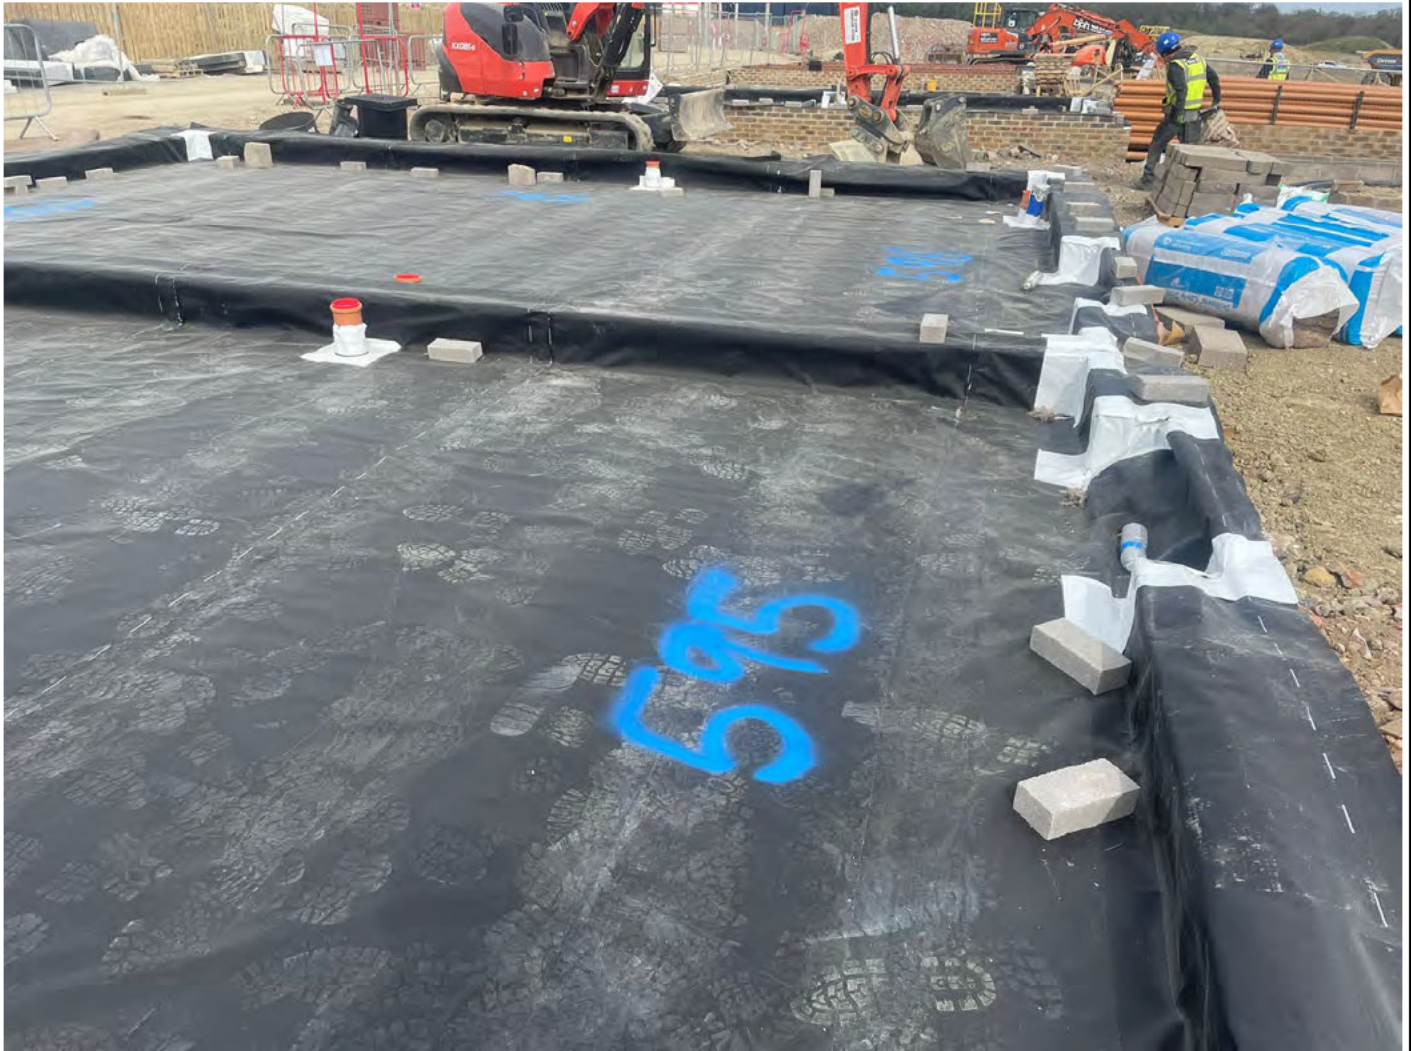
The photograph above displays an overview of Plots 595 & 596 where today's verification inspection took place on site.

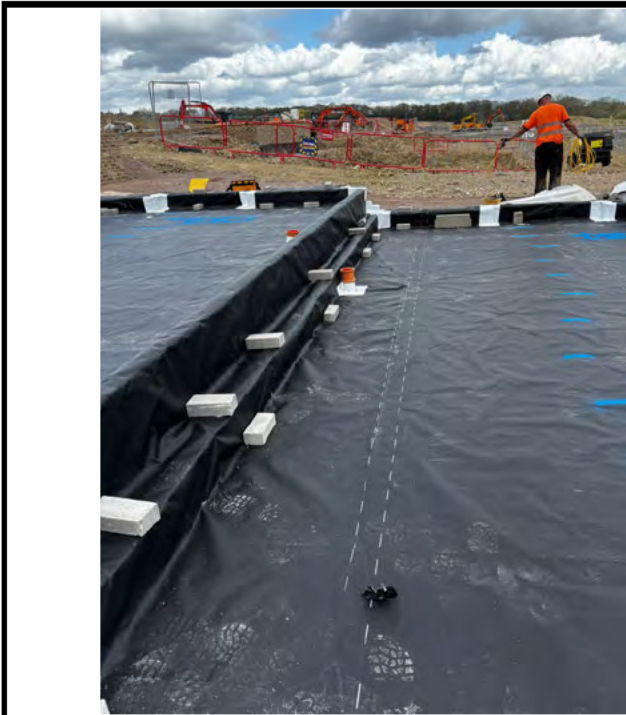
Installation of JUTA GP1 Gas Barrier - Lap Joints

A complete line out of JUTA GP1 Gas Barrier has been installed across the footprint of Plots 583, 584, 585, 594, 595, 596 & 597. The JUTA GP1 Gas Barrier has been lined out across the entirety of the plots, including all internal party walls ensuring it bridges the external cavity to the outer leaf brickwork.

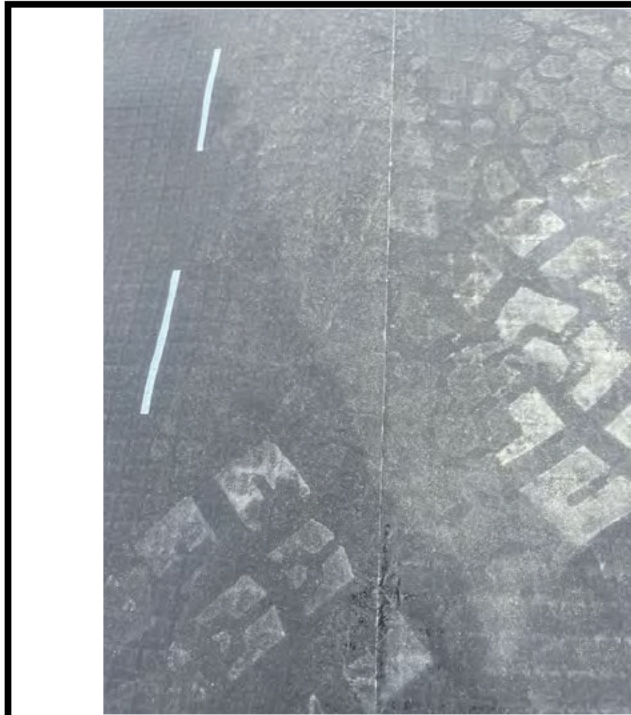
All overlaps between the adjacent sheets of JUTA GP1 Gas Barrier have been overlapped a minimum of 100mm, conforming to manufacturer's specifications and heat welded using a hot air tool and silicone roller with adequate pressure applied to ensure a continuous gas resistant seal is achieved.

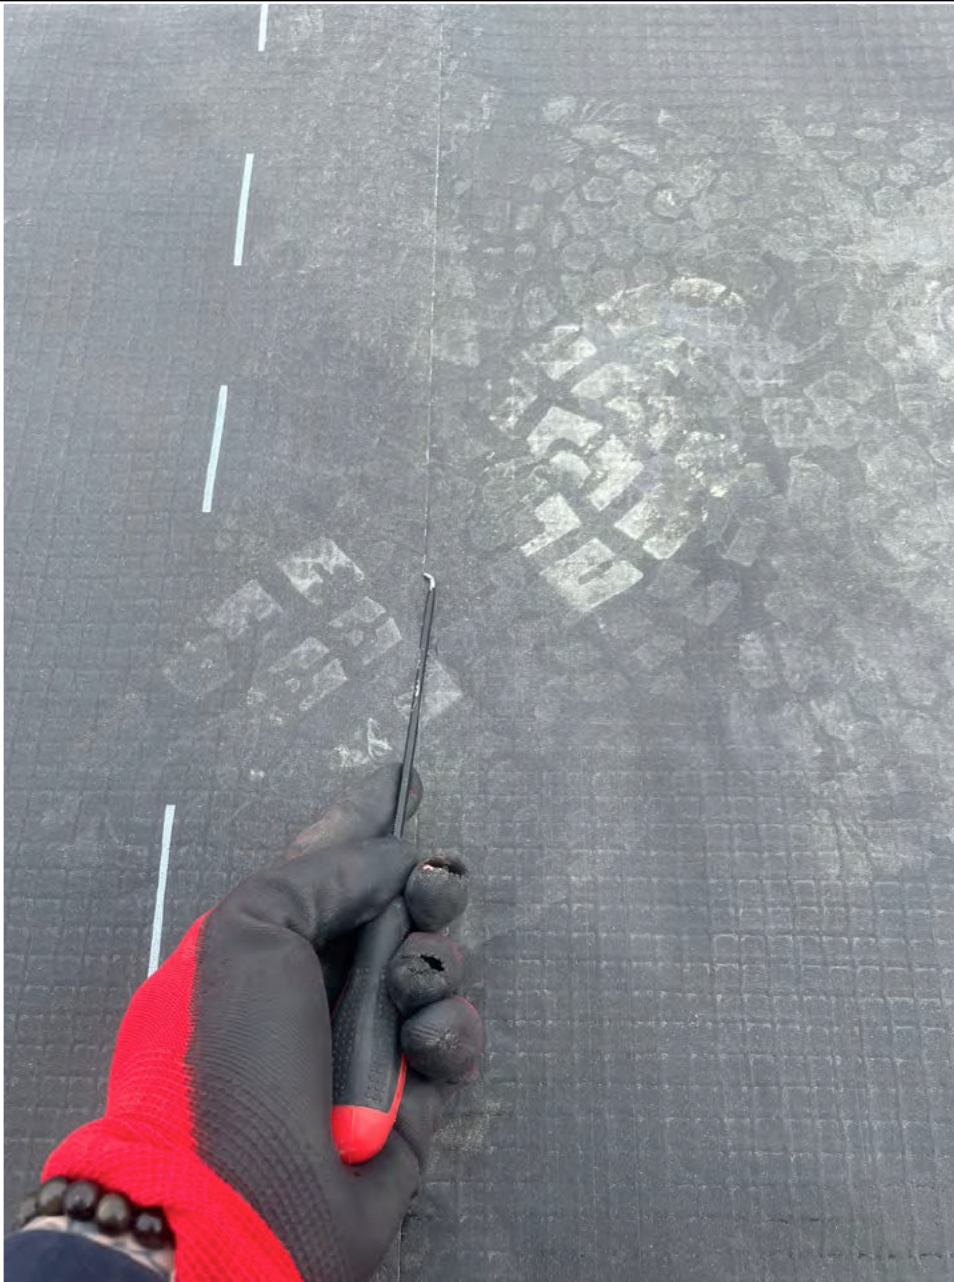
The above image demonstrates a mechanical point stress test being conducted upon a welded overlap of the JUTA GP1 Gas Barrier. All overlaps were subjected to thorough visual inspections, mechanical point stress testing and non destructive air lance integrity testing throughout the verification process. No faults or defects were identified at the time of the inspection.

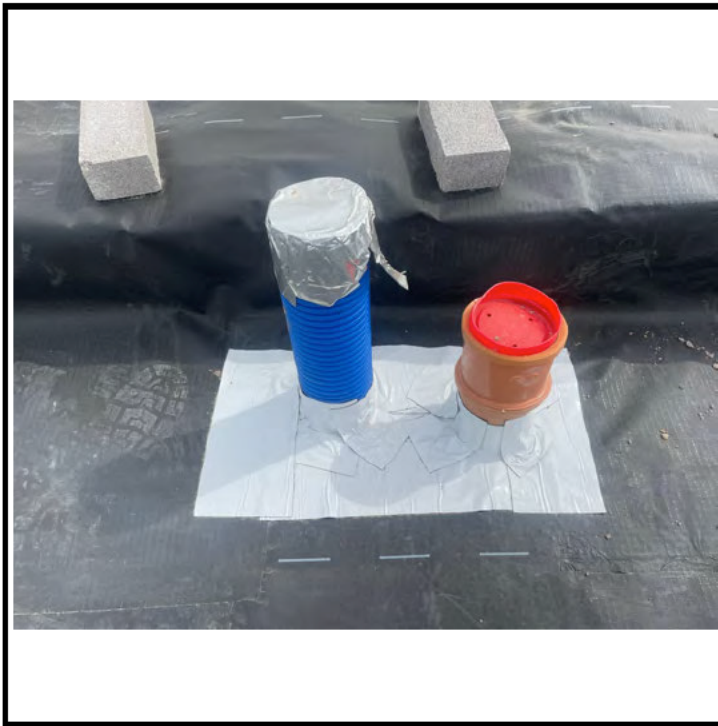
### Pipe Penetrations

Throughout the complete line out installation of the JUTA GP1 Gas Barrier to the referenced plots, there were a number of pipe penetrations that have been sealed in accordance with manufacturer's specifications and guidelines. This has been achieved using JUTA GP SAM, which is a gas resistant self adhesive membrane.

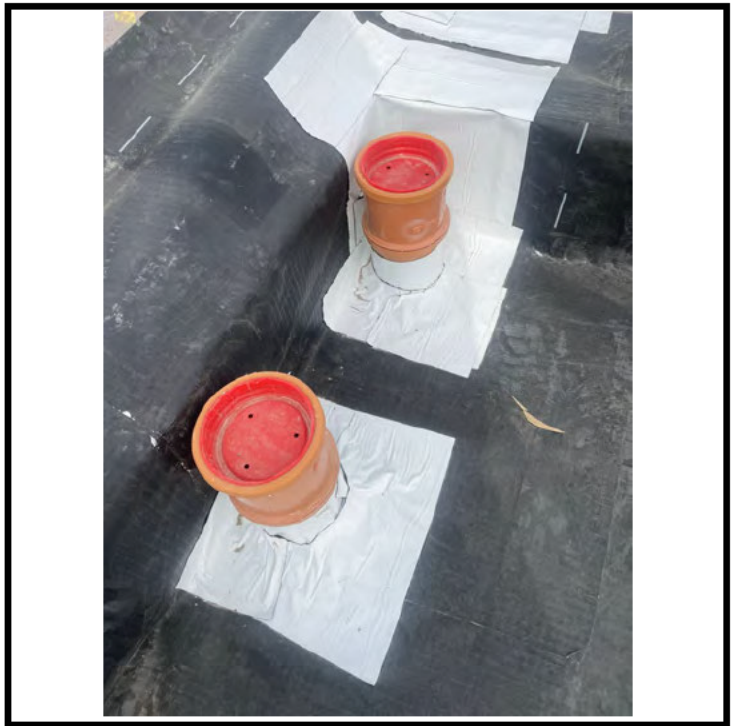
The installers have first cut the JUTA GP1 Gas Barrier tight around the base of each pipe penetration to minimise voided areas. Next, patches of JUTA GP SAM are placed intricately around the pipe and onto the JUTA GP1 Gas Barrier, with a 300mm square of JUTA GP SAM placed over the top to form a top hat detail.

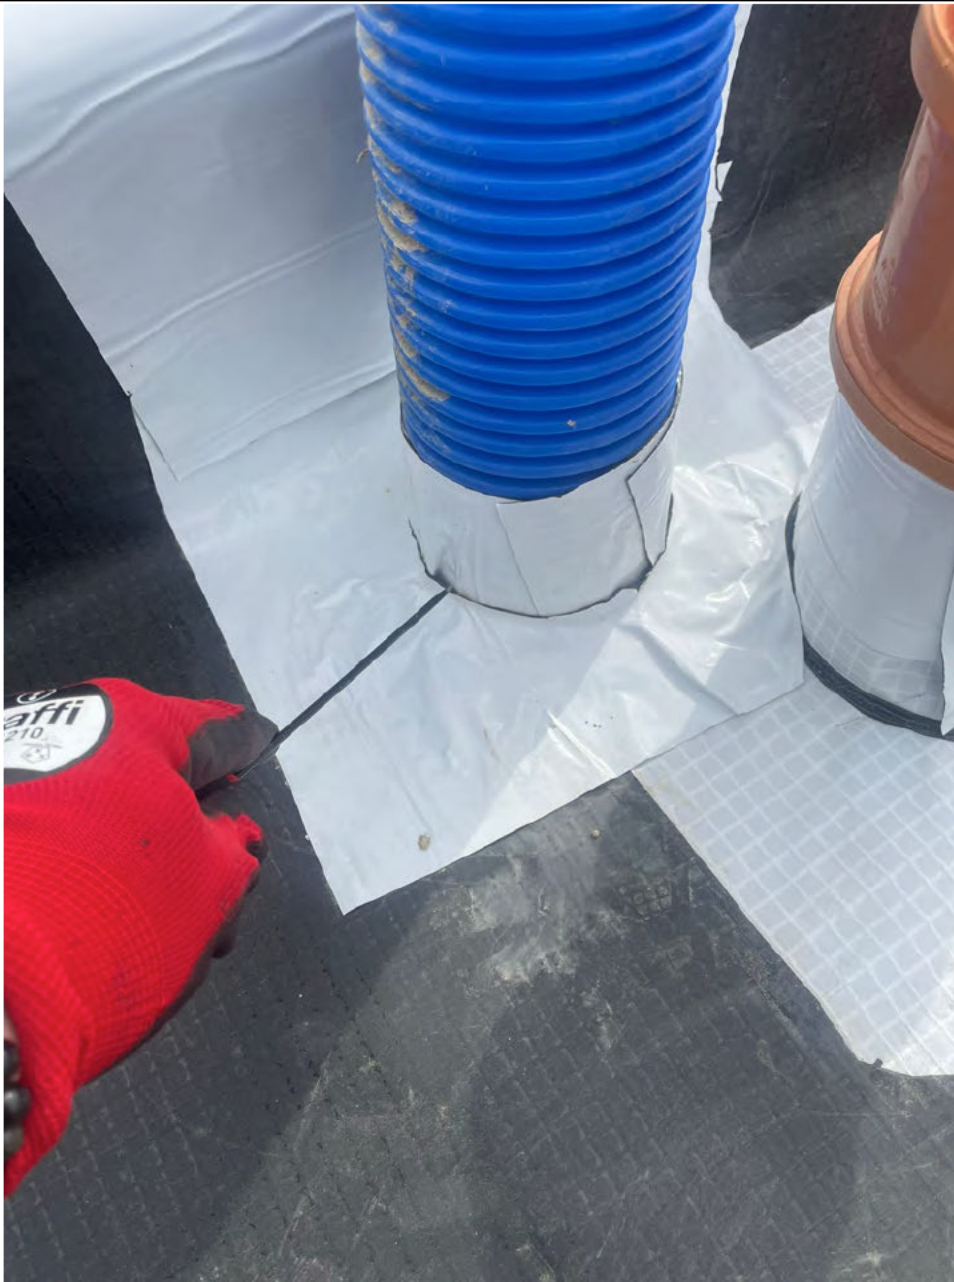
Heat and rolled pressure have been applied to activate the bitumen backing, creating a secure bond between the pipe and the JUTA GP1 Gas Barrier. Thorough visual inspections, supported by mechanical point stress testing and non destructive air lance integrity testing conducted upon all pipe penetrations identified no faults or defects.

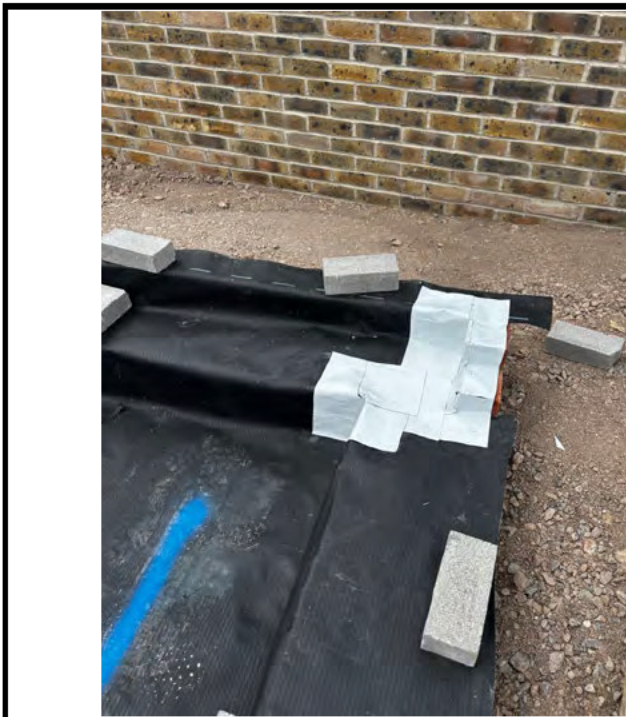
### Corner Detailing

A number of corners throughout the referenced plots have also been sealed as per manufacturer's specifications and design guidelines. This has been achieved using JUTA GP SAM. Where the JUTA GP1 Gas Barrier has been folded to minimise voided areas and gaps across the footprint of the plots, each corner

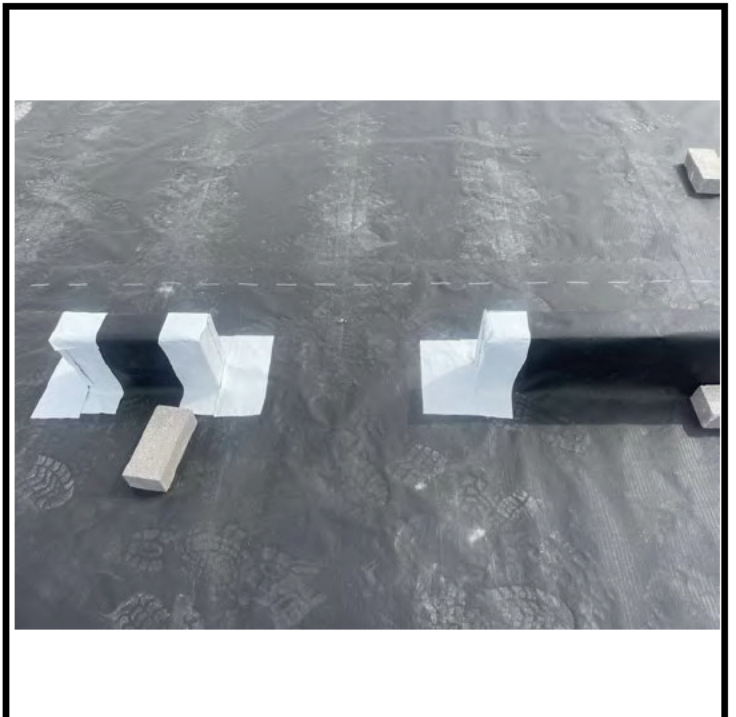
junction has been reinforced by heating strips of JUTA GP SAM and placing into position around each corner, onto the JUTA GP1 Gas Barrier. Firm rolled pressure is applied with a silicone roller to aid in the adhesion, ensuring the JUTA GP SAM has fully bonded.

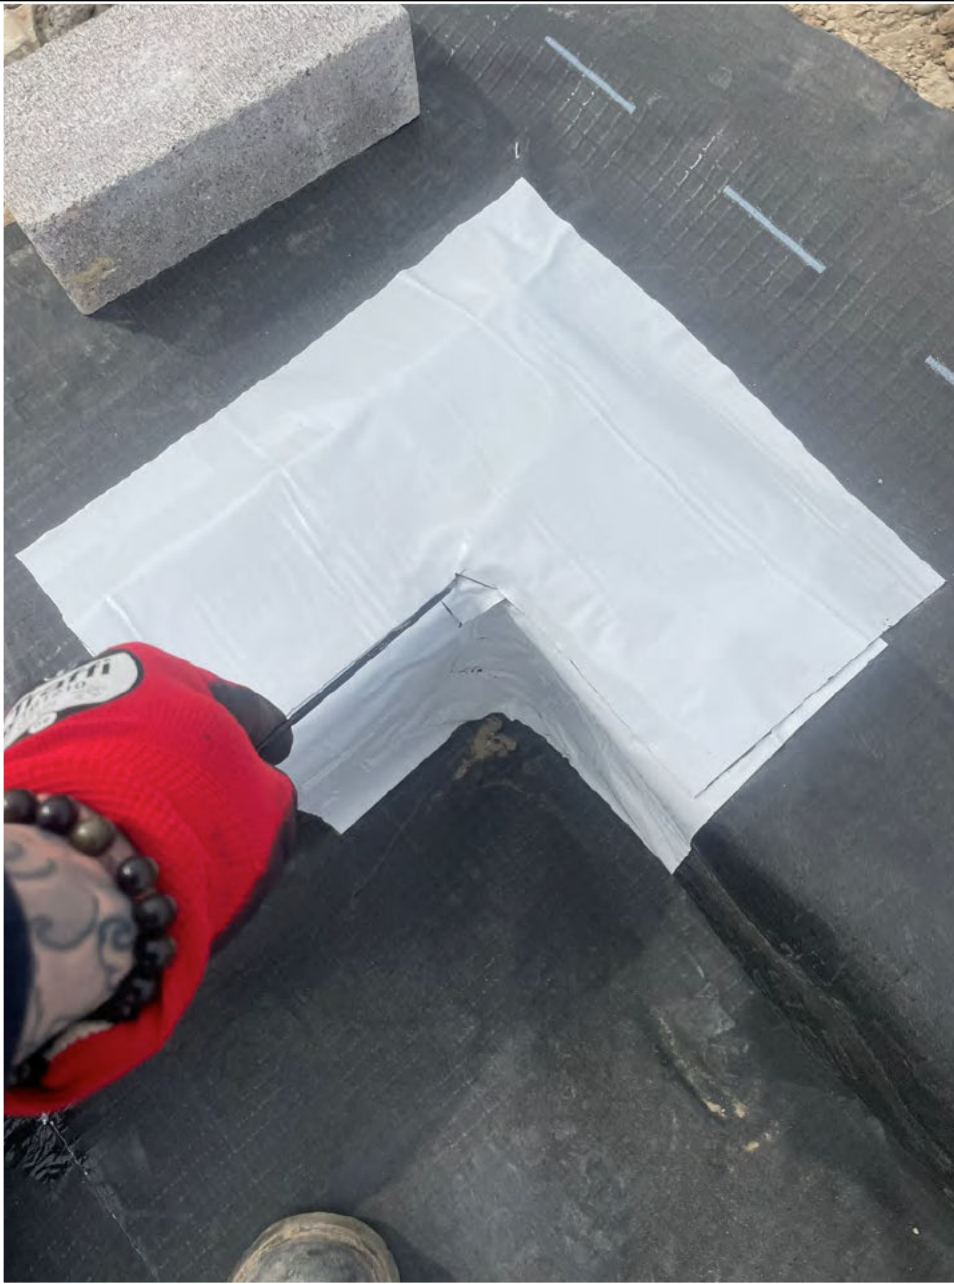
A probe and air lance were run along all edges of the JUTA GP SAM corner detailing to validate that a continuous gas resistant seal had been achieved throughout. No faults or defects were identified.

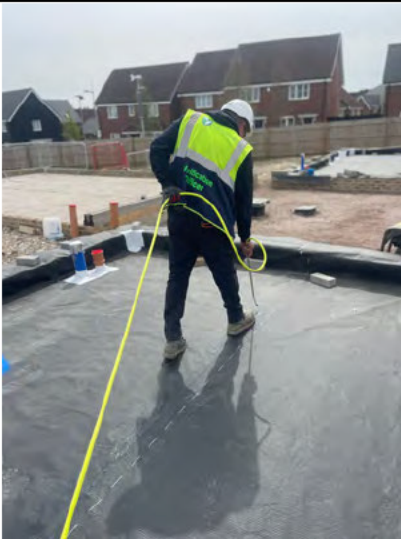
Air lance test on a welded lap.

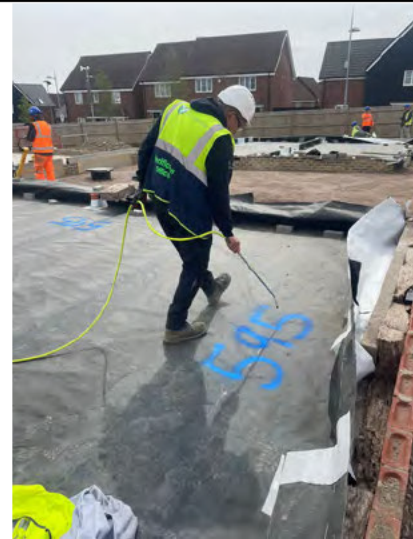
Air lance test on a welded lap.

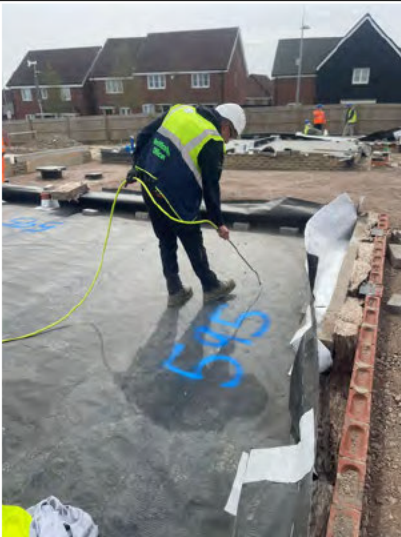
Air lance test on a welded lap.

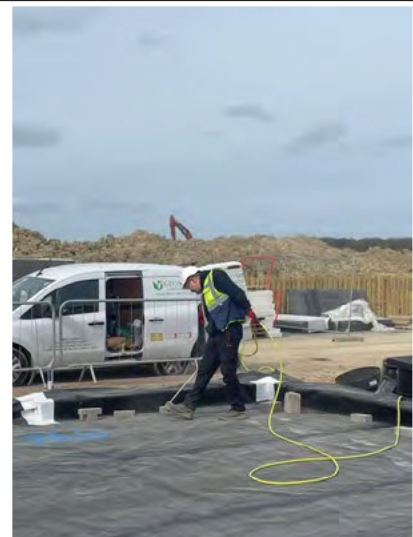
Air lance test on a welded lap.

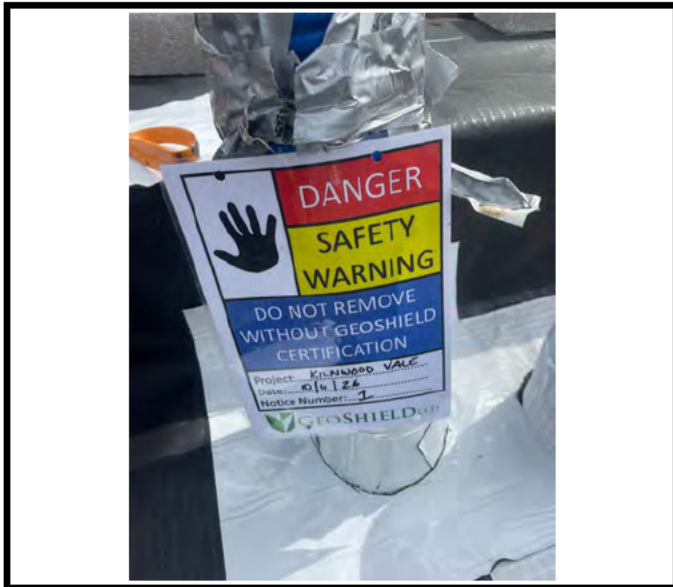
GeoShield safety warning notices placed around details to be sealed internally at a later date.

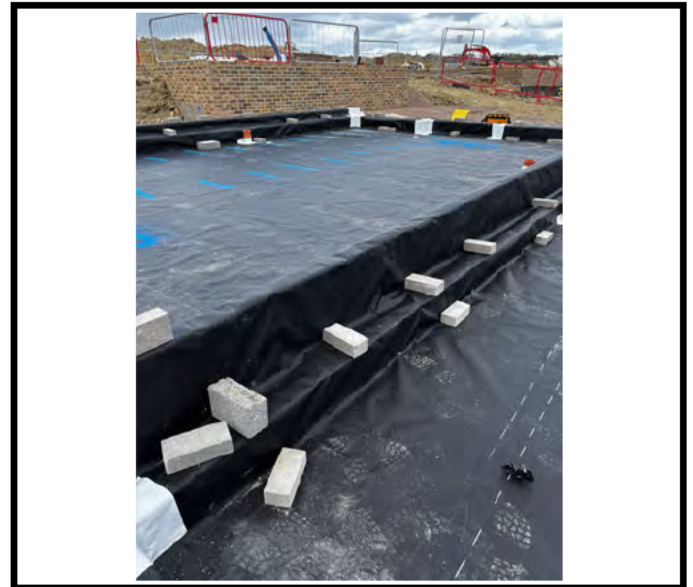
The JUTA GP1 Gas Barrier taken over the internal cavities to ensure continuity throughout.

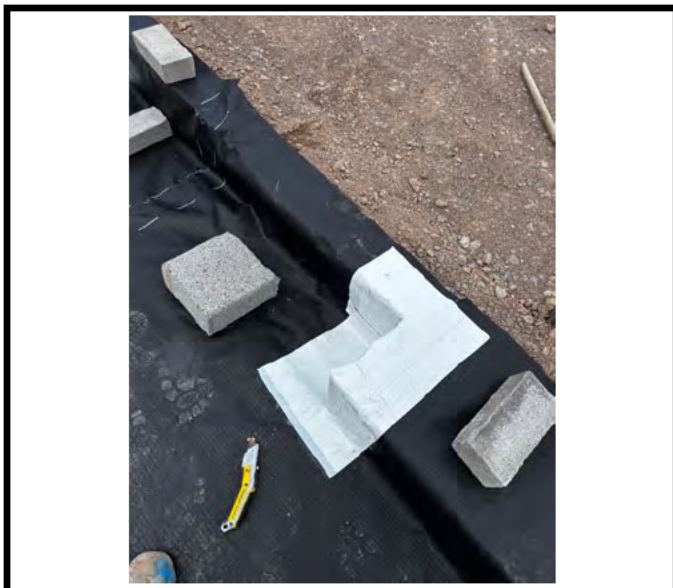
Typical corner detailing.

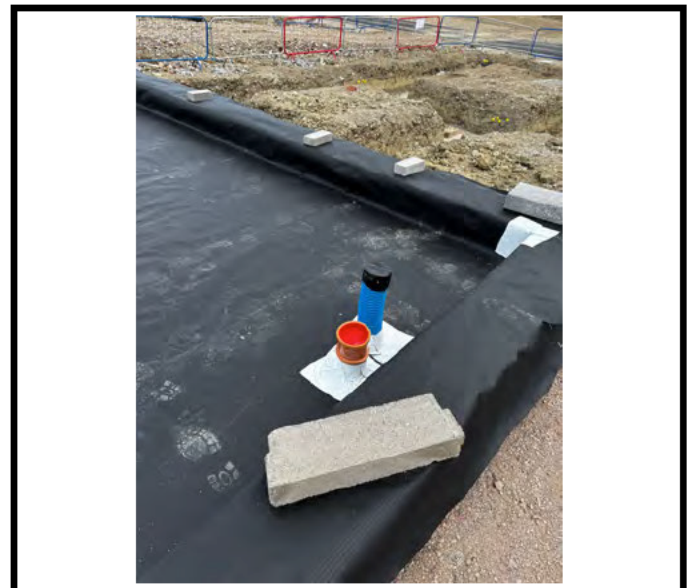
Typical pipe penetration detailing.
