# GeoShield Verification Report 2

GEO105886

Kilnwood Vale 3E  
Off Illett Way  
Faygate  
Horsham  
RH12 0AJ

Plots 586, 587 & 599 - Full Line Out

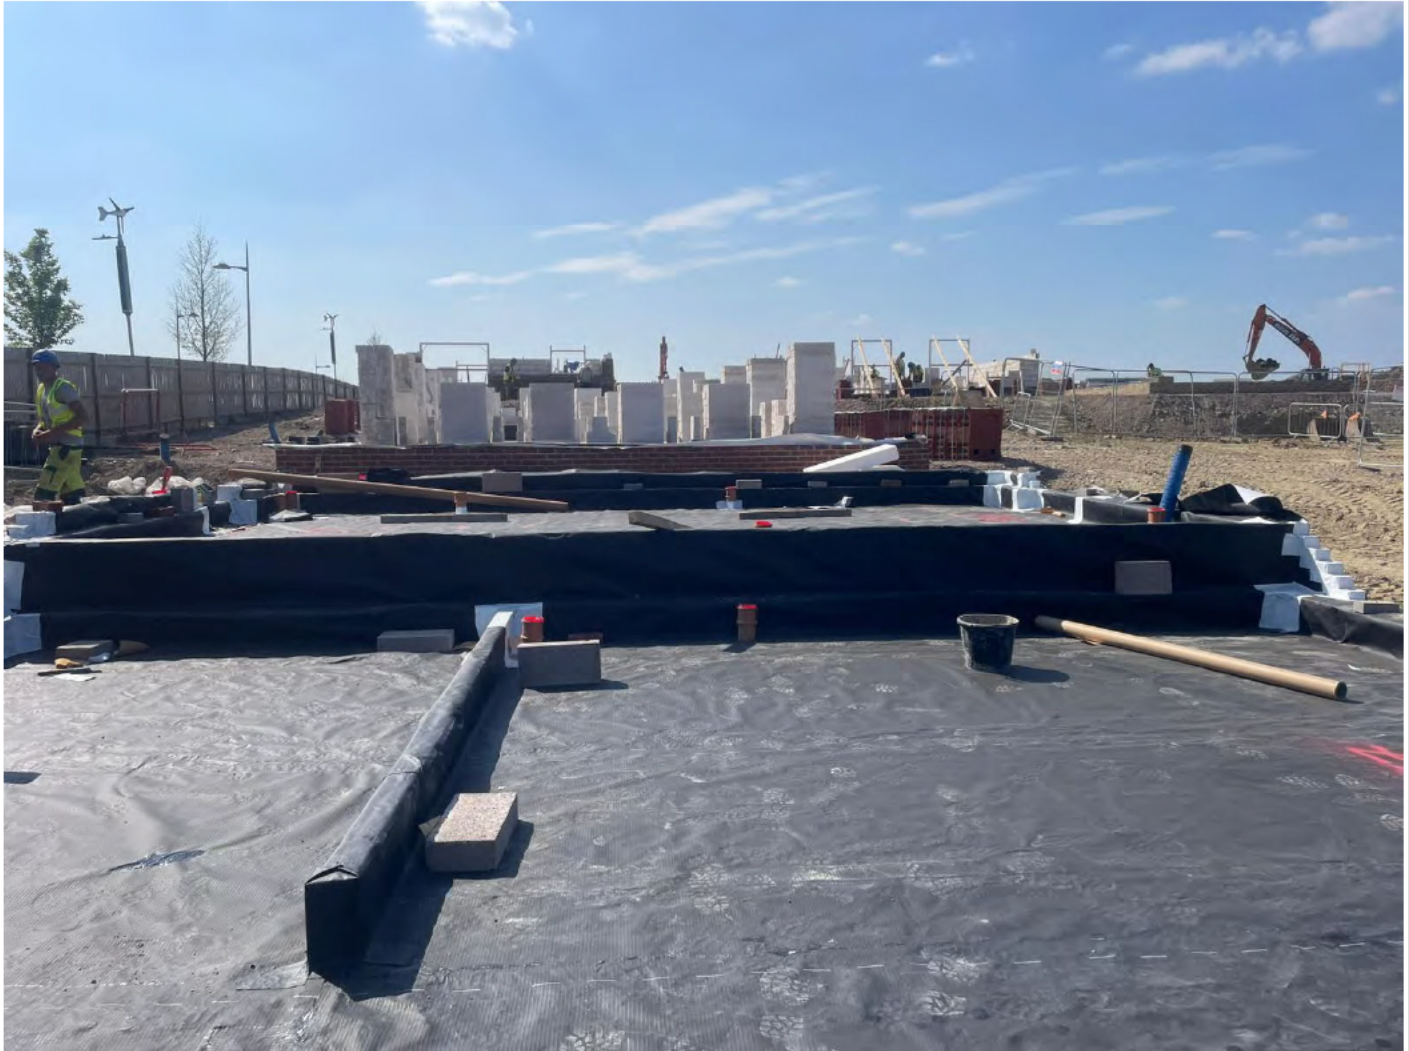
The photograph above displays an overview of Plots 586 & 587 where today's verification inspection took place on site.

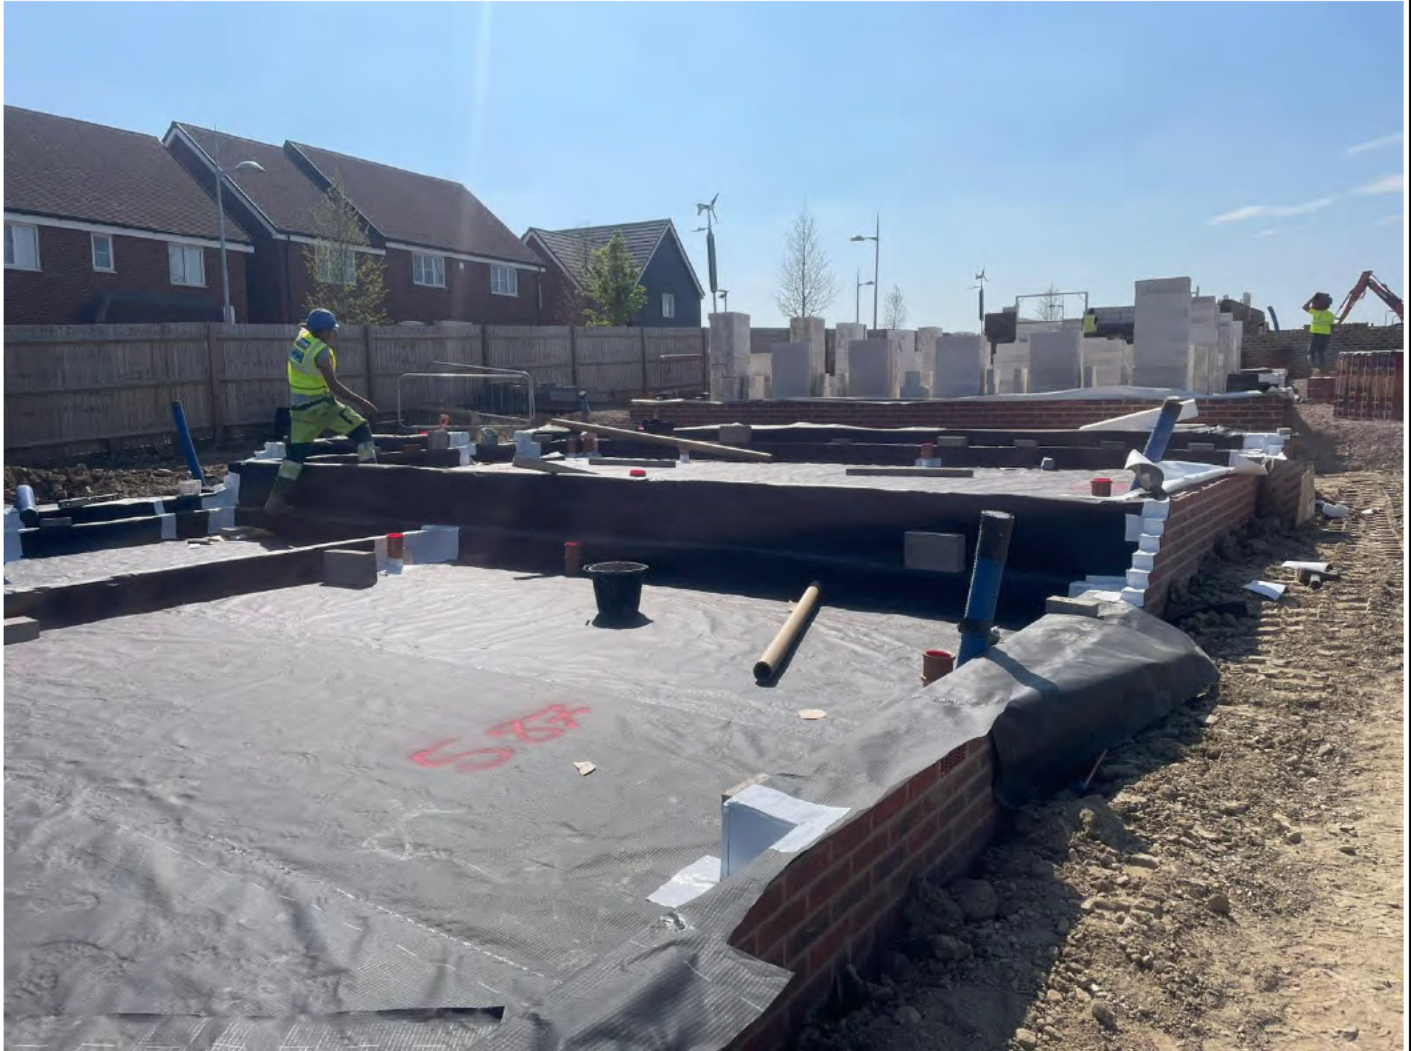
The photograph above displays an overview of Plots 586 & 587 where today's verification inspection took place on site.

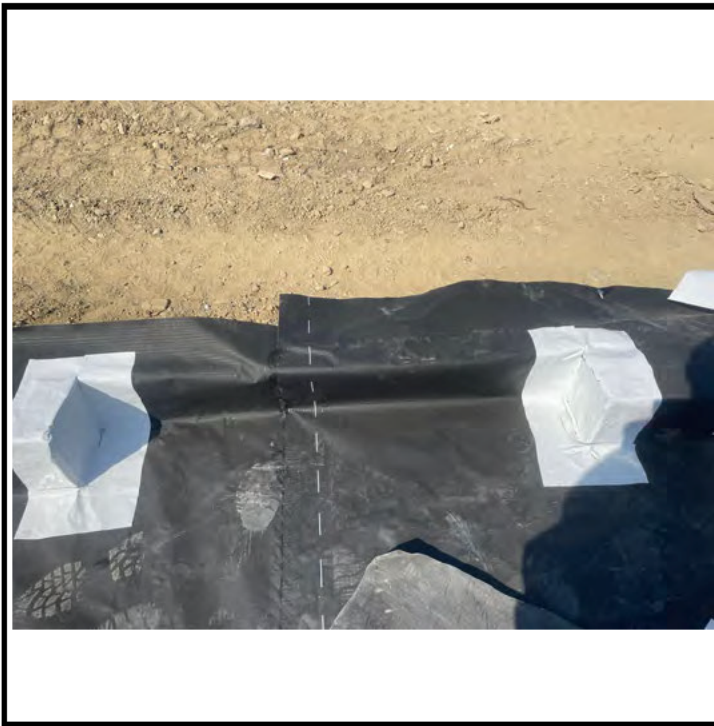
Installation of JUTA GP1 Gas Barrier - Lap Joints

A complete line out of JUTA GP1 Gas Barrier has been installed across the footprint of Plots 586, 587 & 599. The JUTA GP1 Gas Barrier has been lined out across the entirety of the plots, including all internal party walls ensuring it bridges the external cavity to the outer leaf brickwork.

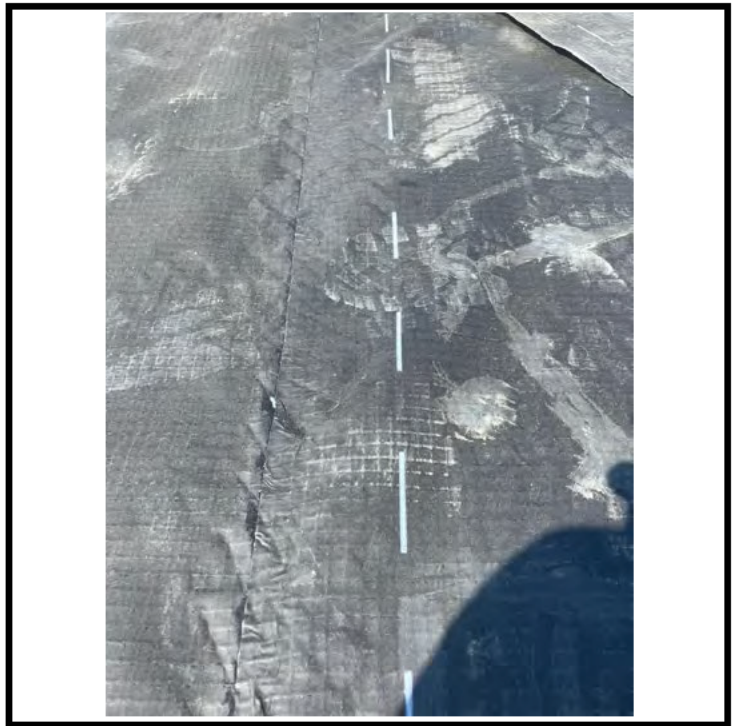
All overlaps between the adjacent sheets of JUTA GP1 Gas Barrier have been overlapped a minimum of 100mm, conforming to manufacturer's specifications and heat welded using a hot air tool and silicone roller with adequate pressure applied to ensure a continuous gas resistant seal is achieved.

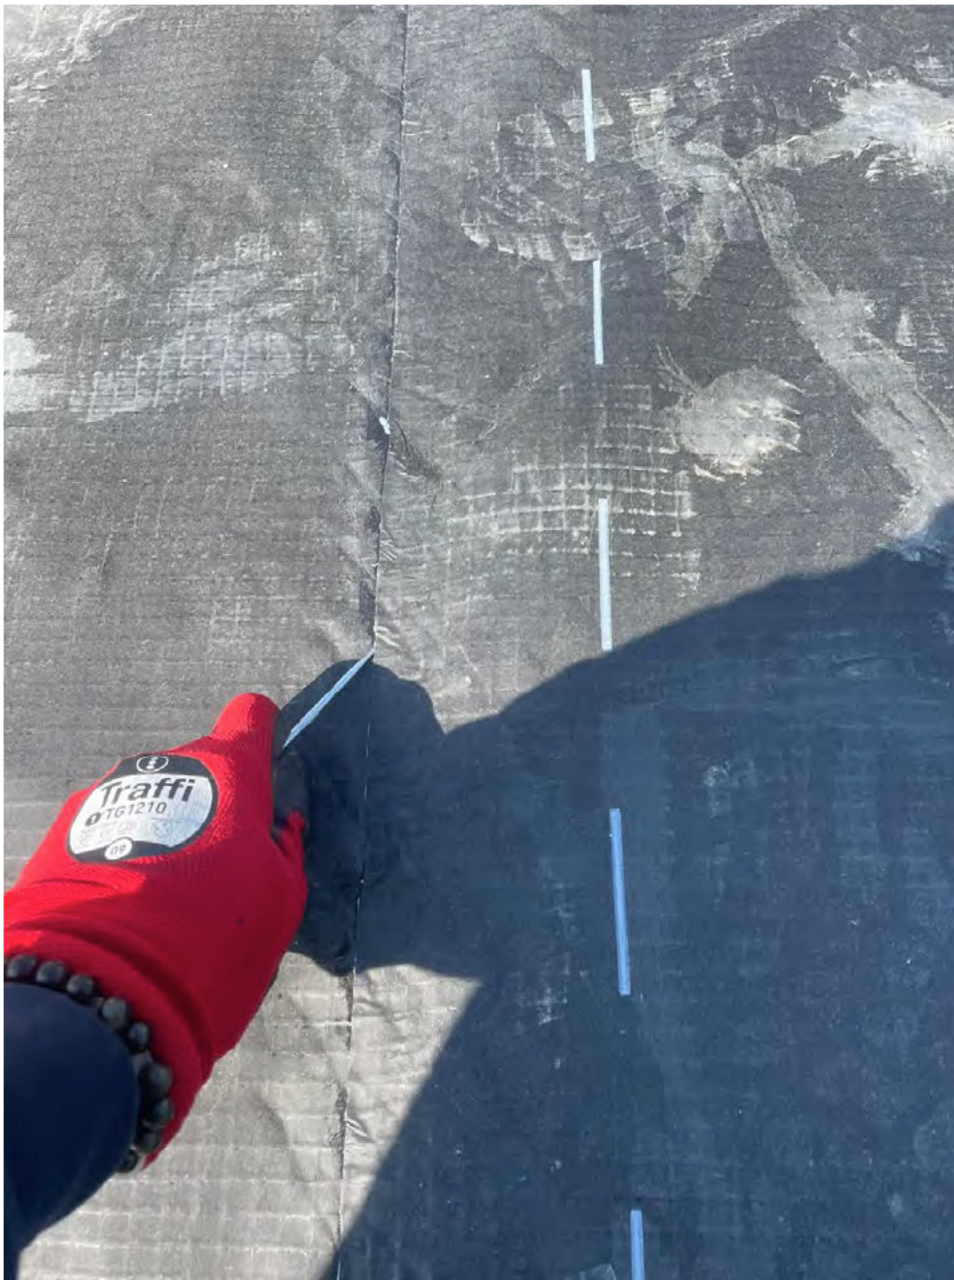
The above image demonstrates a mechanical point stress test being conducted upon a welded overlap of the JUTA GP1 Gas Barrier. All overlaps were subjected to thorough visual inspections, mechanical point stress testing and non destructive air lance integrity testing throughout the verification process. No faults or defects were identified at the time of the inspection.

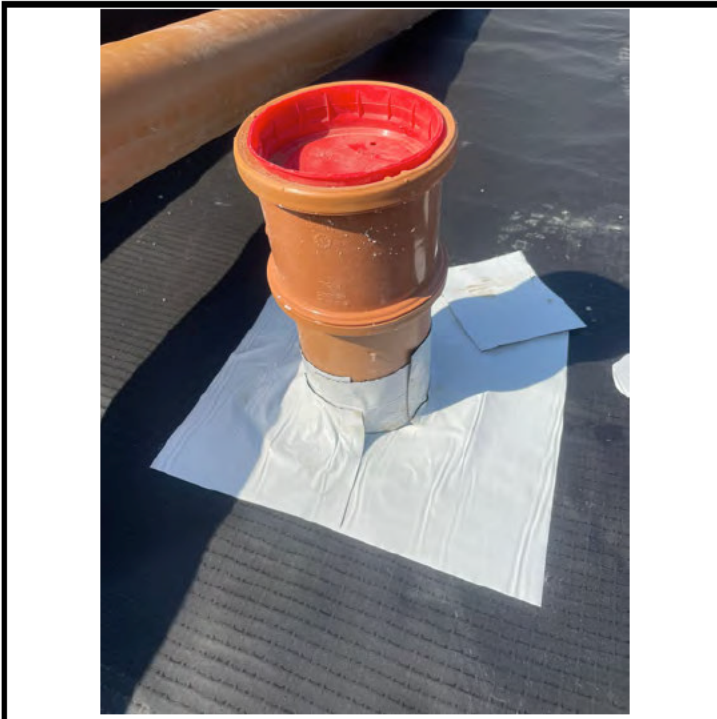
### Pipe Penetrations

Throughout the complete line out installation of the JUTA GP1 Gas Barrier to the referenced plots, there were a number of pipe penetrations that have been sealed in accordance with manufacturer's specifications and guidelines. This has been achieved using JUTA GP SAM, which is a gas resistant self adhesive membrane.

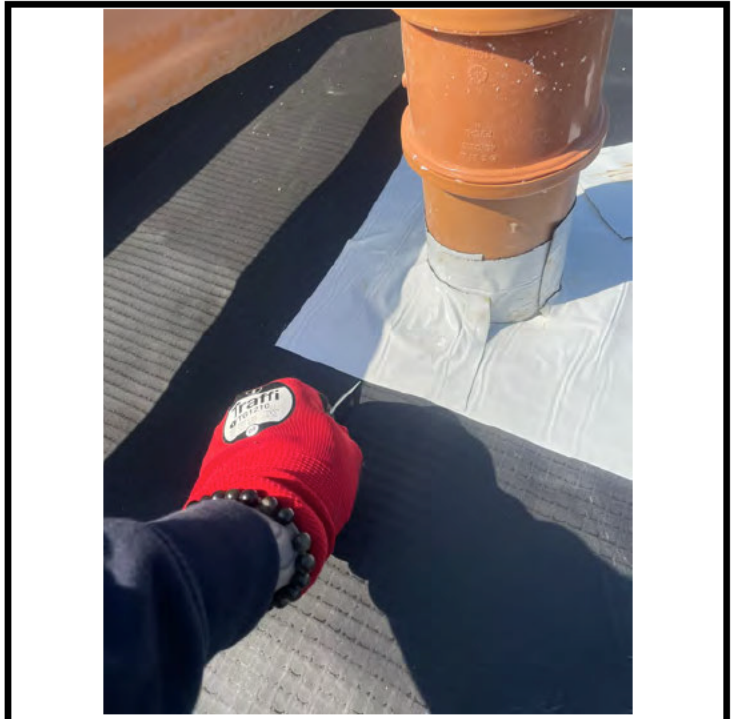
The installers have first cut the JUTA GP1 Gas Barrier tight around the base of each pipe penetration to minimise voided areas. Next, patches of JUTA GP SAM are placed intricately around the pipe and onto the JUTA GP1 Gas Barrier, with a 300mm square of JUTA GP SAM placed over the top to form a top hat detail.

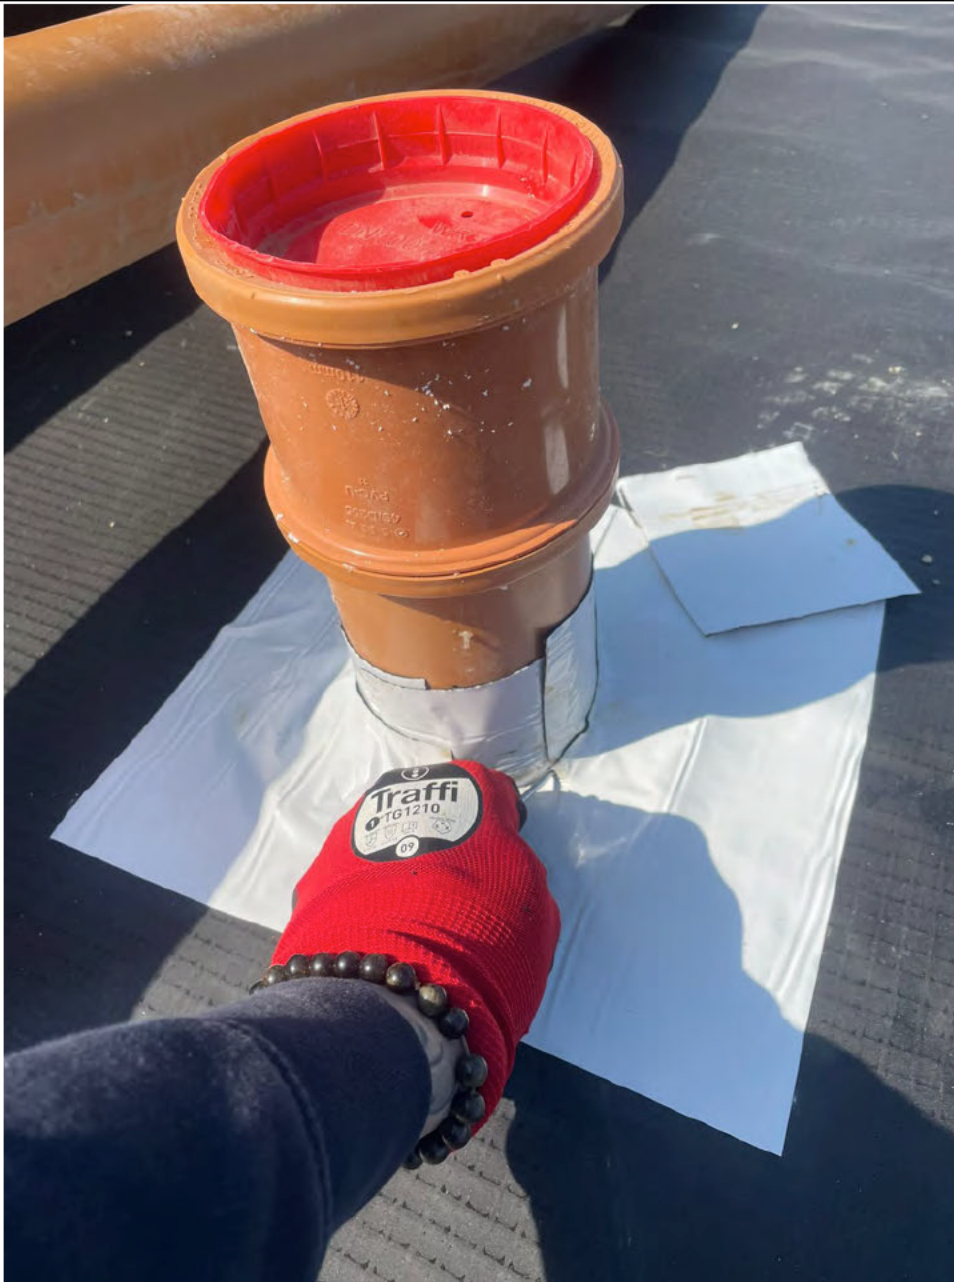
Heat and rolled pressure have been applied to activate the bitumen backing, creating a secure bond between the pipe and the JUTA GP1 Gas Barrier. Thorough visual inspections, supported by mechanical point stress testing and non destructive air lance integrity testing conducted upon all pipe penetrations identified no faults or defects.  
Tested and verified in accordance with CIRIA C735.

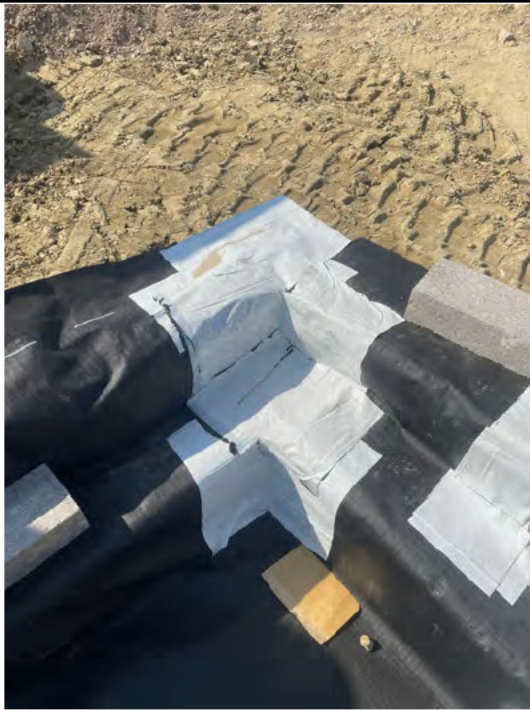
### Corner Detailing

A number of corners throughout the referenced plots have also been sealed as per manufacturer's specifications and design guidelines. This has been achieved using JUTA GP SAM. Where the JUTA GP1 Gas Barrier has been folded to minimise voided areas and gaps across the footprint of the plots, each corner

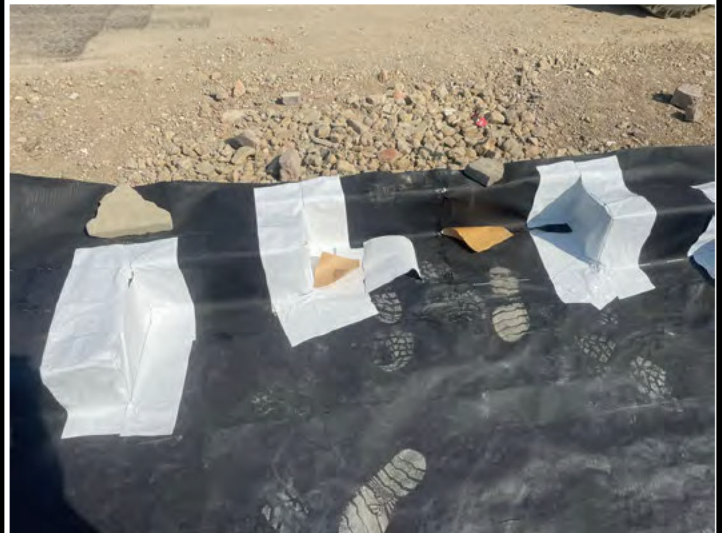
junction has been reinforced by heating strips of JUTA GP SAM and placing into position around each corner, onto the JUTA GP1 Gas Barrier. Firm rolled pressure is applied with a silicone roller to aid in the adhesion, ensuring the JUTA GP SAM has fully bonded.

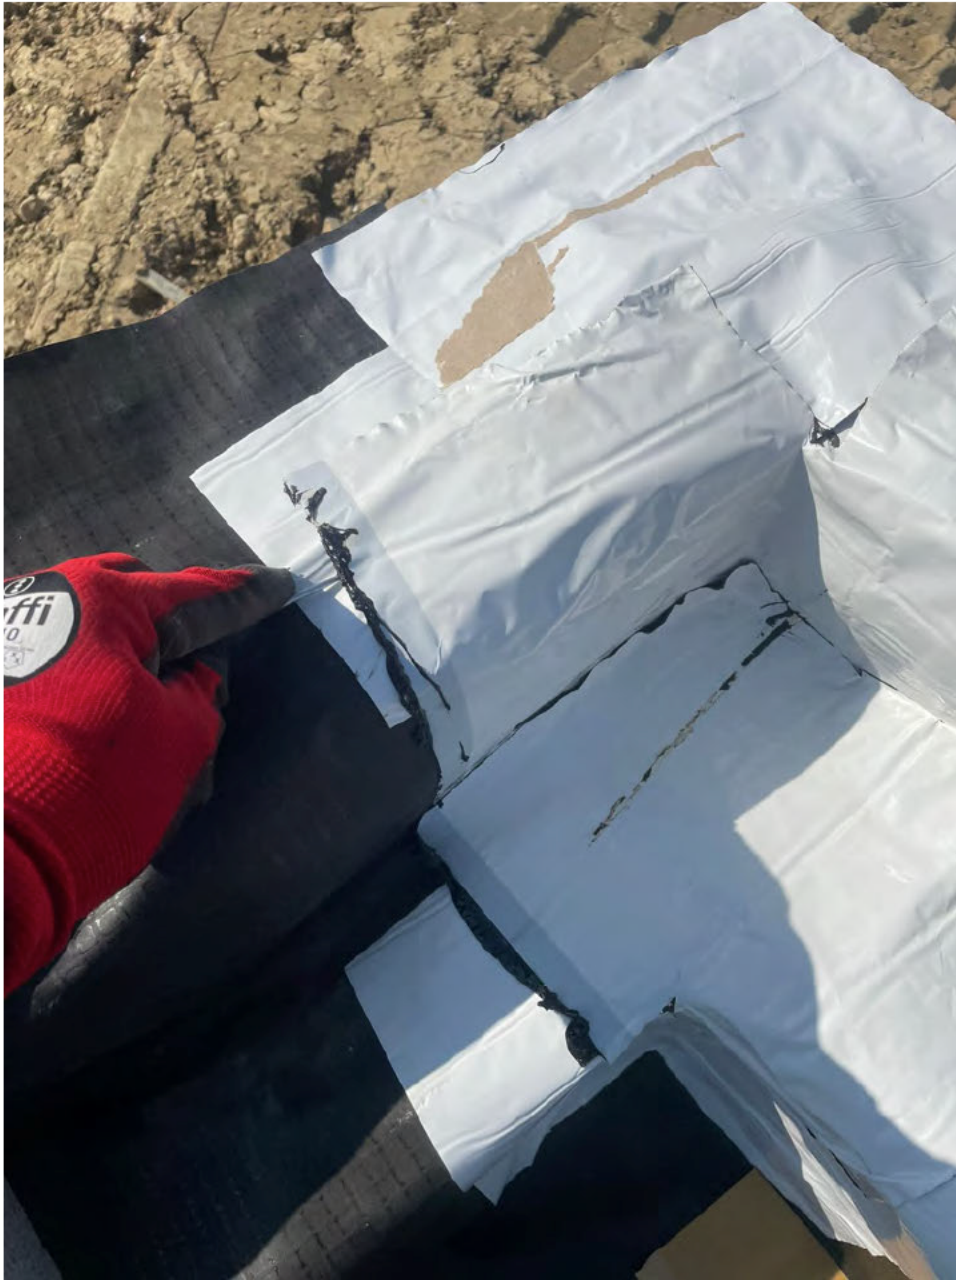
A probe and air lance were run along all edges of the JUTA GP SAM corner detailing to validate that a continuous gas resistant seal had been achieved throughout. No faults or defects were identified.

Tested and verified in accordance with CIRIA C735.

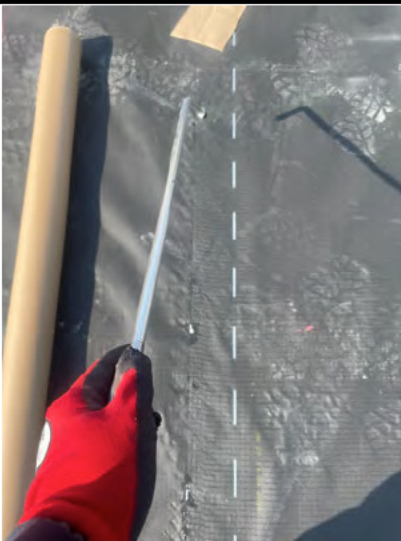
Air lance test on a welded lap.

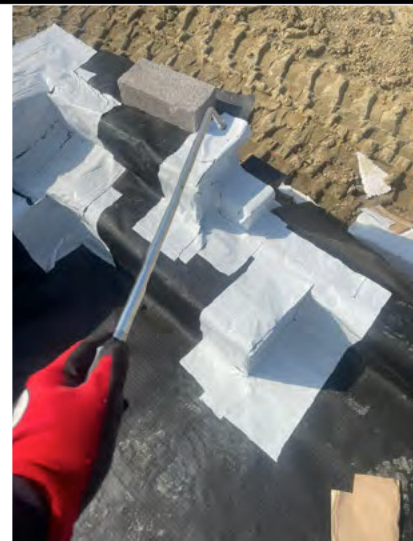
Air lance test on a corner.

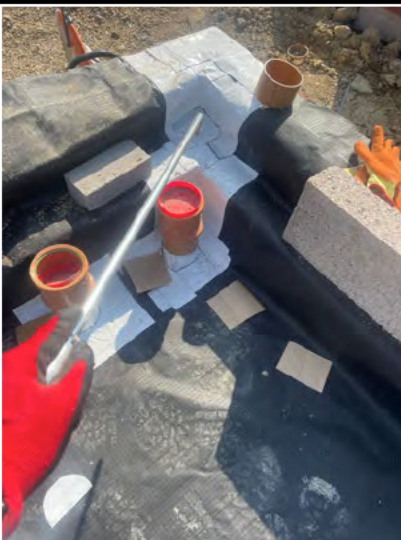
Air lance test on a pipe penetration.

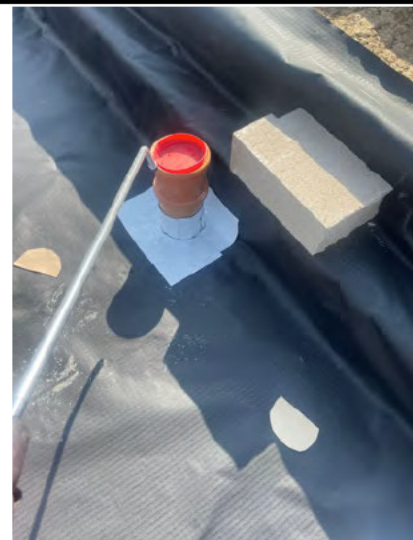
Air lance test on a pipe penetration.
