# GeoShield Verification Report 3

GEO105886

Kilnwood Vale 3E  
Off Illett Way  
Faygate  
Horsham  
RH12 0AJ

Plots 590 & 591 - Full Line Out  
Plots 592 & 593 - CQA

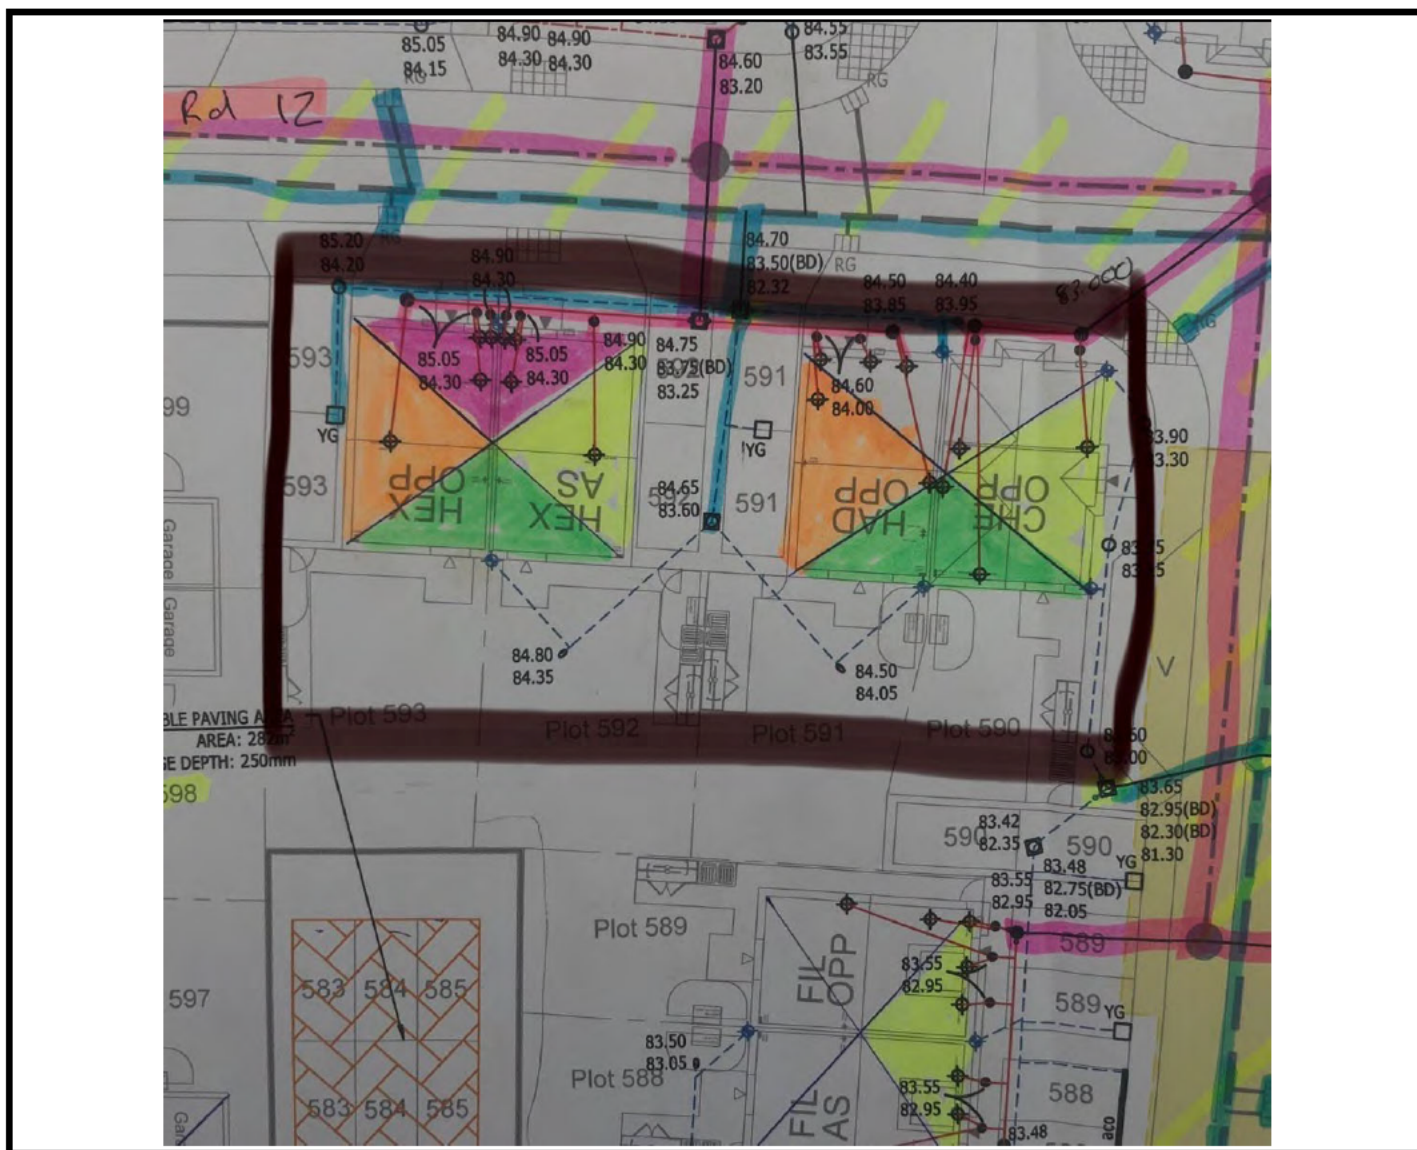
The photograph above shows a plan layout of the site. The areas highlighted show Plots 590, 591, 592 & 593 where the verification inspection took place on site today.

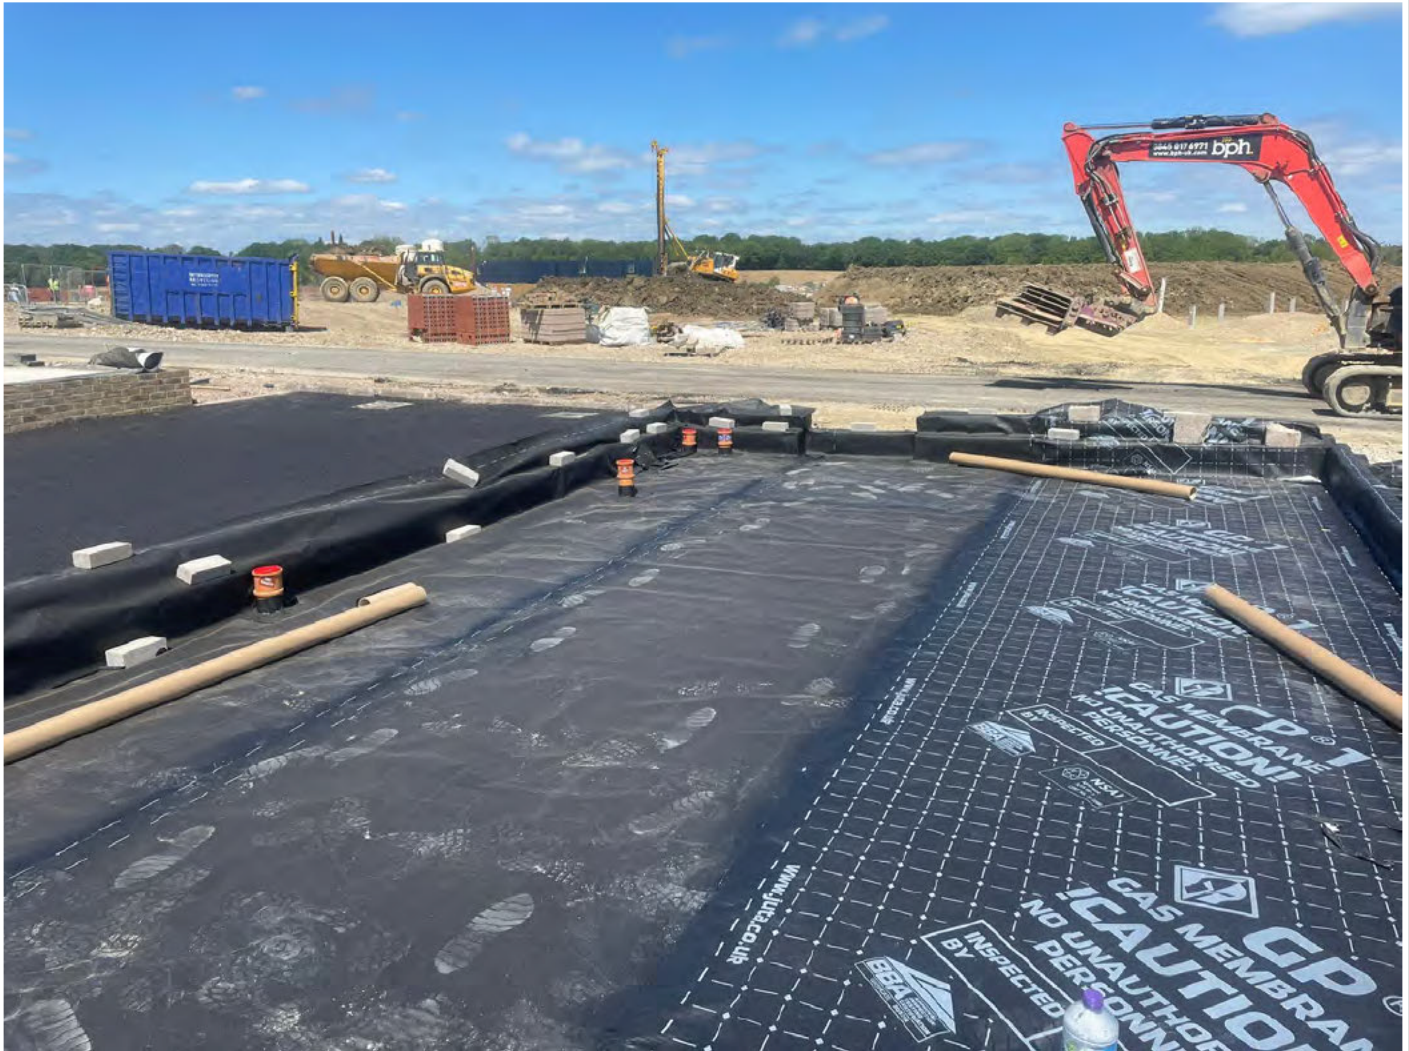
The photograph above displays an overview of Plots 590 & 591 where today's verification inspection took place on site.

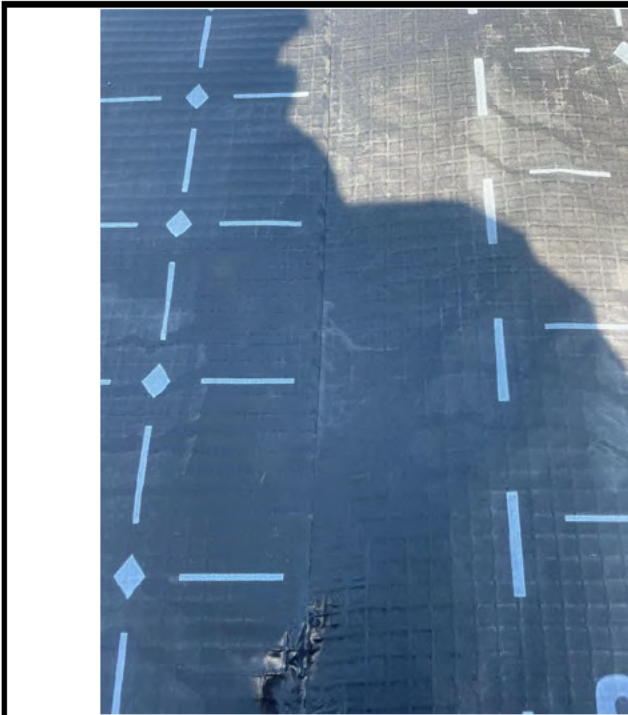
Installation of JUTA GP1 Gas Barrier - Lap Joints

A complete line out of JUTA GP1 Gas Barrier has been installed across the footprint of Plots 590 & 591. The JUTA GP1 Gas Barrier has been lined out across the entirety of the plots, including all internal party walls ensuring it bridges the external cavity to the outer leaf brickwork.

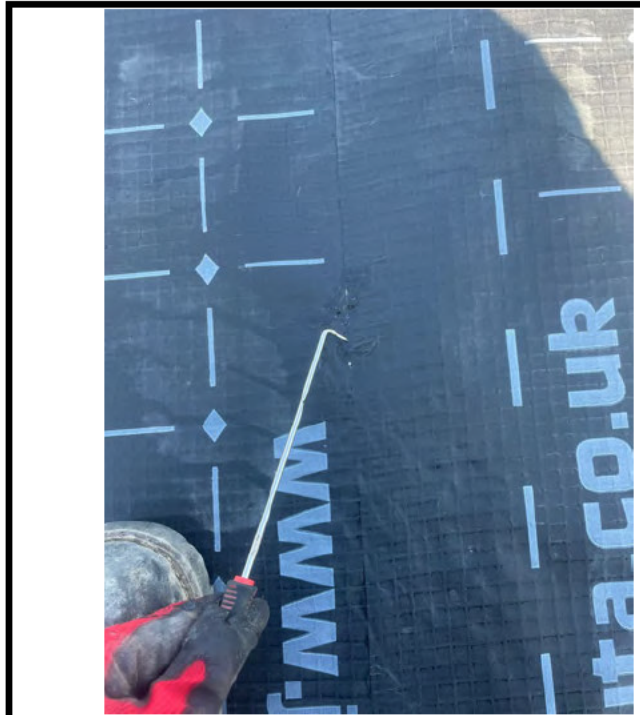
All overlaps between the adjacent sheets of JUTA GP1 Gas Barrier have been overlapped a minimum of 100mm, conforming to manufacturer's specifications and heat welded using a hot air tool and silicone roller with adequate pressure applied to ensure a continuous gas resistant seal is achieved.

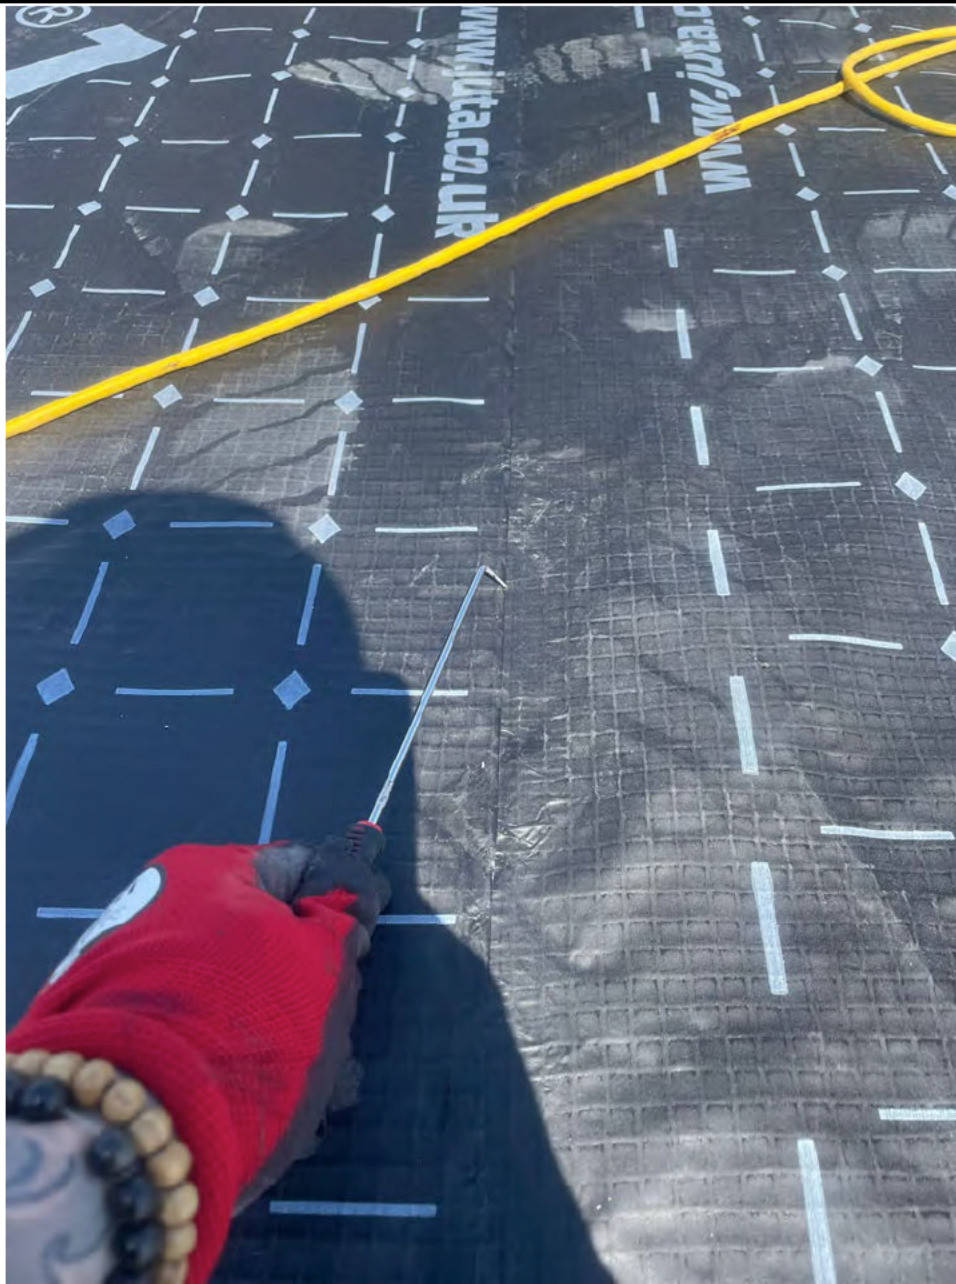
The above image demonstrates a mechanical point stress test being conducted upon a welded overlap of the JUTA GP1 Gas Barrier. All overlaps were subjected to thorough visual inspections, mechanical point stress testing and non destructive air lance integrity testing throughout the verification process. No faults or defects were identified at the time of the inspection.

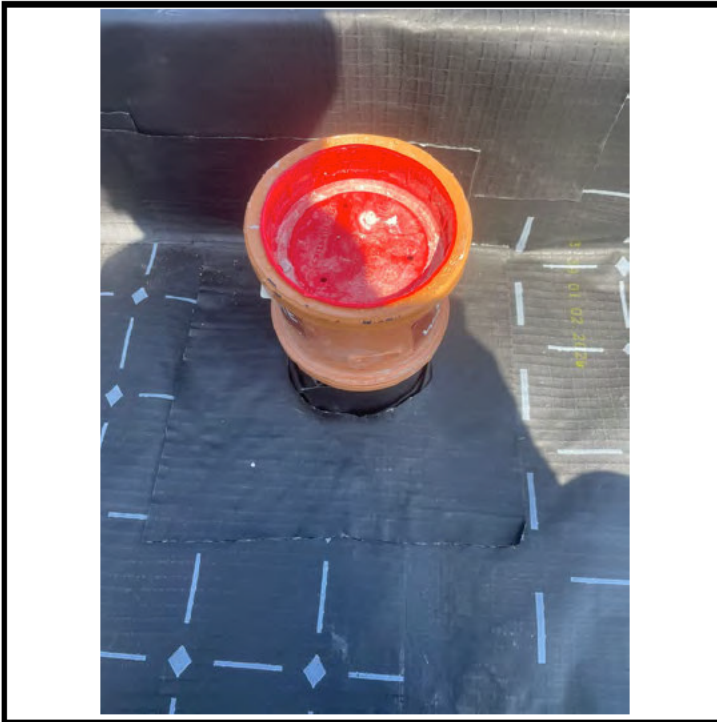
### Pipe Penetrations

Throughout the complete line out installation of the JUTA GP1 Gas Barrier to the referenced plots, there were a number of pipe penetrations that have been sealed in accordance with manufacturer's specifications and guidelines. This has been achieved using JUTA GP1 SAM, which is a gas resistant self adhesive

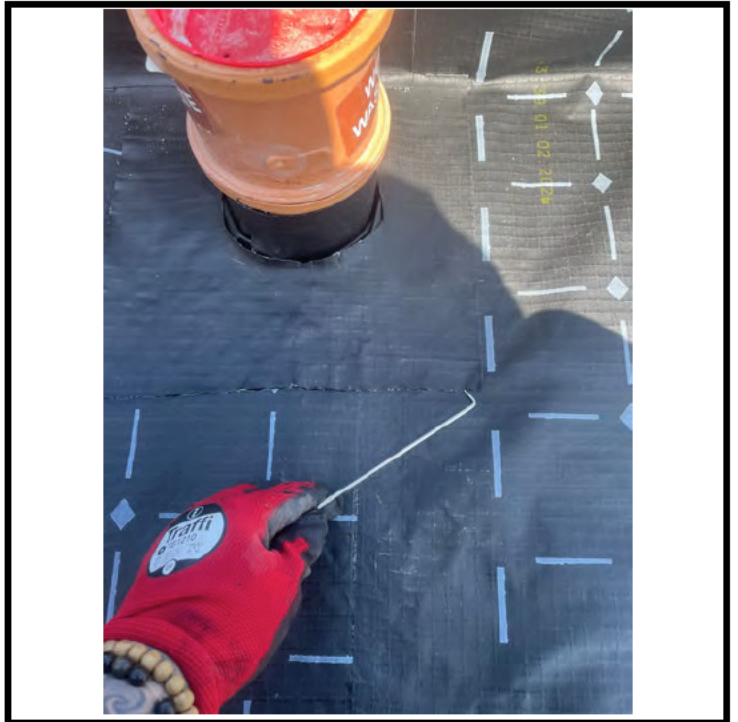
membrane. The installers have first cut the JUTA GP1 Gas Barrier tight around the base of each pipe penetration to minimise voided areas. Next, patches of JUTA GP1 SAM are placed intricately around the pipe and onto the JUTA GP1 Gas Barrier, with a larger square of JUTA GP1 SAM placed over the top to form a top hat detail.

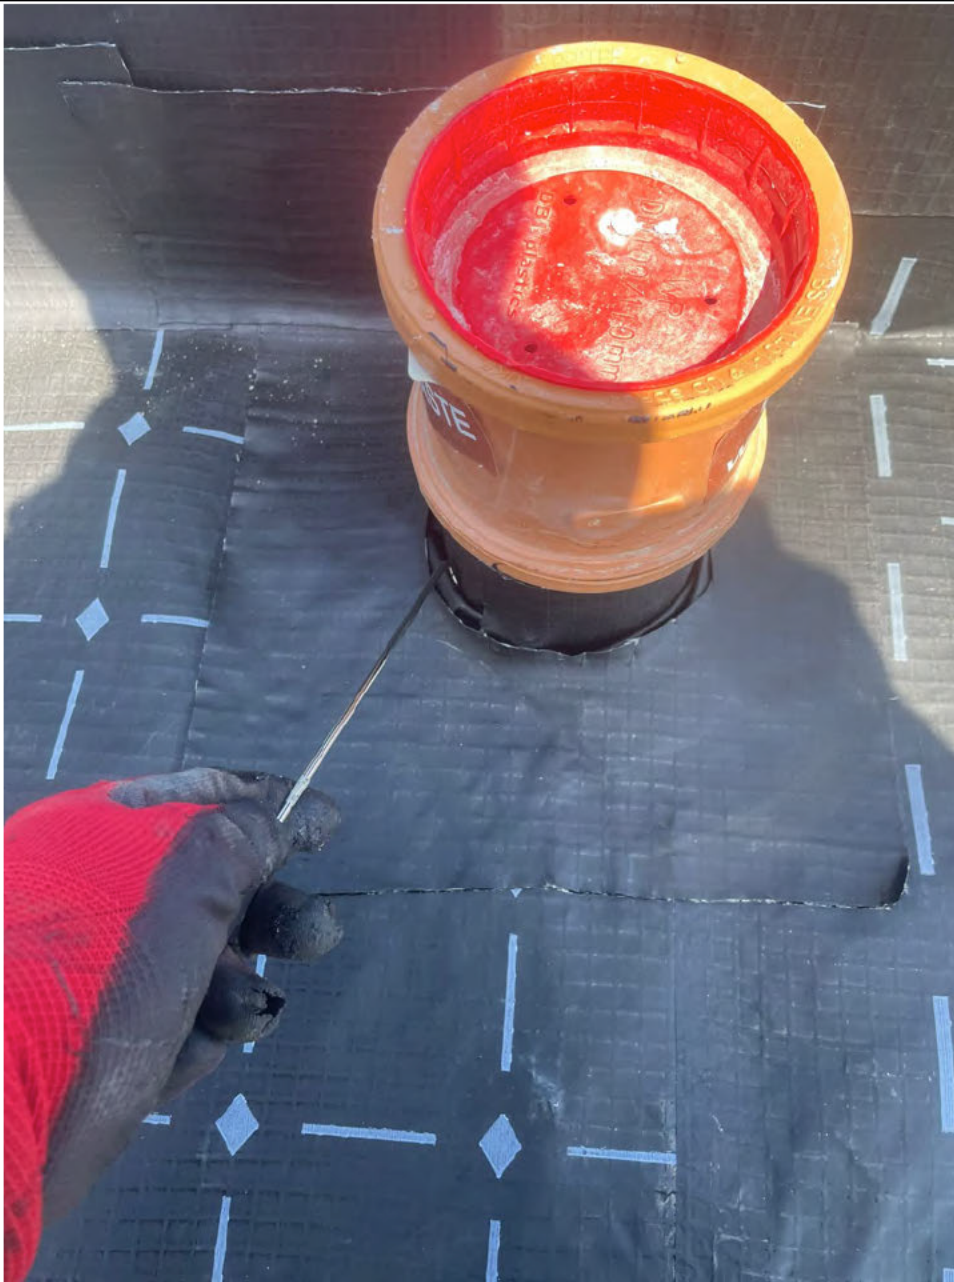
Heat and rolled pressure have been applied to activate the bitumen backing, creating a secure bond between the pipe and the JUTA GP1 Gas Barrier. Thorough visual inspections, supported by mechanical point stress testing and non destructive air lance integrity testing conducted upon all pipe penetrations identified no faults or defects.  
Tested and verified in accordance with CIRIA C735.

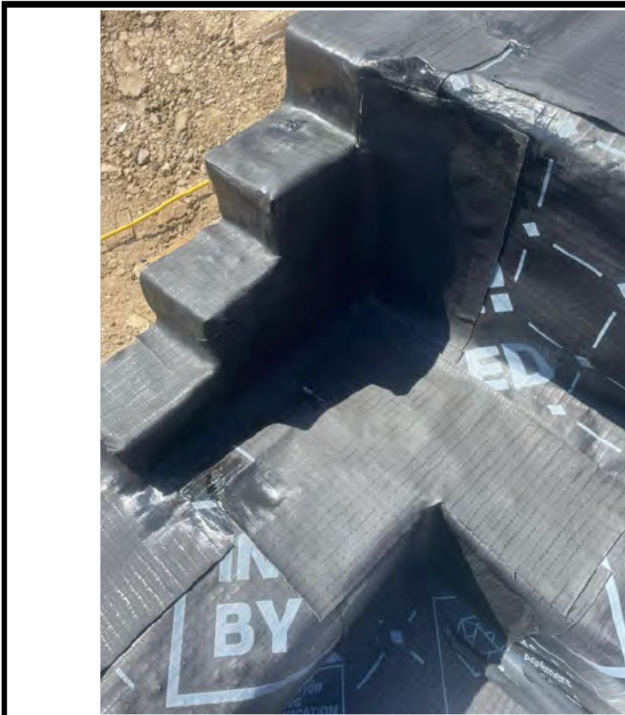
### Corner Detailing

A number of corners throughout the referenced plots have also been sealed as per manufacturer's specifications and design guidelines. This has been achieved using JUTA GP1 SAM. Where the JUTA GP1 Gas Barrier has been folded to minimise voided areas and gaps across the footprint of the plots, each corner

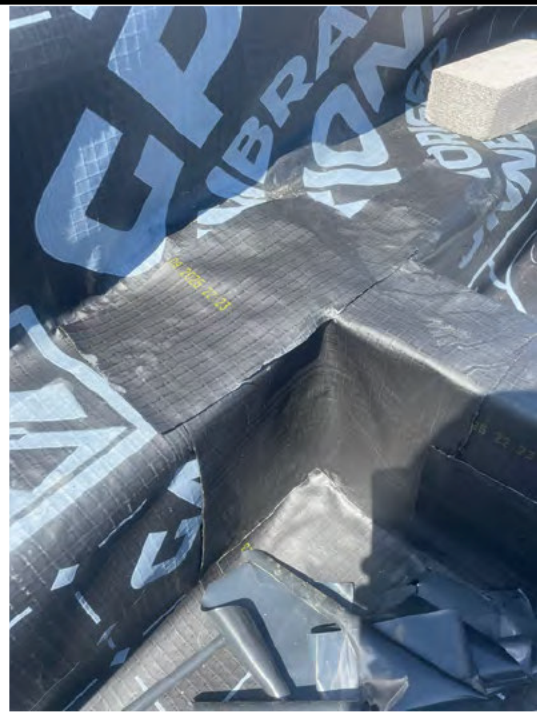
junction has been reinforced by heating strips of JUTA GP1 SAM and placing into position around each corner, onto the JUTA GP1 Gas Barrier. Firm rolled pressure is applied with a silicone roller to aid in the adhesion, ensuring the JUTA GP1 SAM has fully bonded.

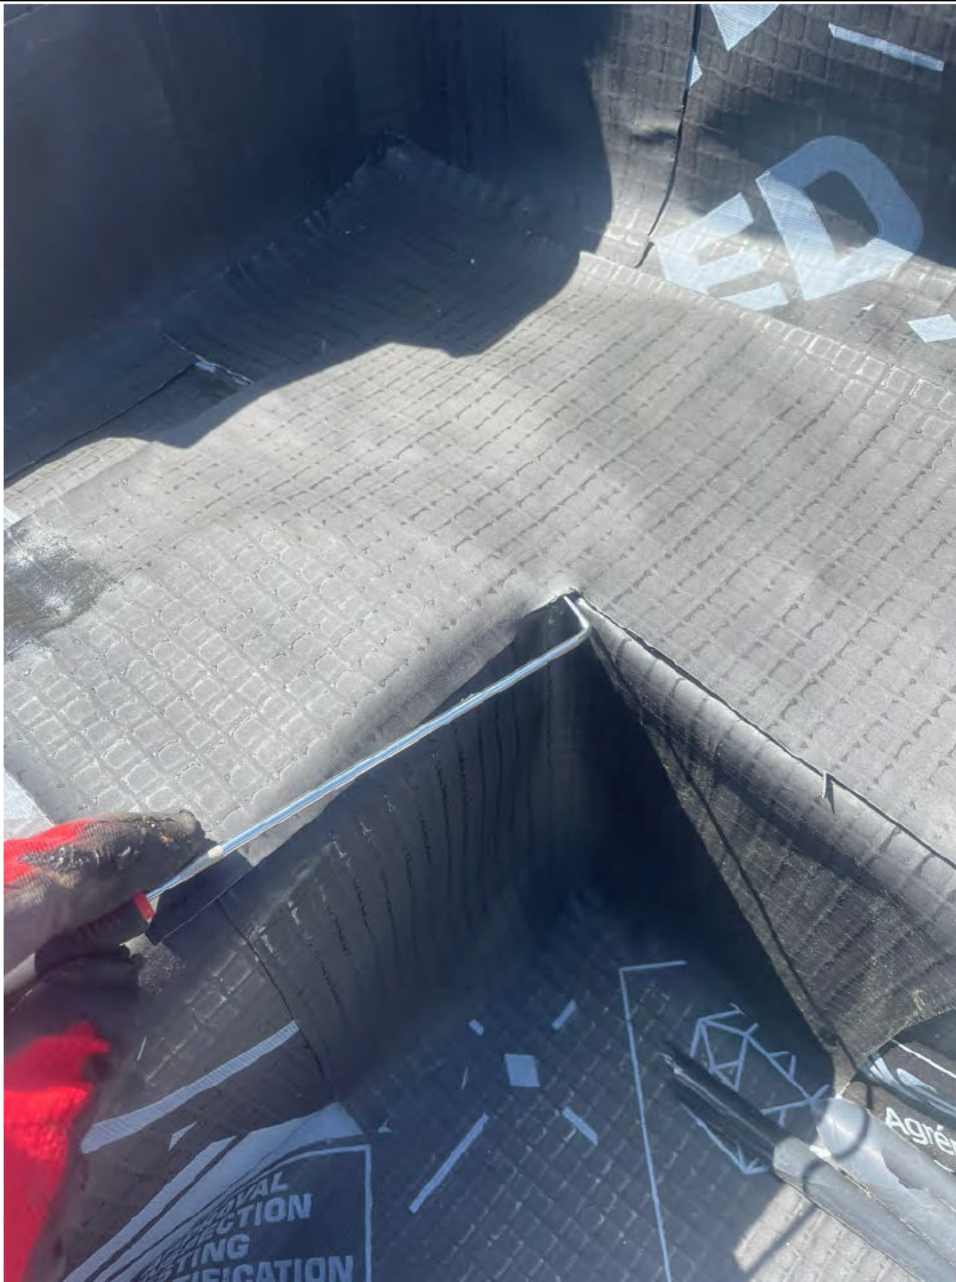
A probe and air lance were run along all edges of the JUTA GP1 SAM corner detailing to validate that a continuous gas resistant seal had been achieved throughout. No faults or defects were identified.

Tested and verified in accordance with CIRIA C735.

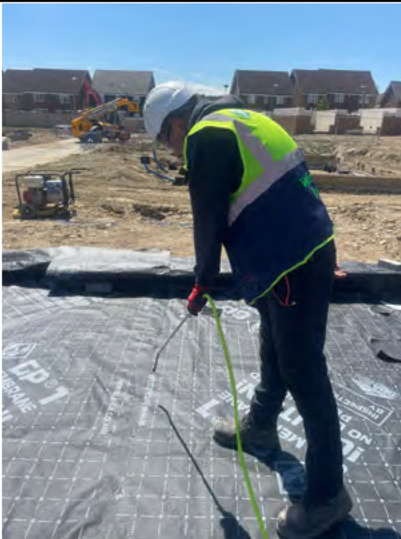
Air lance test on a welded lap.

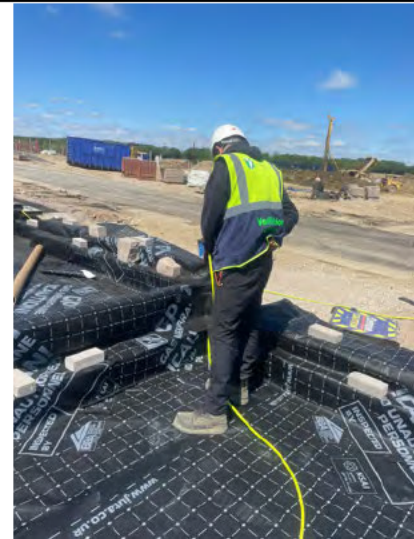
Air lance test on a corner.

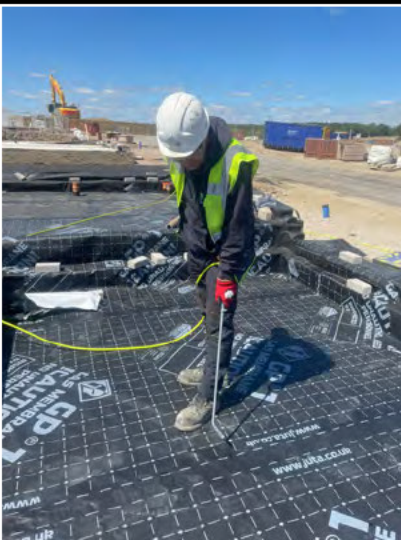
Air lance test on a welded lap.

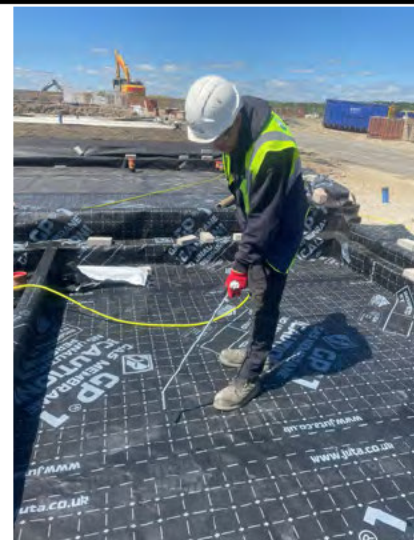
Air lance test on a welded lap.

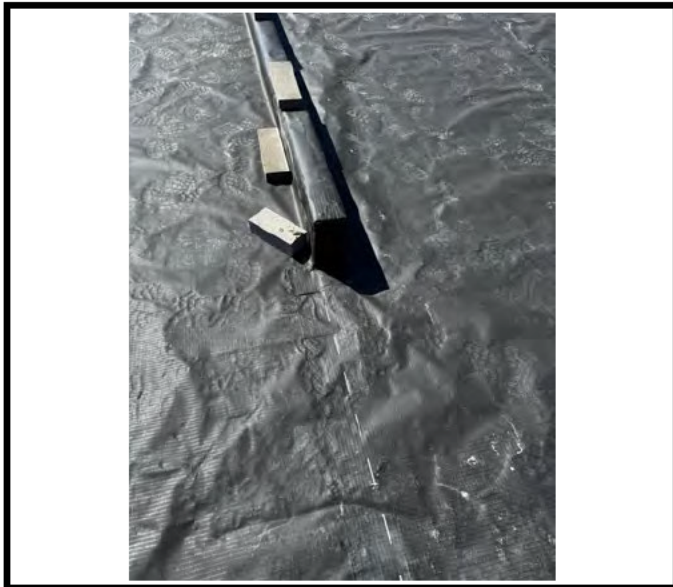
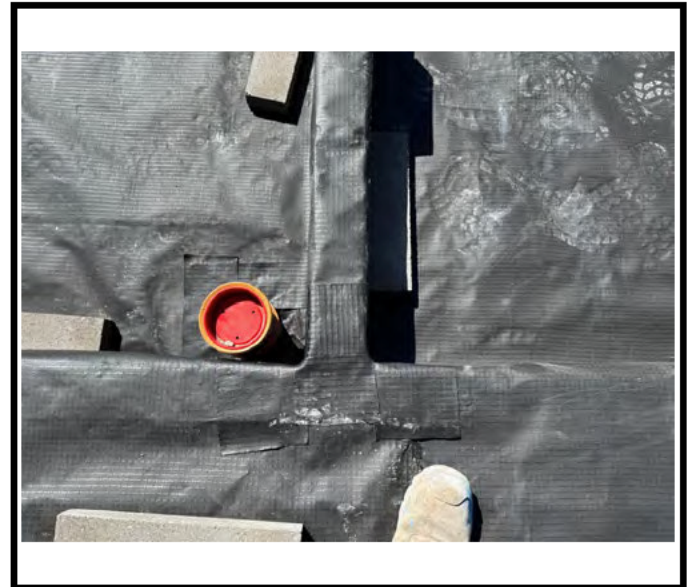
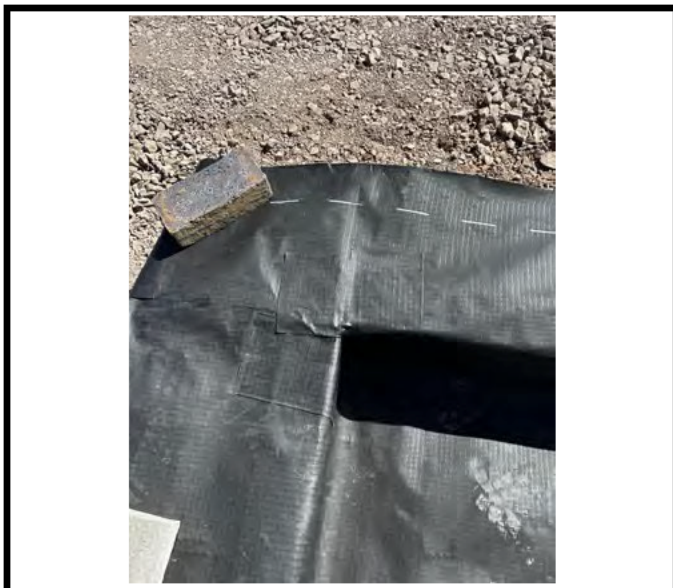
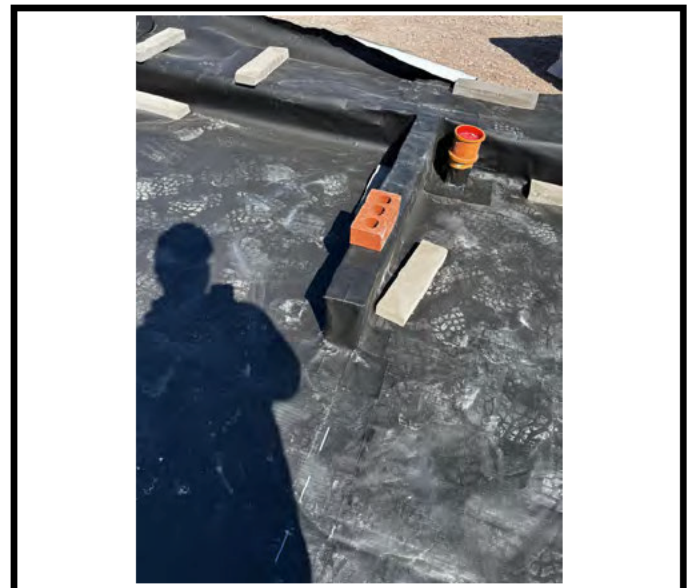
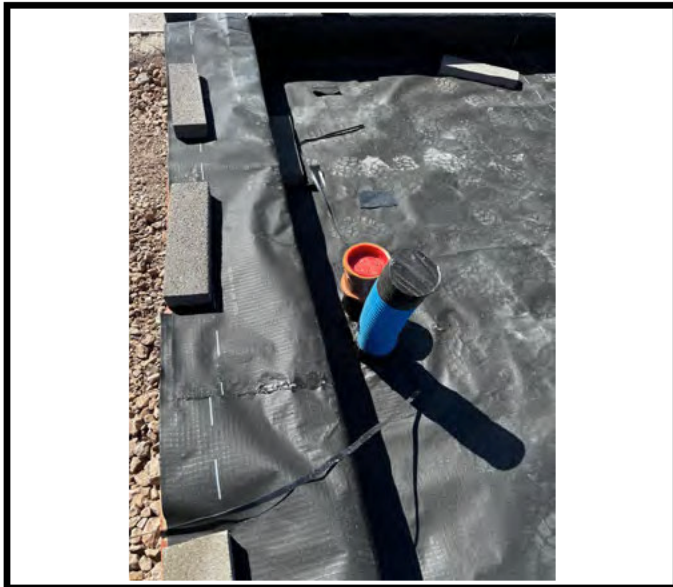
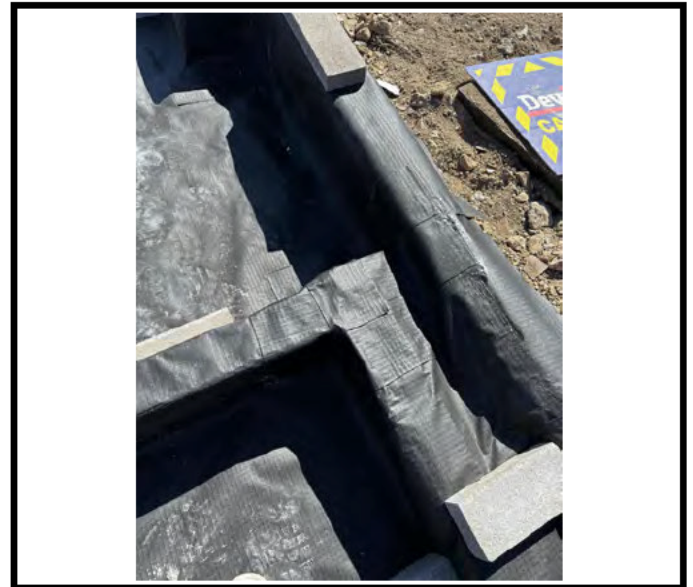
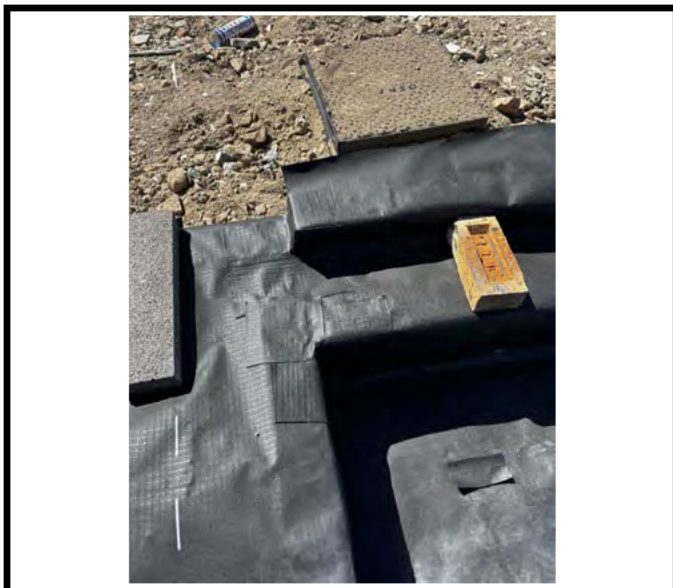
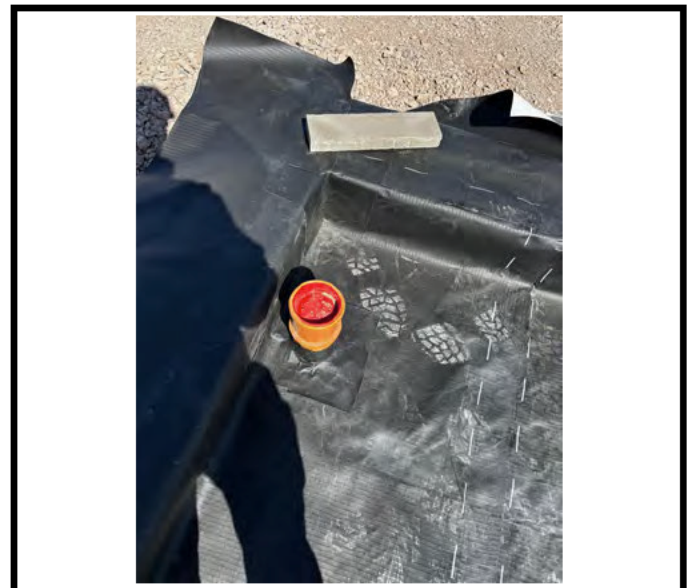
CQA photographic evidence of the JUTA GP1 Gas Barrier line out installation within Plots 592 & 593.
