# GeoShield Verification Report 4

GEO105886

Kilnwood Vale 3E  
Off Illett Way  
Faygate  
Horsham  
RH12 0AJ

Plots 588, 589 & 598 - Full Line Out

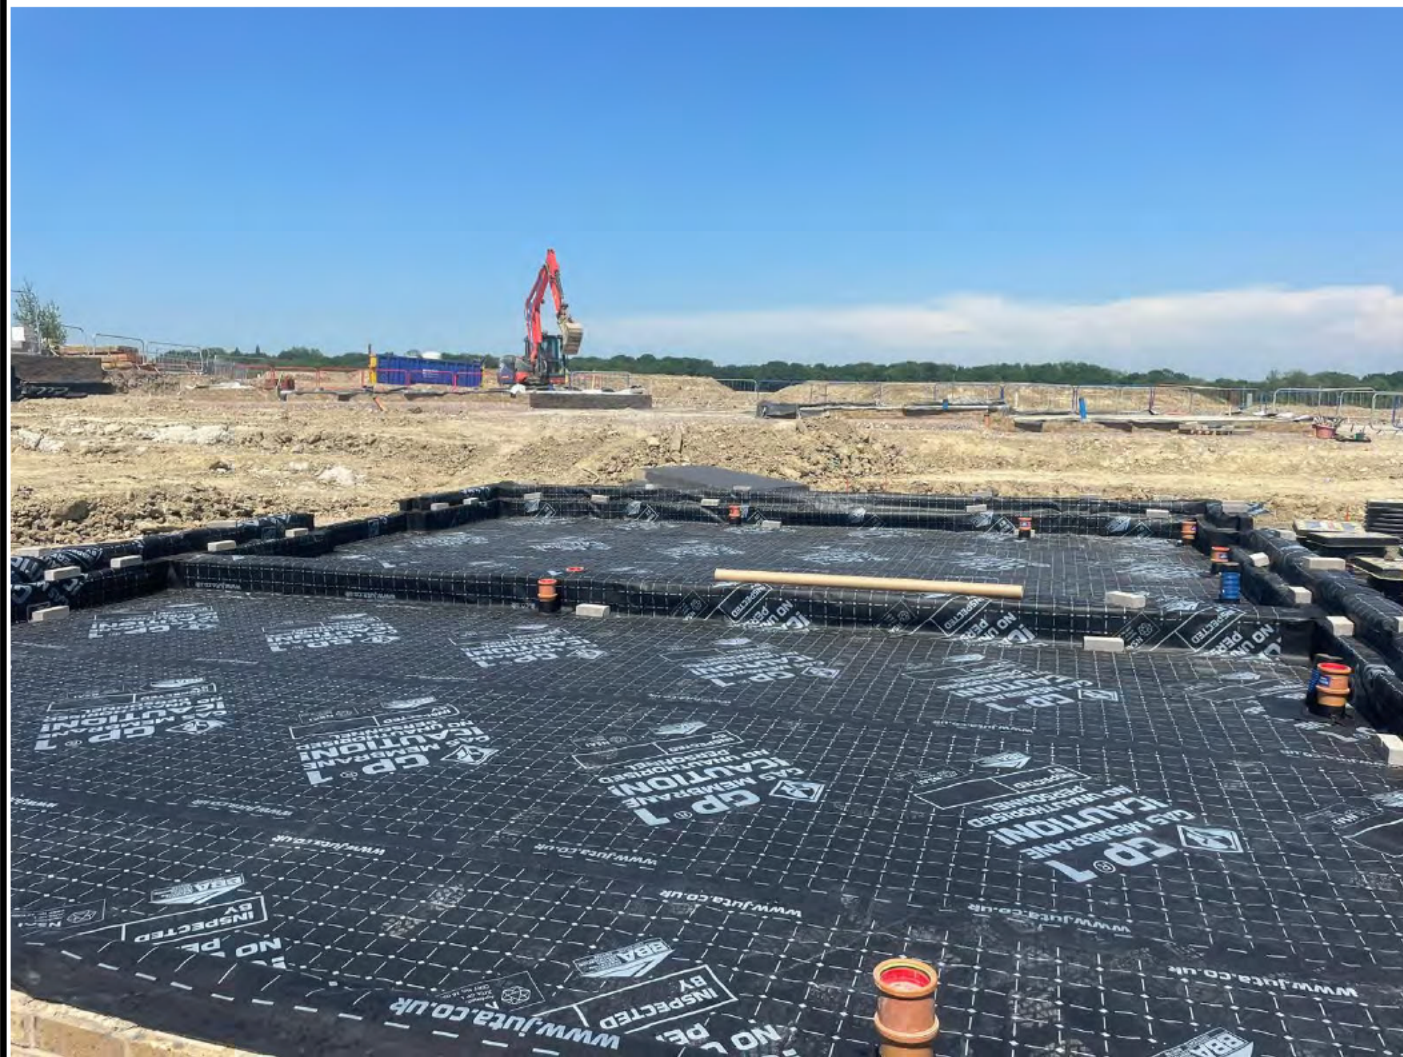
The photograph above displays an overview of Plots 588 & 589 where today's verification inspection took place on site.

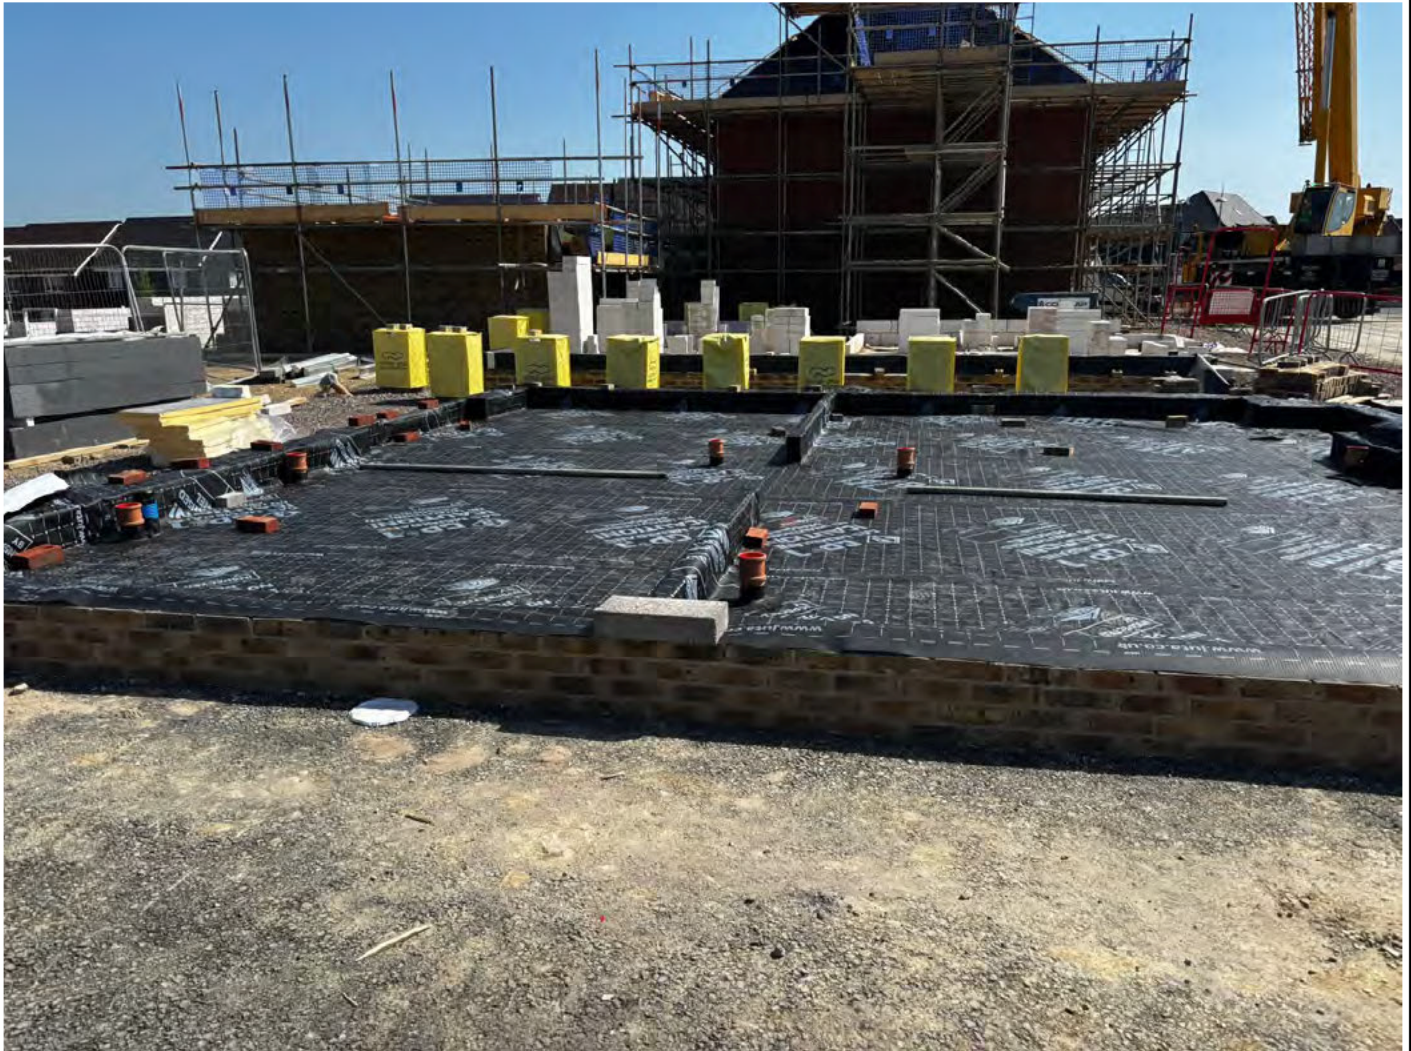
The photograph above displays an overview of Plot 598 where today's verification inspection took place on site.

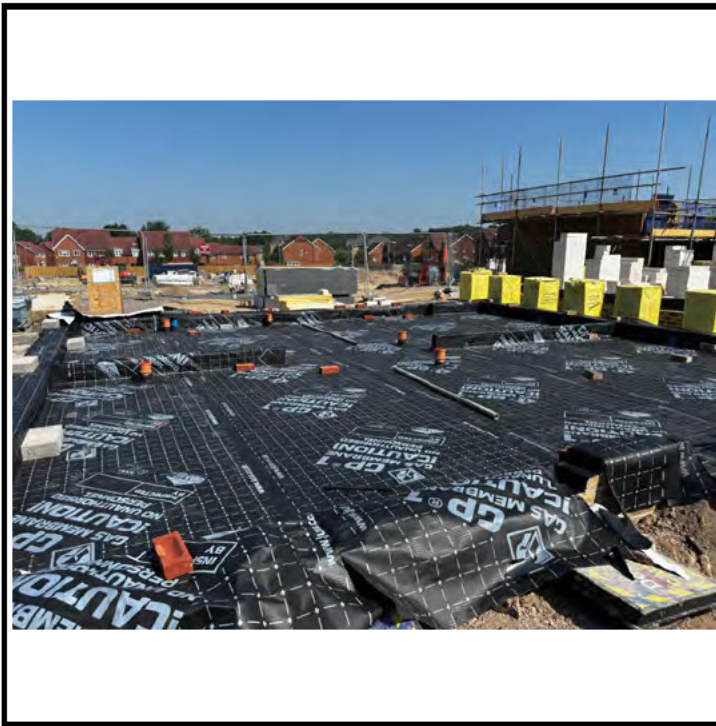
Installation of JUTA GP1 Gas Barrier - Lap Joints

A complete line out of JUTA GP1 Gas Barrier has been installed across the footprint of Plots 588, 589 & 598. The JUTA GP1 Gas Barrier has been lined out across the entirety of the plots, including all internal party walls ensuring it bridges the external cavity to the outer leaf brickwork.

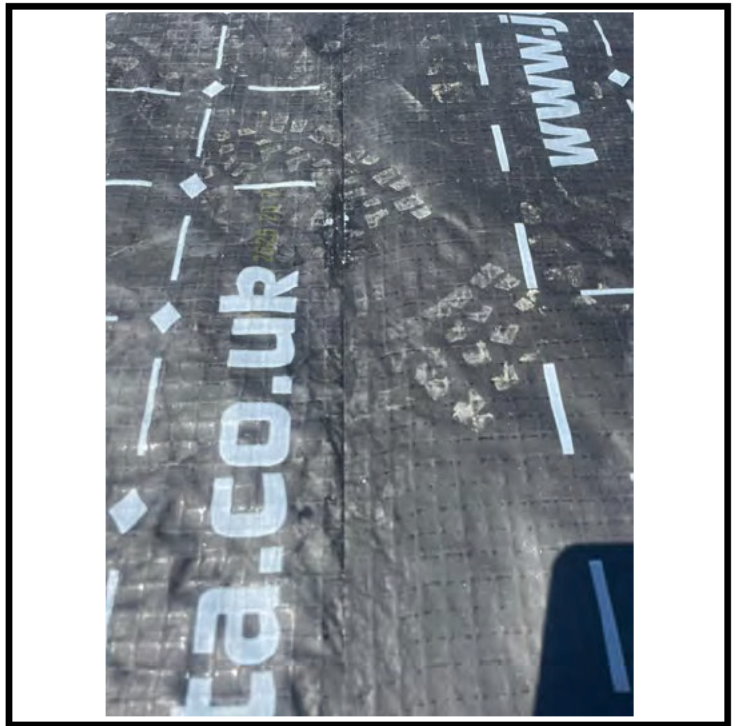
All overlaps between the adjacent sheets of JUTA GP1 Gas Barrier have been overlapped a minimum of 100mm, conforming to manufacturer's specifications and heat welded using a hot air tool and silicone roller with adequate pressure applied to ensure a continuous gas resistant seal is achieved.

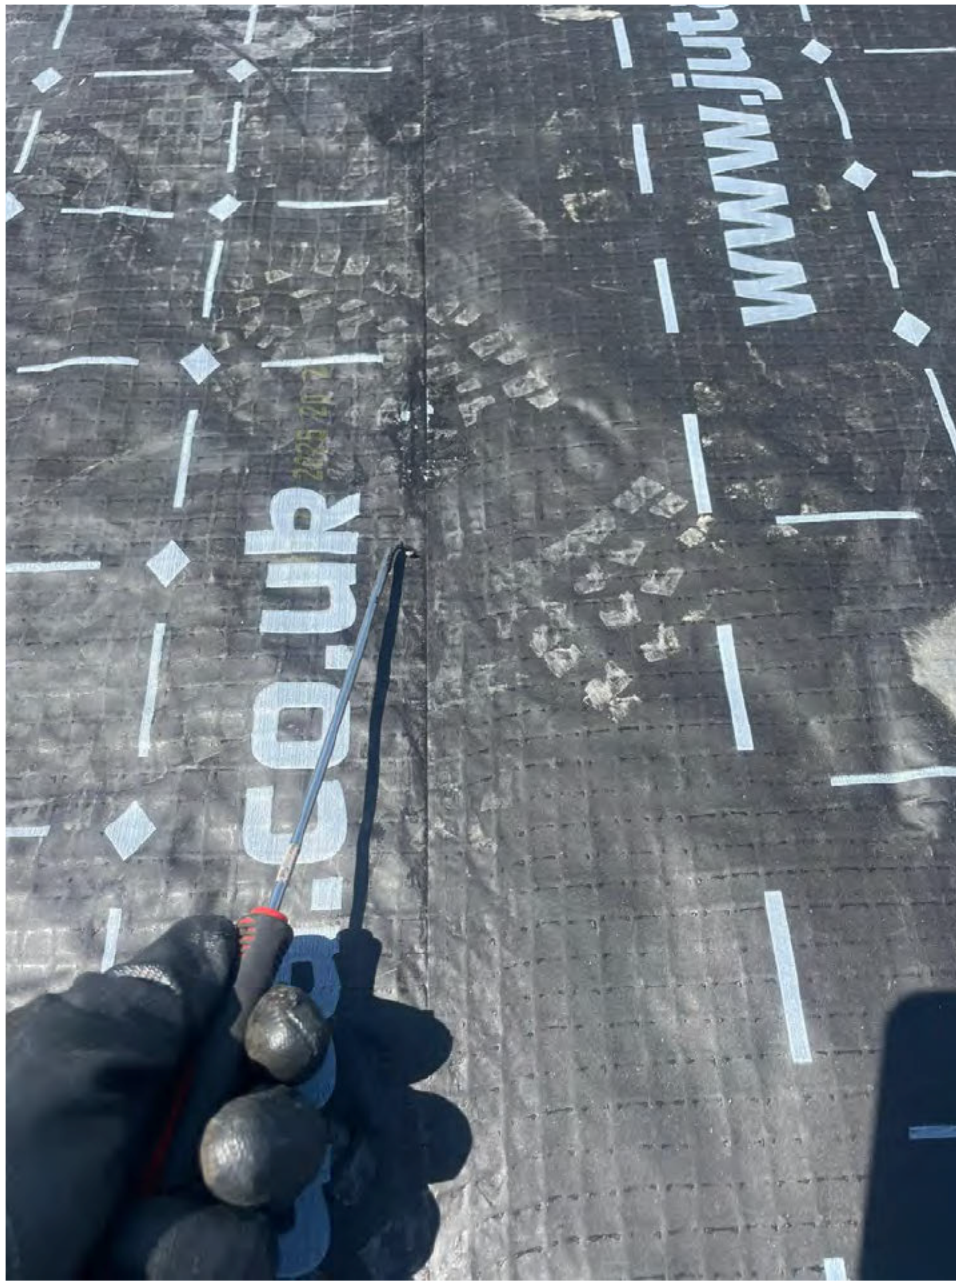
The above image demonstrates a mechanical point stress test being conducted upon a welded overlap of the JUTA GP1 Gas Barrier. All overlaps were subjected to thorough visual inspections, mechanical point stress testing and non destructive air lance integrity testing throughout the verification process. No faults or defects were identified at the time of the inspection.

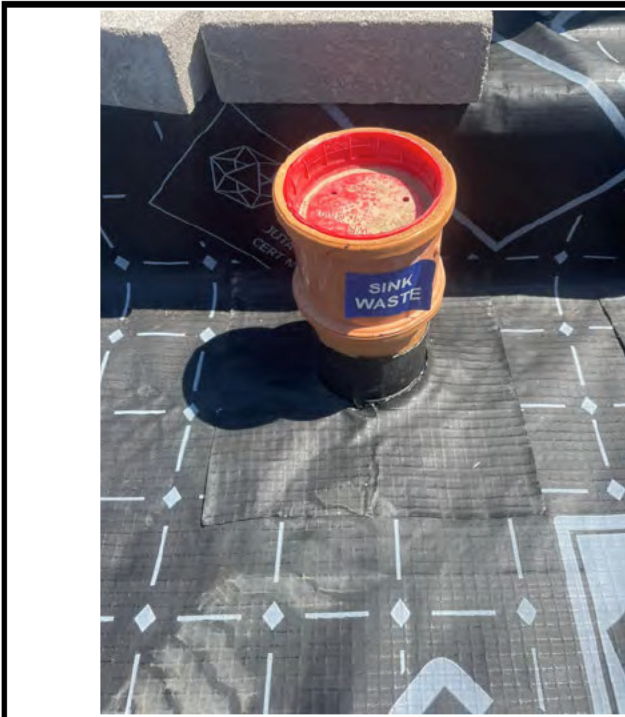
### Pipe Penetrations

Throughout the complete line out installation of the JUTA GP1 Gas Barrier to the referenced plots, there were a number of pipe penetrations that have been sealed in accordance with manufacturer's specifications and guidelines. This has been achieved using JUTA GP1 SAM, which is a gas resistant self adhesive

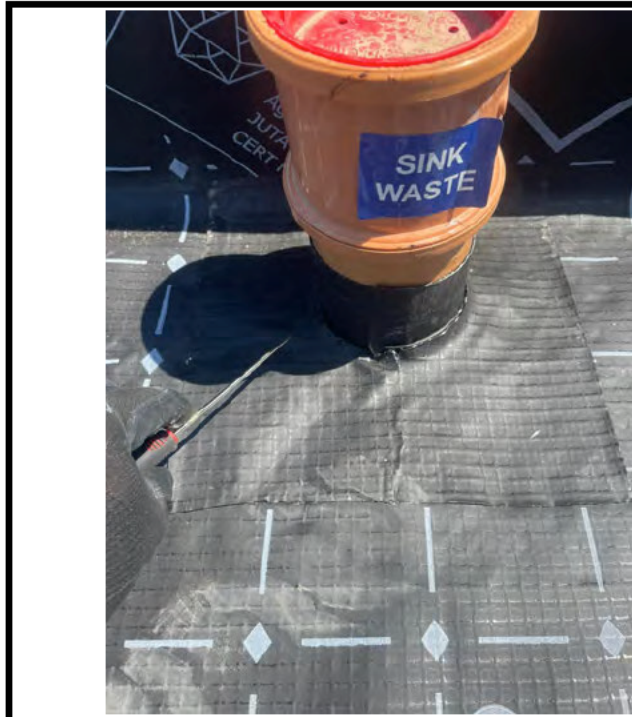
membrane. The installers have first cut the JUTA GP1 Gas Barrier tight around the base of each pipe penetration to minimise voided areas. Next, patches of JUTA GP1 SAM are placed intricately around the pipe and onto the JUTA GP1 Gas Barrier, with a larger square of JUTA GP1 SAM placed over the top to form a top hat detail.

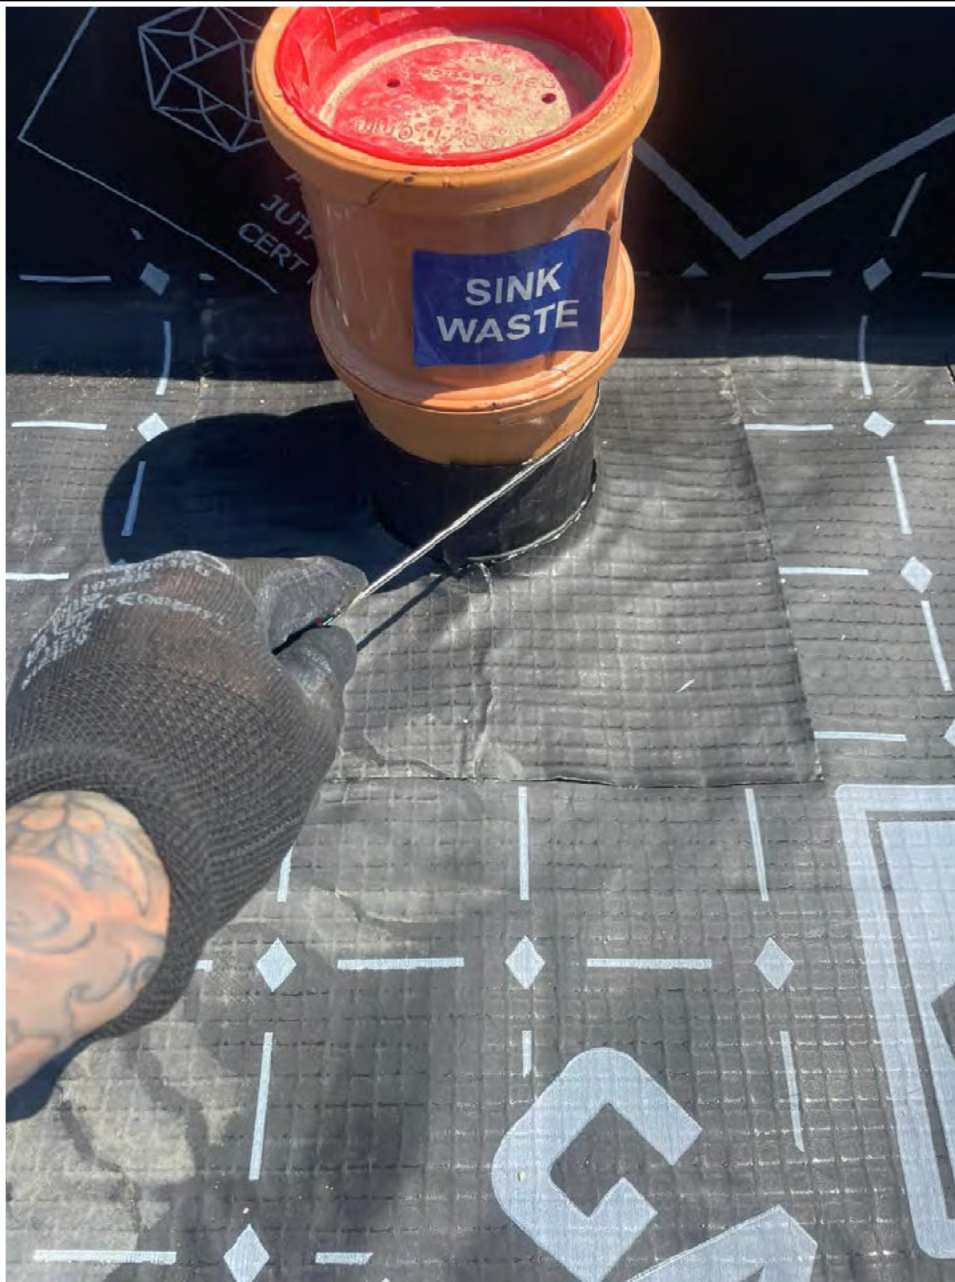
Heat and rolled pressure have been applied to activate the bitumen backing, creating a secure bond between the pipe and the JUTA GP1 Gas Barrier. Thorough visual inspections, supported by mechanical point stress testing and non destructive air lance integrity testing conducted upon all pipe penetrations identified no faults or defects. Tested and verified in accordance with CIRIA 735.

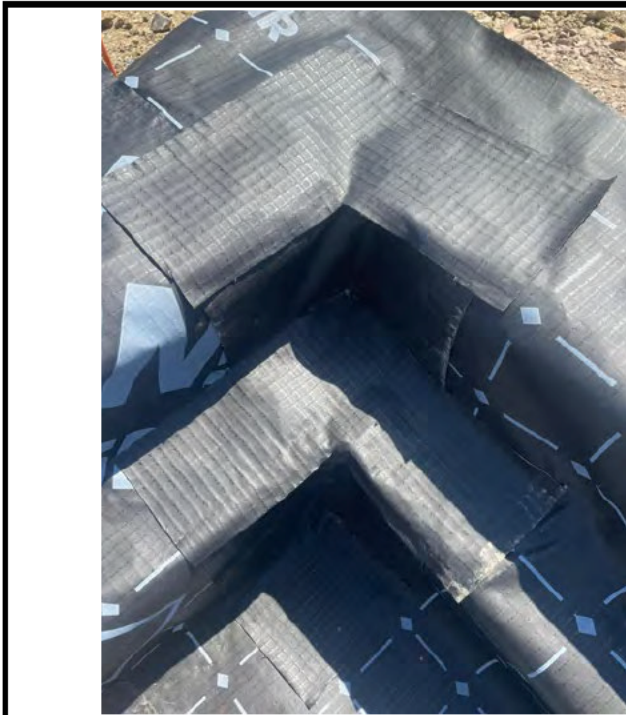
### Corner Detailing

A number of corners throughout the referenced plots have also been sealed as per manufacturer's specifications and design guidelines. This has been achieved using JUTA GP1 SAM. Where the JUTA GP1 Gas Barrier has been folded to minimise voided areas and gaps across the footprint of the plots, each corner

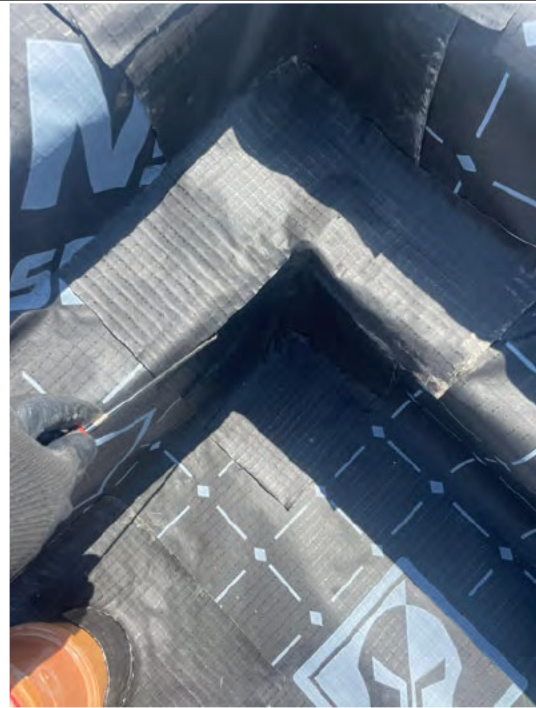
junction has been reinforced by heating strips of JUTA GP1 SAM and placing into position around each corner, onto the JUTA GP1 Gas Barrier. Firm rolled pressure is applied with a silicone roller to aid in the adhesion, ensuring the JUTA GP1 SAM has fully bonded.

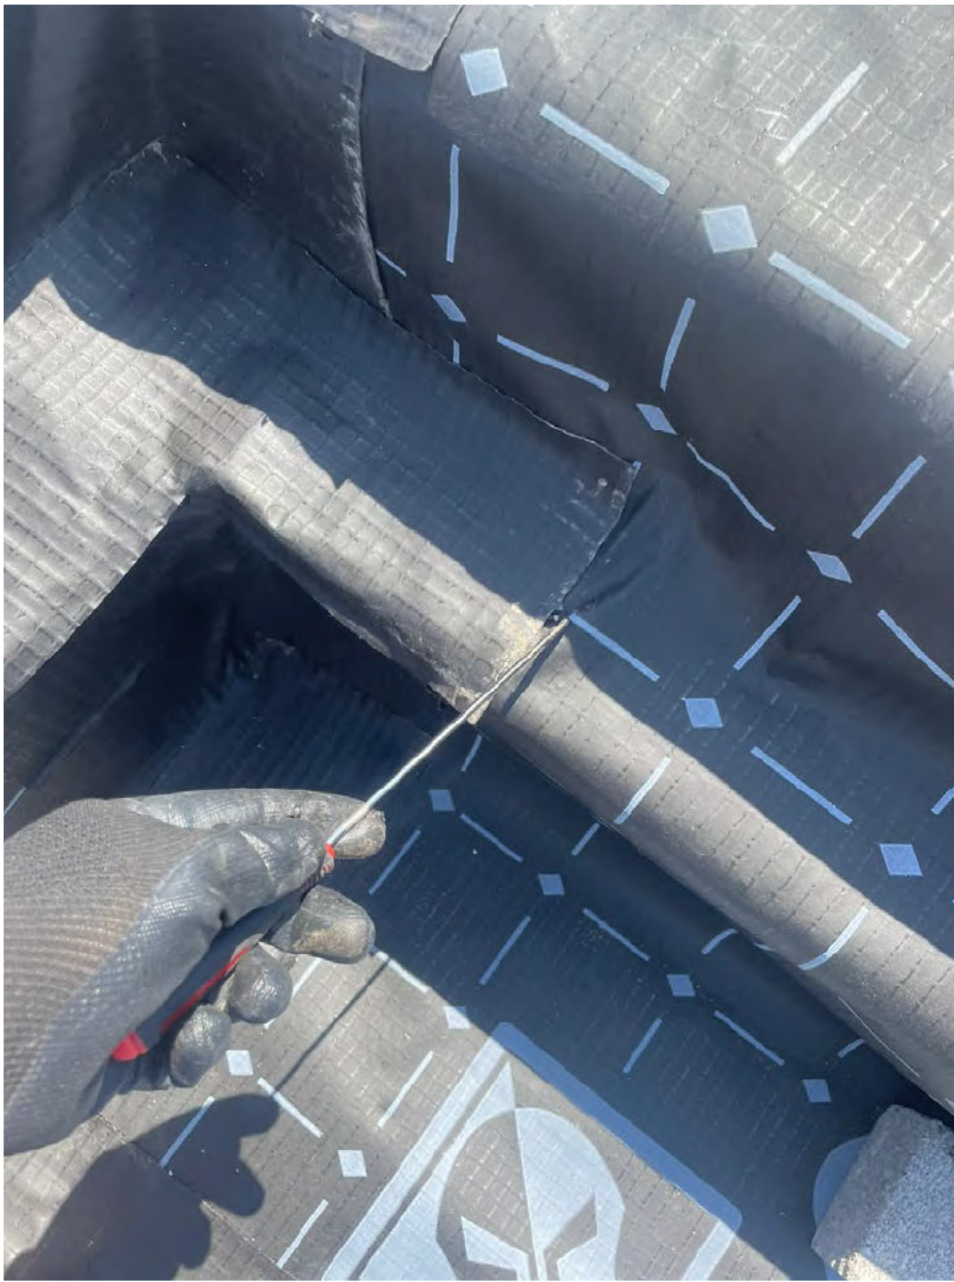
A probe and air lance were run along all edges of the JUTA GP1 SAM corner detailing to validate that a continuous gas resistant seal had been achieved throughout. No faults or defects were identified.

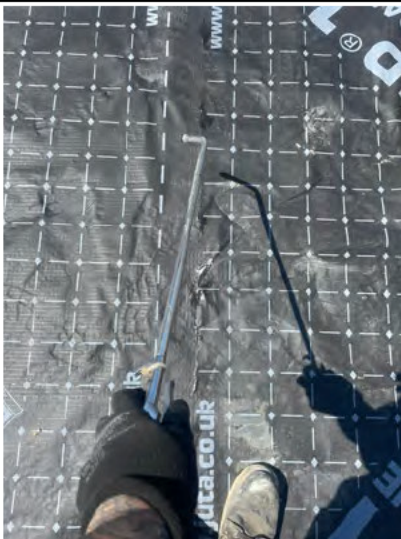
Air lance test on a welded lap.

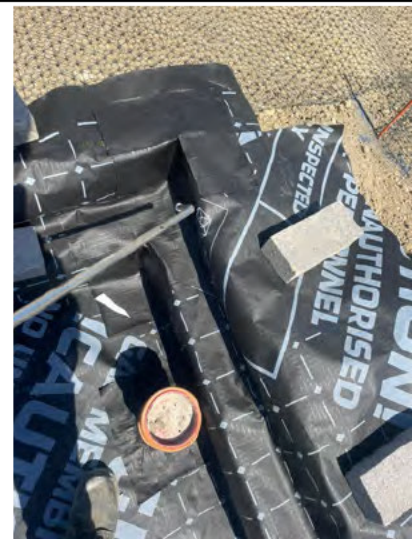
Air lance test on a corner.

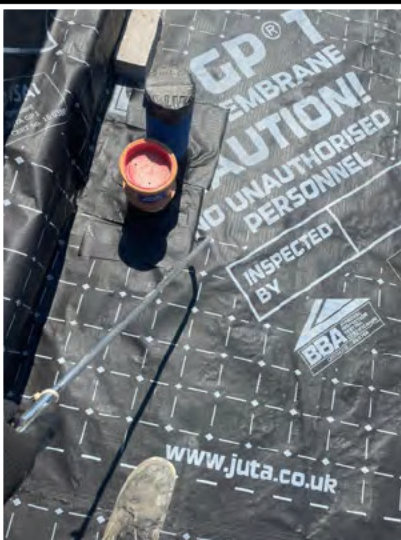
Air lance test on a pipe penetration.

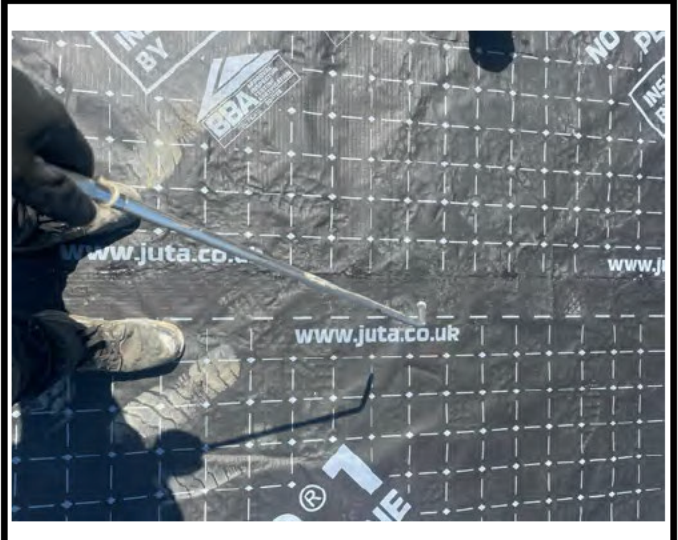
Air lance test on a welded lap.

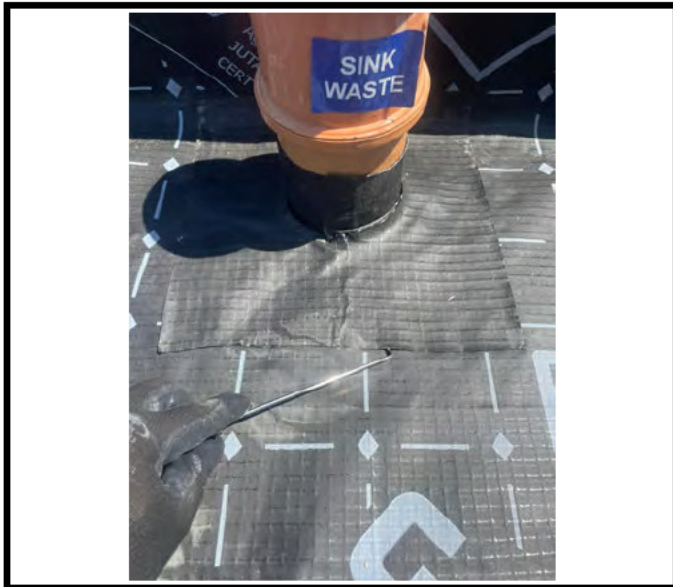
A mechanical point stress test being conducted upon a sealed pipe penetration.

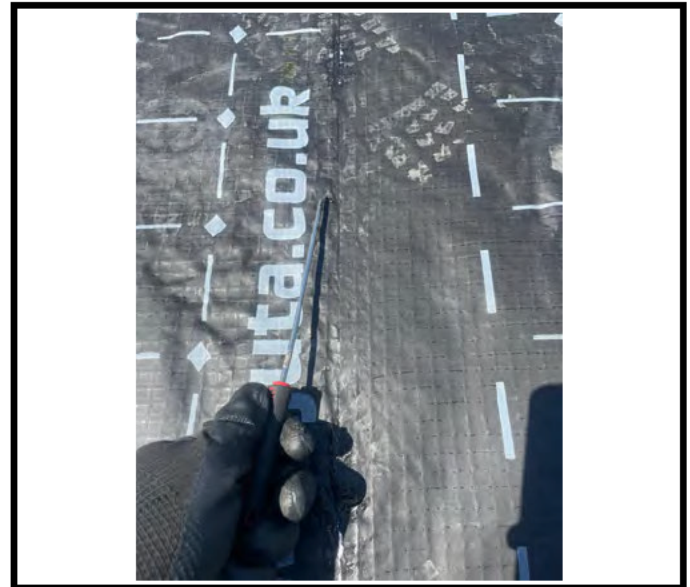
A mechanical point stress test being conducted upon a welded lap joint.

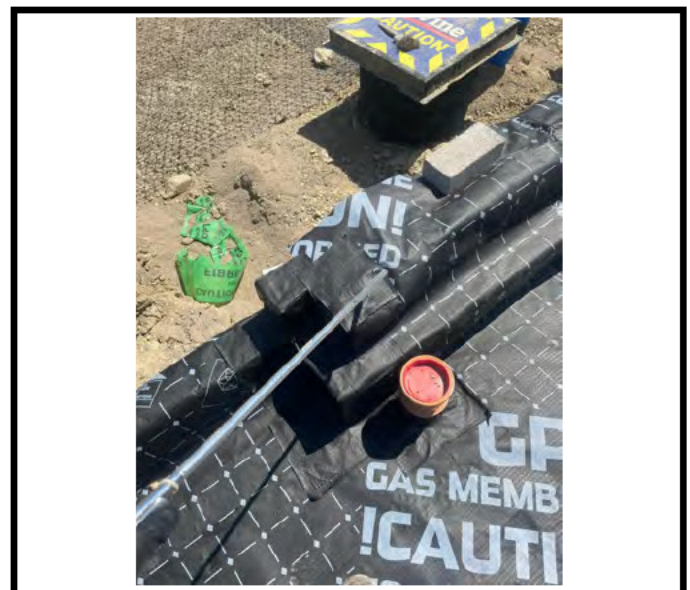
A non destructive air lance integrity test being conducted upon a sealed corner.
