## Monitoring Details:

Job Reference: QG1S1132179

Address: 8 St Gabriels Road, Billingshurst, West Sussex, RH14 9TX

## Job Summary

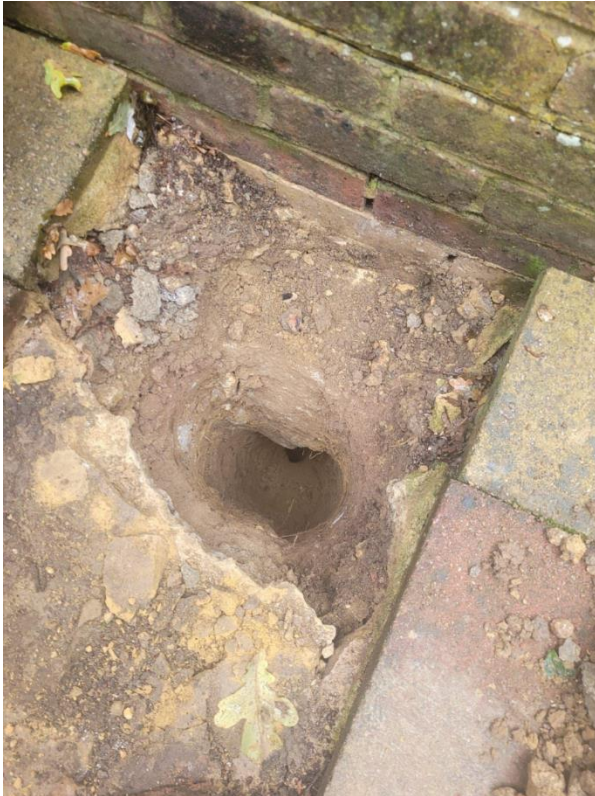
**Photo 1 – Trial Pit 1**

Trial Pit Details can be found in Appendix C, where in trial pit 1, a 1450mm thick concrete footing was founded at a depth of 1.70m below ground level, with a projection of 150mm only present at the top 700mm of the footing.

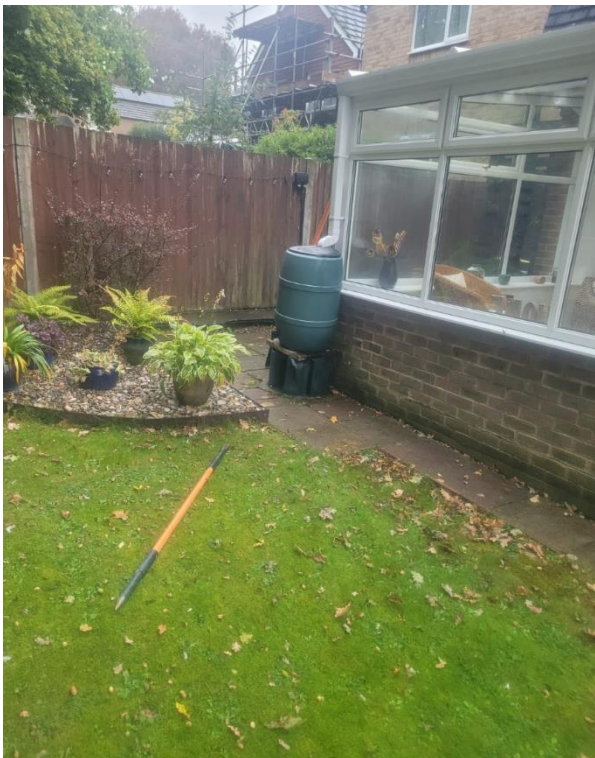
**Photo 3 – Trial Pit 2**

In trial pit 2, a 300mm thick concrete footing was founded at a depth of 0.50m below ground level, with a projection of 50mm.

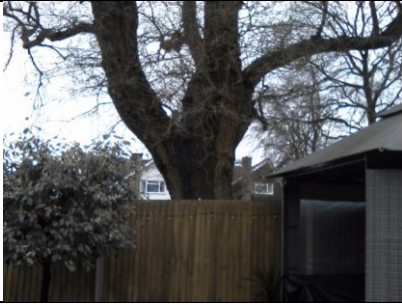
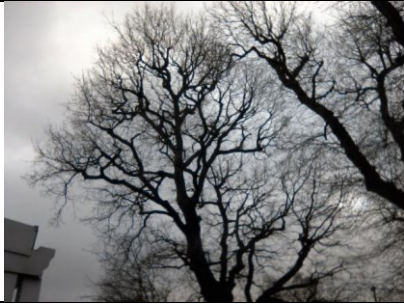
| T2 - Oak | T3 - Oak |

4. This application seeks consent to remove the western most of the two mature oak trees in the area (T2) due to its alleged involvement with, and contribution to, a structural defect at the adjacent property to the north 8 St Gabriels Road. The application has been supported by detailed evidence indicating the presence of oak roots under the building and that the sub-strate consists of clay with a high shrinkage potential. Specialised soil analysis has shown that the underlying clay strata is desiccated, and there is an abnormal soil moisture content profile at a depth beyond which ambient soil drying can be influential. Crack and level monitoring have both indicated a cyclical, seasonal pattern of sub-strate movement, such that it can only realistically have been caused by the adjacent vegetation. It is well known that this can be a result of the abstraction of moisture from clay sub-strate caused by the roots of trees on clay soils.

5. Oak is classified as a species of 'High' water demand, and the house is accordingly within the tree's 'Zone of Influence' (ZOI), both of these terms as defined under NHBC guidelines (Chapter 4.2: Building near trees). The presence of the trees to the property and the underlying soil type, clay soils of medium to high plasticity, would imply that, on the balance of probabilities, the root actions of the tree are likely to be contributing to the ground movement causing the structural defect at 8 St Gabriels Road.

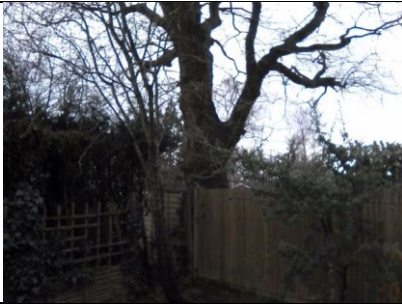
| T3 - Oak | T4 - Laburnum |

3. This application seeks consent to remove the eastern most of the two mature oak trees in the area (T3) due to its alleged involvement with, and contribution to, a structural defect at the adjacent property to the north 8 St Gabriels Road. The application has been supported by detailed evidence indicating the presence of oak roots under the building and that the sub-strate consists of clay with a high shrinkage potential. Specialised soil analysis has shown that the underlying clay strata is desiccated, and there is an abnormal soil moisture content profile at a depth beyond which ambient soil drying can be influential. Crack and level monitoring have both indicated a cyclical, seasonal pattern of sub-strate movement, such that it can only realistically have been caused by the adjacent vegetation. It is well known that this can be a result of the abstraction of moisture from clay sub-strate caused by the roots of trees on clay soils.

5. Oak is classified as a species of 'High' water demand, and the house is accordingly within the tree's 'Zone of Influence' (ZOI), both of these terms as defined under NHBC guidelines (**Chapter 4.2: Building near trees**). The presence of the trees to the property and the underlying soil type, clay soils of medium to high plasticity, would imply that, on the balance of probabilities, the root actions of the tree are likely to be contributing to the ground movement causing the structural defect at 8 St Gabriels Road.

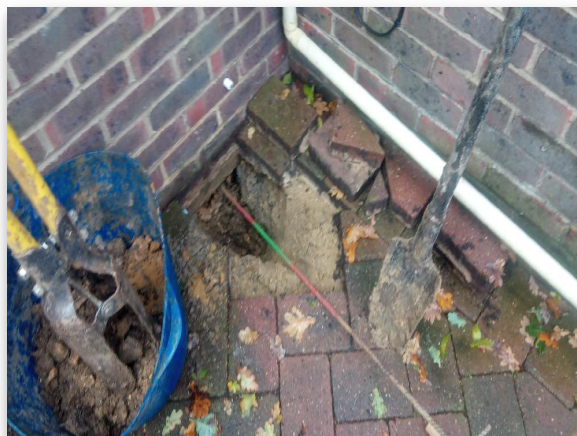
Fig 1.2: Trial Hole 1 Footing

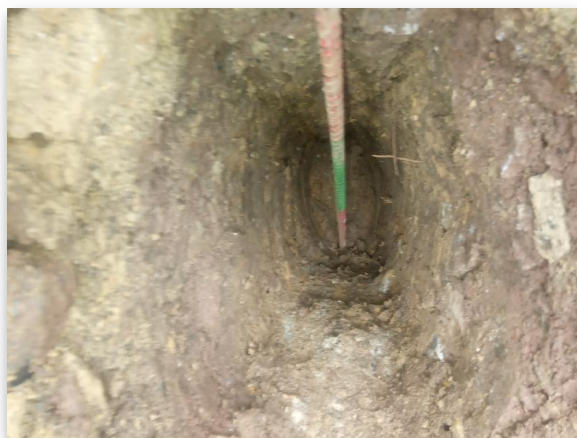
Fig 2.2: Trial Hole 2 Footing

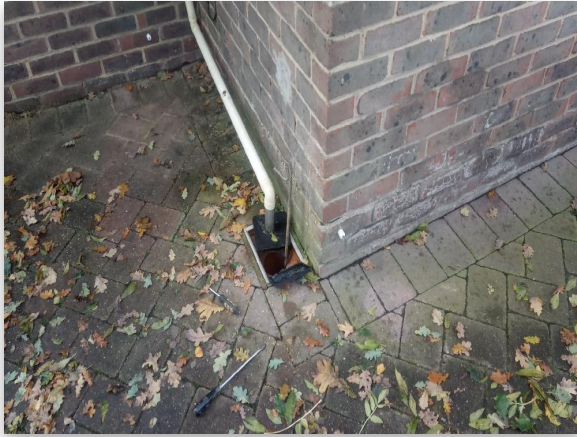
The 2 FWG's to the front of the property were found to have traps over 1m deep on them. However the gullies were plastic and after flow testing seen to be free flowing and serviceable. In order to survey these lines 2 deep excavations would be required to break into the pipework. However, we do not believe that this is necessary due to the pipework being relatively new 100mm plastic.

Fig 7.1: Deep FWG

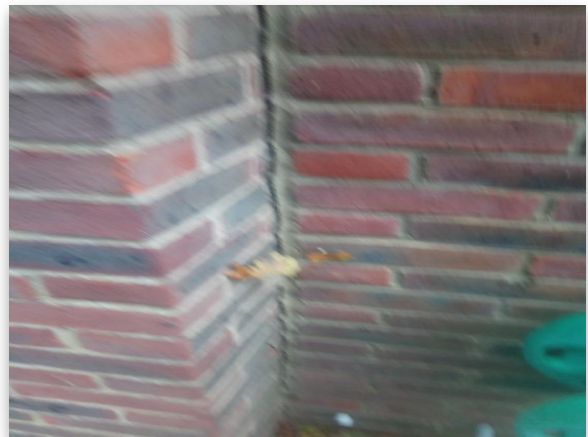
Fig 7.4: Area of damage

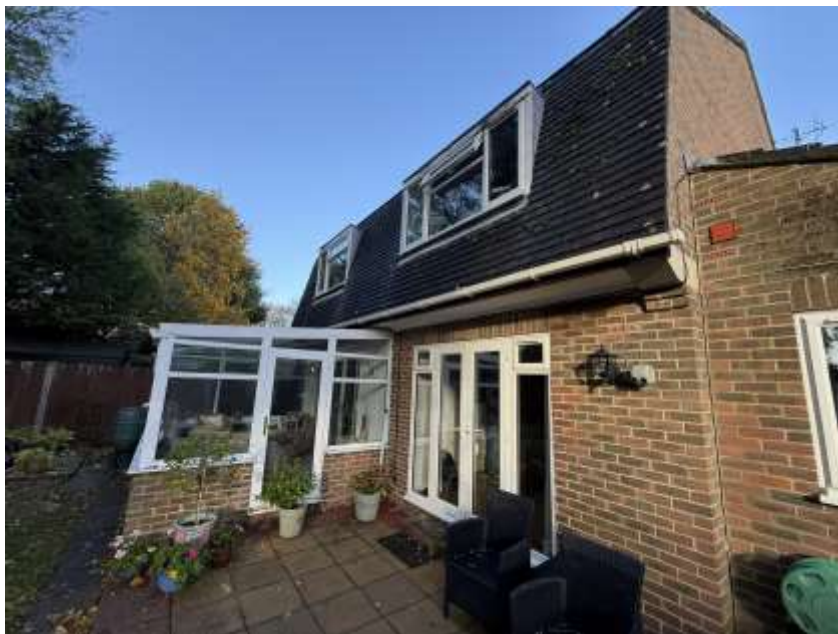
From our visit, it is clear that the left hand extension is rotating away from the main house and this is most acute at the rear, where the tapering fracture increases in width and is circa 15 mm wide at the top.

After discussion with Questgates, our instructions are to demolish the conservatory and provide a new piled raft foundation on which a new conservatory can be built. The existing UPVC frame has been pulled around to such an extent that it now leaks and has no salvageable value.

In addition the side extension is to be stabilised with a piled raft foundation. The extension is a more complex and intricate structure and it is requested that we seek to install a remedial piled raft within the building to retain its fabric. As the extension houses the kitchen which requires removal, the property will be rendered uninhabitable for the duration of the works and the insured will require AA whilst these works are undertaken.

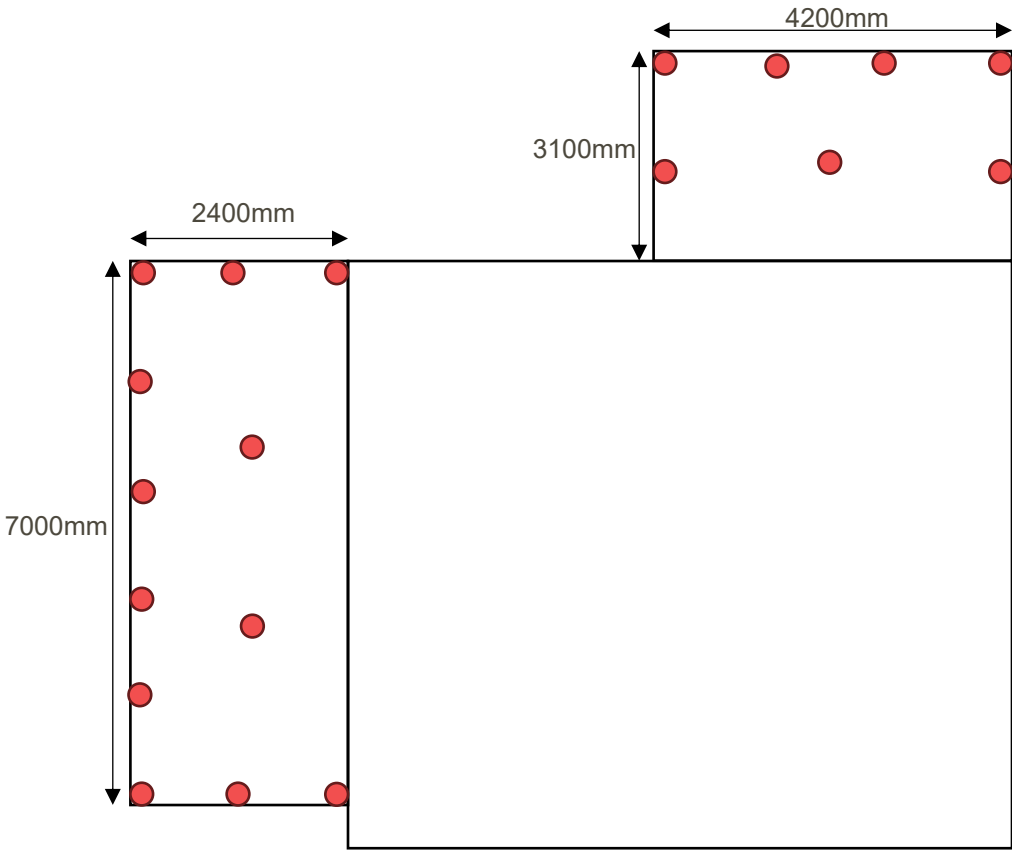
Fig 2 Proposed draft pile layout, to left hand extension and conservatory.

The schematic below indicates the preliminary number and position of piles associated with the works proposed:
