## Appendix B Field reconnaissance photographs

# Site Visit Report

| <b>Project name</b> | Thakeham Tiles | <b>Client</b> | Thakeham Tiles Ltd |
| <b>Document reference</b> | 333800445-STN-XX-XX-SVR-GE-0001 | | |

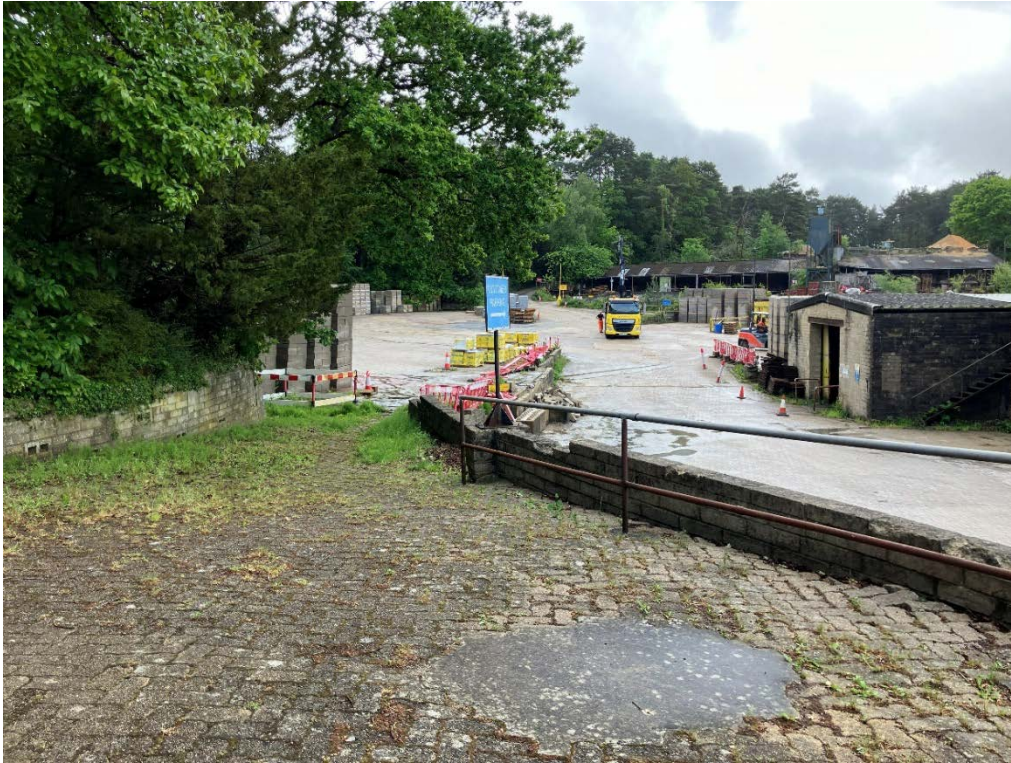
Photograph 1: Overview of yard. Looking south.

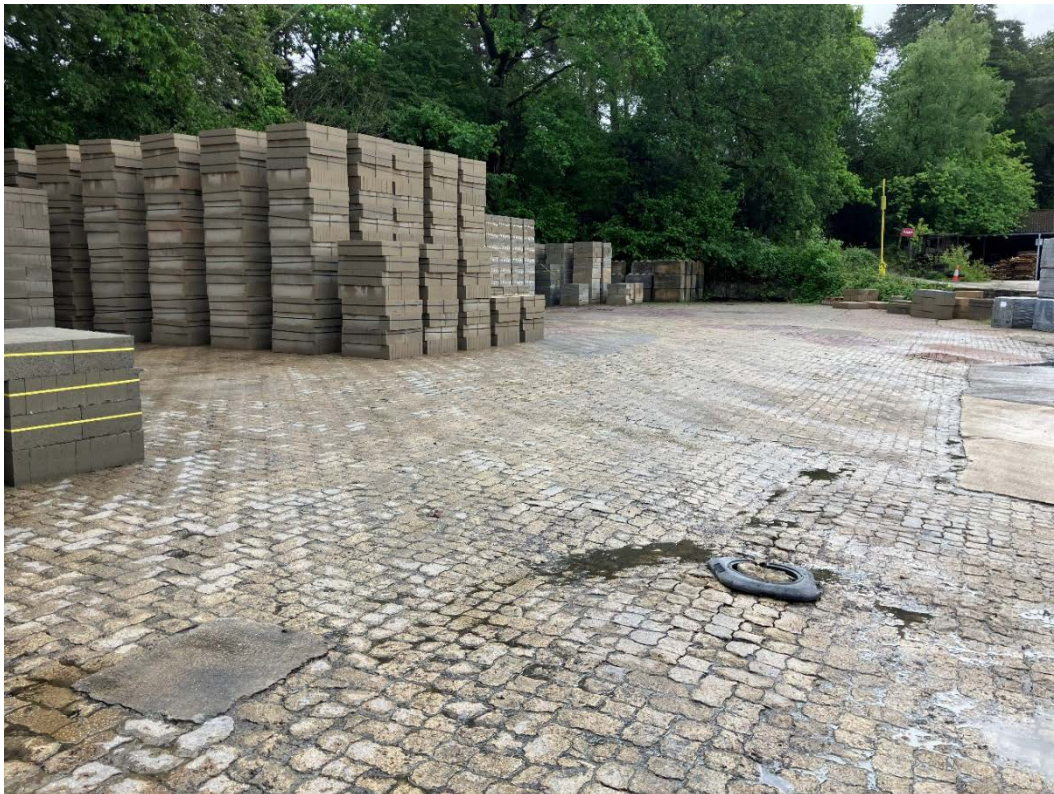
Photograph 2: Storage area in central east part of the site. Looking southeast.

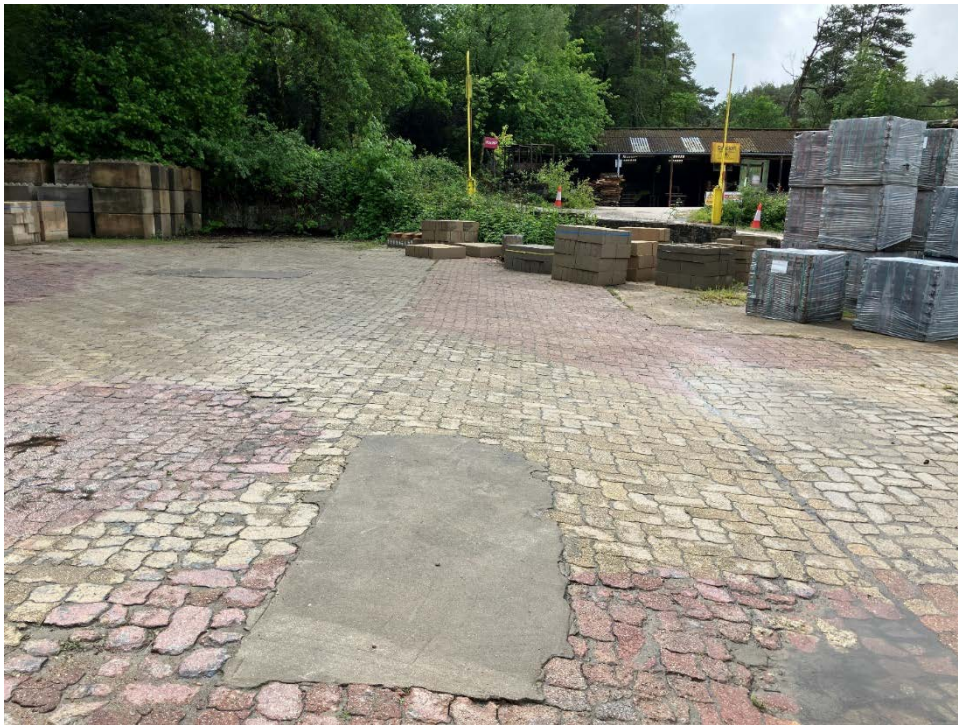
Photograph 3: Evidence of previous ground investigation in central east part of site. Looking south.

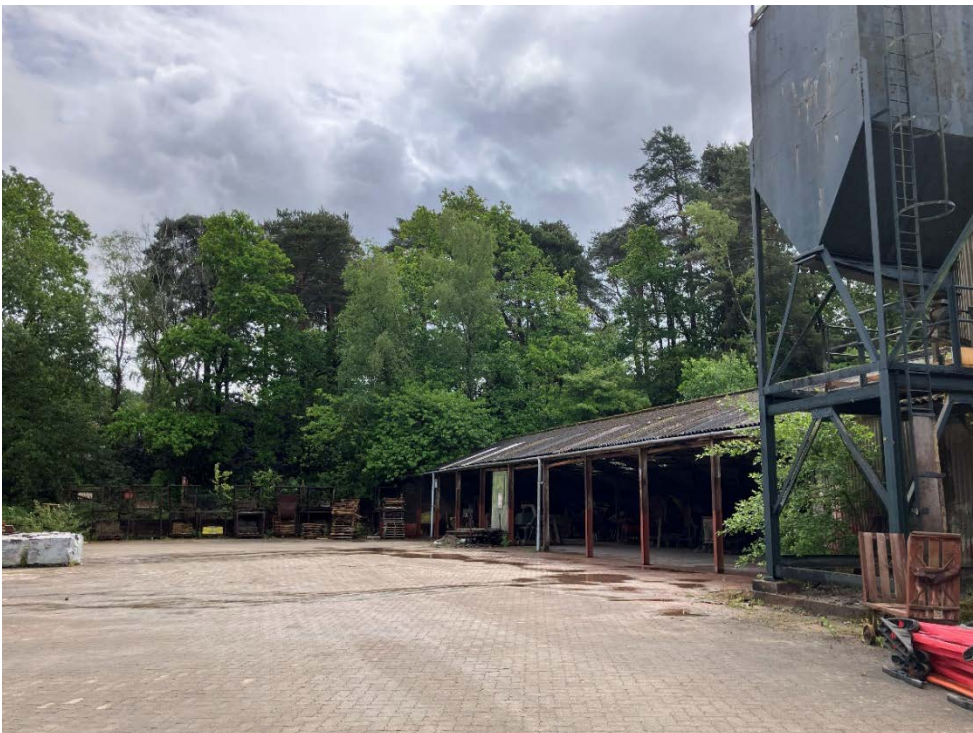
Photograph 4: Storage areas (pallets at far end) with historical processing infrastructure. Looking east.

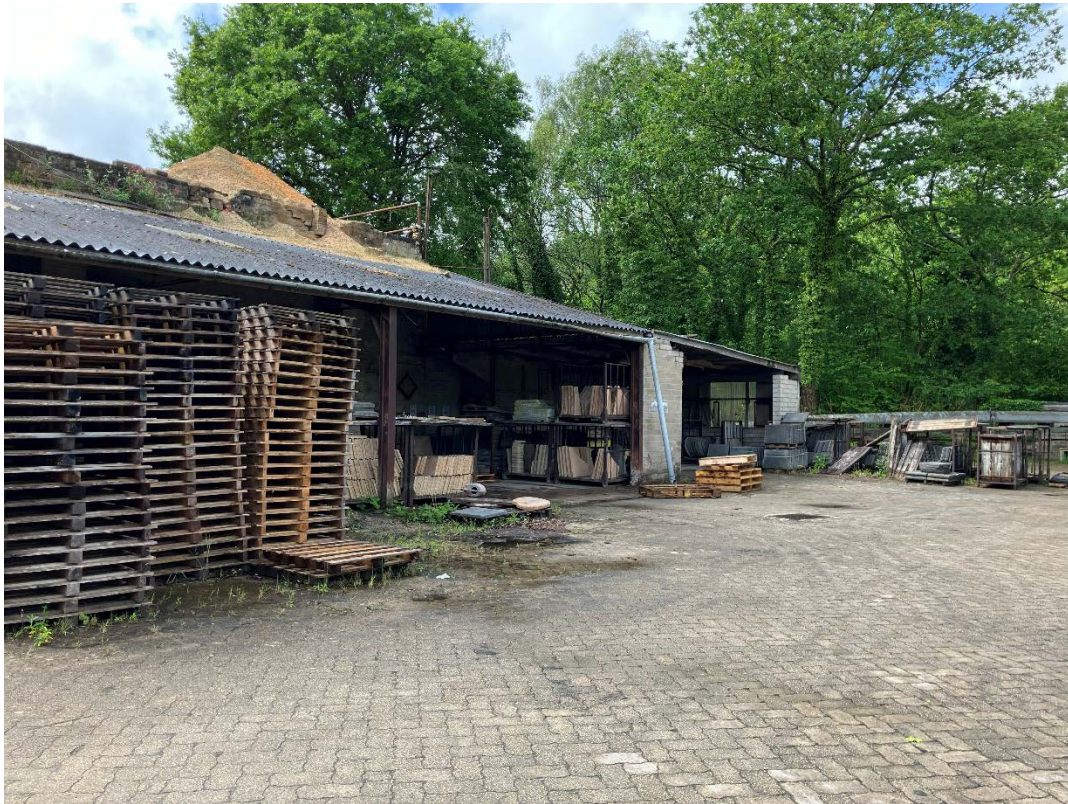
Photograph 5: Storage of manufactured paving slabs. Looking west.

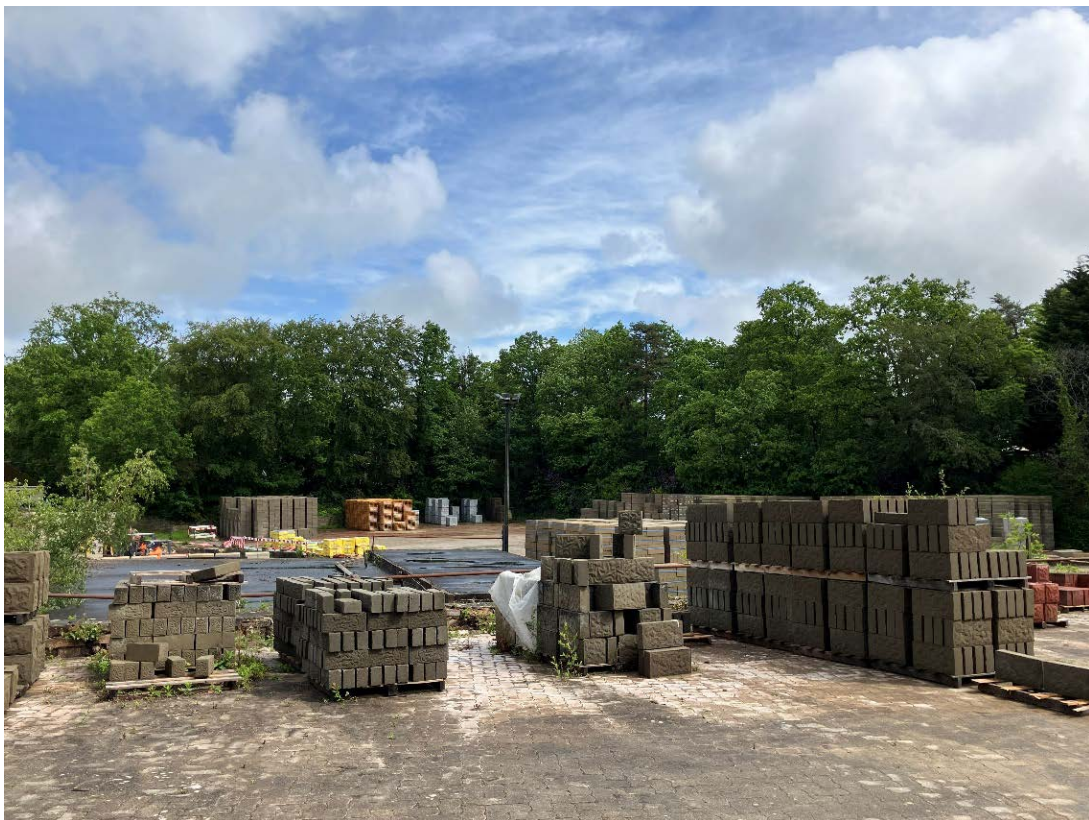
Photograph 6: Site overview – storage of blocks. Looking east.

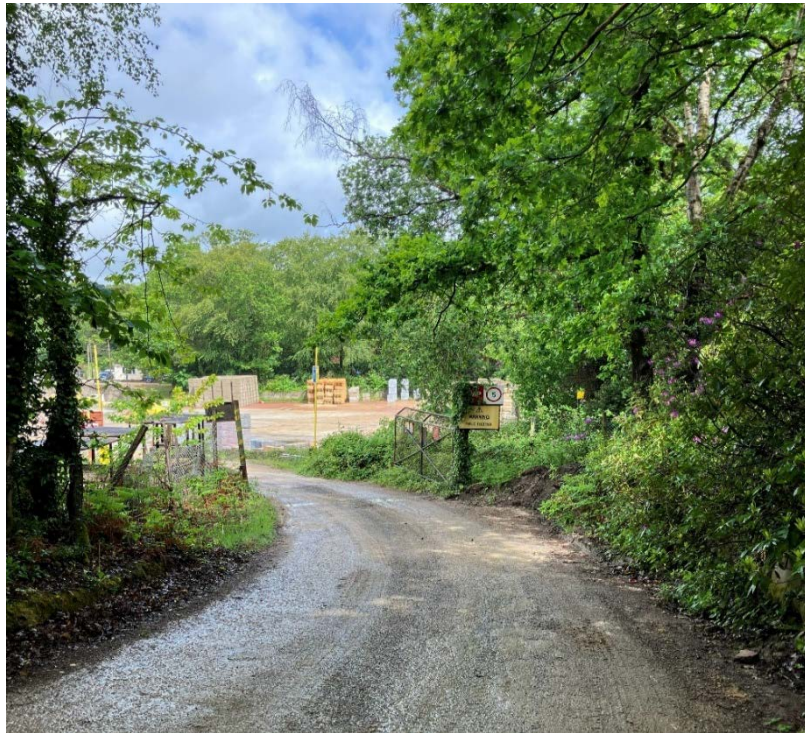
Photograph 7: Access to southern part of the site. Looking north towards where public footpath crosses centre of site.

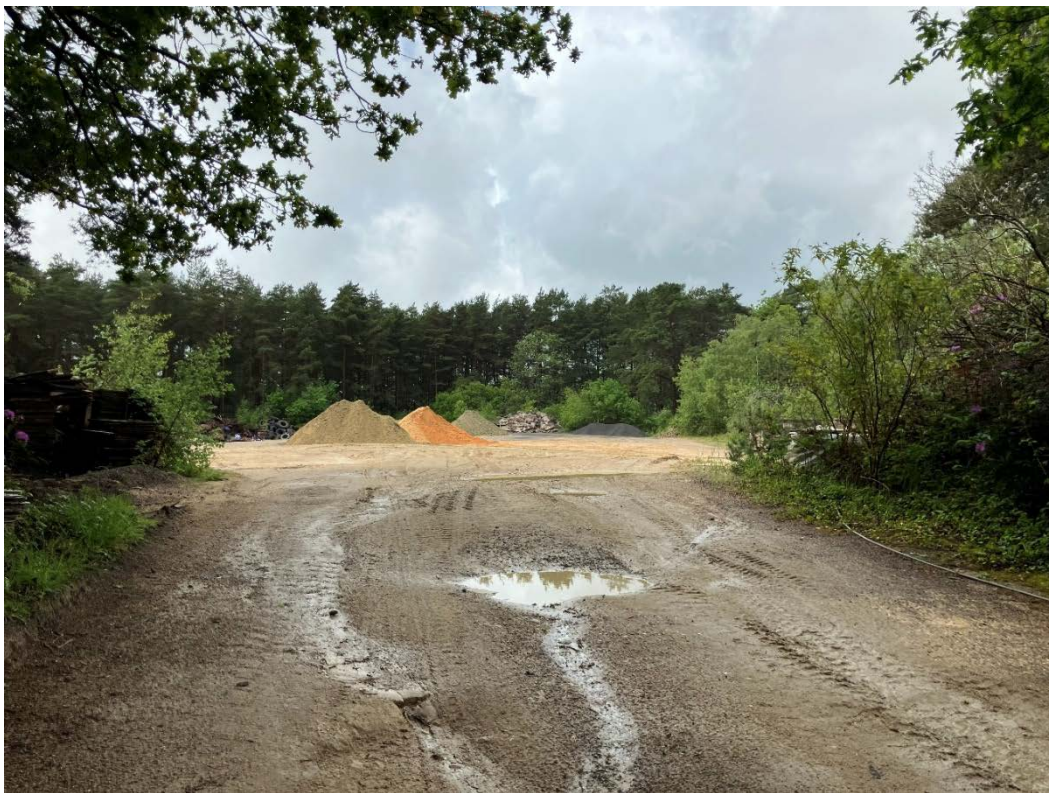
Photograph 8: Southern part of site – storage/delivery area for raw materials. Looking south.

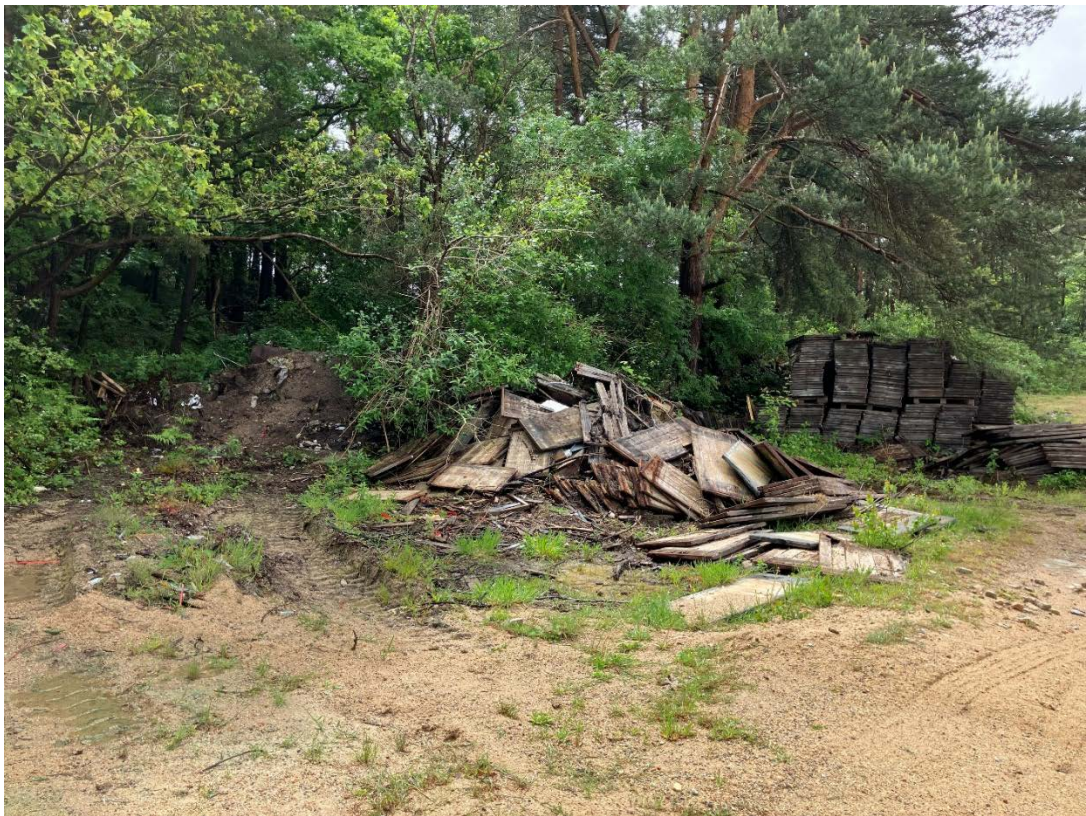
Photograph 9: Storage of old pallets. Looking east.

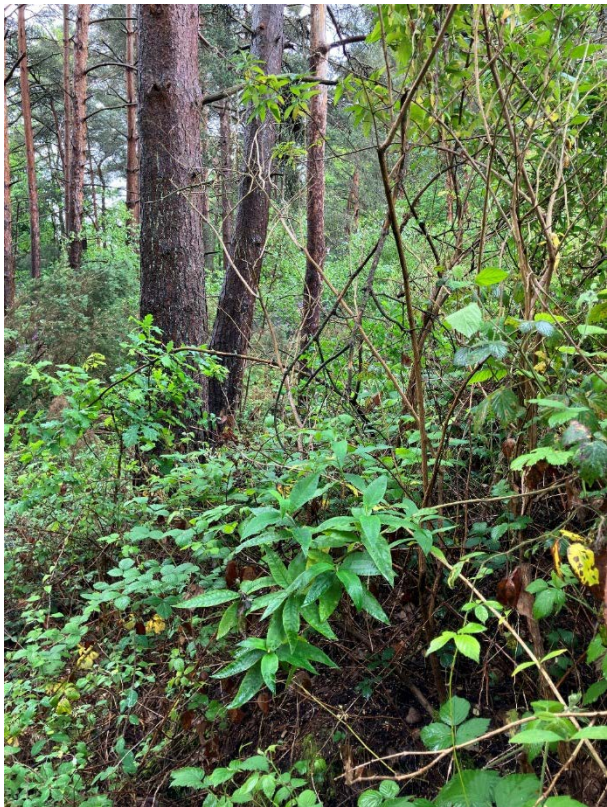
Photograph 10: Heavily vegetated areas with mature trees in southeast of site.

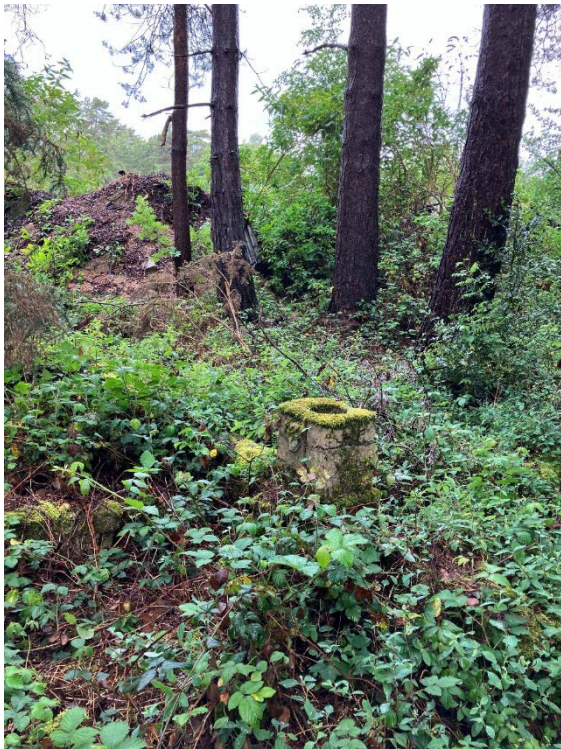
Photograph 11: Heavily vegetated areas with mature trees in southeast of site.

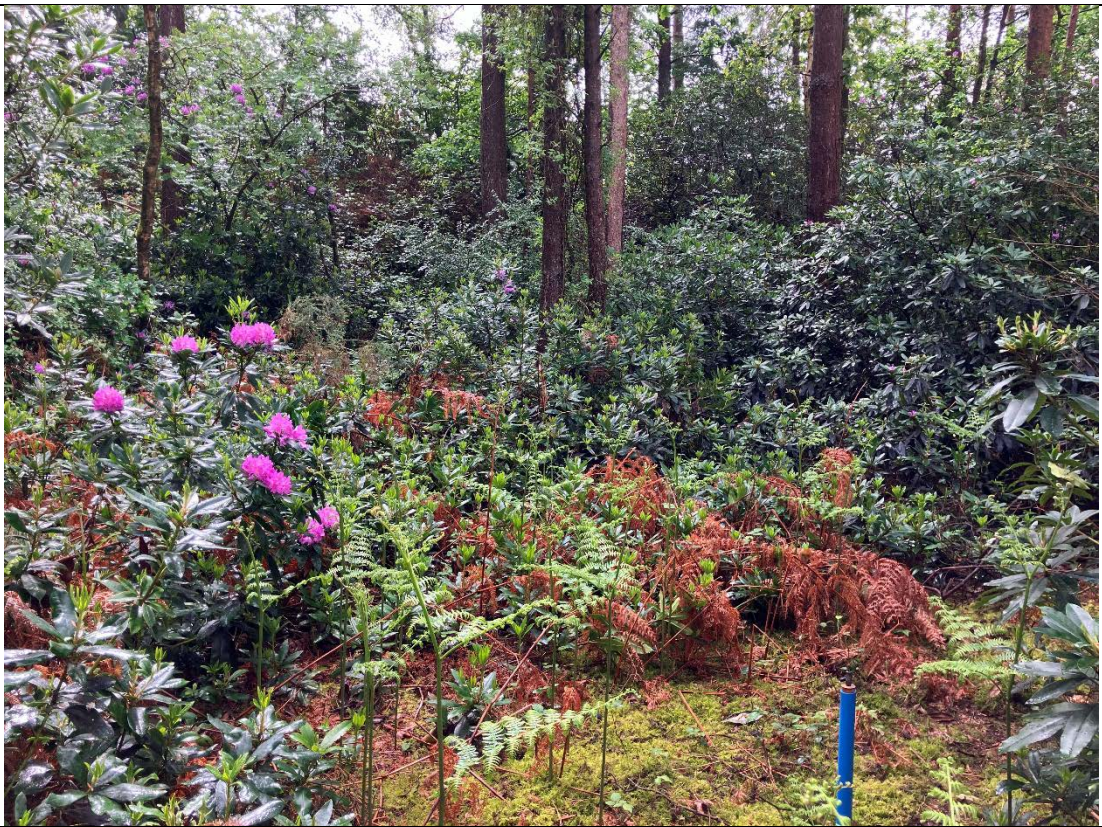
Photograph 12: Heavily vegetated areas with mature trees in southeast of site. WS114 pipe shown.

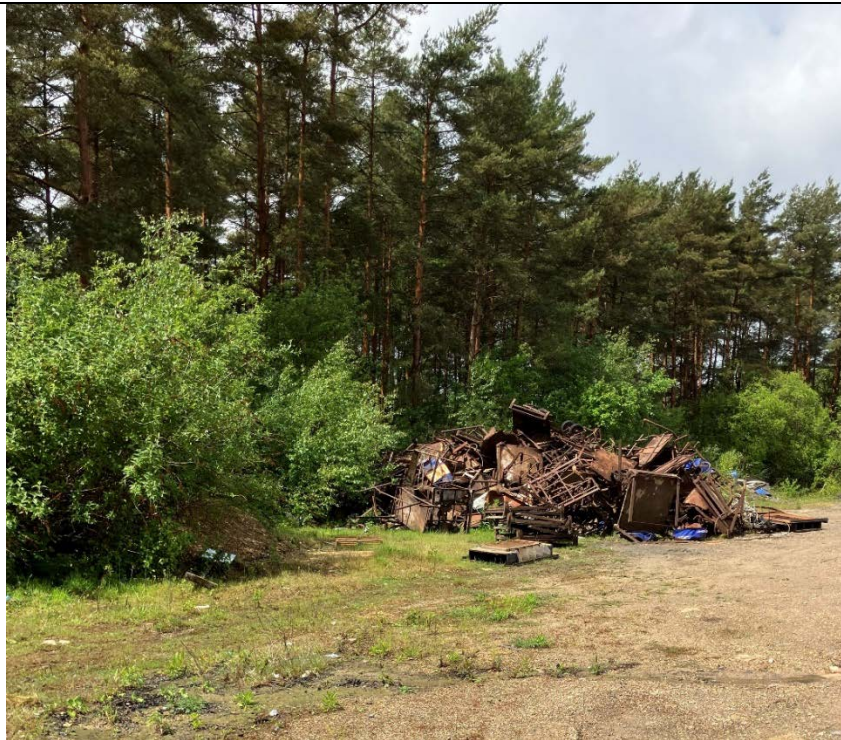
Photograph 13: Scrap metal storage pile. Southeast of site. Looking south.

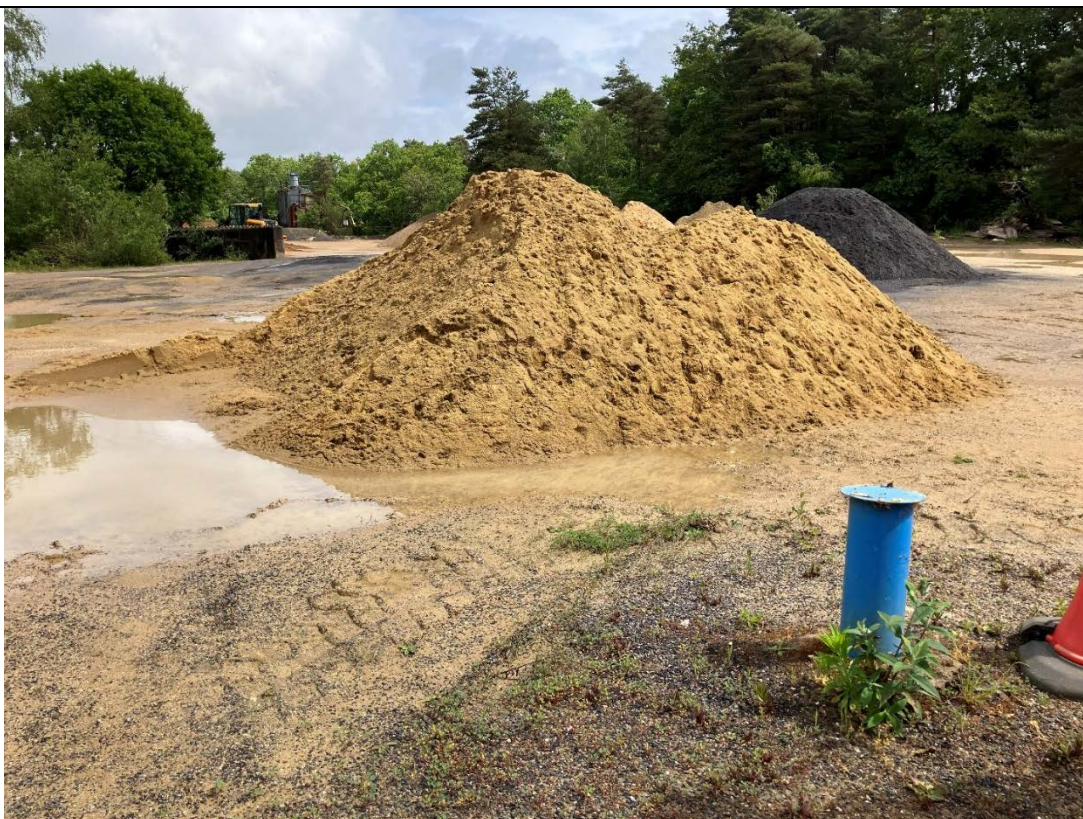
Photograph 14: Materials storage. Southeast of site. Looking north. BH203 monitoring well shown (raised blue cover).

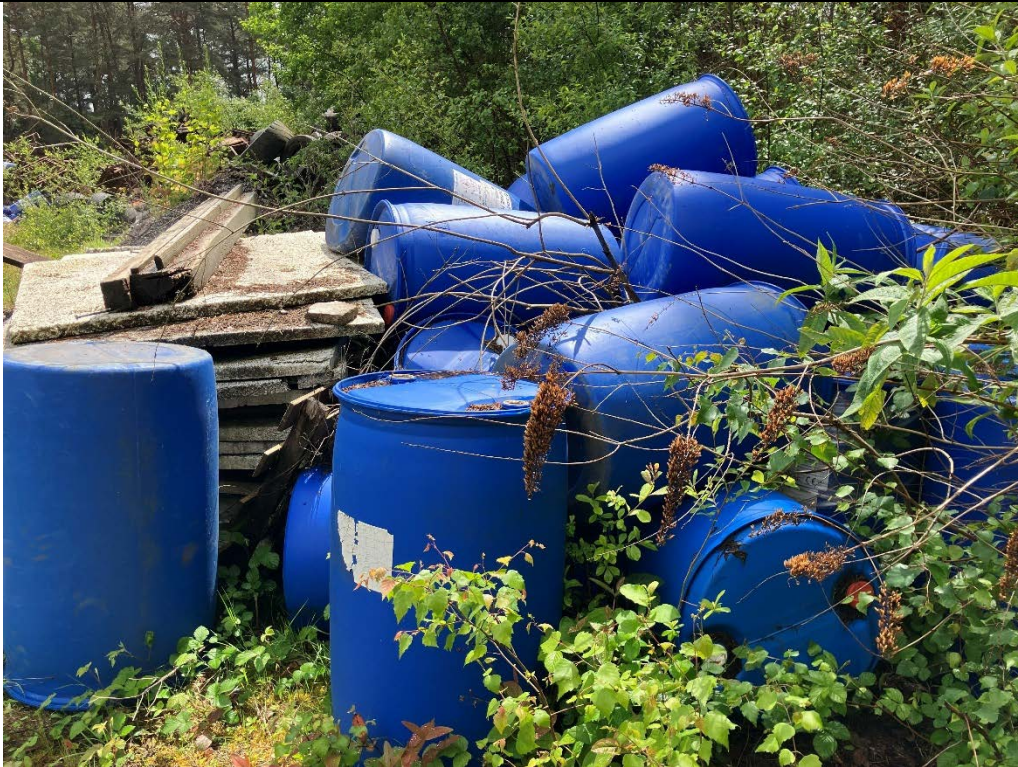
Photograph 15: Storage of empty AdBlue barrels in southwest of southern materials storage area.

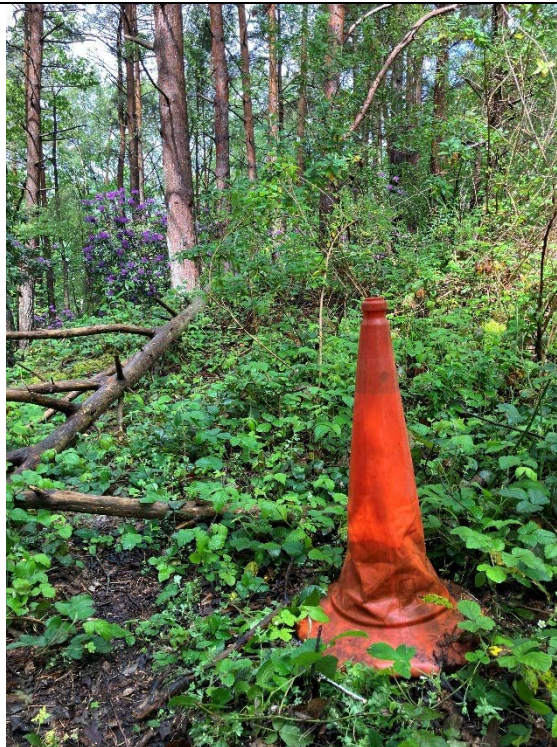
Photograph 16: Heavily vegetated area in south of site. Orange cone covering installation at location WS113. Looking west.

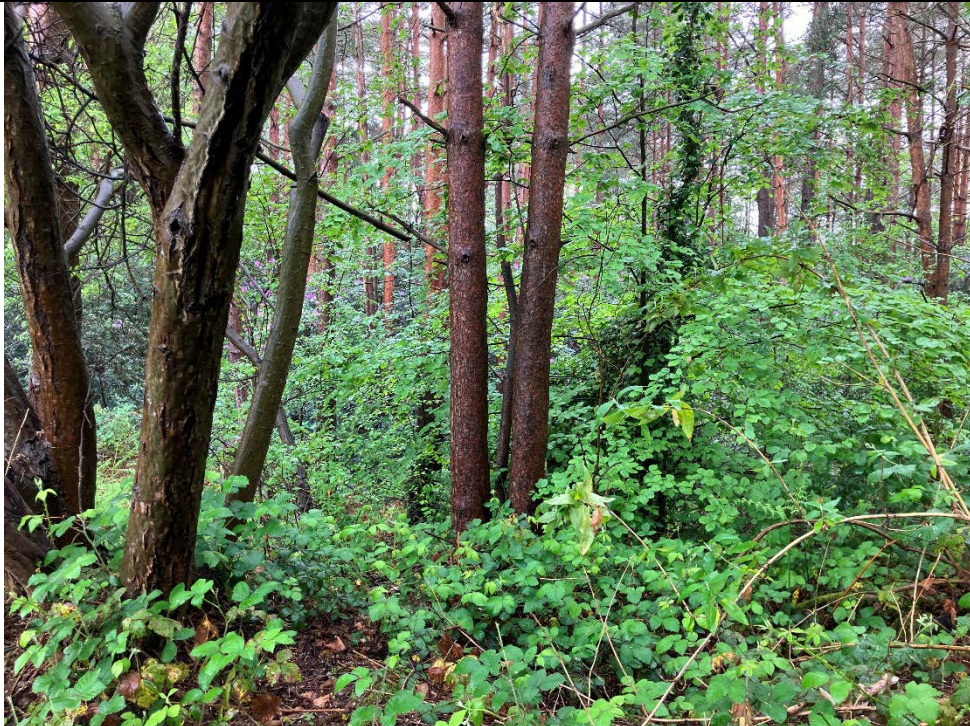
Photograph 17: Heavily vegetated area in south of site with mature trees. Looking south.

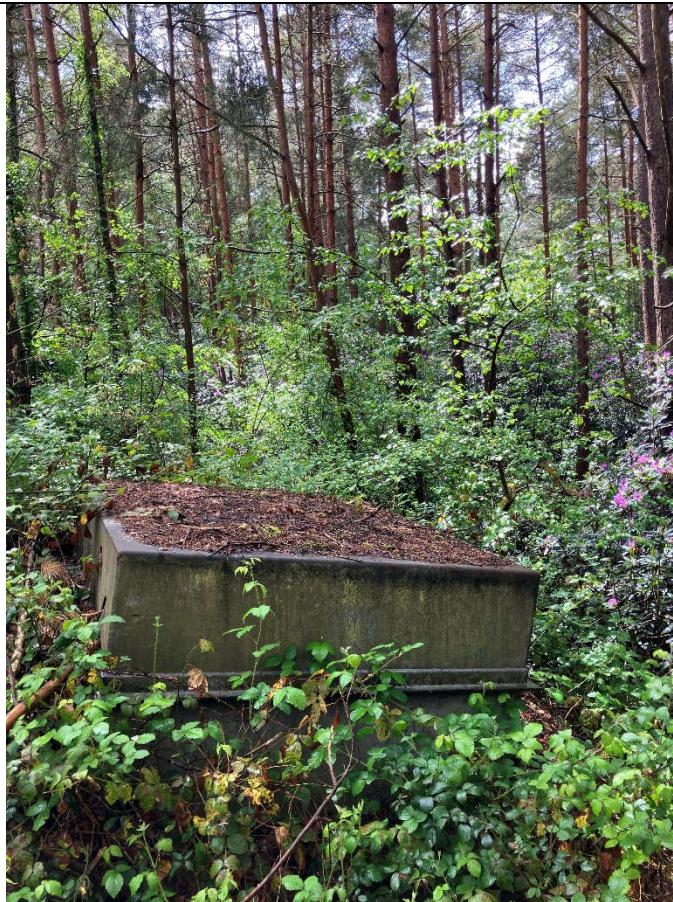
Photograph 18: Heavily vegetated area in south of site, with old container. Looking southeast.

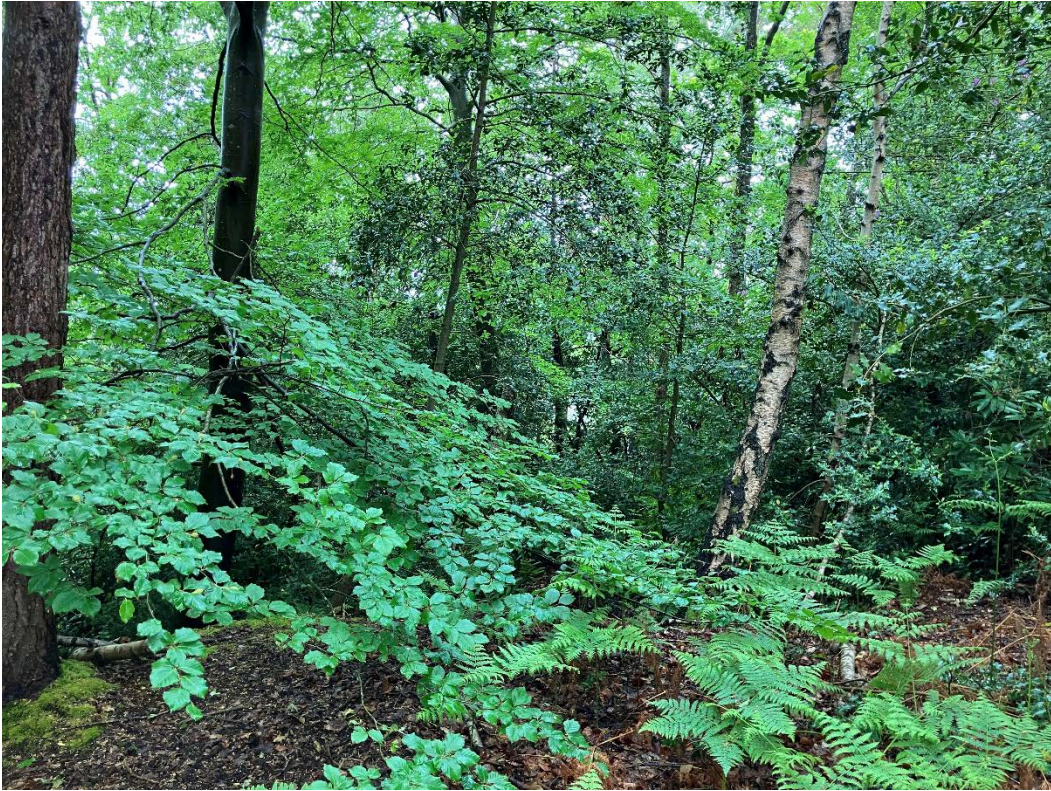
Photograph 19: Heavily vegetated area in southwest of site, with mature trees. Looking west, with residential properties beyond.

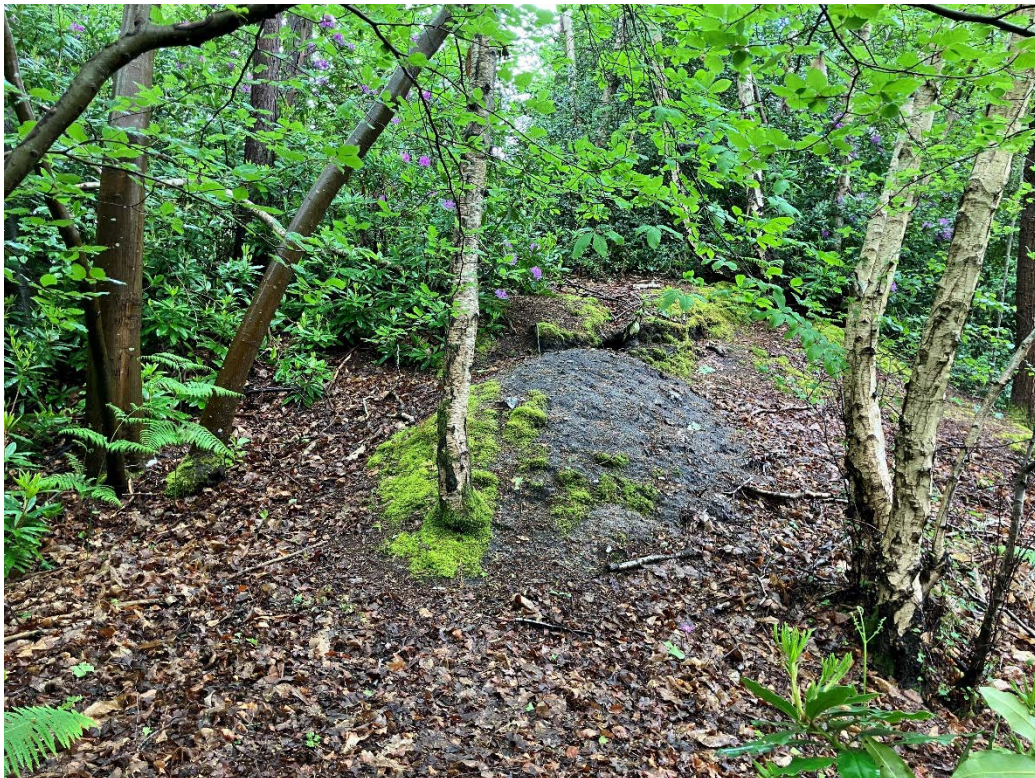
Photograph 20: Heavily vegetated area in southwest of site – in area of mound (near location of HP102). Looking north.

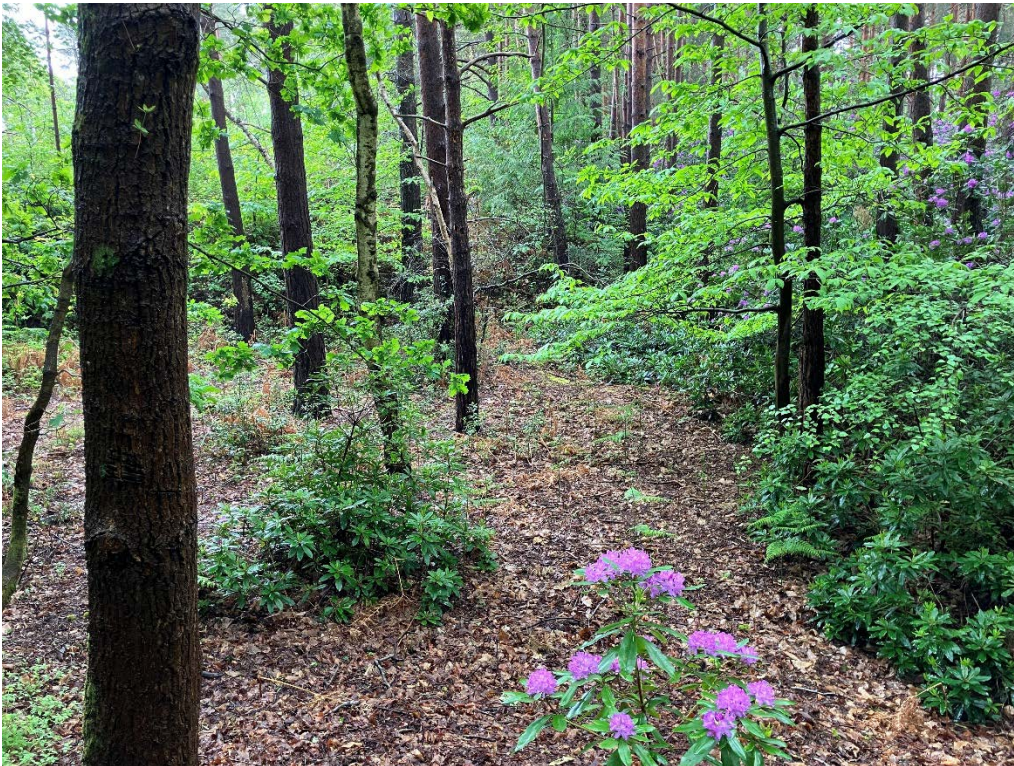
Photograph 21: Heavily vegetated area in southwest of site – photo taken from top of mound (near location of HP102). Looking southeast.

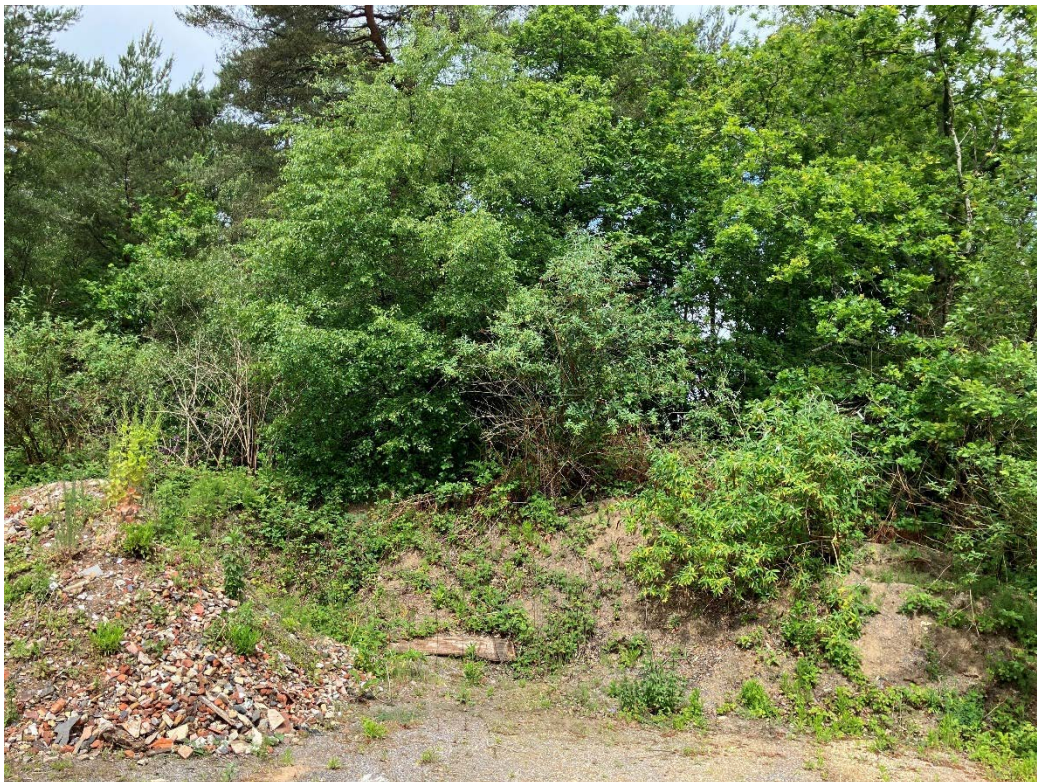
Photograph 22: Heavily vegetated area in southwest of site – photo taken from materials storage area. Looking west.

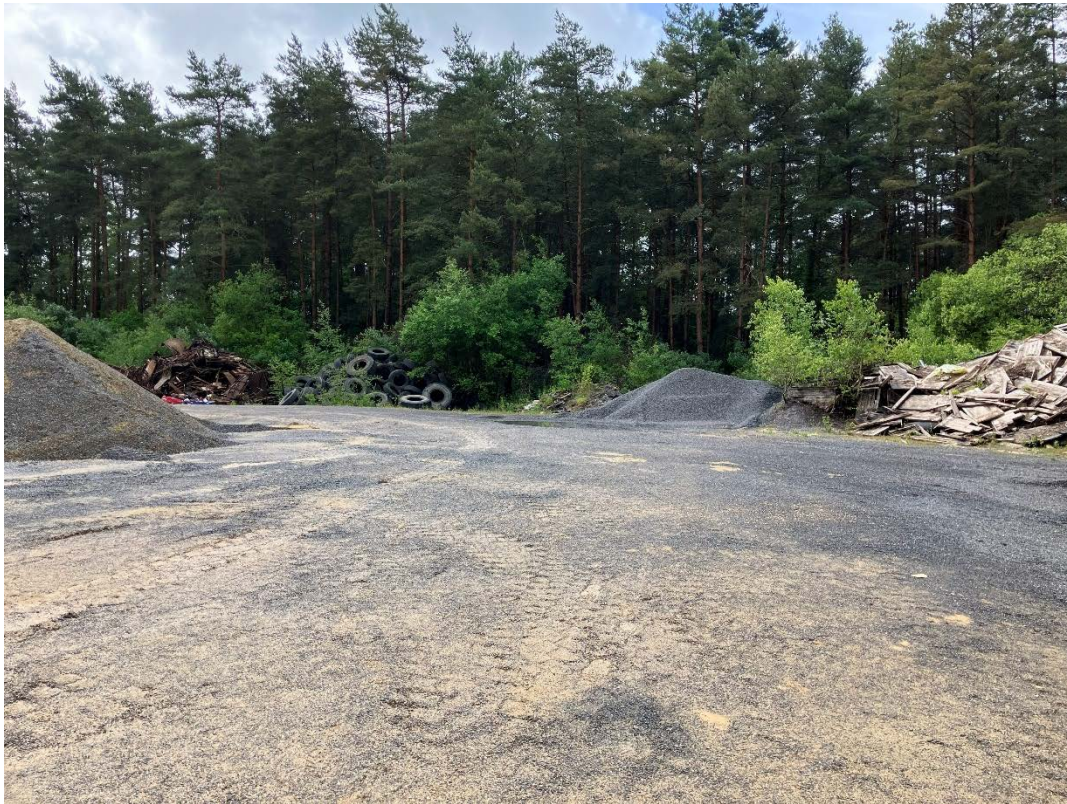
Photograph 23: Materials storage area in south of site – stockpiles of raw materials, pallets, scrap metal and used tyres. Looking southeast.

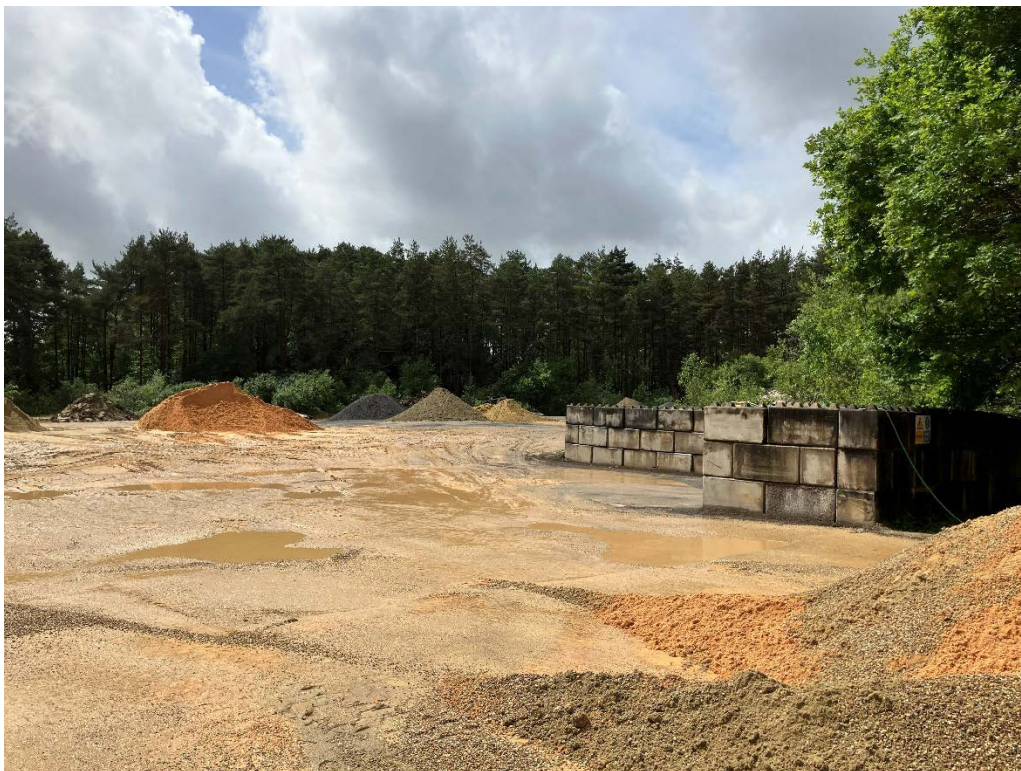
Photograph 24: Overview of materials storage area in south of site – stockpiles of raw materials. Looking south.

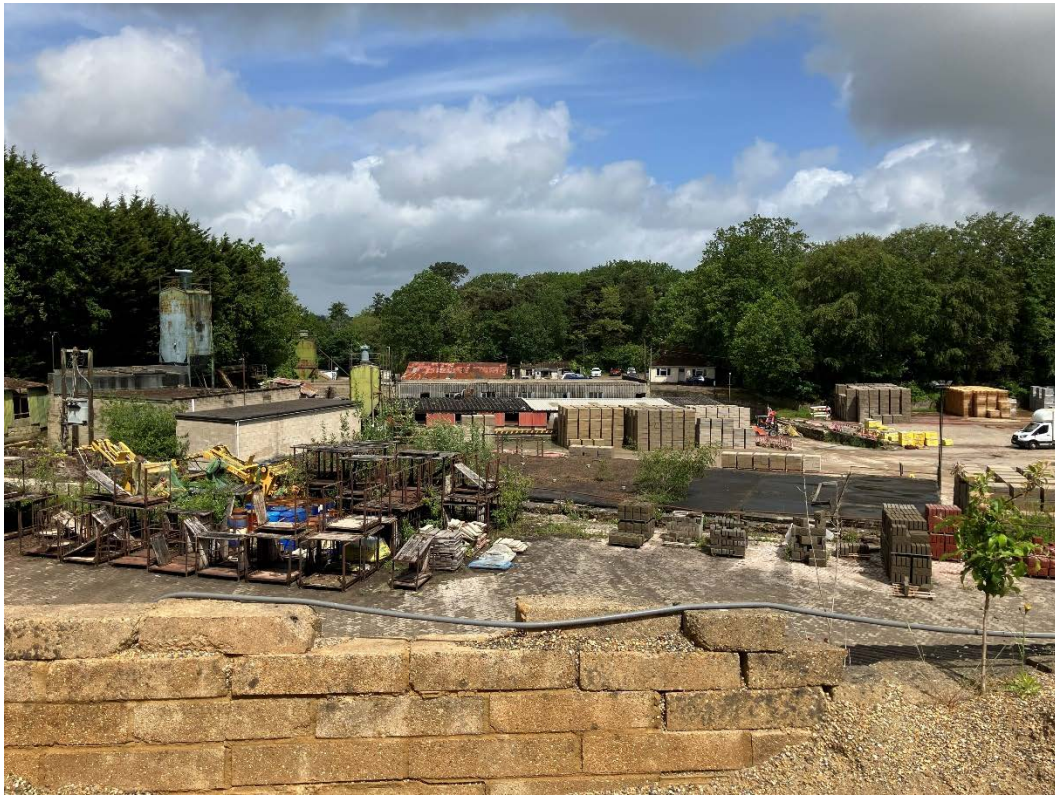
Photograph 25: Overview of site from materials storage area in south. Looking north.

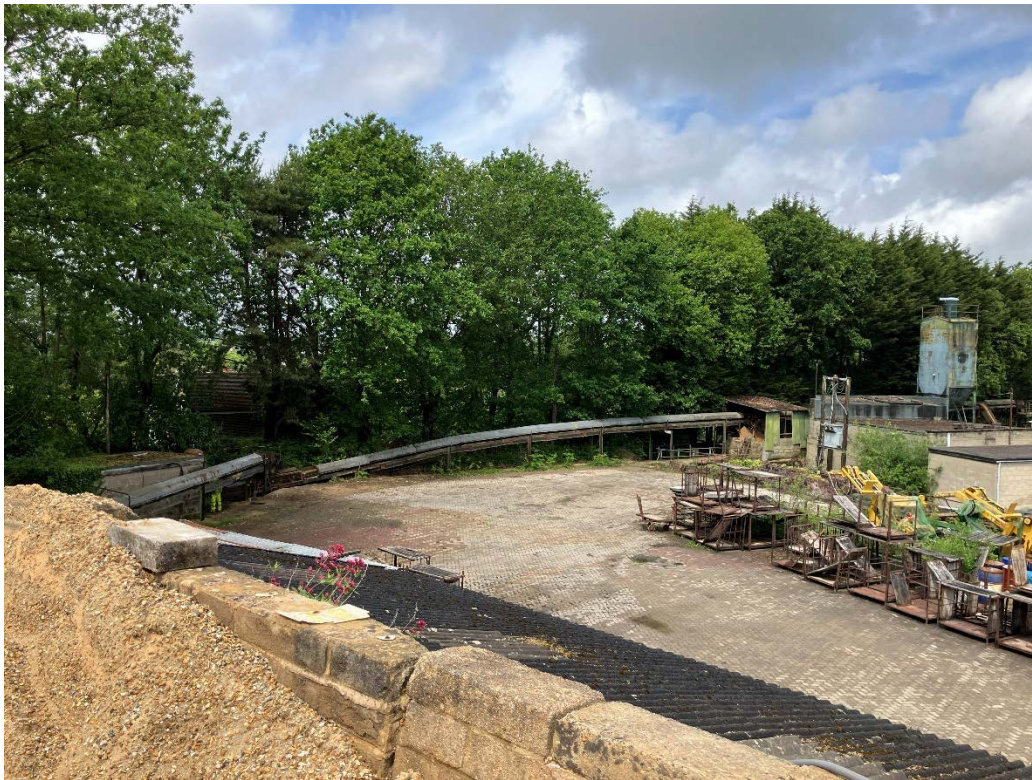
Photograph 26: Overview of conveyer from hoppers of raw materials. Looking northwest.

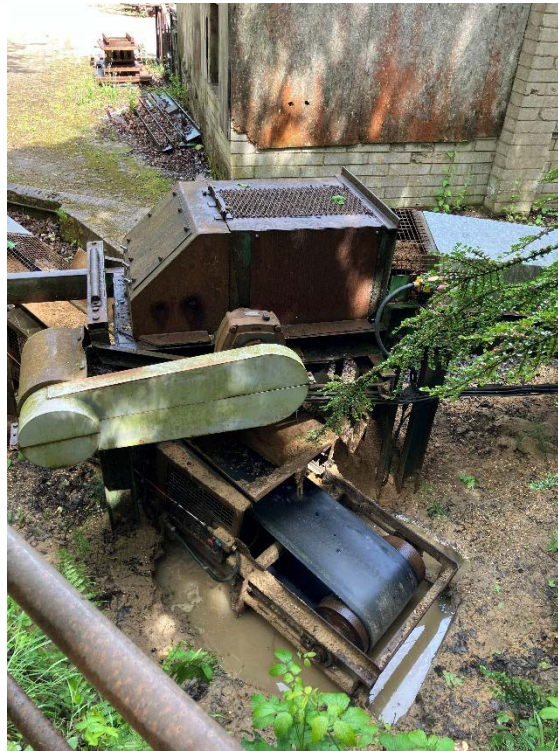
Photograph 27: Conveyor machinery in central west area of site.

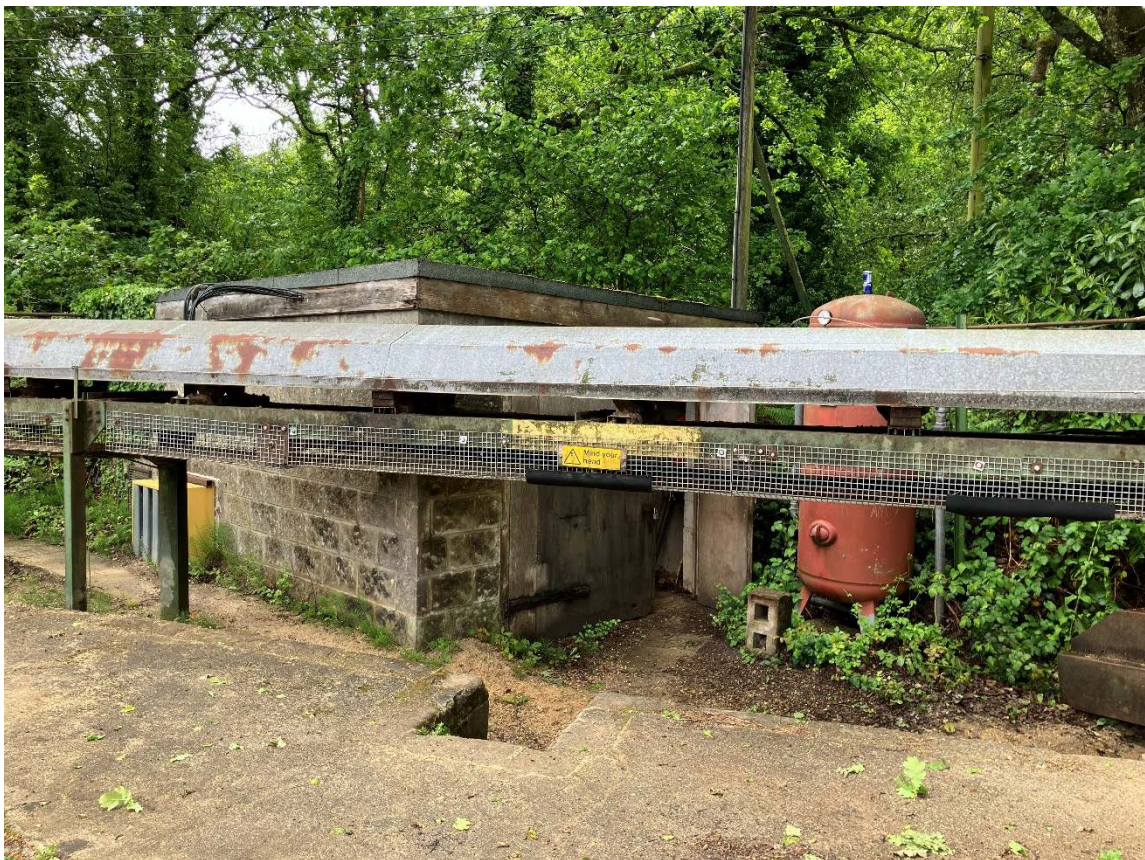
Photograph 28: Compressed air generation unit in central west area of site. Looking west.

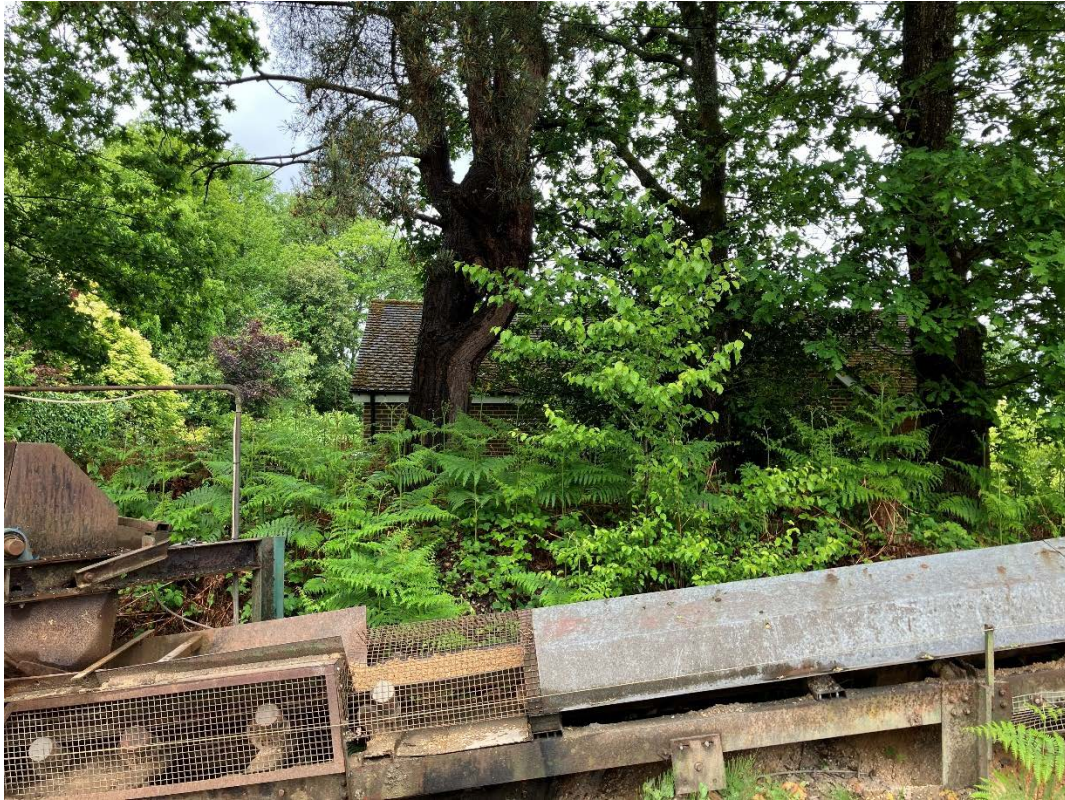
Photograph 29: Conveyor with residential properties beyond western site boundary in central west area of site. Looking west.
