## Appendix B Field reconnaissance photographs

# Site Visit Report

| <b>Project name</b> | Thakeham Tiles | <b>Client</b> | Thakeham Tiles Ltd |
| <b>Document reference</b> | 333800445-STN-XX-XX-SVR-GE-0001 | | |

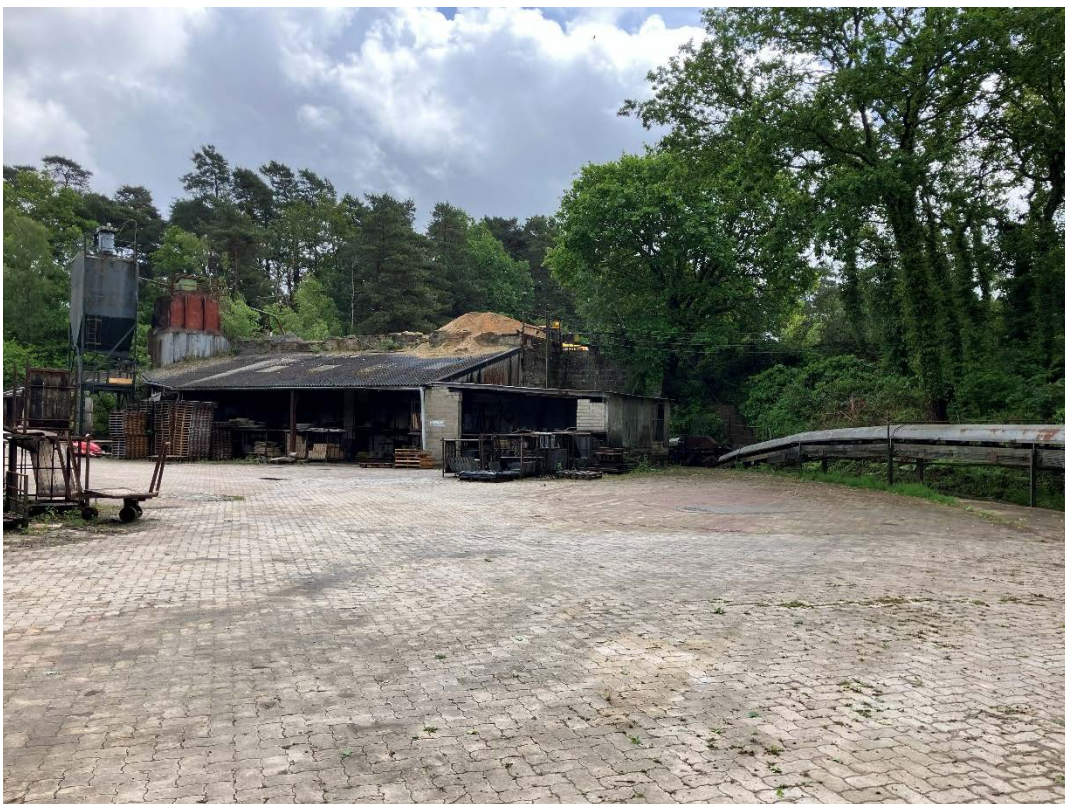
Photograph 30: Building and storage areas, with conveyor, in central area of site. Looking southeast.
