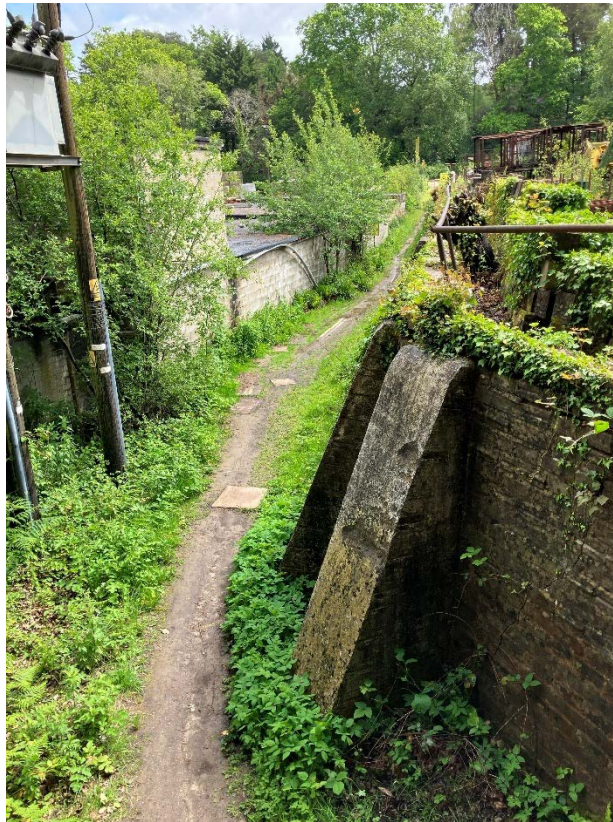
Photograph 31: Public footpath that cuts across central area of site. Looking east.

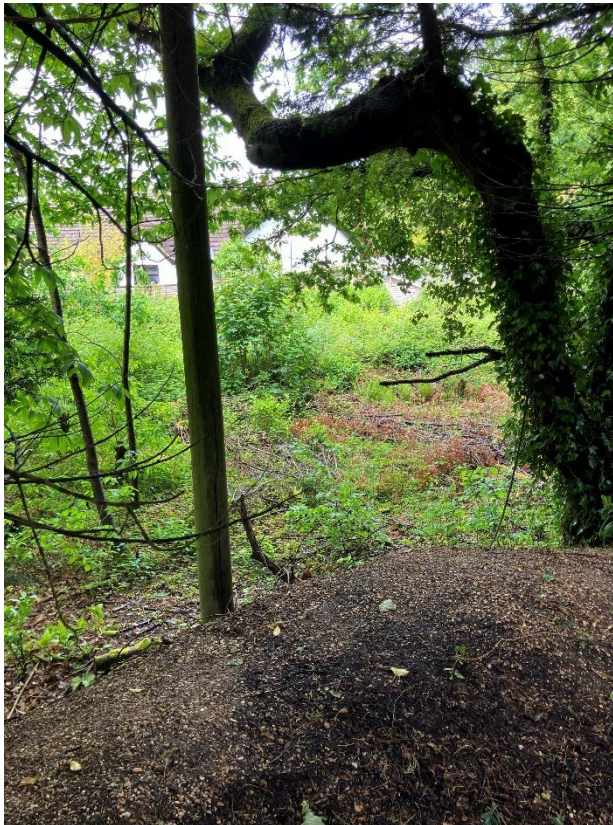
Photograph 32: Vegetated central western area of site (previously Elizabeth Cottage). Looking west towards residential properties beyond.

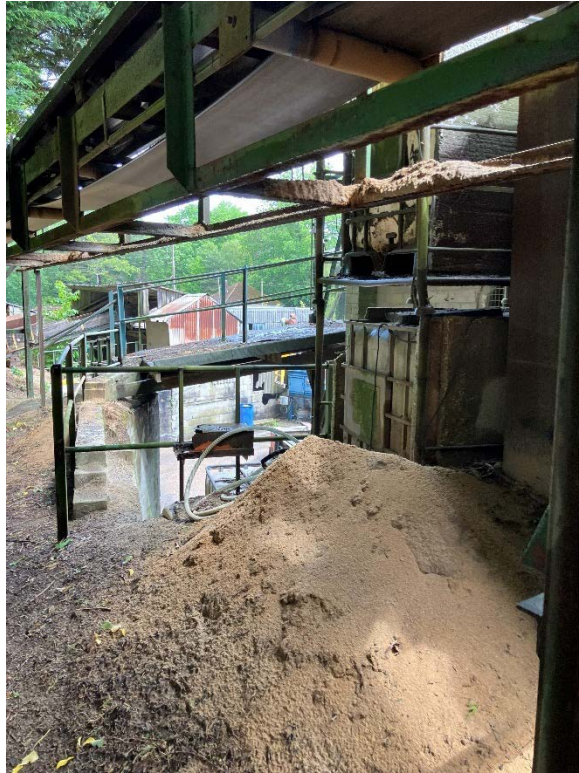
Photograph 33: Conveyor infrastructure close to western site boundary. Looking north.

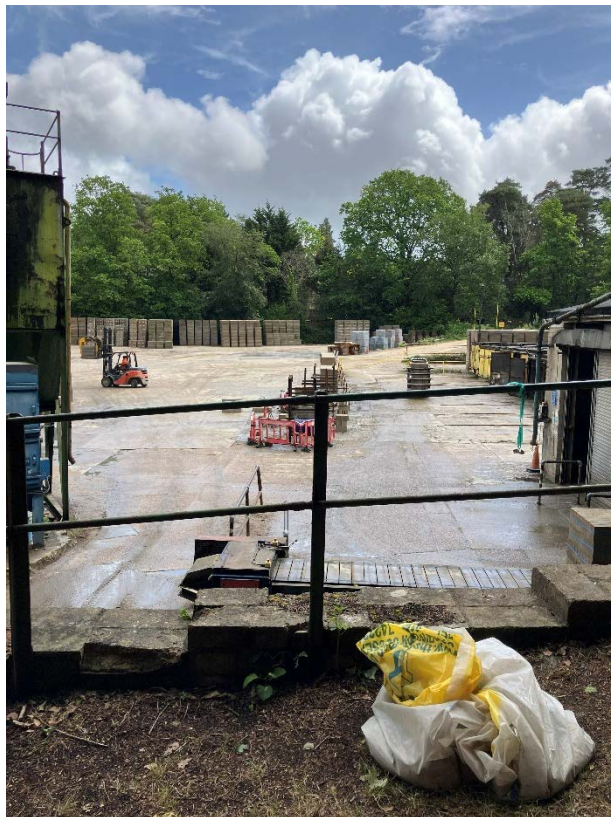
Photograph 34: Overview of central area of site – manufacture, curing and storage of blocks, pavers.  
Looking east.

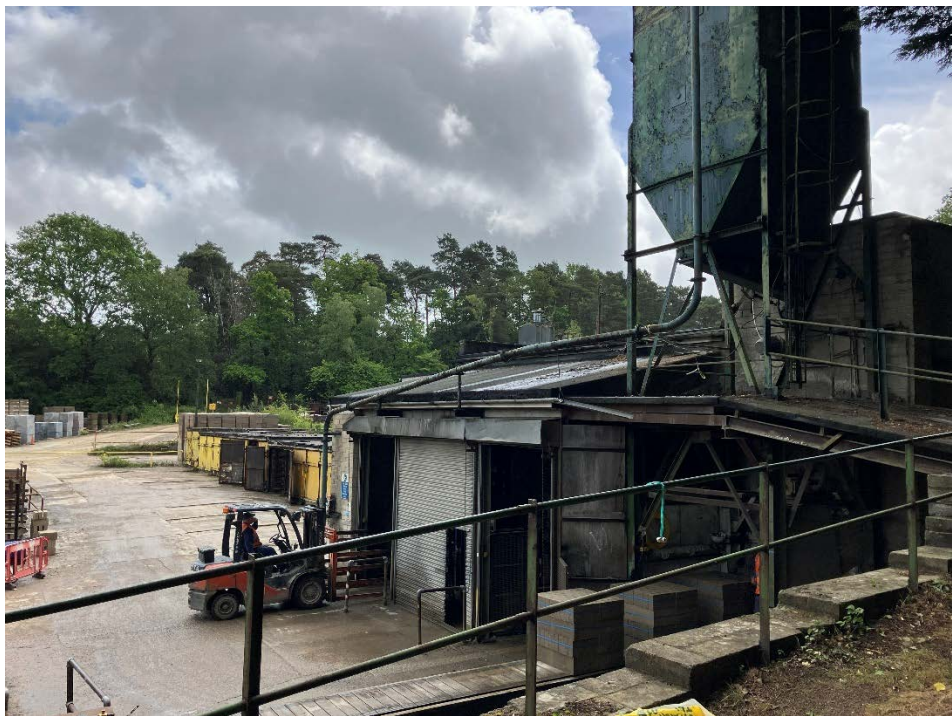
Photograph 35: Building assigned to manufacture of blocks. Looking southeast.

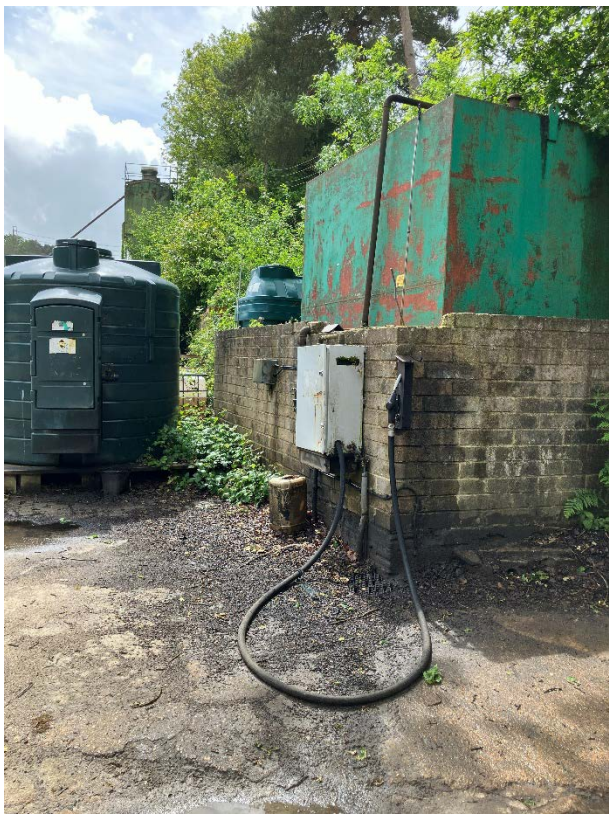
Photograph 36: Fuel storage area with pump. Looking south.

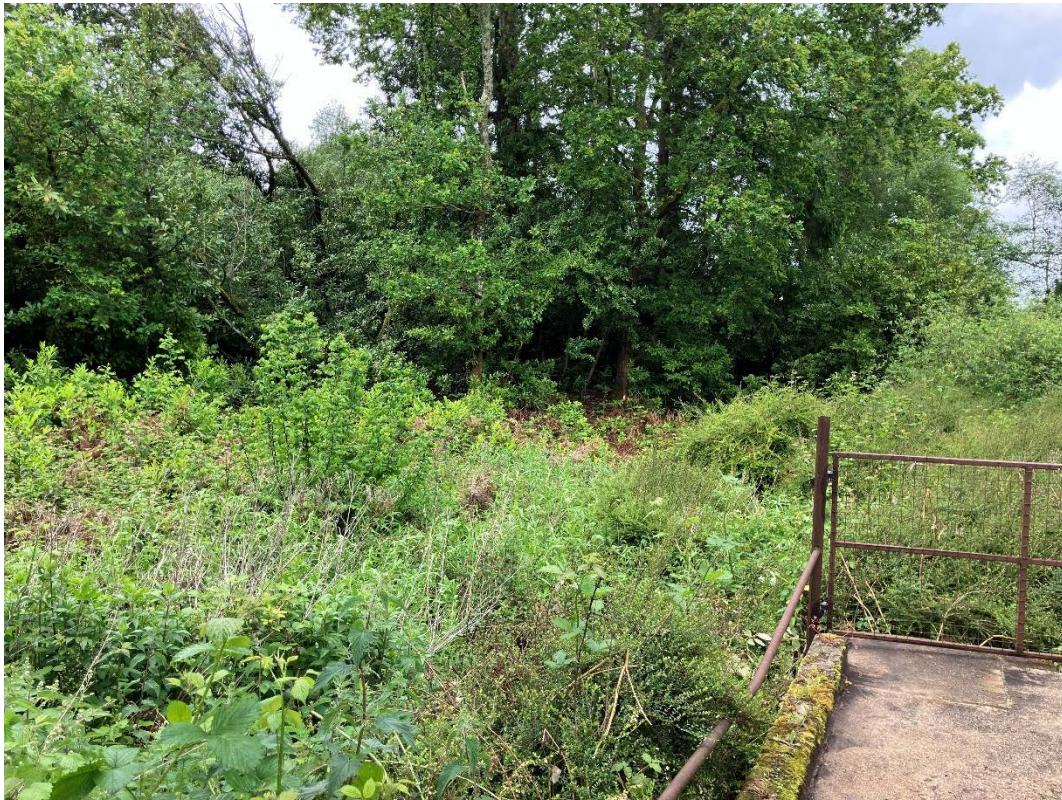
Photograph 37: Heavily vegetated area in west of site, around locations WS205 and WS206 (not visible).  
Looking southwest.

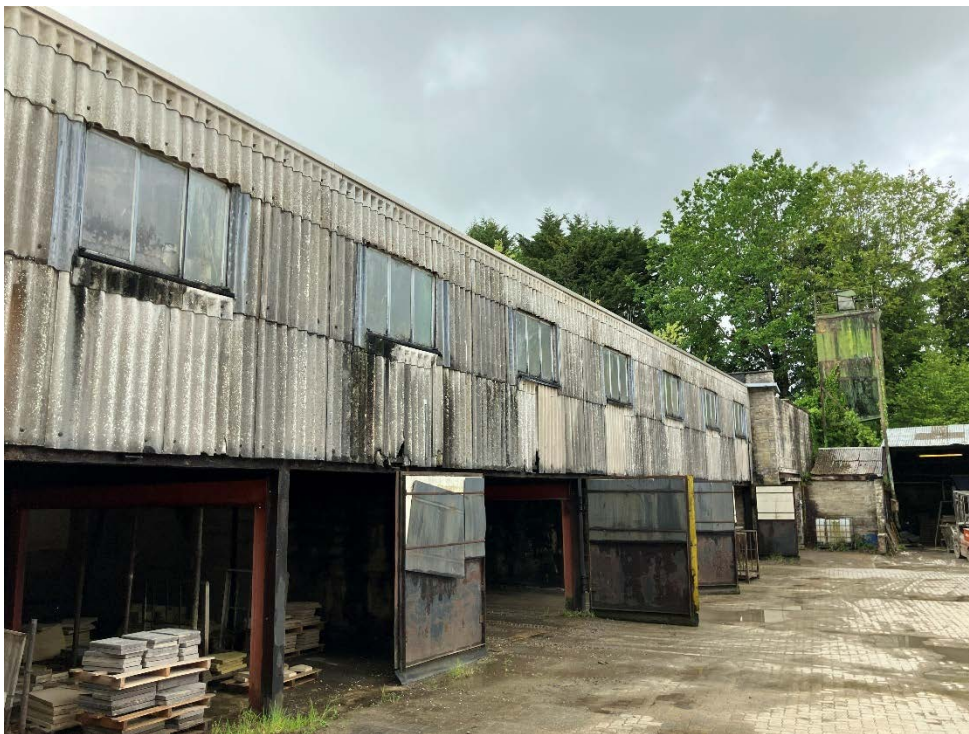
Photograph 38: Building on site used for storage. Looking southwest.

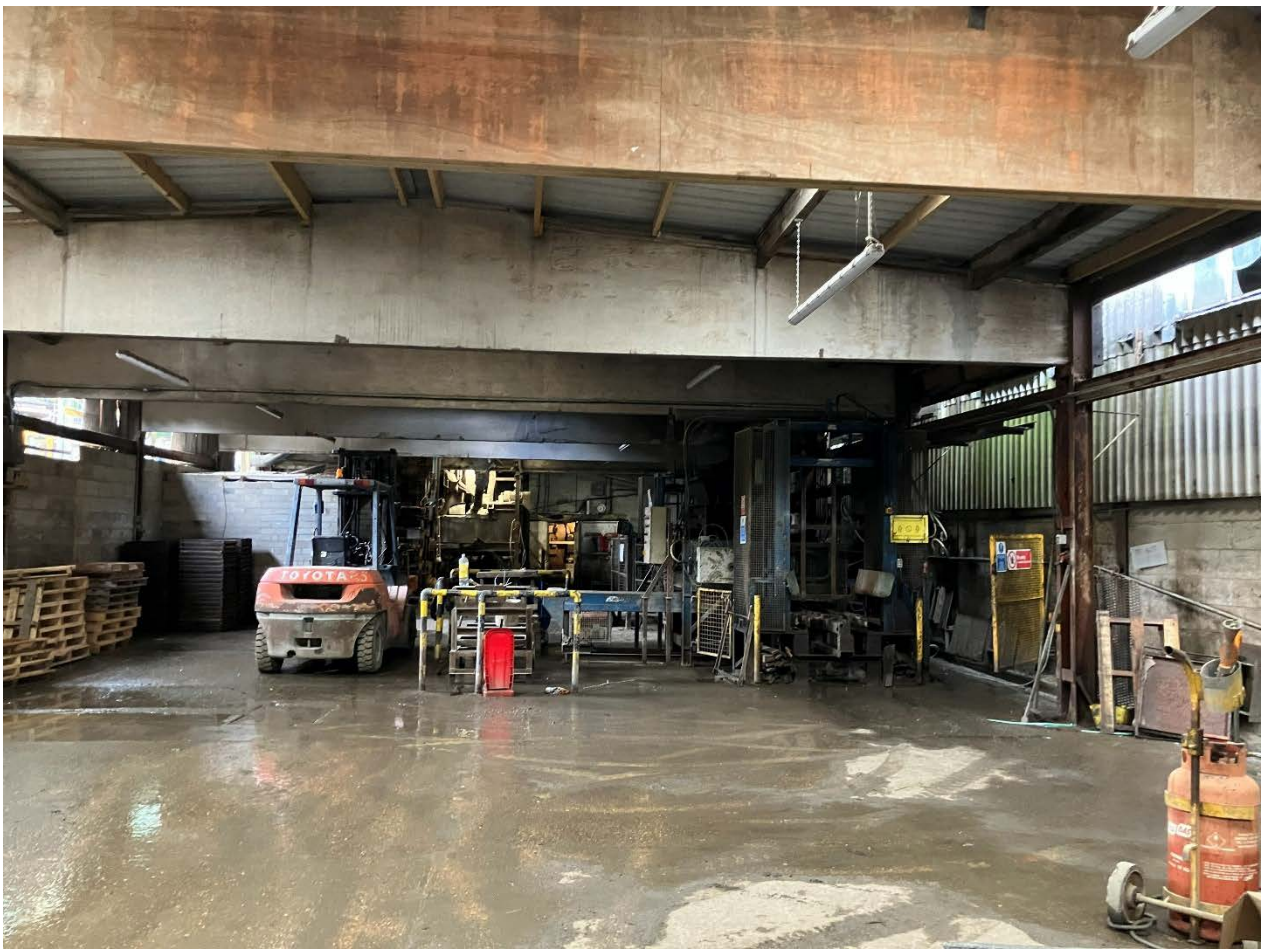
Photograph 39: Internal view of building (in area of WS110) on site used for making pavers. Looking west.

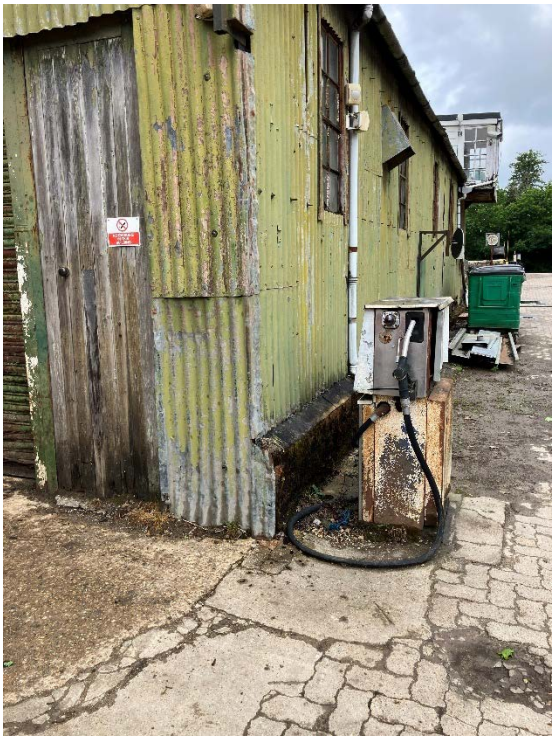
Photograph 40: Disused fuel pump. Looking north.

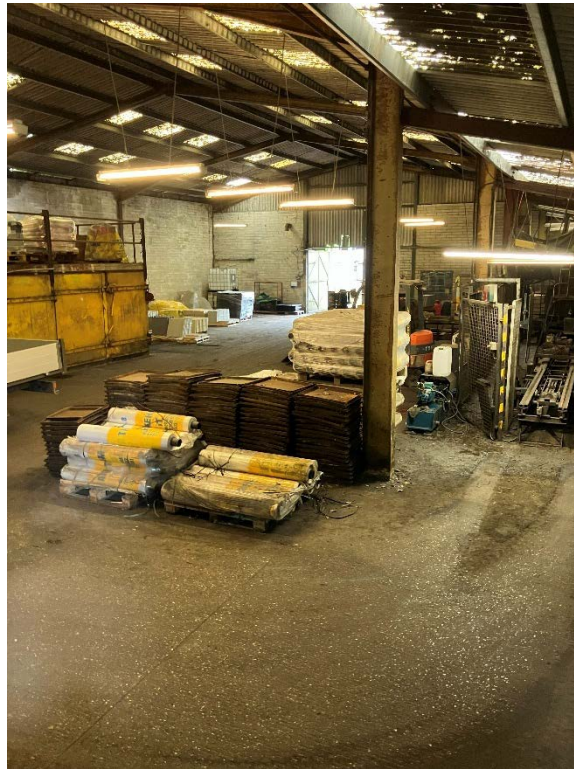
Photograph 41: Internal view of building (in area of WS103) on site used for making pavers. Looking northwest.

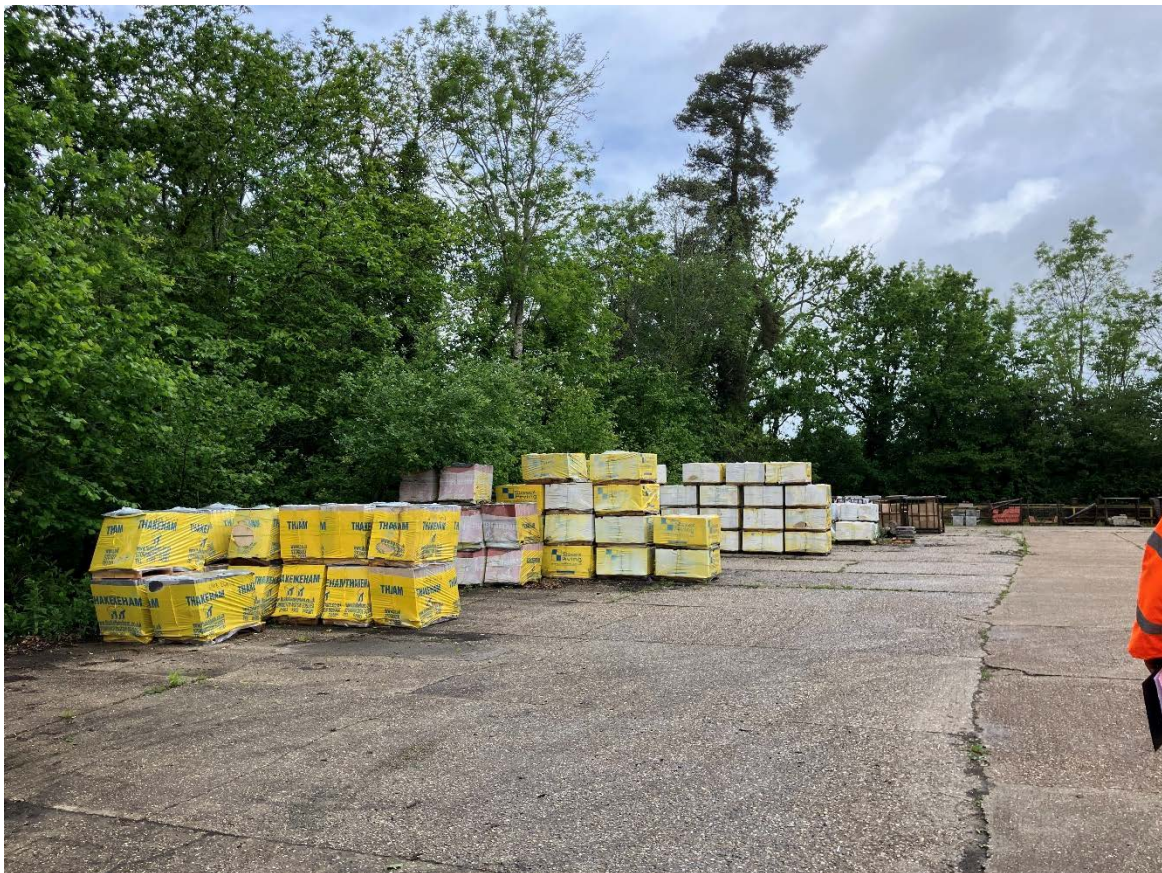
Photograph 42: Storage area for distribution in north of site. Looking north.

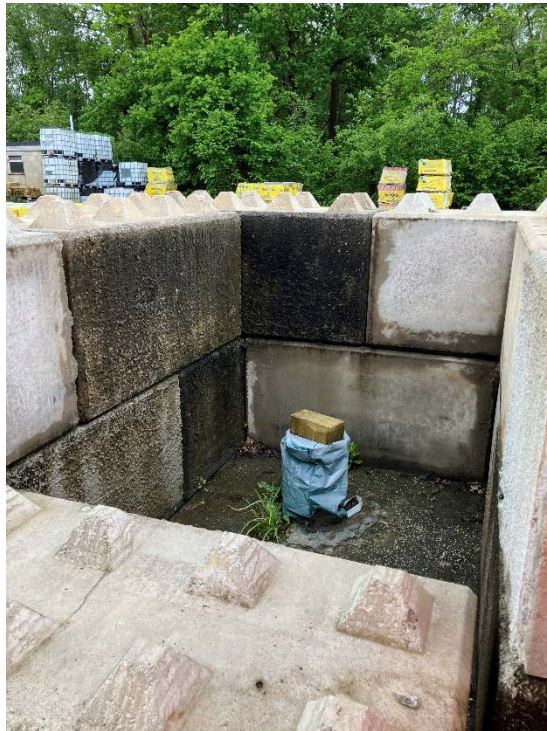
Photograph 43: Deep borehole (BH1) with continuous datalogger. Looking west.

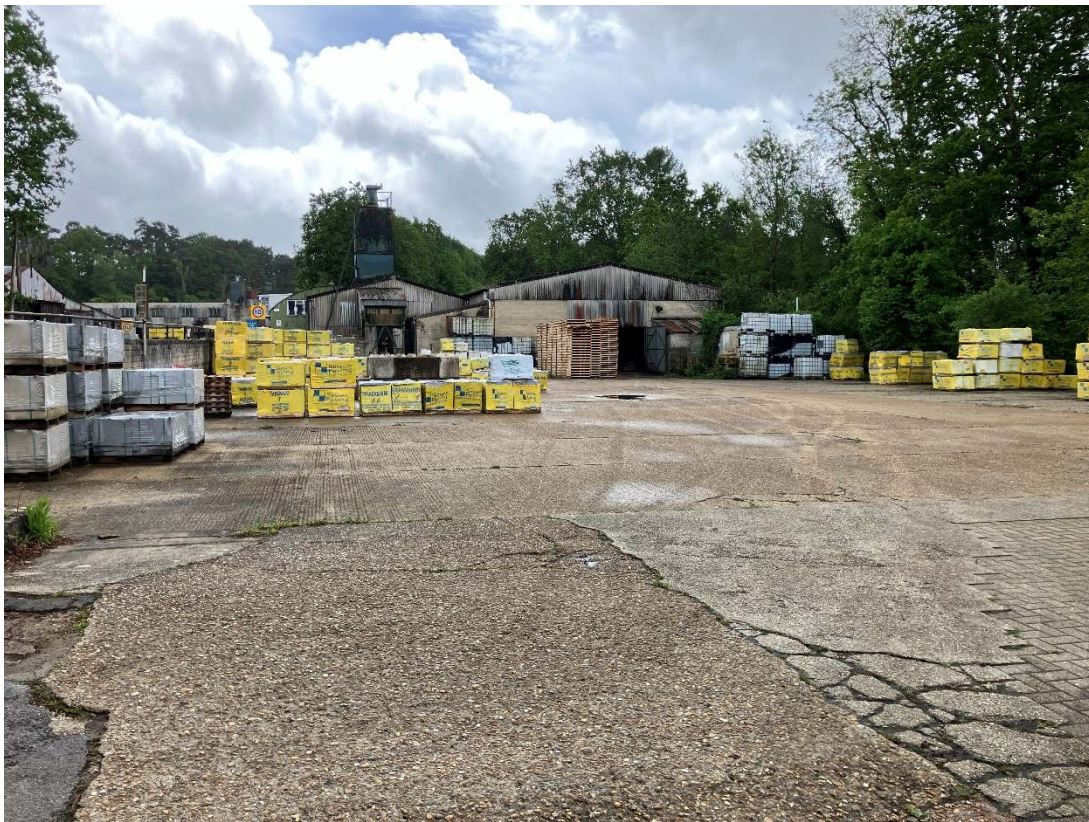
Photograph 44: Overview of northern part of site. Looking south.

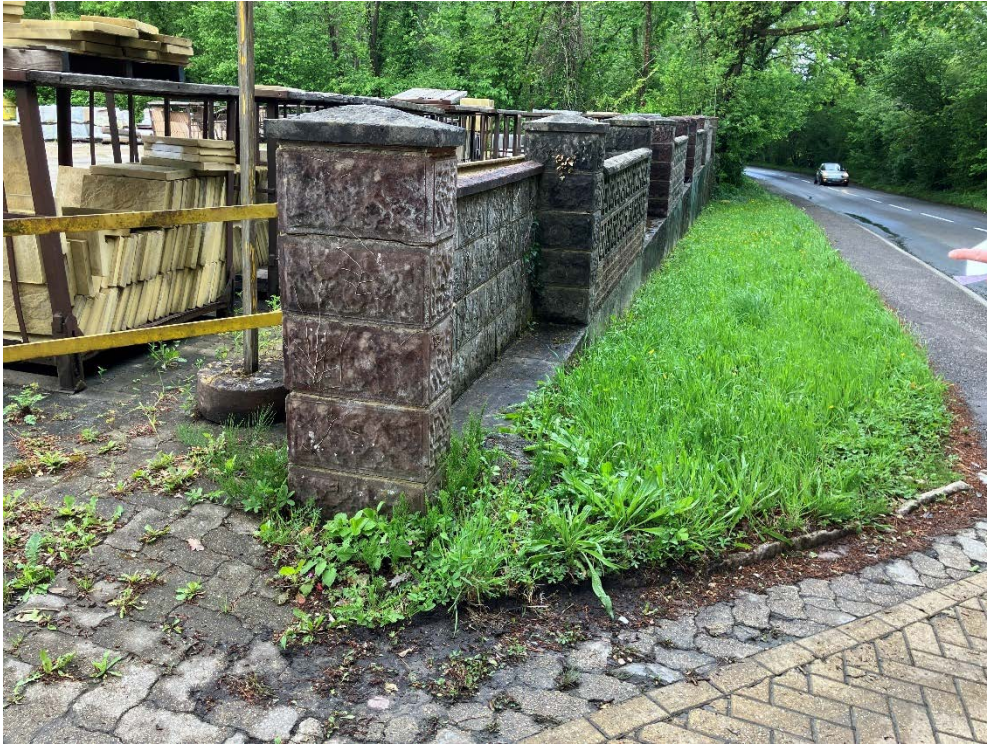
Photograph 45: Entrance to site from Rock Road. Looking west.

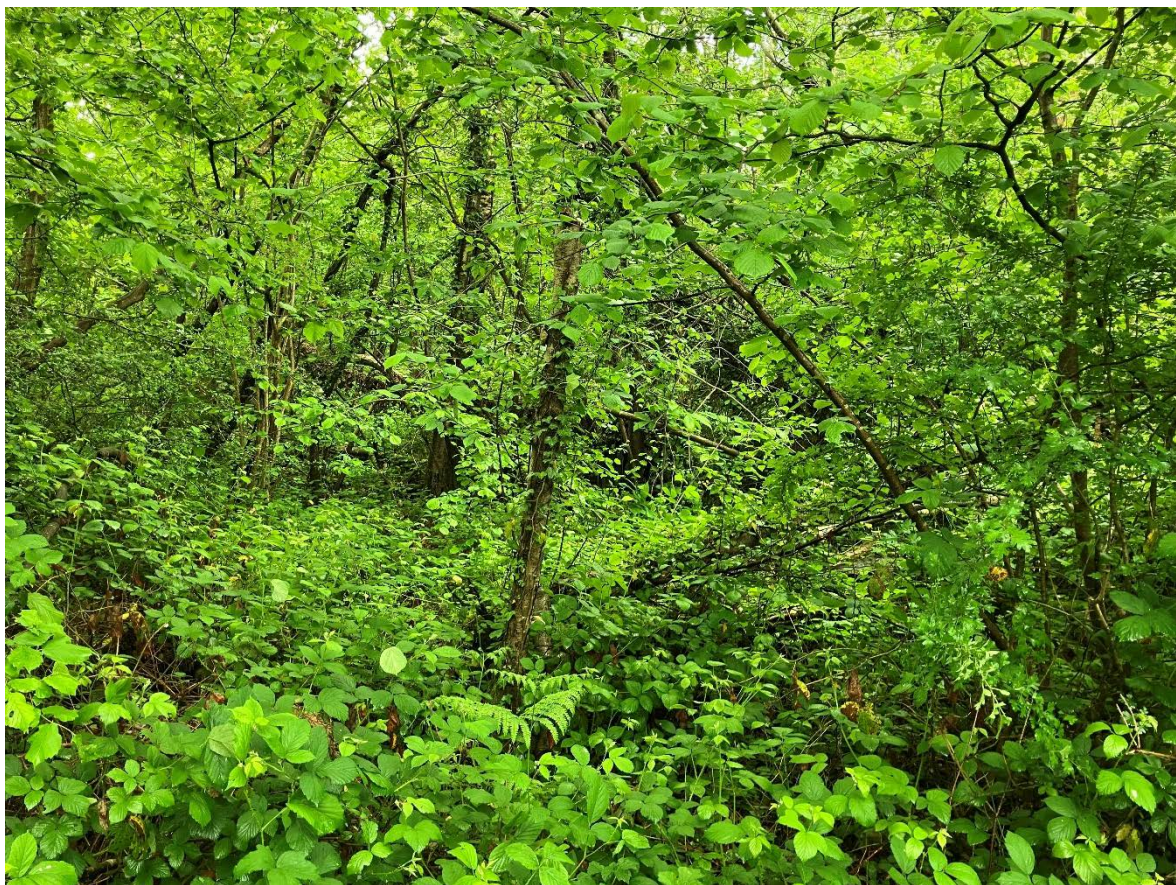
Photograph 46: Heavily vegetated area in northwest of site. Looking south from Rock Road.

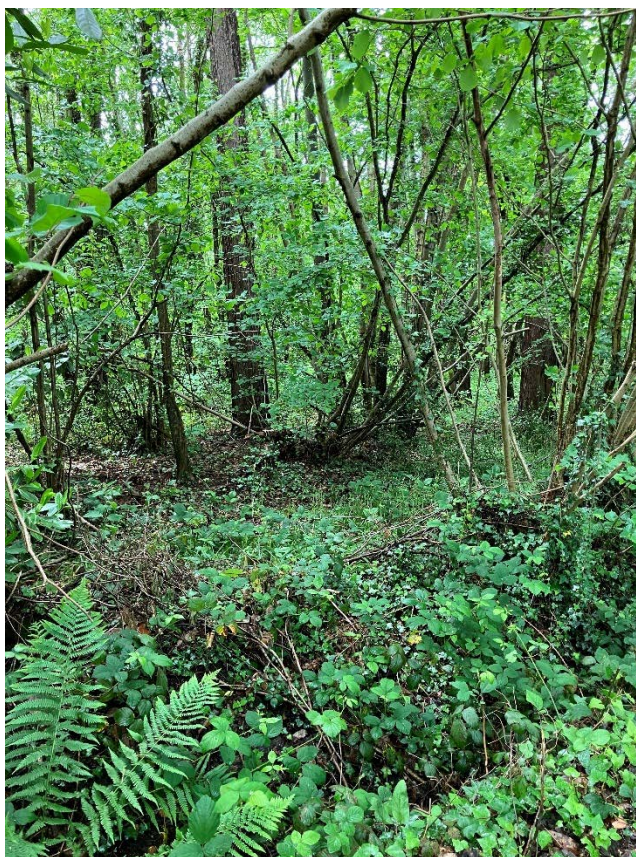
Photograph 47: Heavily vegetated area in northwest of site.

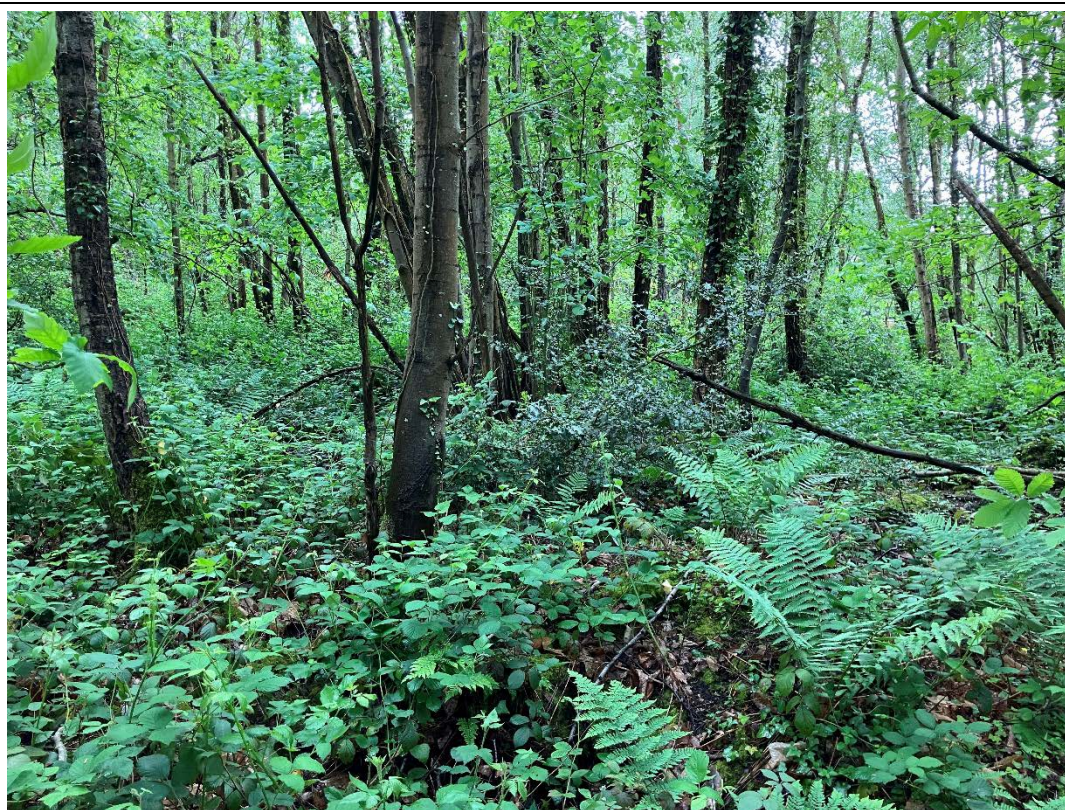
Photograph 48: Heavily vegetated area in northwest of site.

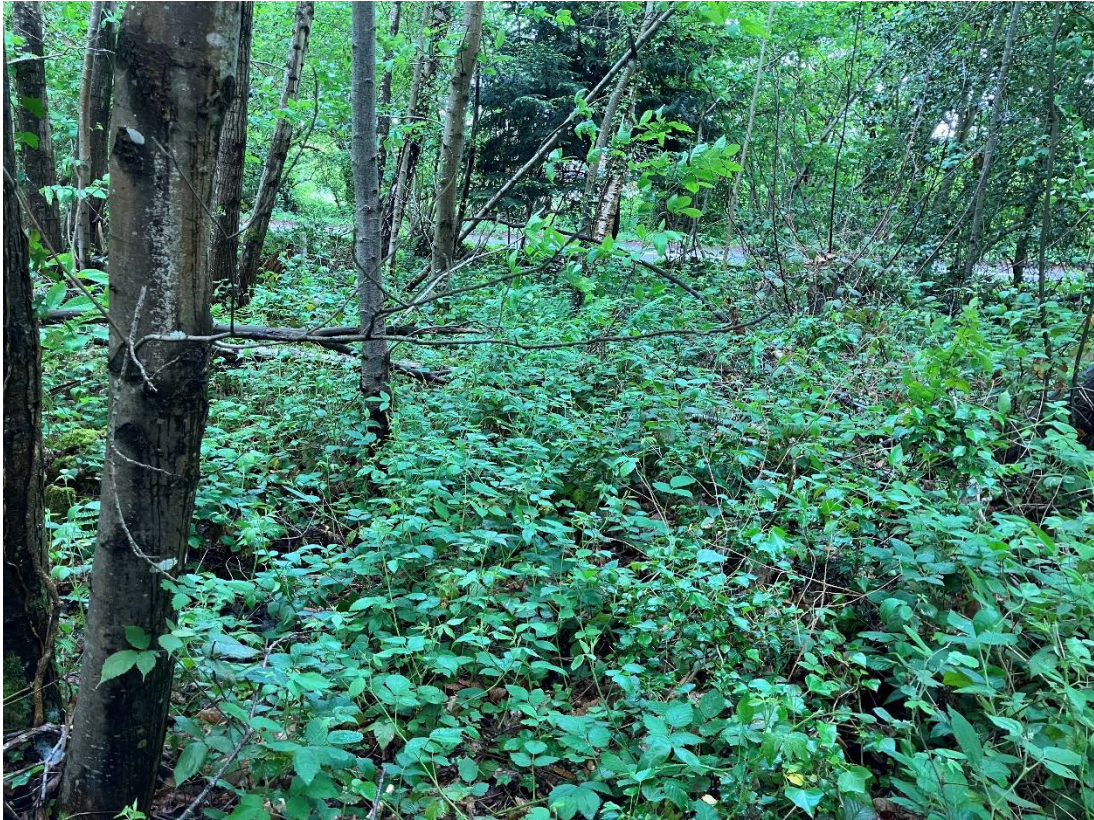
Photograph 49: Heavily vegetated area in northwest of site. Looking north back towards Rock Road.

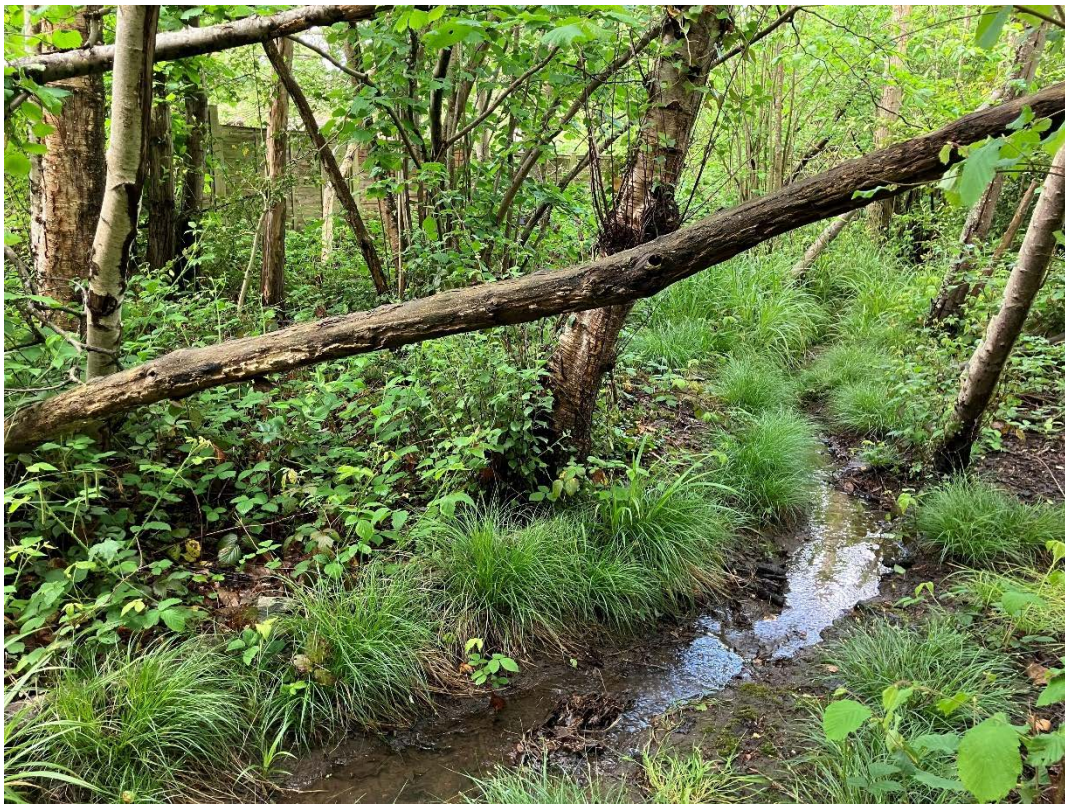
Photograph 50: Drainage channel along northwestern site boundary, understood to have been dug by nearby residents (fences visible beyond). Looking northwest.

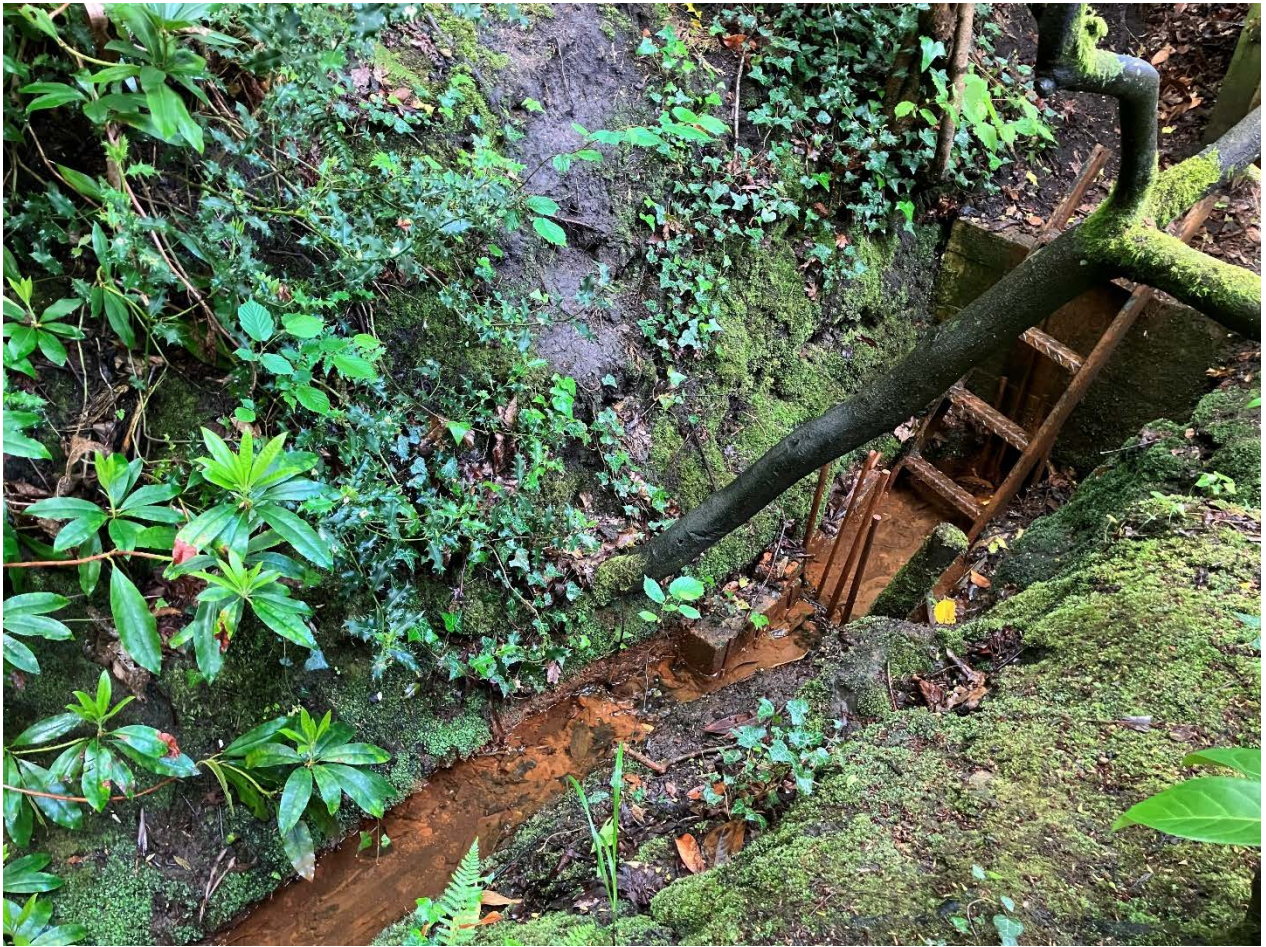
Photograph 51: Drainage infrastructure in northwestern area of site.

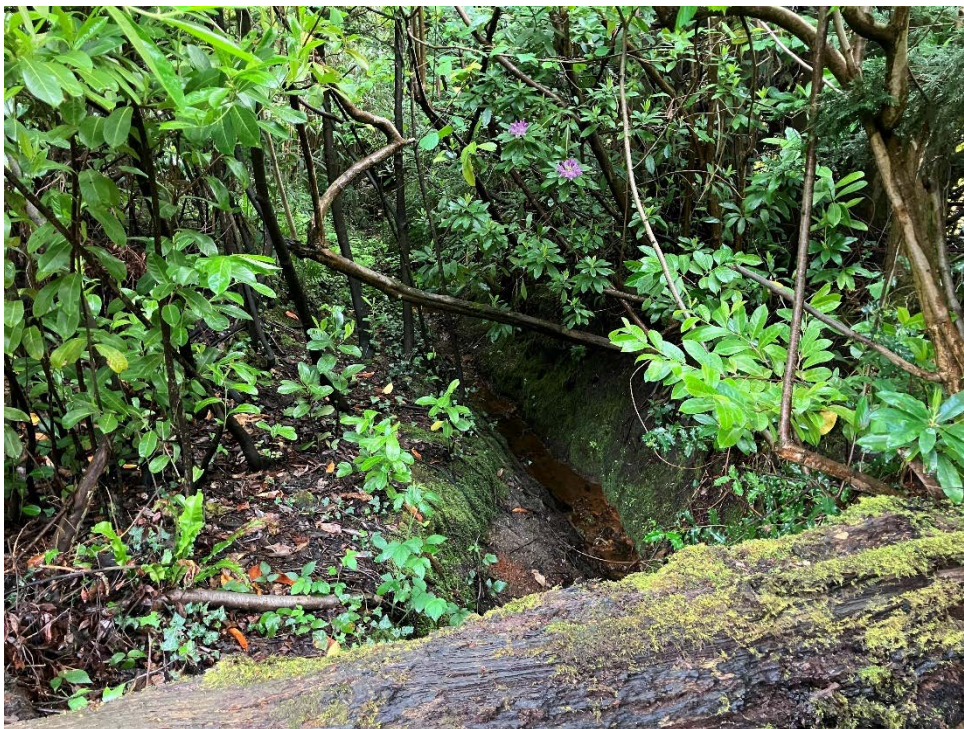
Photograph 52: Drainage infrastructure in northwestern area of site.

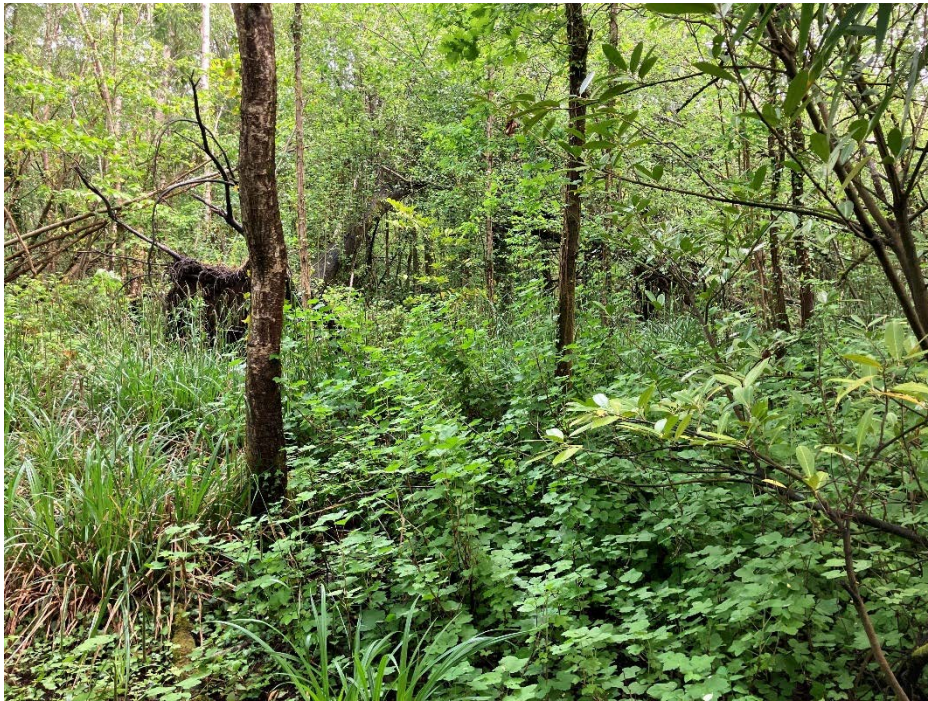
Photograph 53: Heavily vegetated area in northwest of site. Looking east.

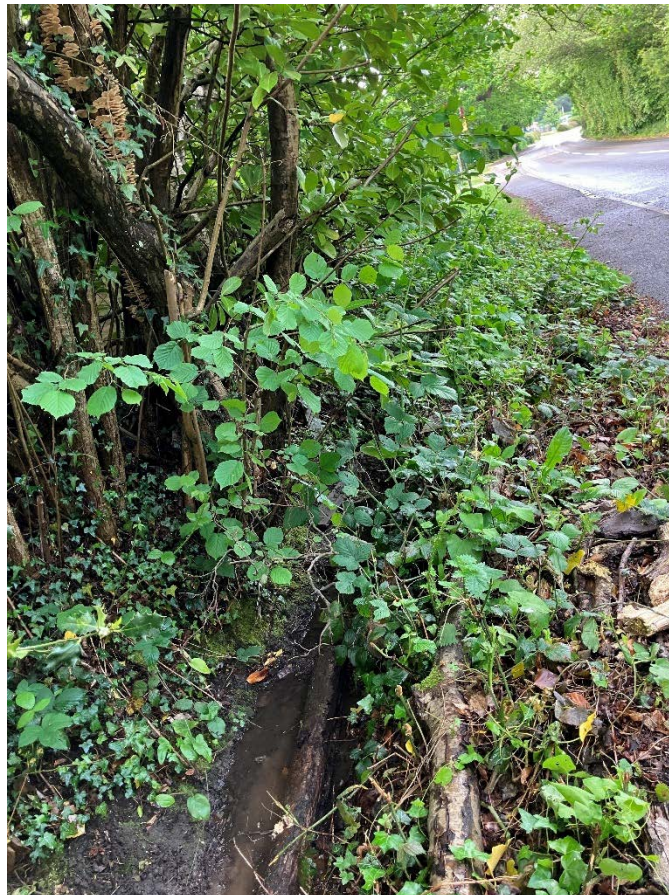
Photograph 54: Vegetation and drainage ditch in northwestern-most corner of site, at Rock Road.

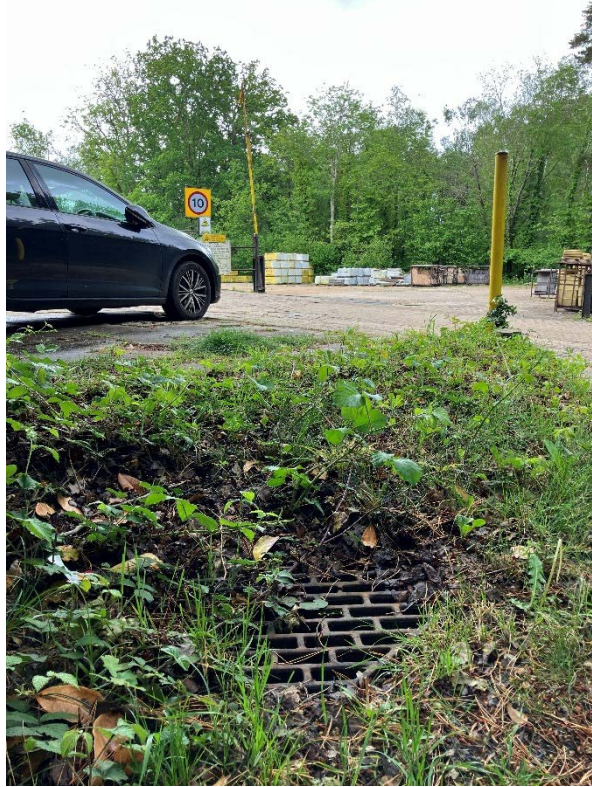
Photograph 55: Drainage along northern boundary at site entrance from Rock Road.

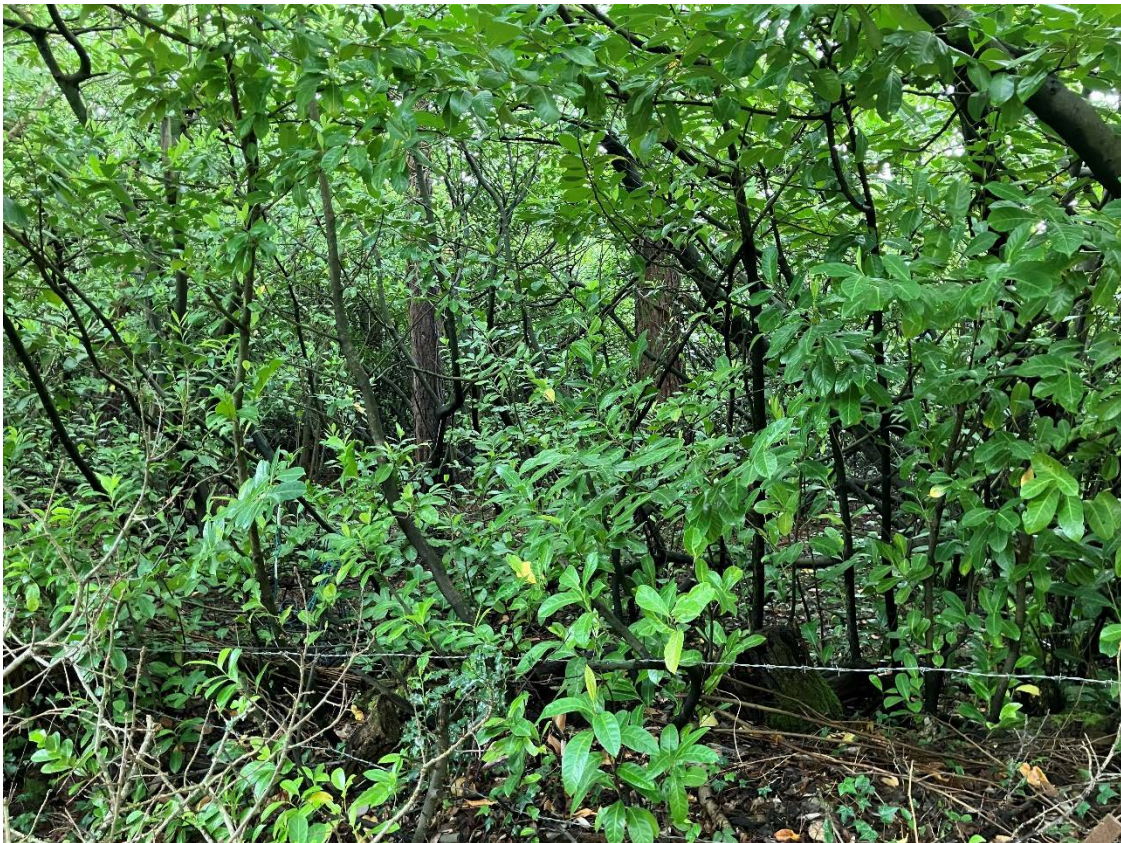
Photograph 56: Heavily vegetated area in northeast of site. Looking south from Rock Road.

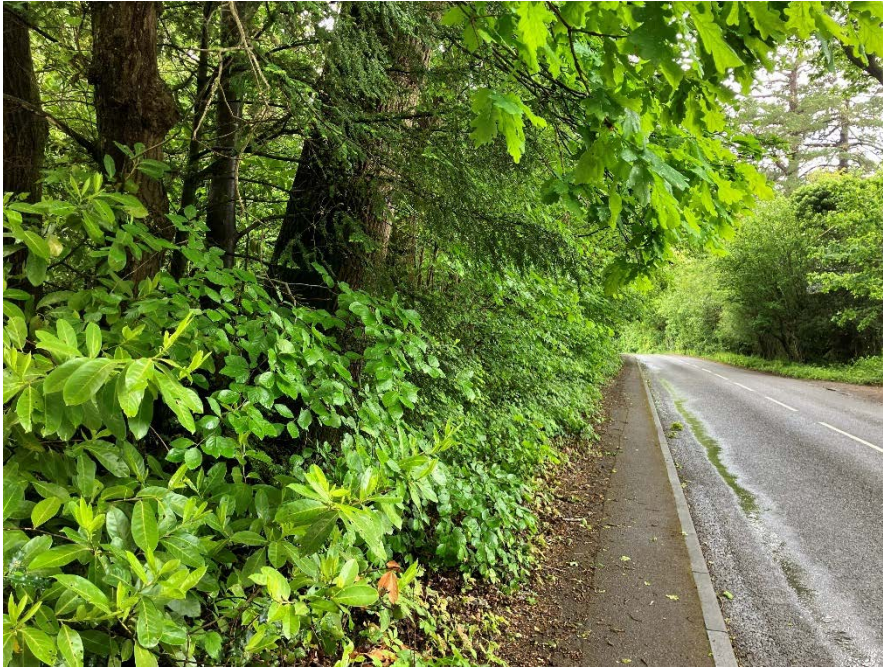
Photograph 57: Heavily vegetated area in northeast of site. Looking along northern boundary with Rock Road.

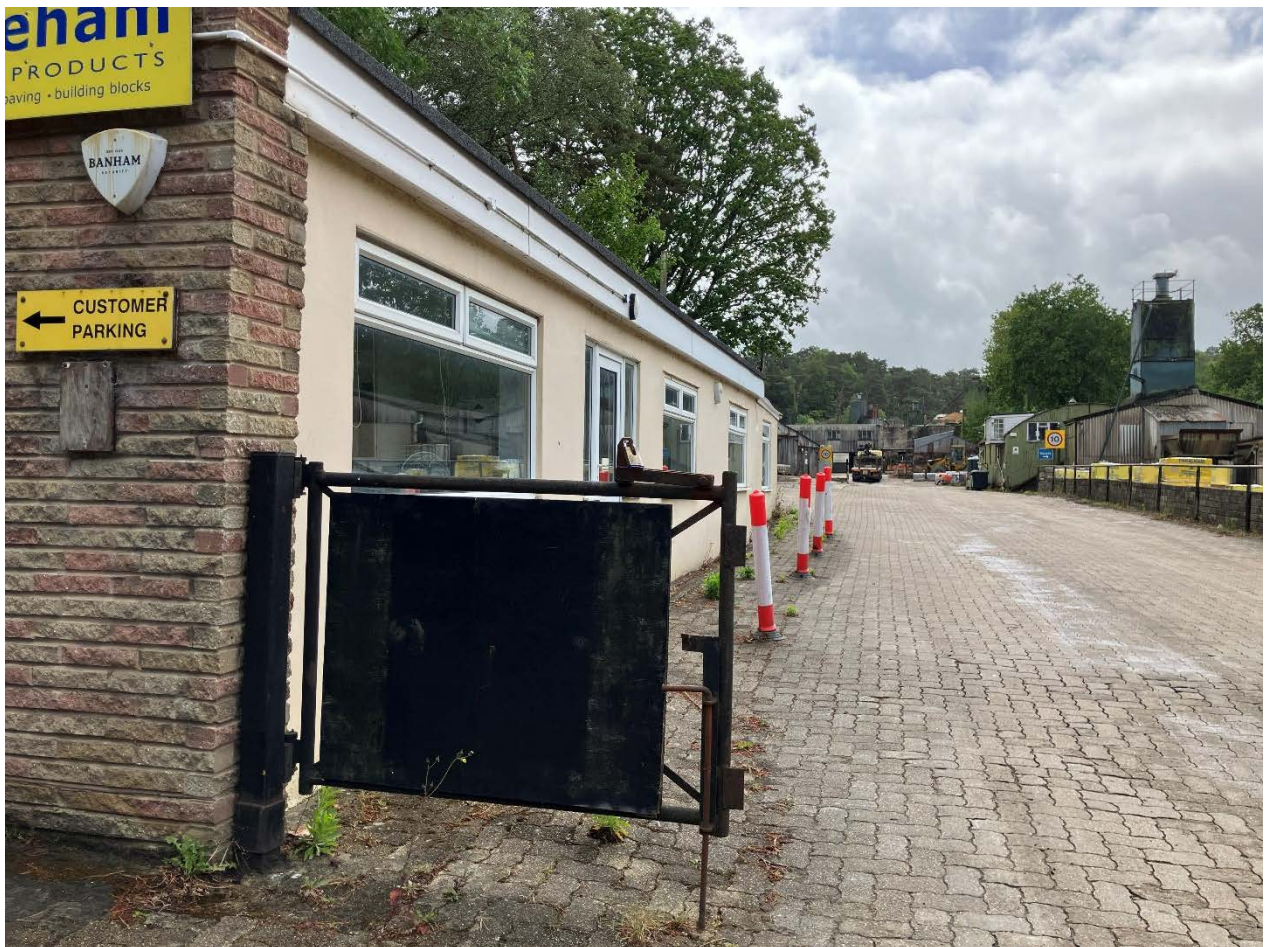
Photograph 58: Existing site entrance and reception building. Looking south.

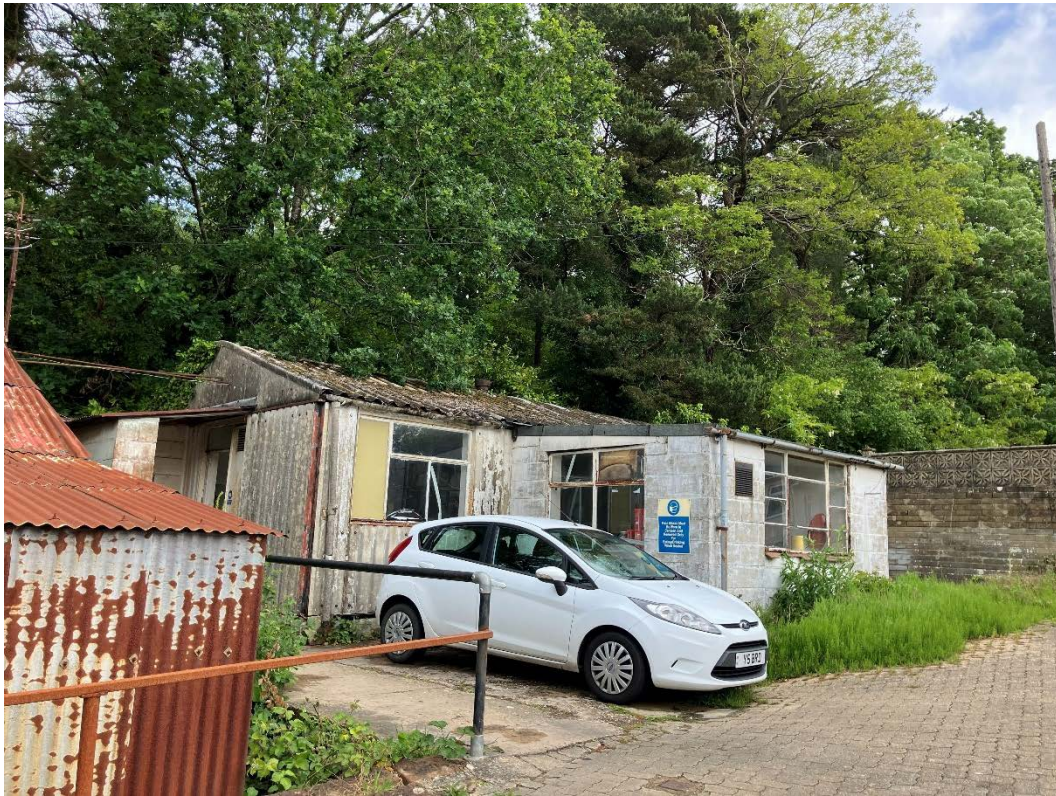
Photograph 59: Canteen building in northeastern area of site. Looking northeast.

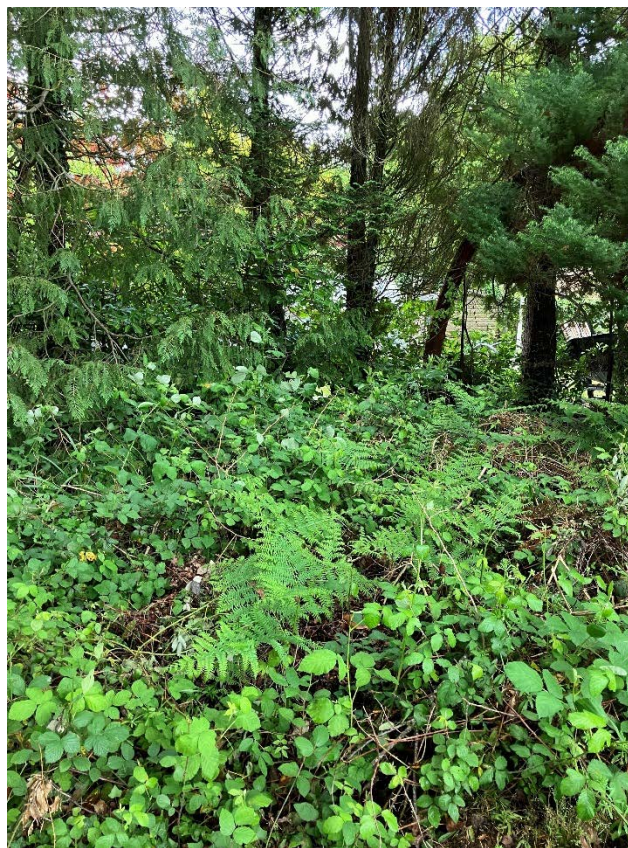
Photograph 60: Heavily vegetated area in northeast of site. Looking east towards neighbouring residential properties.
