**Arboricultural Report**  
**composed of**  
**Arboricultural Impact Assessment**  
**Arboricultural Method Statement**  
**& Tree Protection Plan**

Mr H Sherrad  
Kestral Farm  
Harbolets Road  
West Chiltington  
RH20 2LQ

24th November 2025

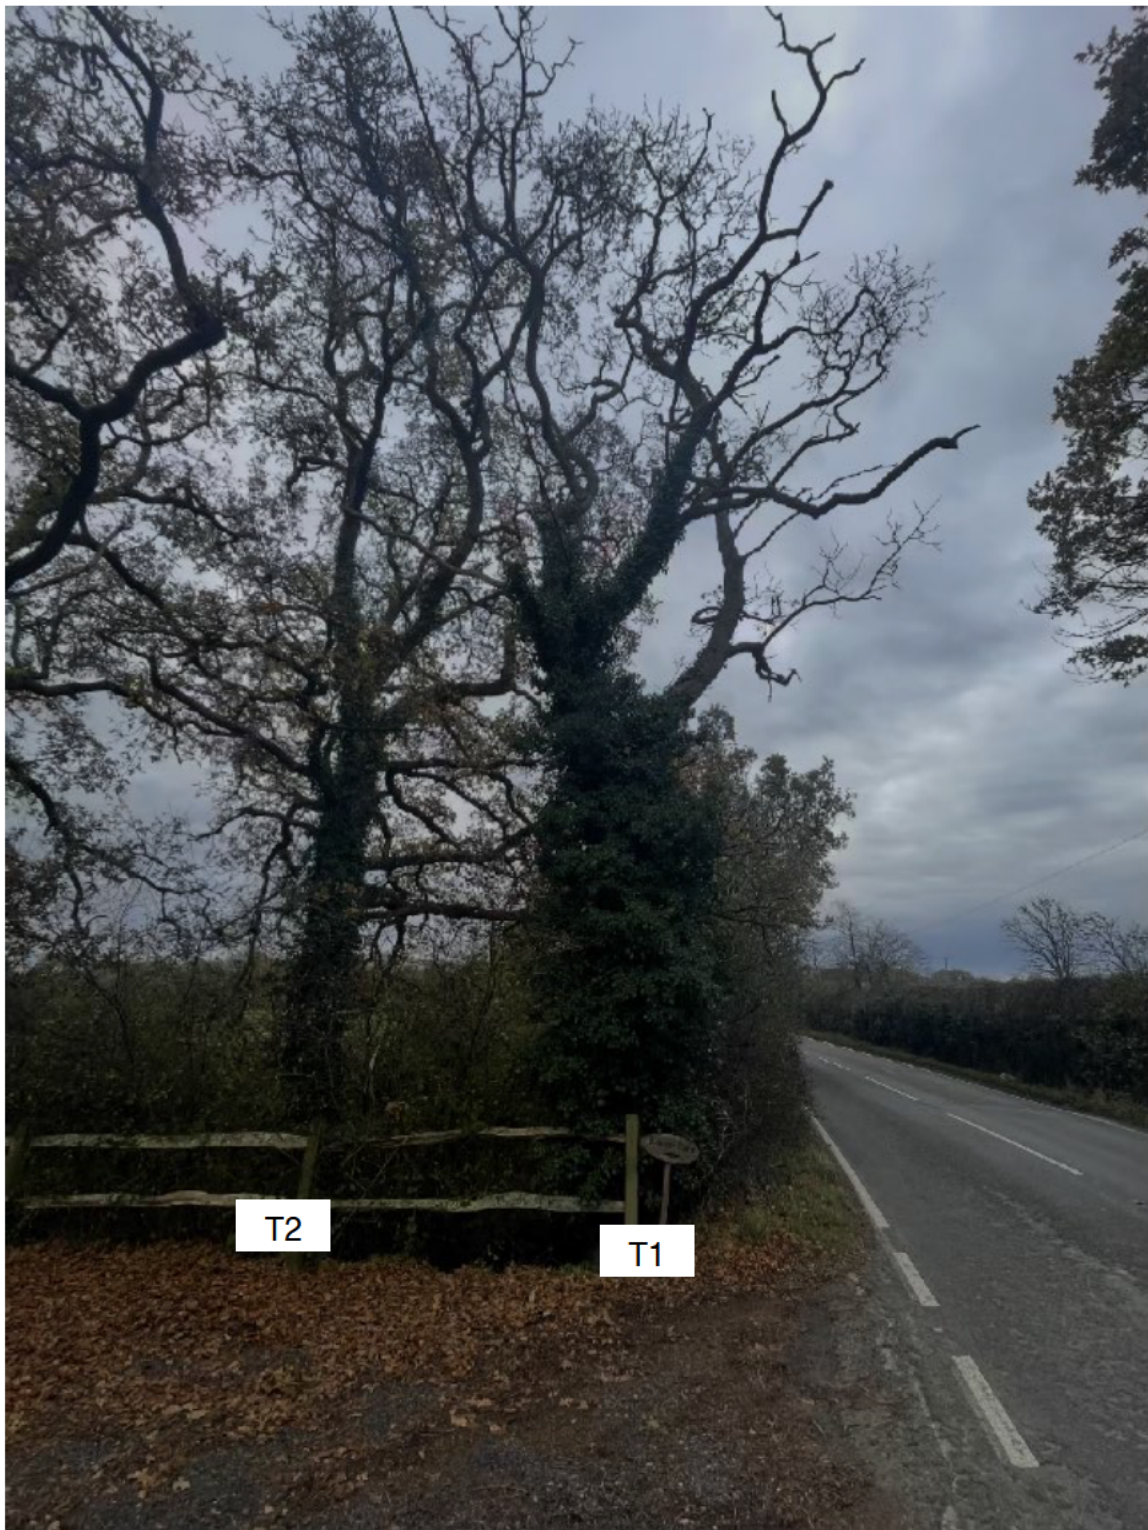
Oak tree T1, set in neighbouring land is dying with 80% deadwood, recommend removal as set by highway

| No | Species | Height | Ø at 1.5m | Spread | Crown | Age | Condition and Recommendations | Removal | ERC | BS | RPA |
|---|---|---|---|---|---|---|---|---|---|---|---|
| <b>T1</b> | Oak<br><i>Quercus robor</i> | 20 | 480 | 10.00 | 6mS | M | Physiological Condition: Poor<br>Structural Condition: Poor<br>Public Amenity Value: Low<br>Inspection Limitations: None<br>Ivy up trunk and into canopy. 80% deadwood, severe canopy dieback - tree is in a state of significant decline<br>Electricity cable runs through canopy @9m<br><b>Recommendations:</b> Remove for safety reasons as within target distance of highway | N<br>Fell | <10<br>B | U | 5.76 |

3.5.2. For this proposal no trees are required to be removed, but there are recommendations for some tree surgery. T1 is tree is in a state of significant decline and due to the position of the tree by the highway it is recommended for removal. In addition it is also recommended removing deadwood from trees T3 and T5. All these trees are located on land not owned by the client and therefore the onus will sit with others who should be informed of these defects.

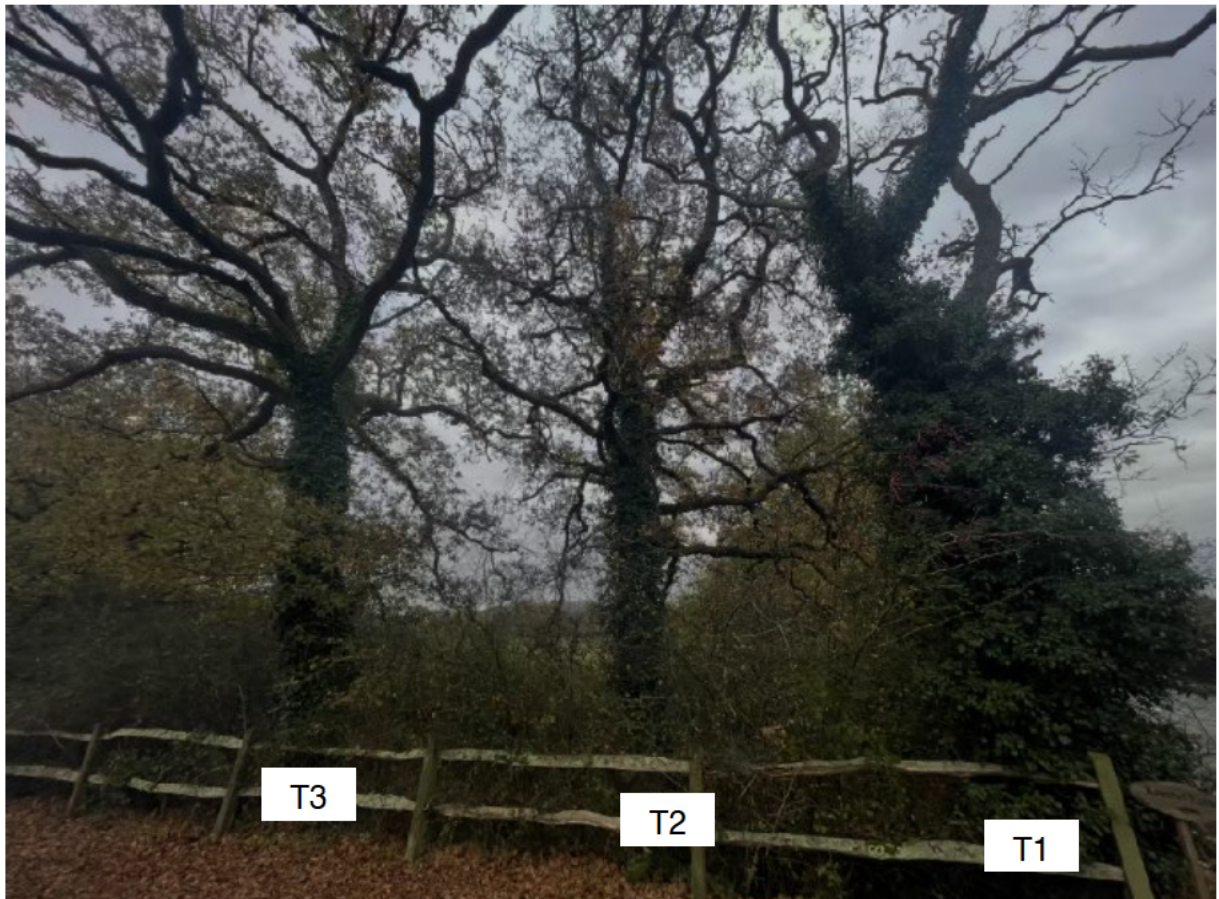
Oak tree T3 set in neighbouring land requires dead wood to be removed over parking bay

| No | Species | Height | Ø at 1.5m | Spread | Crown | Age | Condition and Recommendations | Removal | ERC | BS | RPA |
|---|---|---|---|---|---|---|---|---|---|---|---|
| <b>T3</b> | Oak<br><i>Quercus robor</i> | 17 | 540# | 16.00 | 8mE | M | Physiological Condition: Fair<br>Structural Condition: Fair<br>Public Amenity Value: Moderate<br>Inspection Limitations: Off site - no access<br>Ivy up trunk and into canopy 10m. 10% deadwood<br><b>Recommendations:</b> Remove deadwood positioned over access and parking area | N<br>RD | >20<br>B | C2 | 6.48 |

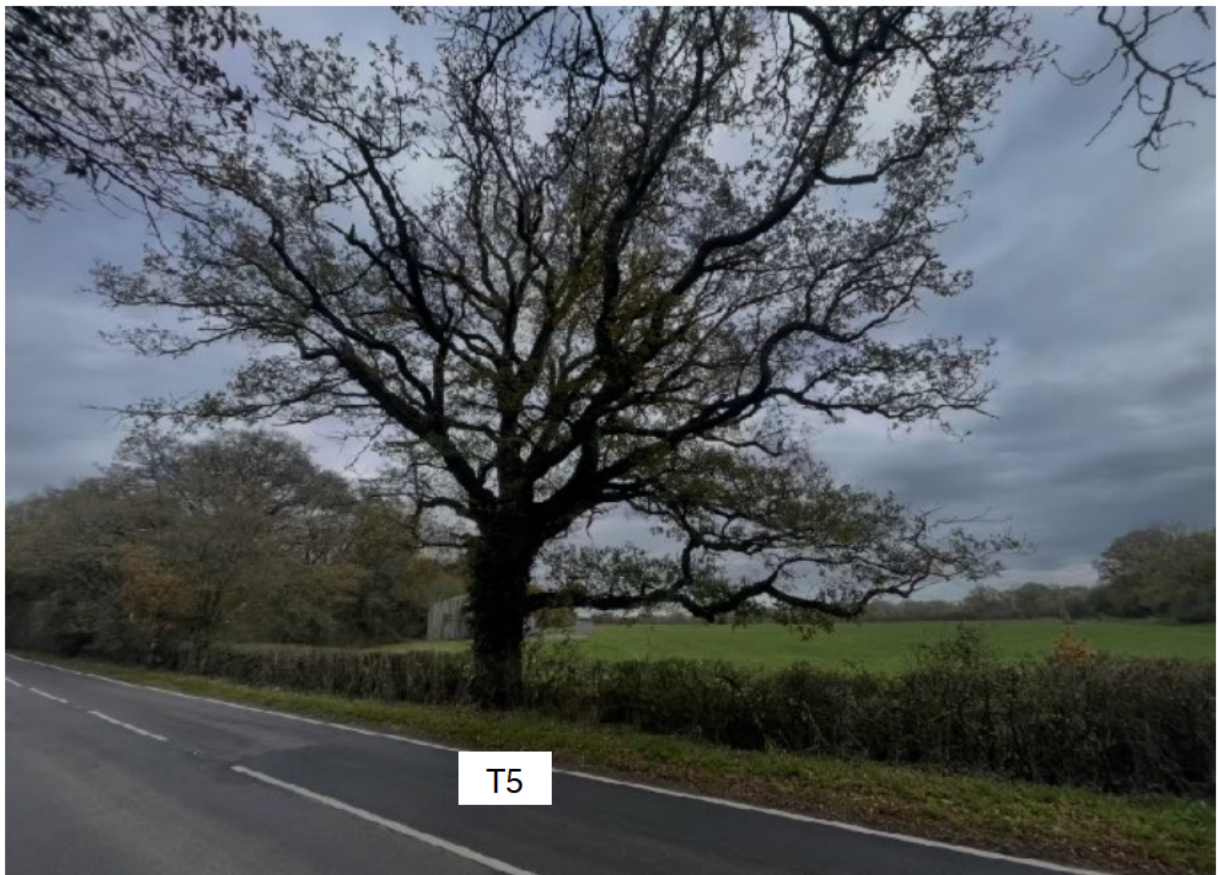
Oak tree T5 set in verge requires dead wood to be removed over highway

| No | Species | Height | Ø at 1.5m | Spread | Crown | Age | Condition and Recommendations | Removal | ERC | BS | RPA |
|---|---|---|---|---|---|---|---|---|---|---|---|
| <b>T5</b> | Oak<br><i>Quercus robor</i> | 18 | 870 | 18.00 | 4mS | M | Physiological Condition: Fair<br>Structural Condition: Good<br>Public Amenity Value: High<br>Inspection Limitations: None<br>Ivy up trunk and into canopy 7m. 10% deadwood<br>Tree dying back from crown<br><b>Recommendations:</b> Remove deadwood positioned over highway. | N<br>RD | >20<br>B | C2 | 10.44 |

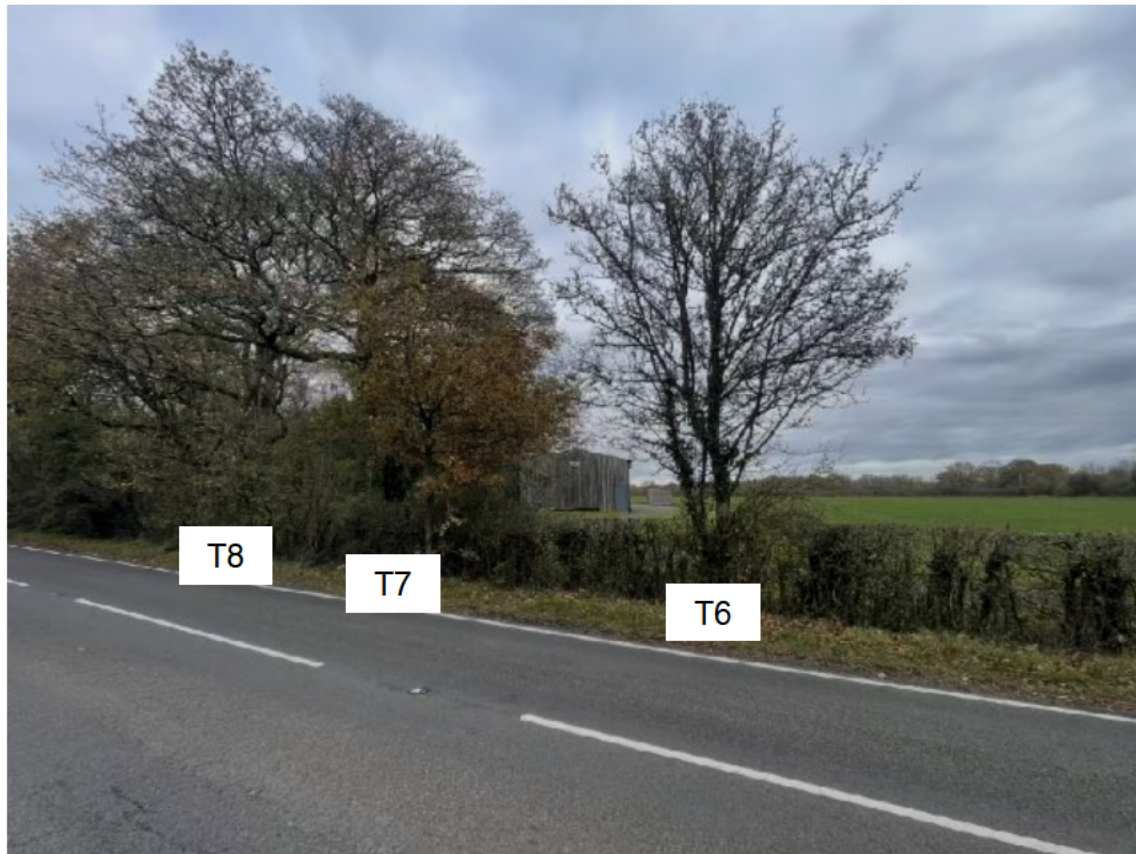
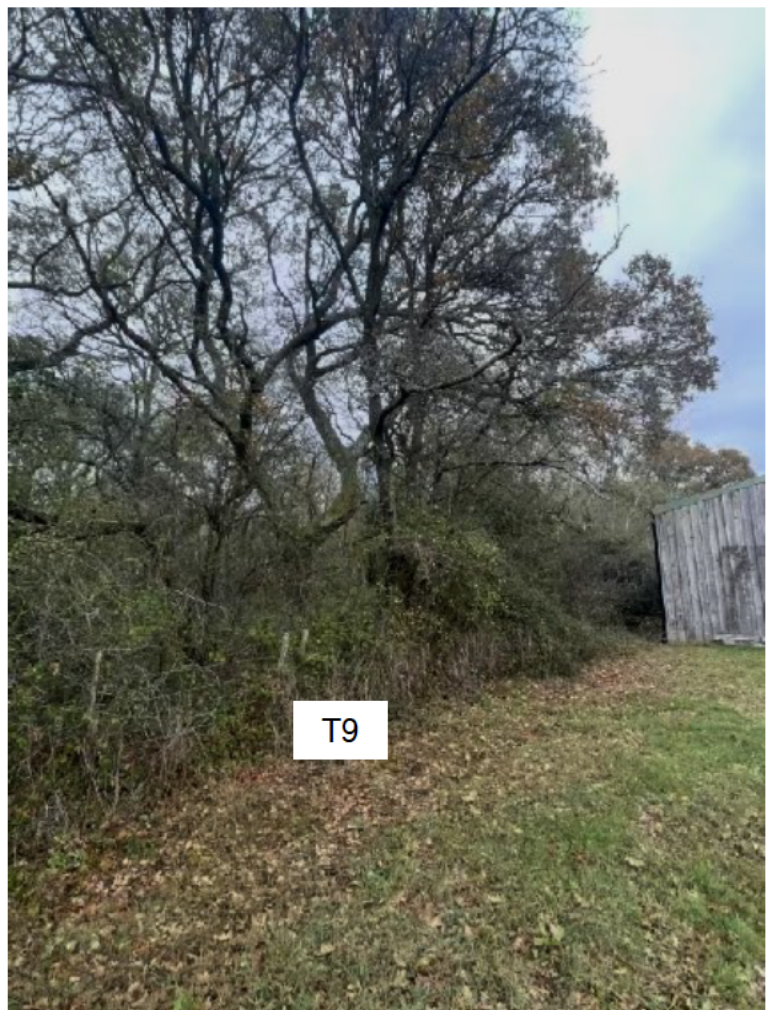
Trees in woodland with their  
RPA's some distance from the  
proposed new house

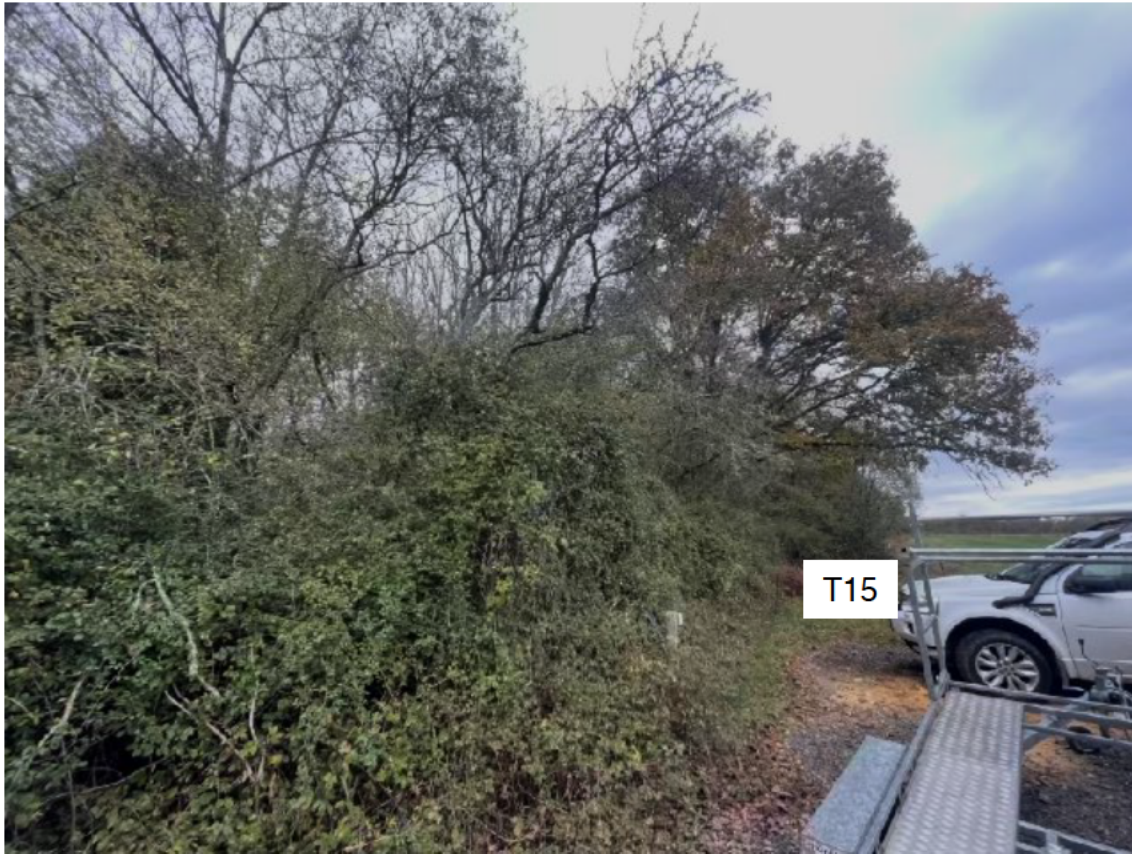
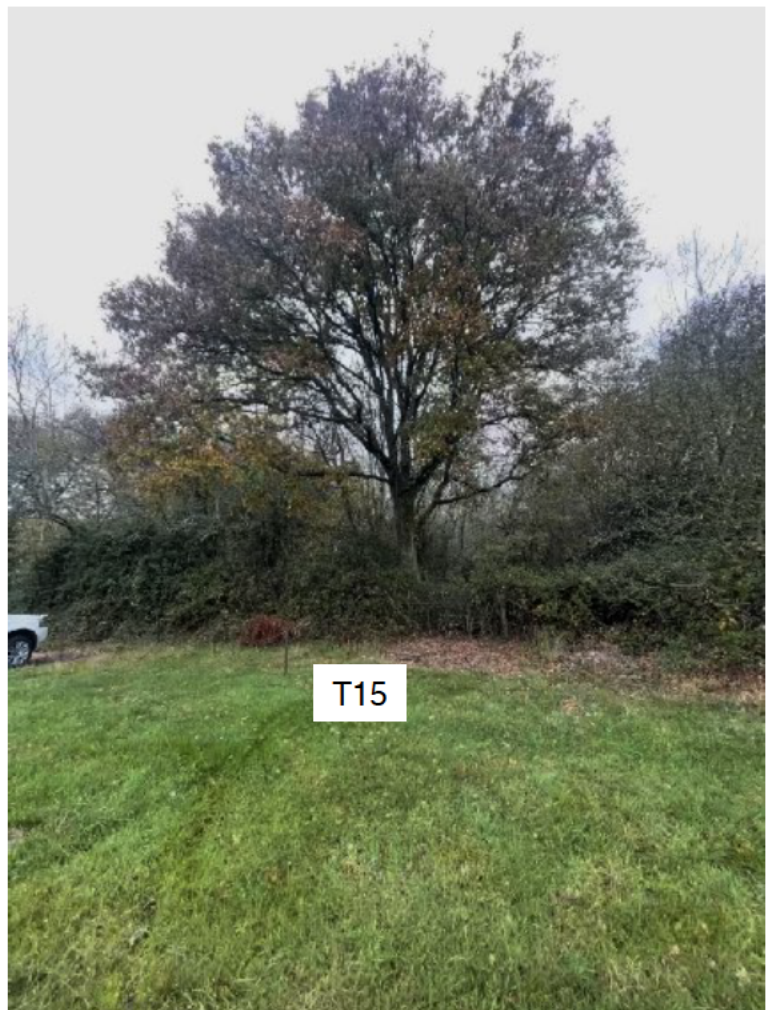
Trees in woodland west of the barn covered in brambles and their RPA's some distance from the proposed new house
