ARBORICULTURAL
IMPACT
ASSESSMENT

Land at Partridge Green

October 2024

Barton Hyett Associates
Arboricultural Consultants

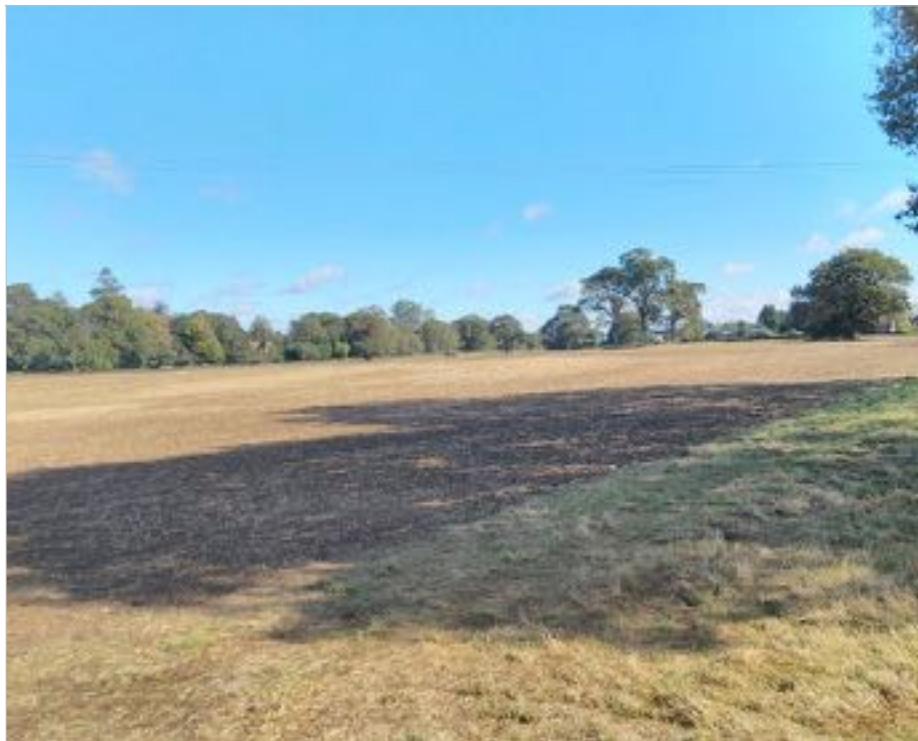
IMAGE 1: Looking north-east across the site from its western boundary. The group of trees to the left of frame are located offsite to the north of Lock Lane. G10, T26 and T27 can be seen to the right of centre frame.

| Ref | Species | On/off site | Top Height (m) | No. of Stems | Est diam ? | Calc. / Actual Stem Dia. (mm) | Crown radii (m) N-E-S-W | Avg. low crown height (m) | 1st branch ht (m) | 1st branch dir. | Life Stage | Special importance | General Observations | Health & vitality | Structural condition | Estimated Remaining Contribution (Years) | BS5837 Category | RPA Radius (m) | RPA m ² | Veteran/ Ancient Tree buffer radius (m) |
|---|---|---|---|---|---|---|---|---|---|---|---|---|--|---|---|--|---|---|---|---|
| T26 | Oak (English) | On | 9.5 | 1 | | 680 | 3-4-3-5 | 4.0 | 4.0 | S | M | None | Split out primary limb at 4m. Column of decay in main stem. Fistulina hepatica fruiting bodies observed. Remaining crown retrenching. | Fair | Fair | 20+ | A3 | 8.2 | 209 | - |

| Ref | Species | On/off site | Height range (m) | No. of trees | Est diam? | Max stem diam (mm) | Av. Crown radius (m) | Avg. low crown height (m) | Life Stage | Special importance | General Observations | Health & vitality | Structural condition | Estimated Remaining Contribution (Years) | BS5837 Category | RPA Radius (m) | Veteran/ Ancient Tree buffer radius (m) |
|---|---|---|---|---|---|---|---|---|---|---|--|---|---|--|---|---|---|
| G10 | English oak | On | 12-16 | 3 | - | 1060 | 7.0 | 5.0 | M | Veteran | Three close grown trees with single crown. Central tree is largest. Northern tree dead.. Southern most tree successfully retrenching. Numerous decay pockets, branch loss scars and deadwood. Central tree has <i>fistulina hepatica</i> at base | Fair | Fair | 40+ | A3 | 12.7 | 12 |

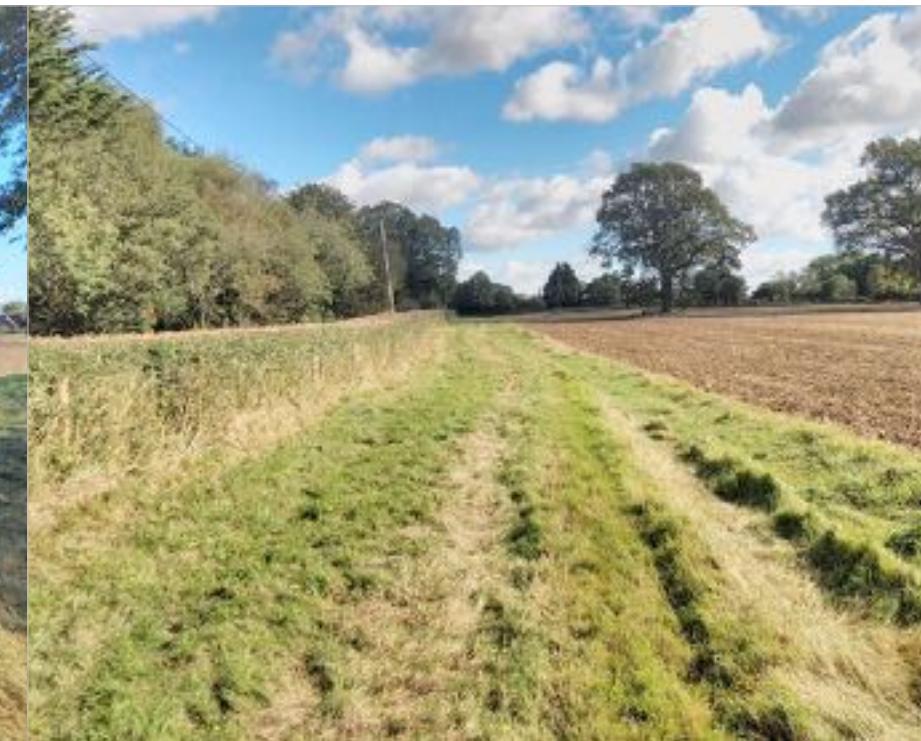
IMAGE 2: Looking east along H5 on the northern boundary of the site. The trees to the left of frame are located offsite to the north of Lock Lane. T24 and T23 can be seen to right of frame.

| Ref | Species | On/off site | Top Height (m) | No. of Stems | Est diam ? | Calc. / Actual Stem Dia. (mm) | Crown radii (m) N-E-S-W | Avg. low crown height (m) | 1st branch ht (m) | 1st branch dir. | Life Stage | Special importance | General Observations | Health & vitality | Structural condition | Estimated Remaining Contribution (Years) | BS5837 Category | RPA Radius (m) | RPA m ² | Veteran/ Ancient Tree buffer radius (m) |
|---|---|---|---|---|---|---|---|---|---|---|---|---|--|---|---|--|---|---|---|---|
| T24 | Oak (English) | On | 14.0 | 1 | | 1010 | 7-9-7-7 | 2.5 | 5.0 | S | M | None | Plough line very close to the base of tree. Deadwood in crown. Recent mechanical damage to stem. Would benefit from the cessation of ploughing at base. | Good | Good | 40+ | A1 | 12.1 | 461 | - |

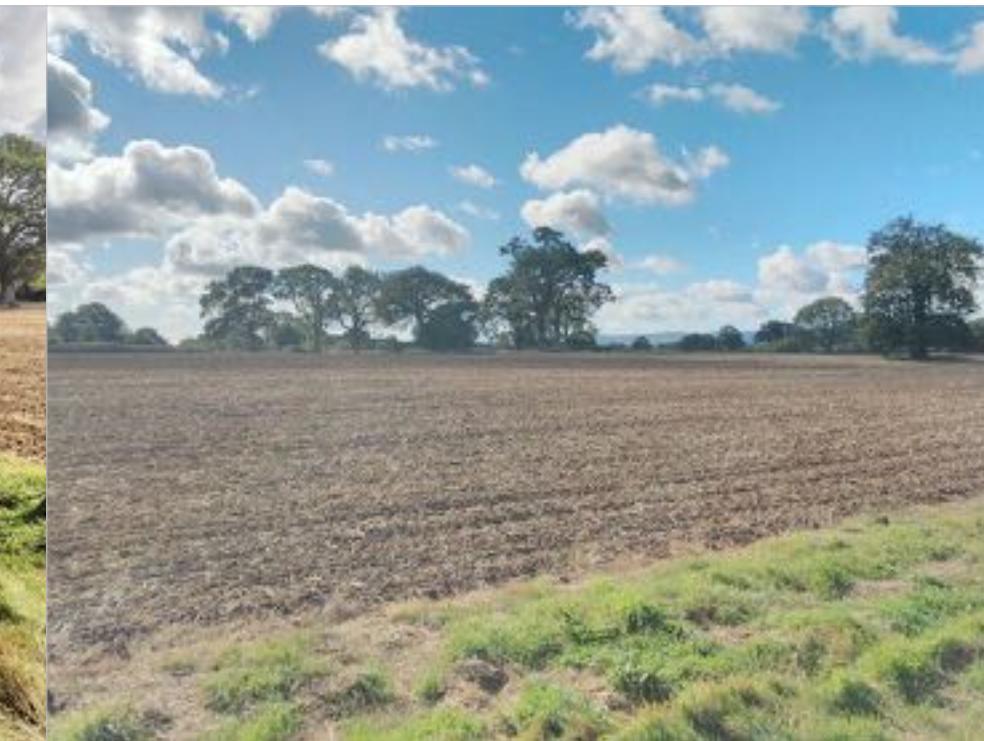
IMAGE 3: Looking south-west across the northern part of the site towards G10 and T26 through to T30. T25 can be seen to the right of frame.

| Ref | Species | On/off site | Top Height (m) | No. of Stems | Est diam ? | Calc. / Actual Stem Dia. (mm) | Crown radii (m) N-E-S-W | Avg. low crown height (m) | 1st branch ht (m) | 1st branch dir. | Life Stage | Special importance | General Observations | Health & vitality | Structural condition | Estimated Remaining Contribution (Years) | BS5837 Category | RPA Radius (m) | RPA m ² | Veteran/ Ancient Tree buffer radius (m) |
|---|---|---|---|---|---|---|---|---|---|---|---|---|--|---|---|--|---|---|---|---|
| T25 | Oak (English) | On | 12.0 | 1 | | 1060 | 5-6-5-6 | 1.0 | 1.0 | S | M | Veteran | Tree crown is retrenching with secondary crown establishing from Epicormic growth. Leaf condition is good. Exposed and elevated buttress roots. Has old appearance. Deadwood in crown. Numerous branch loss scars. Small fistulina hepatica at base and at 2.5m. | Good | Fair | 40+ | A3 | 12.7 | 508 | 16 |

| Ref | Species | On/off site | Top Height (m) | No. of Stems | Est diam ? | Calc. / Actual Stem Dia. (mm) | Crown radii (m) N-E-S-W | Avg. low crown height (m) | 1st branch ht (m) | 1st branch dir. | Life Stage | Special importance | General Observations | Health & vitality | Structural condition | Estimated Remaining Contribution (Years) | BS5837 Category | RPA Radius (m) | RPA m ² | Veteran/ Ancient Tree buffer radius (m) |
|---|---|---|---|---|---|---|---|---|---|---|---|---|--|---|---|--|---|---|---|---|
| T30 | Oak (English) | On | 18 | 1 | | 1120 | 6-8-9-11 | 5.0 | 5.0 | E | M | None | Heavily reduced in past. Adjacent overhead power lines and recently side pruned on north side. Asymmetric crown. Branch tear scars and small decay pockets at old pruning wounds. | Good | Fair | 40+ | B3 | 13.4 | 567 | - |

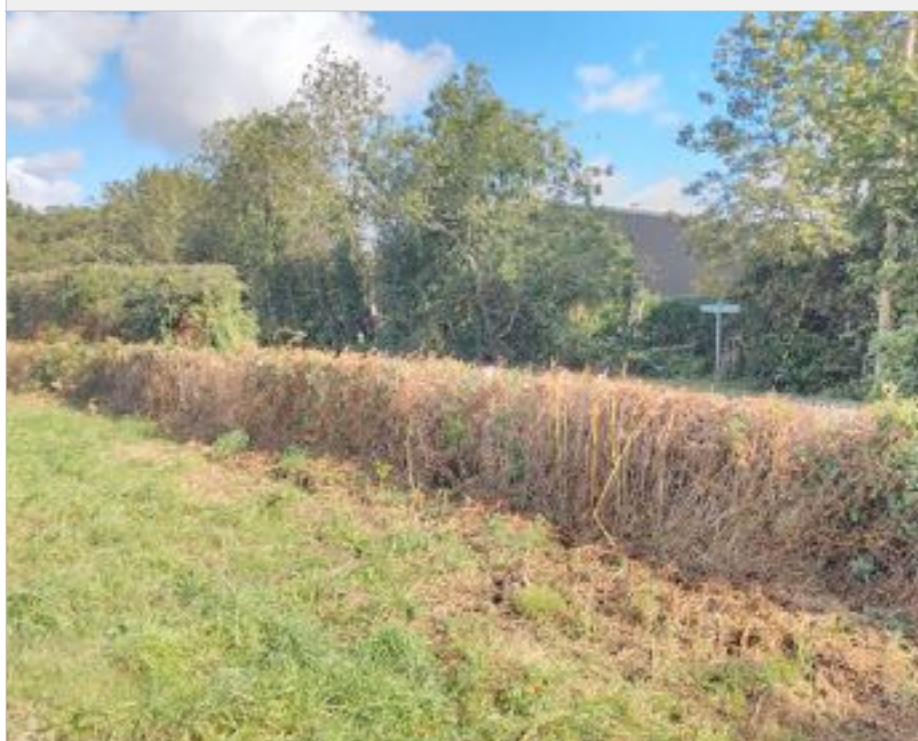
IMAGE 4: Looking west from the site onto the B2135. The end of H6 can be seen to the left of frame with the existing hedgerow gap vegetated brambles and nettles.

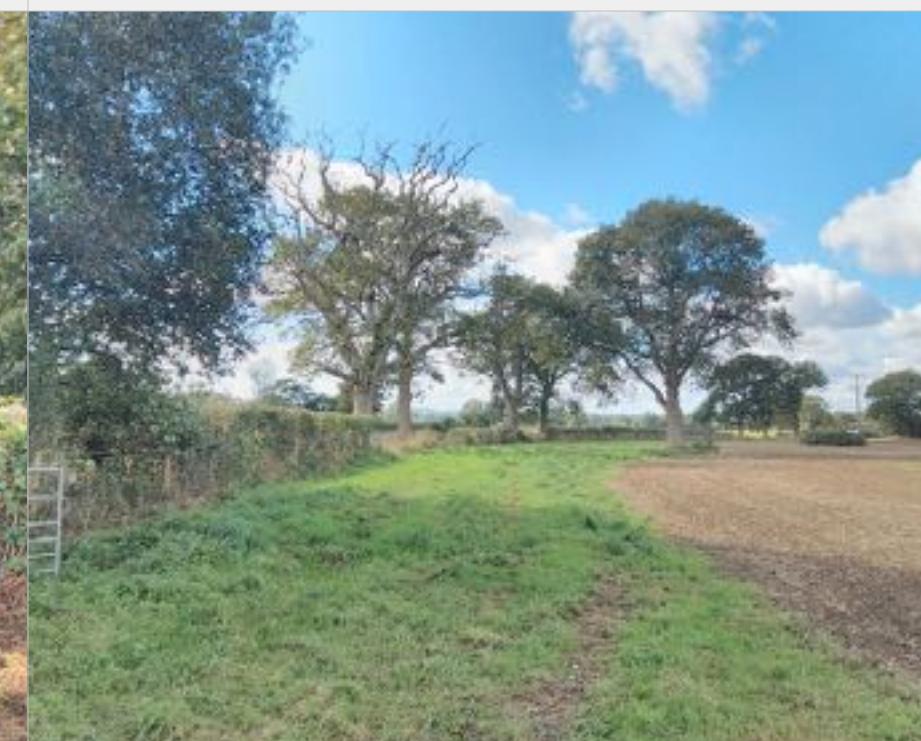
- 4.4. A mature oak tree (T15) was categorised as low-quality (Category C) due to its poor physiological condition and past management works resulting from pruning to provide clearance to overhead power lines. Whilst this tree is not the best specimen, it does provide habitat value.

IMAGE 5: Looking west along the north edge of H9 towards T15 to T19.

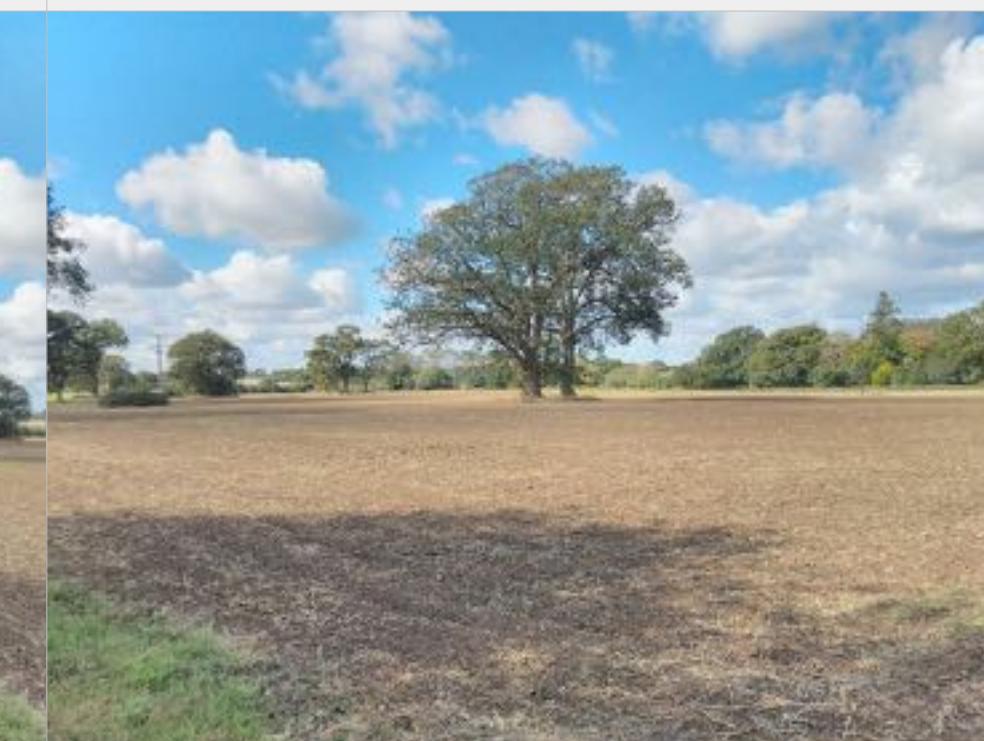
IMAGE 6: Looking west across the northern part of the site with T20 and T21 in centre frame.

| Ref | Species | On/off site | Top Height (m) | No. of Stems | Est diam ? | Calc. / Actual Stem Dia. (mm) | Crown radii (m) N-E-S-W | Avg. low crown height (m) | 1st branch ht (m) | 1st branch dir. | Life Stage | Special importance | General Observations | Health & vitality | Structural condition | Estimated Remaining Contribution (Years) | BS5837 Category | RPA Radius (m) | RPA m ² | Veteran/ Ancient Tree buffer radius (m) |
|---|---|---|---|---|---|---|---|---|---|---|---|---|--|---|---|--|---|---|---|---|
| T20 | Oak (English) | On | 19 | 1 | | 1510 | 8-13-14-13 | 6.0 | 3.0 | S | M | Veteran | Ploughing of ground under tree seems to have ceased. Has increased vigour. Leaf density and vitality poor. Would benefit from the cessation of ploughing at base. Numerous branch loss scars, splits and small decay pockets and deadwood. Exposed and | Good | Good | 20+ | A3 | 15.0 | 707 | 22 |
