## HORSHAM DISTRICT COUNCIL CONSULTATION

<b>TO:</b>	Horsham District Council – Planning Dept
<b>LOCATION:</b>	Units 4 to 5 Redkiln Close Horsham
<b>DESCRIPTION:</b>	Demolition of warehouse building and associated structures. Construction of two no self-contained warehouse units for storage (Class B8).
<b>REFERENCE:</b>	DC/25/0803
<b>RECOMMENDATION:</b>	Holding objection / modification with regards to new development with the Root Protection Area (RPA) of Tree T3
<b>SUMMARY OF COMMENTS &amp; RECOMMENDATION:</b> The application is supported by an AMS which is a fair assessment of the condition, and development related impacts on trees within and those located outside the site's boundary. However, concerns are raised with proposed development within the RPA of a TPO tree, TPO/0084 served 24-12-1963 and the way in which these works are intended to be undertaken.

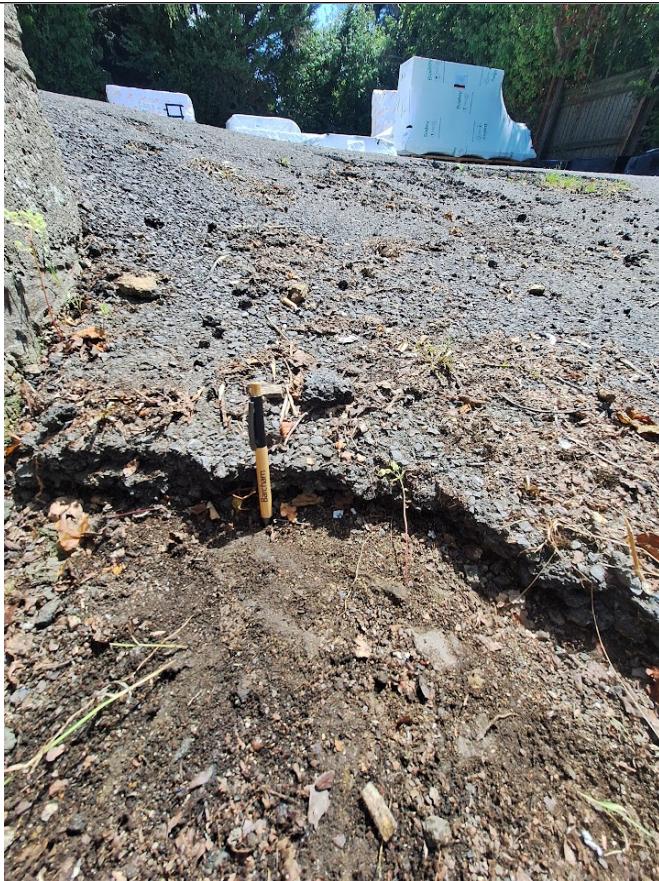
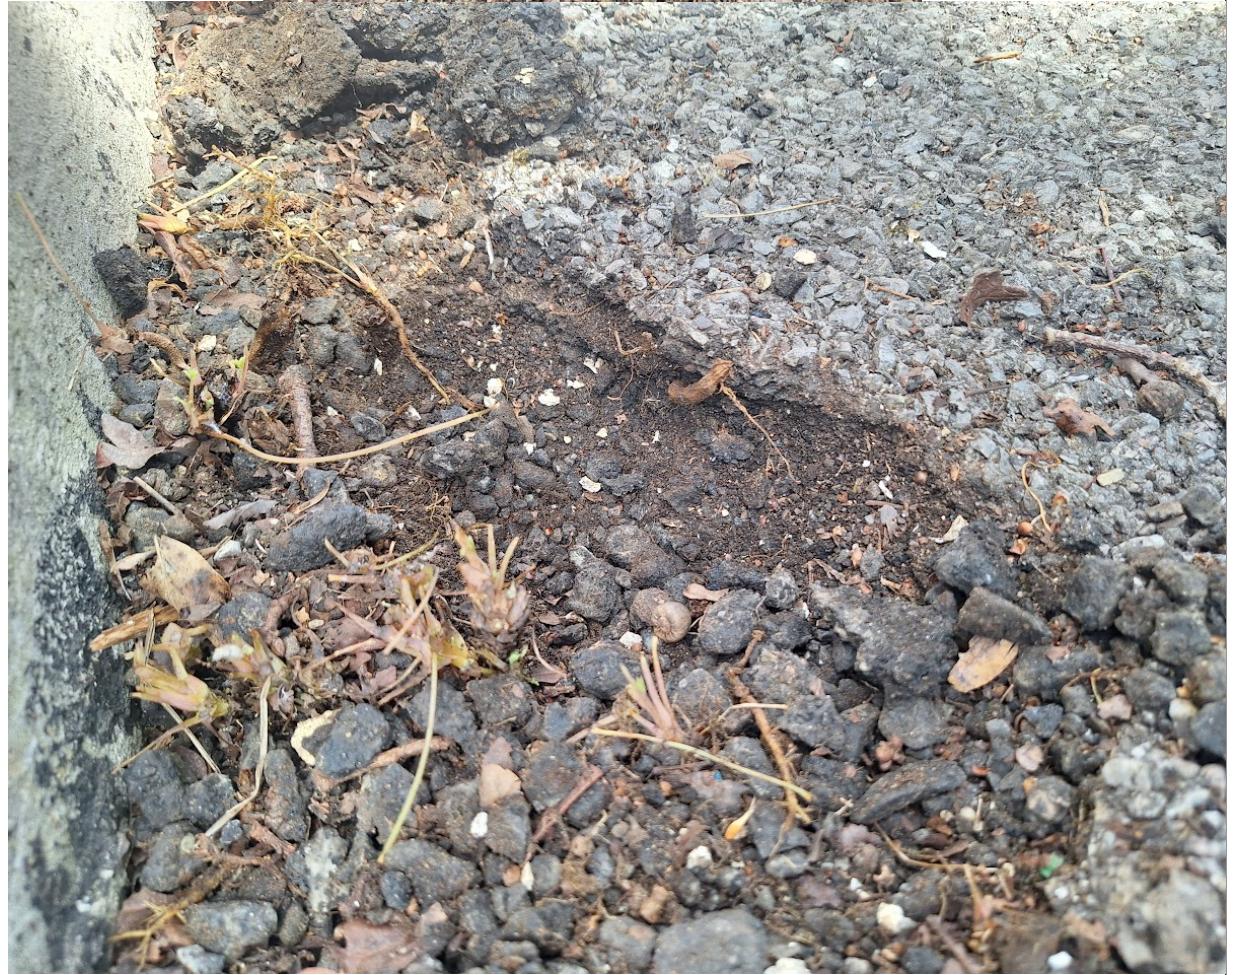
The significance of this would be that the bulk of its roots will likely be located within the site and in the area of the proposed development due to the historical management of the ditch, and the impact this will have possibly had on root development in the area to the east. While it is acknowledged that there is hard surfacing in the area to the east of T3. However, observations made on site suggest that the depth of the surfacing is limited to only a few inches. Please see photos below, the second photo is taken from where the new building is proposed, and the one with the pen provides an example of the thickness of the surfacing.

The proposed root severance will remove essential structural and fibrous roots, potentially impacting the tree's stability and nutrient uptake. This cumulative impact will, over time, significantly diminish the tree's health and resilience, increasing the likelihood of decline or failure in the short to medium term. As a protected specimen, the oak should be afforded significant consideration in the way in which the redevelopment works at the site are undertaken.

The current proposal will impact the tree's long-term viability for retention and fails to meet the minimum requirements of BS5837. Alternatives should be explored, such as moving the new structure outside the RPA of T3, to satisfactorily preserve this protected tree, which makes a positive contribution to the character and amenities of the locality.
