RE: Land at Campfields, Southwater – Ecology comments

This rebuttal has been produced in response to comments received from Horsham District Council with regards to outline planning application DC/25/0102.

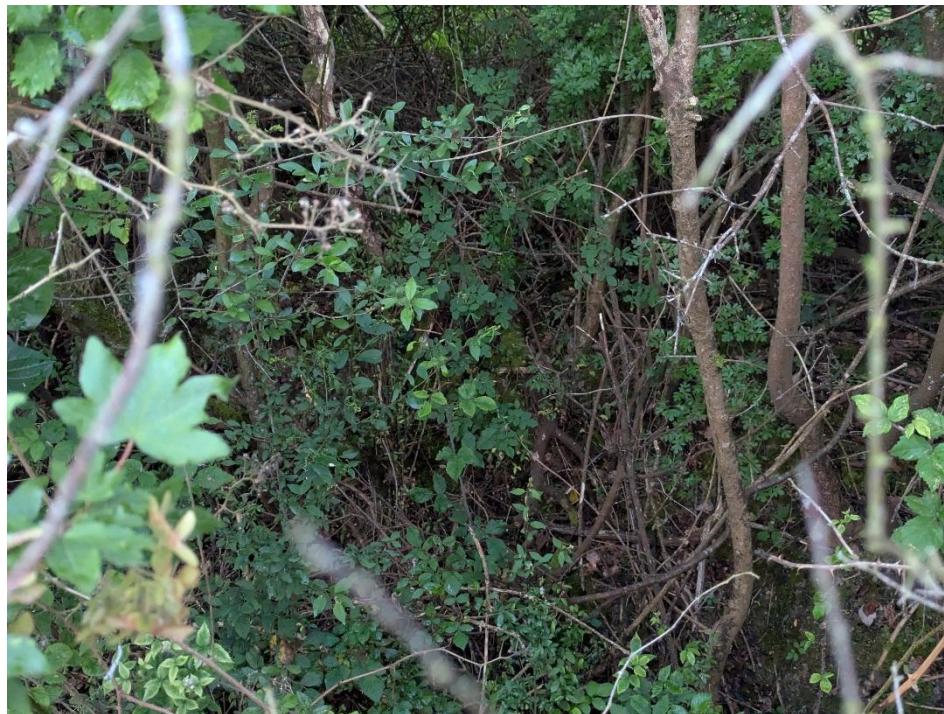
During the walkover, the features were identified, but were difficult to view due to the density of scrub particularly from within the site itself (**Fig 1 & 2**). A more established ditch was found to be present outside of the site, towards the northwestern corner, connecting the northern boundary of the site to the watercourse present to the east of the site (**Fig 3**).

Figure 1. View of the ditch present along the northern boundary of the site (taken June 2025)

The ditches within the site were all found to be dry, with a buildup of leaf litter and non-aquatic vegetation such as Ivy and Bramble. The soil was damp, but the site visit was following a day of intense rain on the 5th June. Pendulous Sedge (*Carex pendula*) was noted particularly along the public right of way present outside of the southern boundary (Fig 4) of the site, indicative of damp soil to be present, however, the site has been identified to be damp overall due to its topography. The sedge was not found to be present within the ditch along the northern boundary but was found in the more established ditch outside of the boundary of the site. The ditches present have not been identified to be carry water on any previous walkovers in March 2023 and March 2024 or during the numerous visits to the site to conduct field work between March and October 2023.

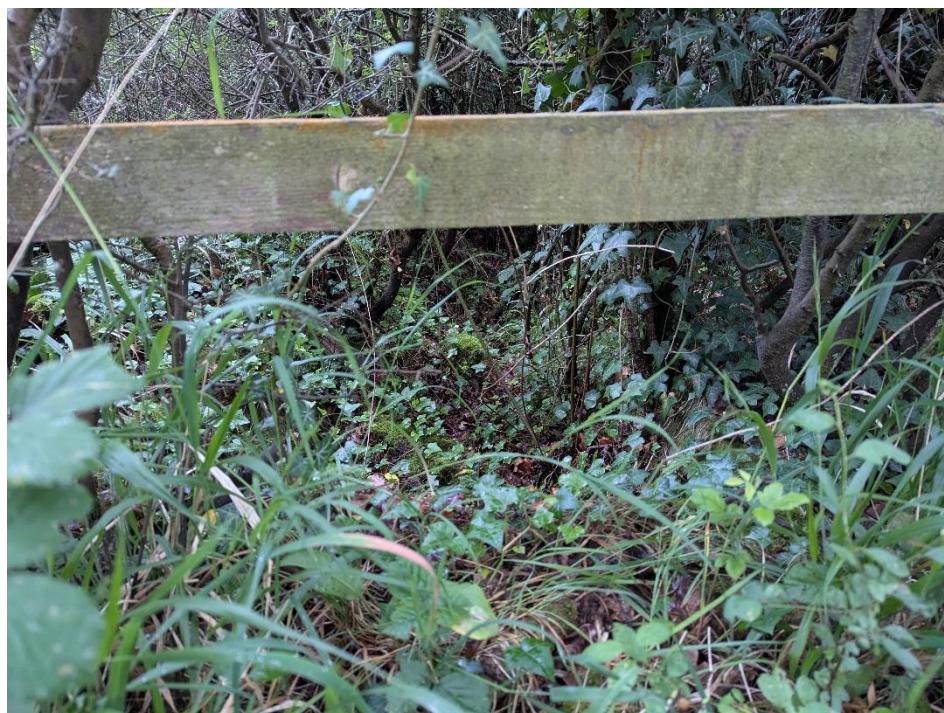
Figure 2. View of the ditch present along the southern boundary of the site (taken June 2025)

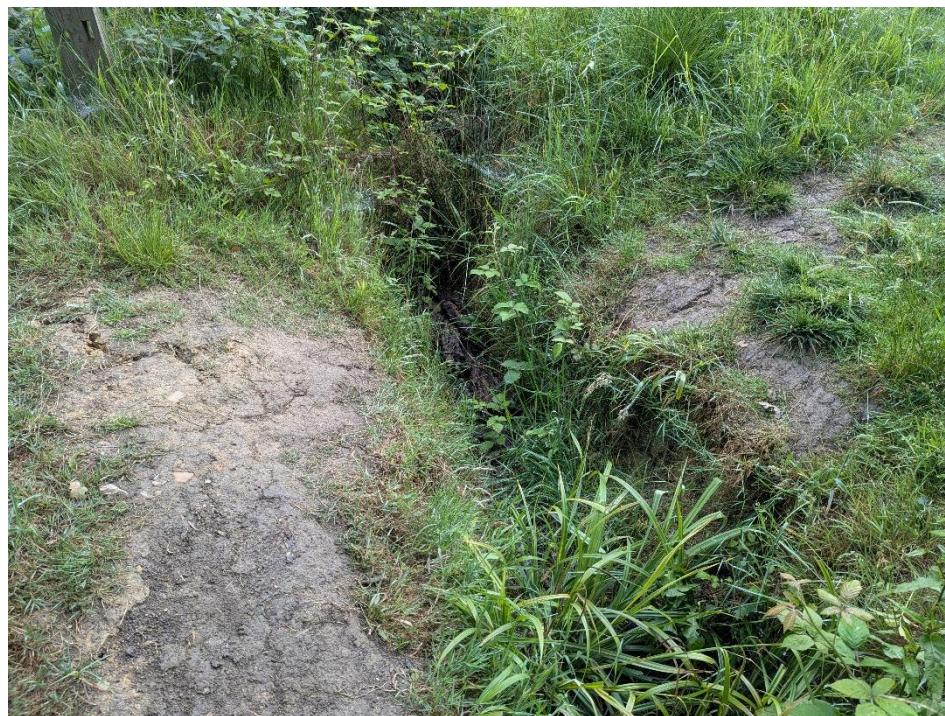
Figure 3. View of the ditch found to be outside of the site's boundary (taken June 2025).

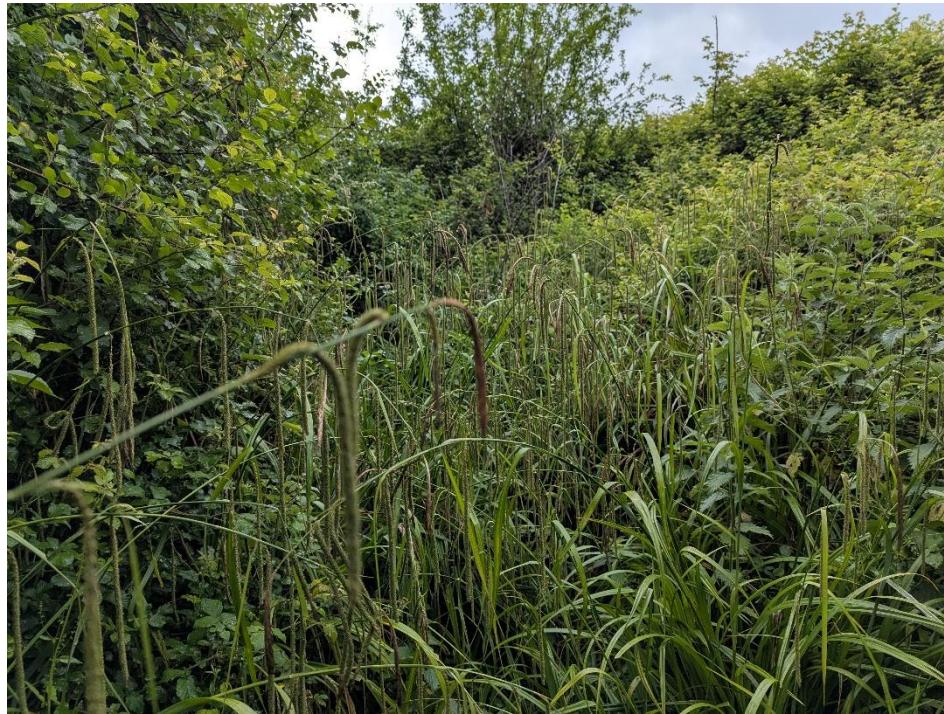
Figure 4. View of the Pendulous Sedge present along the PRoW (taken June 2025).
