HORSHAM DISTRICT COUNCIL CONSULTATION

TO:	Horsham District Council – Planning Dept
LOCATION:	Former Novartis Site Parsonage Road Horsham West Sussex
DESCRIPTION:	Residential development comprising approximately 206 dwellings, including the conversion of 'Building 3' and demolition of 'Building 36'. Vehicular access taken from Wimblehurst Road. Car and cycle parking, landscaping and open space and associated works. The replacement of the existing cedar trees at the site.
REFERENCE:	DC/25/0629
RECOMMENDATION:	Advice / more information / modification
2nd response in Red	Holding objection to RPA concerns that have not been addressed or appropriately justified and additional RPA concerns with proposed drainage infrastructure / more information / modification
3rd Response in Blue	Advice – previous concerns have been mostly addressed- subject to an Arboricultural Method Statement being secured by condition that sets out how sensitive works within RPAs of retained trees will be undertaken in accordance with the approved documents.

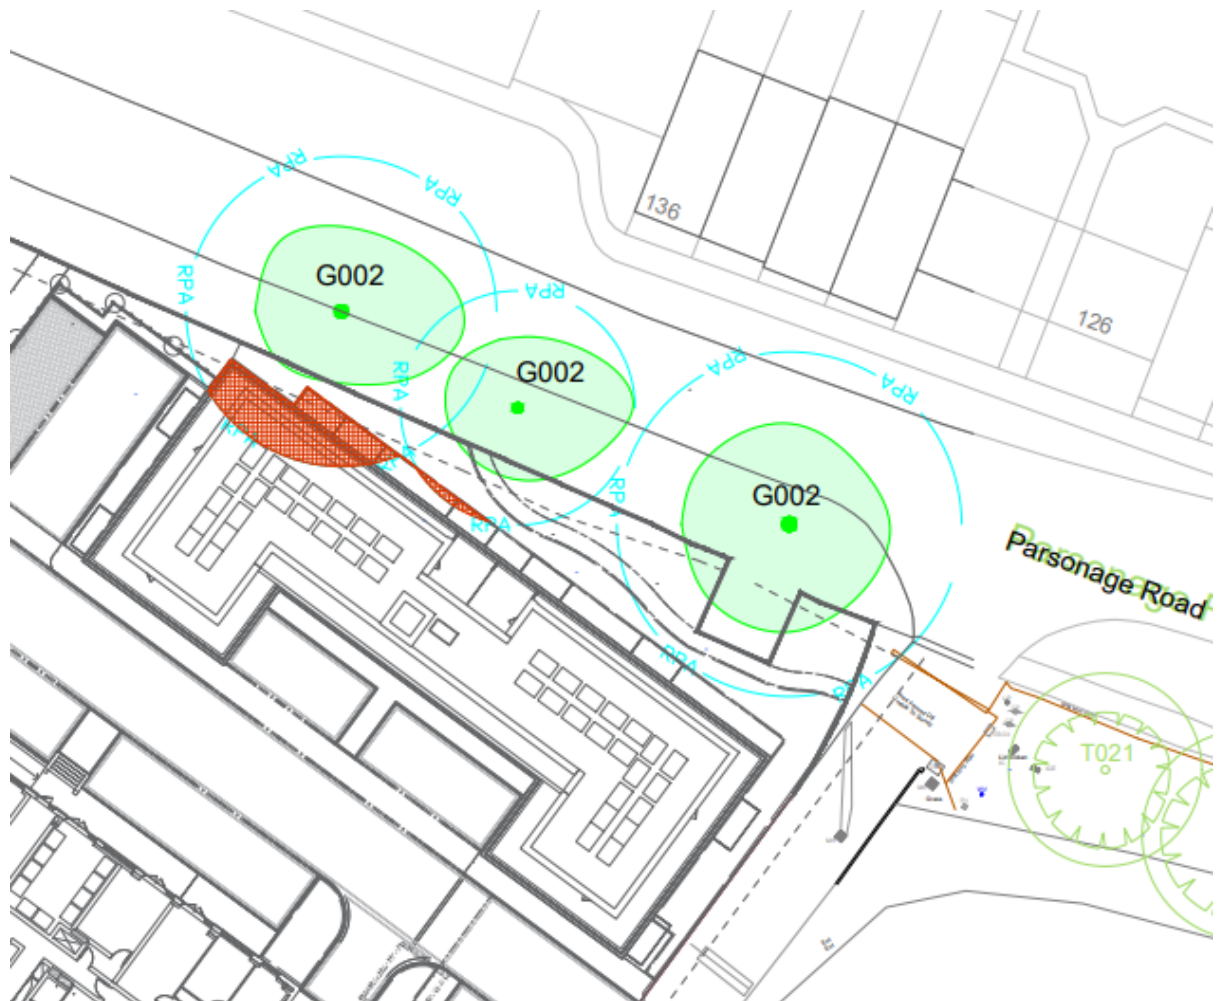
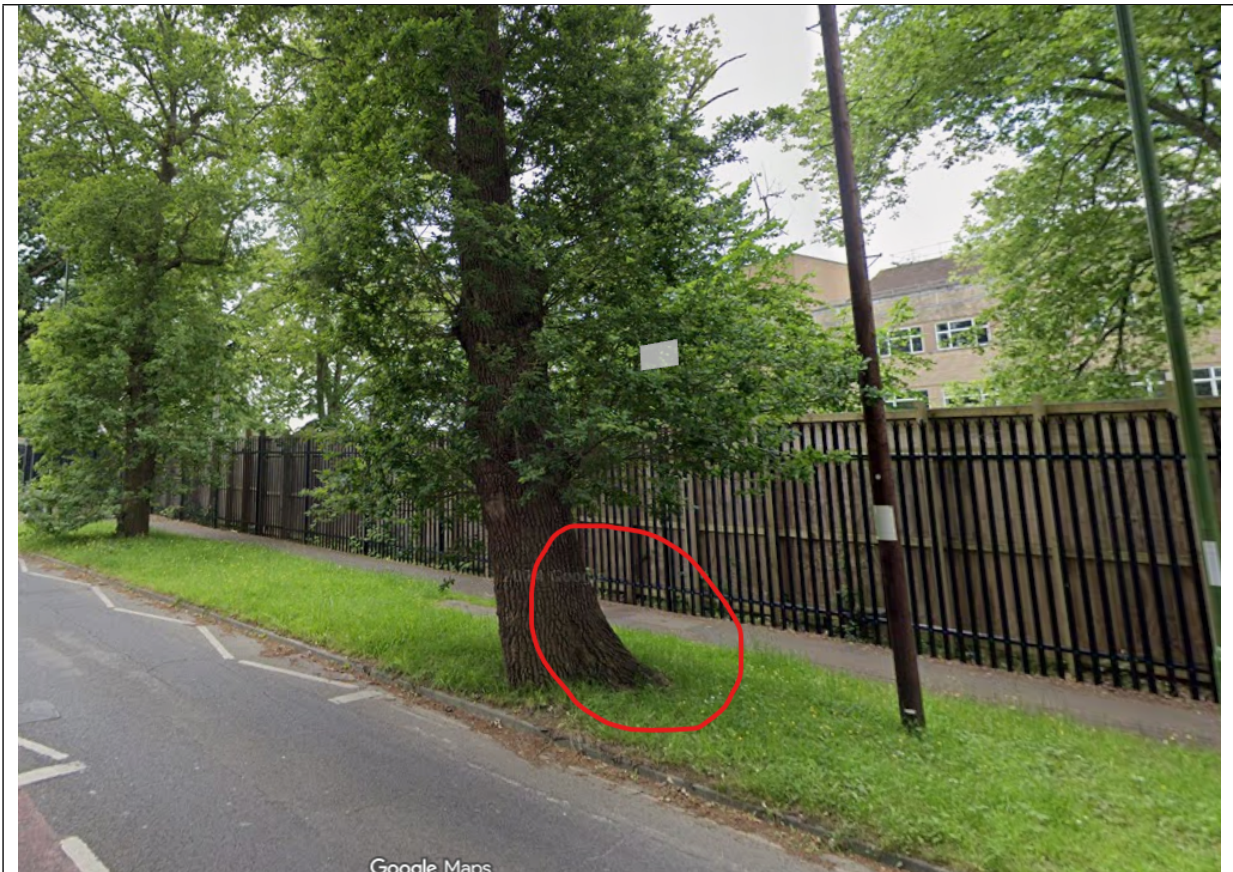
The RPAs of the off-site Oaks within G2 are still plotted using the standard circular RPA, which is shown to extend under Parsonage Road to the north. This method of plotting the RPA does not appropriately consider the impact that the road may have had on root distribution in this area.

The westernmost oak within G2 exhibits the characteristics of an old ditch-line tree, whereby the roadside edge is relatively flat, and it has a pronounced buttress root flare on the southern side. This is consistent with a tree that historically grew next to a previously maintained ditch. This feature strongly suggests that the main rooting area for this tree is likely located primarily to the south, within the site. The presence of the adjacent highway further supports this assumption.

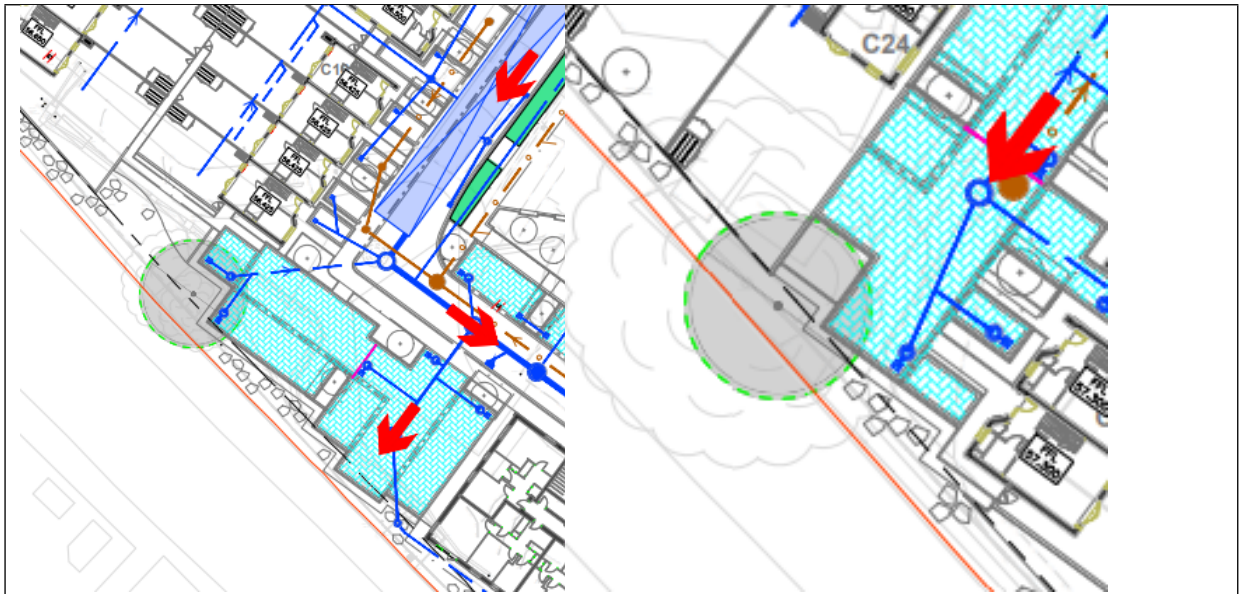
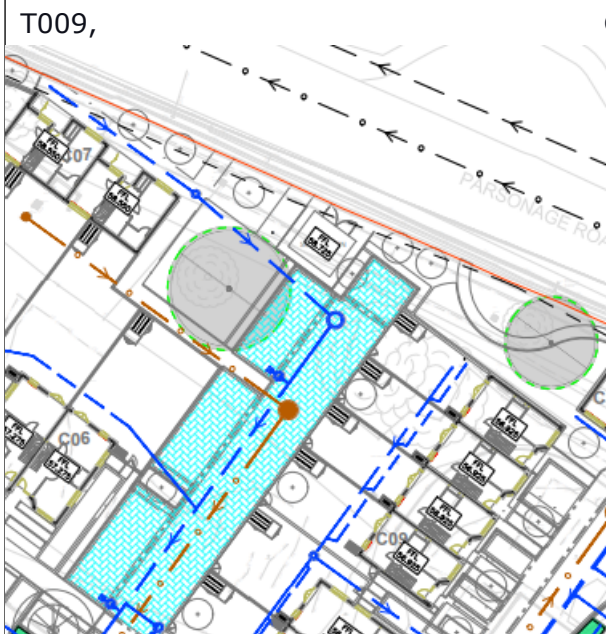
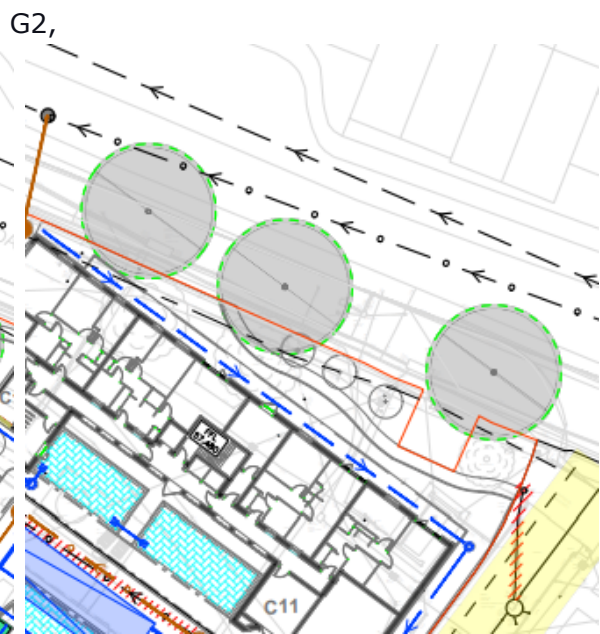
Services and drainage routes have not been provided; these will need to be kept outside the RPAs of retained trees. **Concerns raised regarding underground services within the RPAs of trees T045, T048, T009, and Group G2. Please either modify the routing of these services or provide confirmation that any works within the RPAs will be carried out using trenchless construction methods, such as impact moling or thrust boring; more information needed.** Concerns addressed, whereby service are proposed to be re-routed outside of RPAs

T045,

T048,
