HORSHAM DISTRICT COUNCIL CONSULTATION

TO:	Horsham District Council – Planning Dept
LOCATION:	Woodfords Shipley Road Southwater
DESCRIPTION:	Reserved matters application for the erection of up to 73no. dwellings, open space and child play provision, residential parking facilities and associated infrastructure, including access arrangements following outline application DC/21/2180, relating to layout, scale, appearance and landscaping.
REFERENCE:	DC/25/1658
RECOMMENDATION:	Advice/Modification
SUMMARY OF COMMENTS & RECOMMENDATION: The proposed layout is relatively favourable towards arboricultural constraints at the site. Significant boundary trees and hedgerow features are largely retained, and tree loss is for the most part limited to low-quality, dead, or diseased specimens or minor hedgerow sections required for access. Some incursions into RPAs occur, and have been technically justified, and mitigated through appropriate no-dig construction and arboricultural supervision, although some amendments to the route of the drainage infrastructure in some areas to avoid RPA conflicts. The proximity of a small number of dwellings to mature boundary oaks may give rise to some future resid

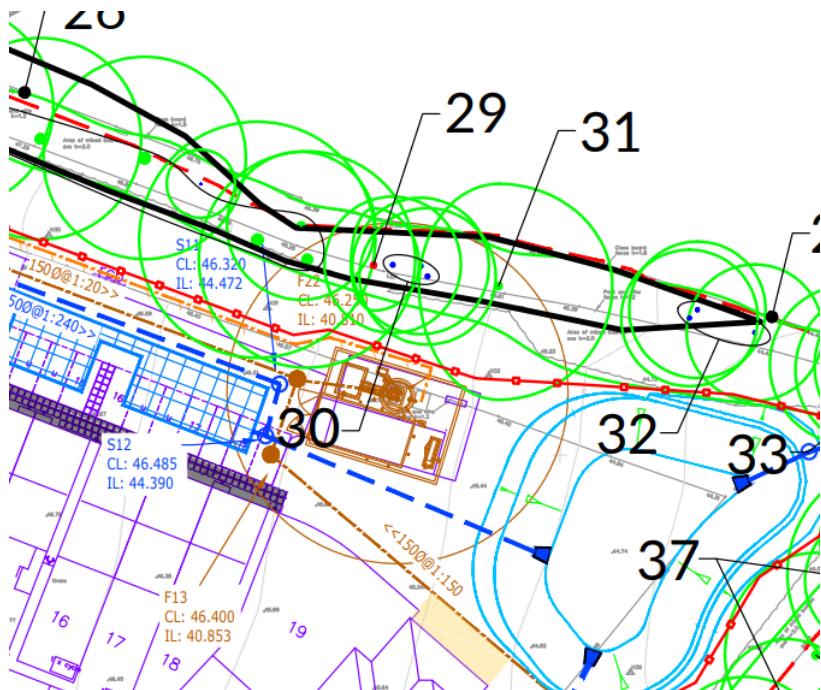
TPO trees in northeast corner – Drainage infrastructure sited in southern section of RPAs, given the protected status of the affected trees this should be moved and any drainage infrastructure should be located outside of RPAs, and the Pumping Station should also be moved at least 2m to the south, to allow for an appropriate amount of separation from the RPAs in the area, not only to protect the RPAs during the build process, but also form likely post development impacts. Whereby, new infrastructure often requires ongoing maintenance and occasional intrusive repair, posing additional long-term risks to the affected protected trees and their RPAs, should any underground services need to be re-opened to allow for future repairs to the pipework post development.

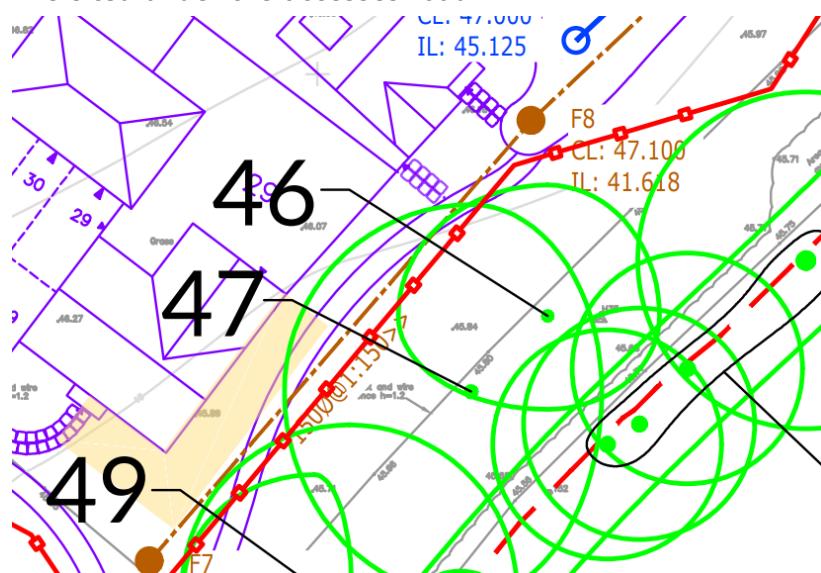
T47 - It is apparent that drainage infrastructure sited with the RPA of T47, as with the section of drainage infrastructure in the northeast corner this should be removed from the RPA of the affected tree. Also there is no reference to no no-dig build methods where the RPA of T47 is sited under the accesses road.

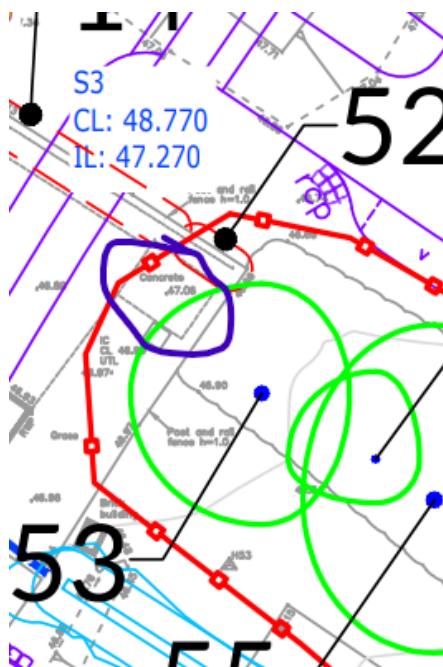
T53-T56 (English oaks along the internal tree line): Footpath alignment in the northern parcel crosses into their outer RPAs. A no-dig cellular confinement system is proposed to avoid root disturbance. However, confirmation should be sought on what this concrete base is shown in the RPA of T37
