HORSHAM DISTRICT COUNCIL CONSULTATION

TO:	Horsham District Council – Planning Dept
LOCATION:	Former Novartis Site Parsonage Road Horsham West Sussex
DESCRIPTION:	Residential development comprising approximately 206 dwellings, including the conversion of 'Building 3' and demolition of 'Building 36'. Vehicular access taken from Wimblehurst Road. Car and cycle parking, landscaping and open space and associated works. The replacement of the existing cedar trees at the site.
REFERENCE:	DC/25/0629
RECOMMENDATION:	Advice / more information / modification
2nd response in Red	Holding objection to RPA concerns that have not been addressed or appropriately justified and additional RPA concerns with proposed drainage infrastructure /more information / modification
SUMMARY OF COMMENTS & RECOMMENDATION: The application seeks planning consent for a mixed residential-led redevelopment of the former Novartis site. The submitted Arboricultural Impact Assessment (AIA) identifies 30+ individual trees and several hedgerows for removal, primarily due to direct conflicts with the proposed layout or limited remaining life expectancy. While several trees are to be retained and protected throughout constru

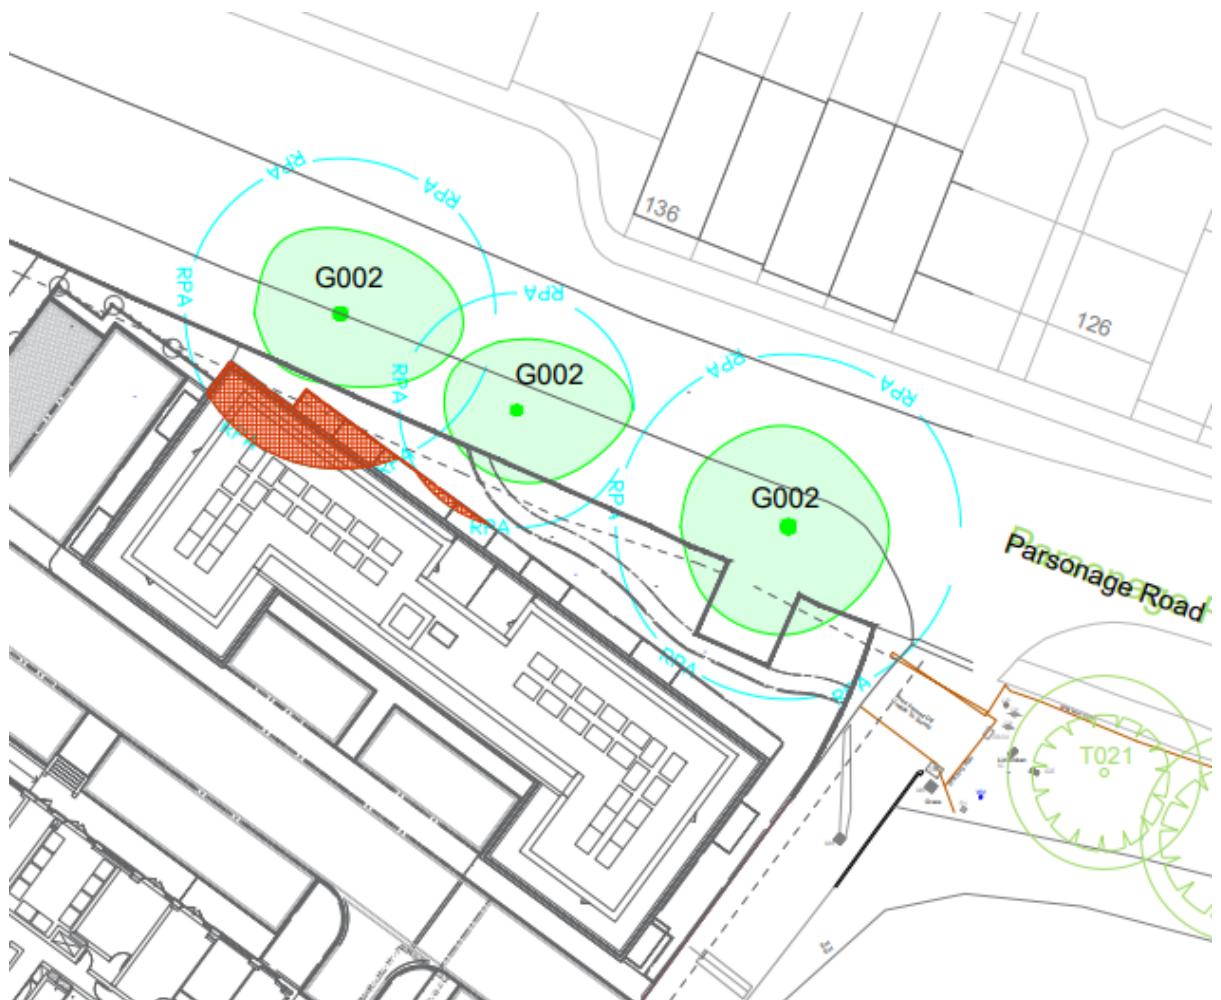
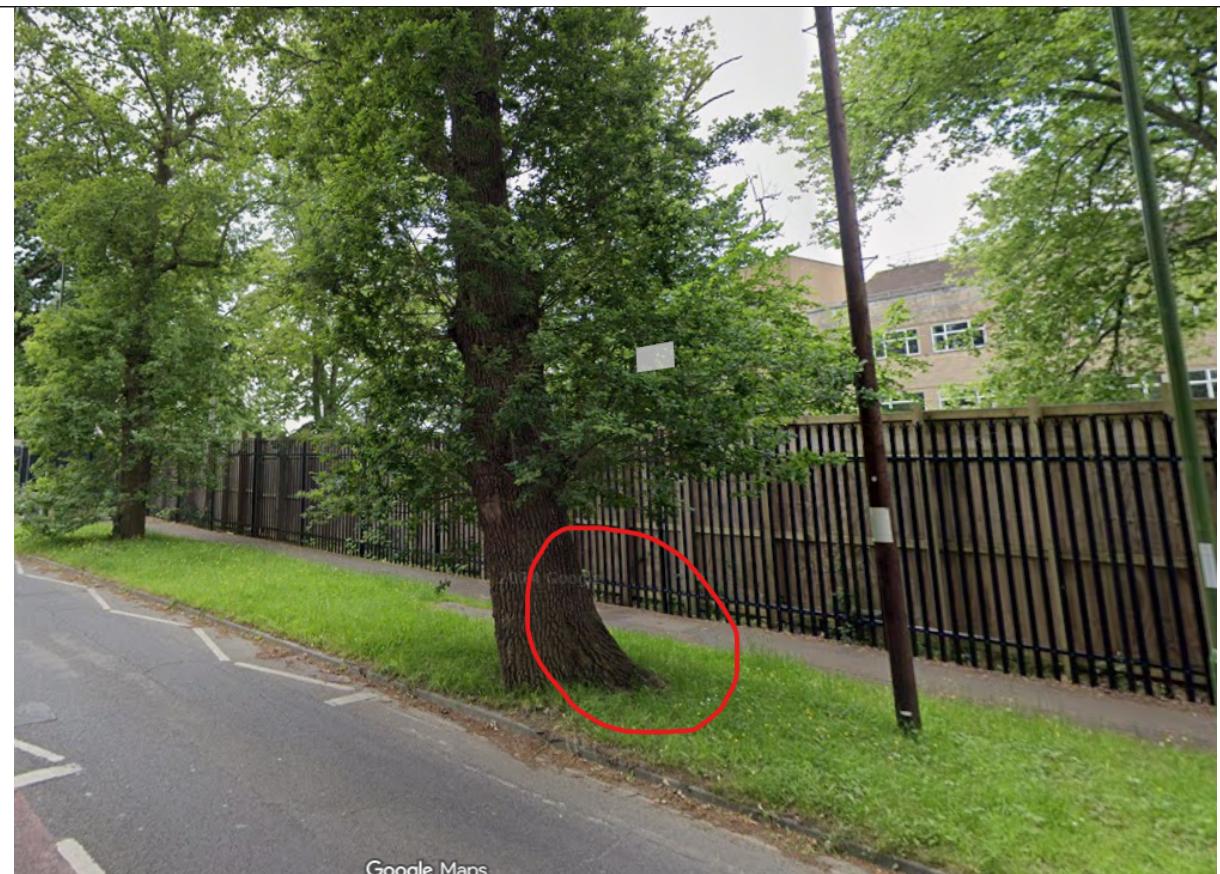
The RPAs of the off-site Oaks within G2 are still plotted using the standard circular RPA, which is shown to extend under Parsonage Road to the north. This method of plotting the RPA does not appropriately consider the impact that the road may have had on root distribution in this area.

The westernmost oak within G2 exhibits the characteristics of an old ditch-line tree, whereby the roadside edge is relatively flat, and it has a pronounced buttress root flare on the southern side. This is consistent with a tree that historically grew next to a previously maintained ditch. This feature strongly suggests that the main rooting area for this tree is likely located primarily to the south, within the site. The presence of the adjacent highway further supports this assumption.

While it is noted that additional tree coverage exists at the site, principally T016, T017, and T018. The assumption that these trees would have acted as a barrier to any significant roots from the G2 trees has not been adequately demonstrated. Given that the area to the south of the trees has historically been maintained as soft ground, and considering the built environment surrounding the G2 trees, it is highly likely that roots from the G2 trees extend into the site, including the area where the new apartment block is proposed.

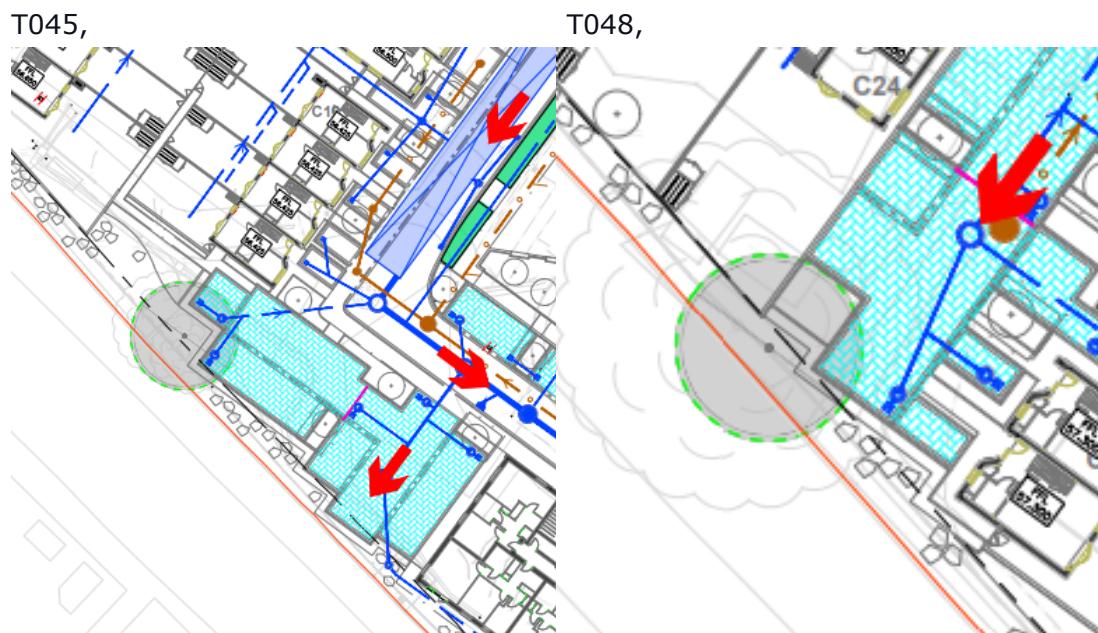
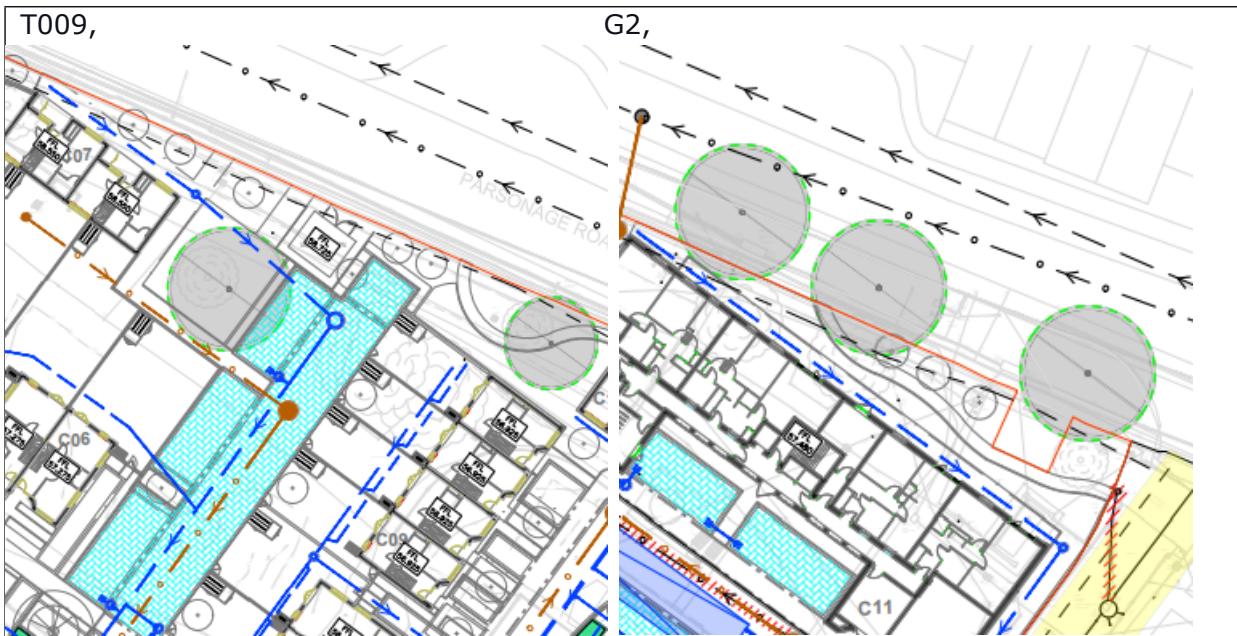
Services and drainage routes have not been provided; these will need to be kept outside the RPAs of retained trees. **Concerns raised regarding underground services within the RPAs of trees T045, T048, T009, and Group G2. Please either modify the routing of these services or provide confirmation that any works within the RPAs will be carried out using trenchless construction methods, such as impact moling or thrust boring; more information needed.**

Where the use of no-dig construction methods is proposed in the RPAs of retained trees, it is acceptable in some instances, and it is acknowledged that the extent of all the incursions falls below 20%. Nonetheless, some adjustment to the site layout is needed to reduce the need for any root pruning, as root pruning to address RPA conflicts is not considered to be appropriate.
